FLOYD CONSULT

An assessment of timber condition and damp at

THE CHURCH OF ST NICHOLAS, LOWER FYFIELD.

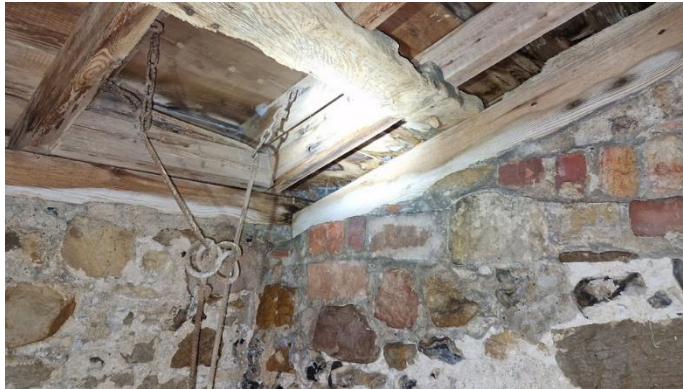
1

Localised and current water ingress and low level decay to edge of sarking above verge masonry. Unable to get onto roof at this time, although it seems probable there is a problem with the flashing or roof covering.

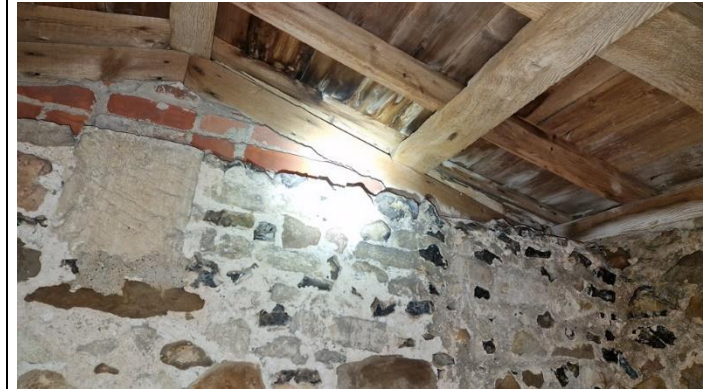
2

Comment as 1.

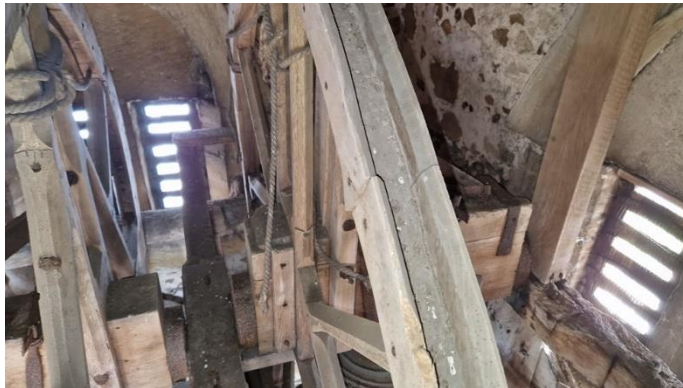
3

Possible current wood borer activity in elm bell wheel rim. This is not unusual – would always have been a maintenance item, and requires no action.

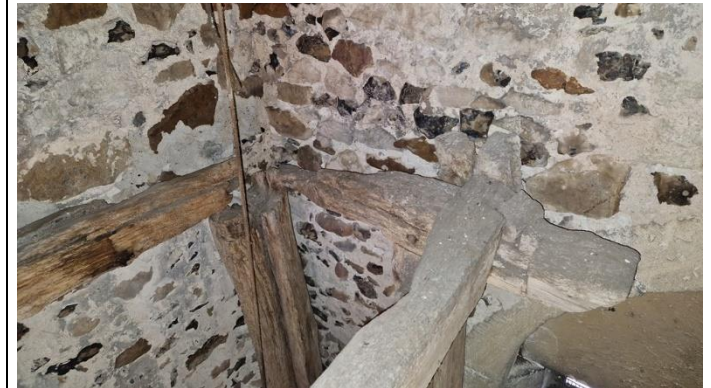
4

Historic damage to top of bell frame – not progressive.

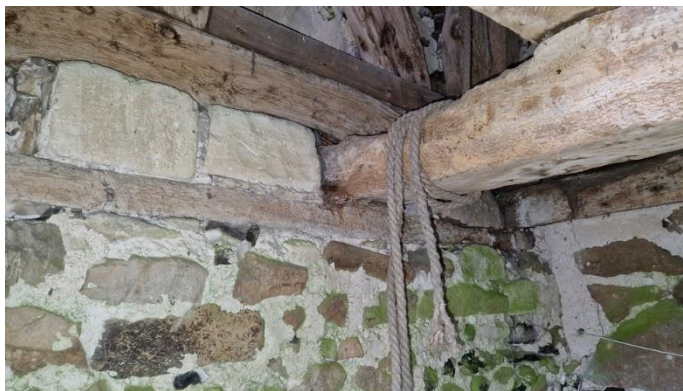
5

Historic loss of 50% section of bell frame foundation beam in wall.

The bells are not being swung, so it is probable the remaining section is sufficient to support the frame – engineer to confirm.

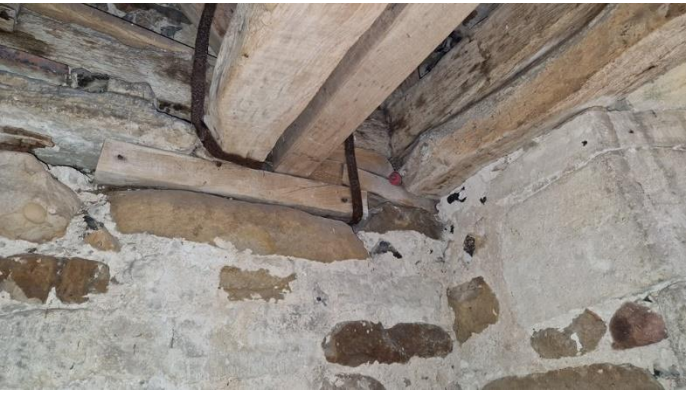
<p>6 The edge plate for the bell frame is decayed in the wall – note screwdriver.</p> <p>This is historic decay. The frame seems to be picked up by the masonry ledge, so no remedial work required.</p>

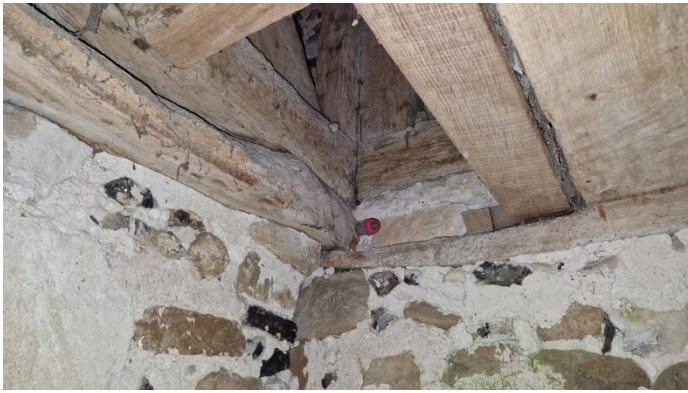
<p>7 Comment as 6.</p>

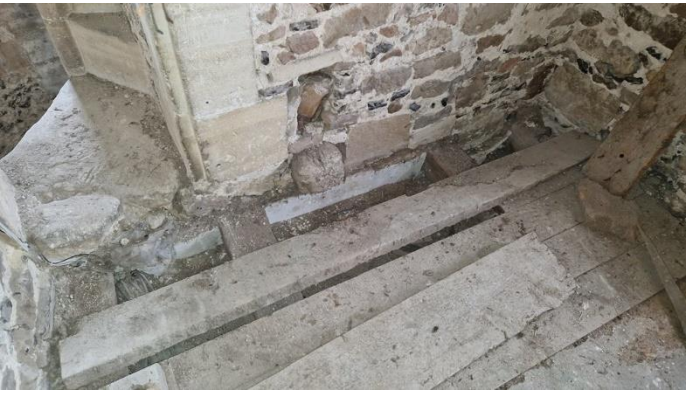
<p>8 There is historic loss of sapwood margin in the bearings of bell chamber floor joists. However sufficient section remains for the floor to function.</p>

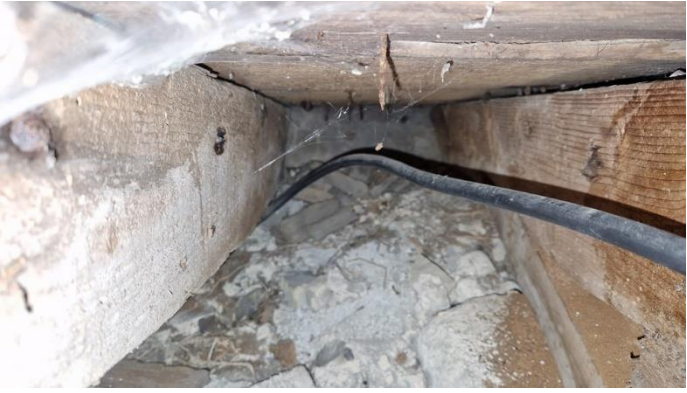
NAVE			
<p>9 Cornice boards conceal the wall head.</p> <p>All timber at wall head found to be sound and dry.</p>

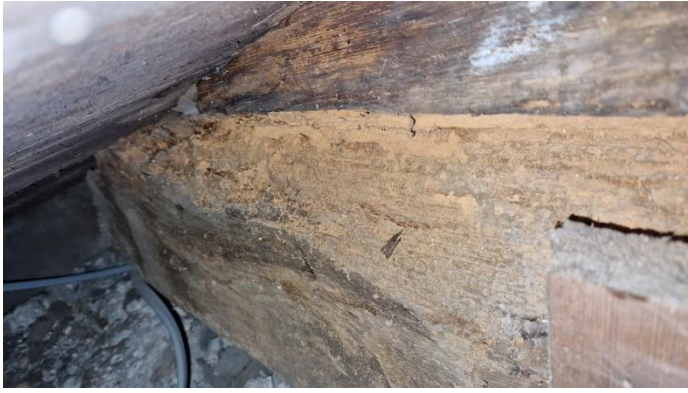
<p>10 Superficial and historic wood borer damage to arriase of tie beam.</p>

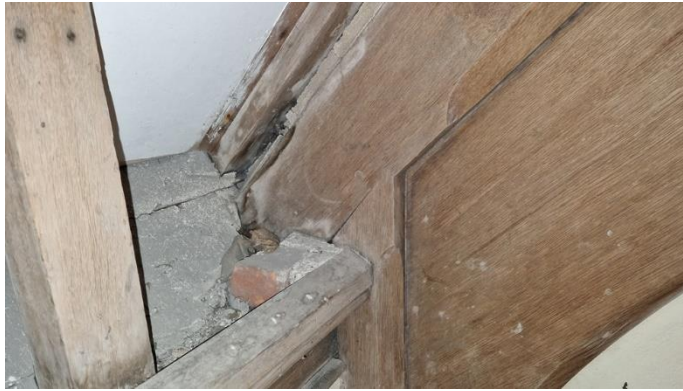
11

Relatively recent oak rebuild. Some very localised water staining. But now sound and dry.

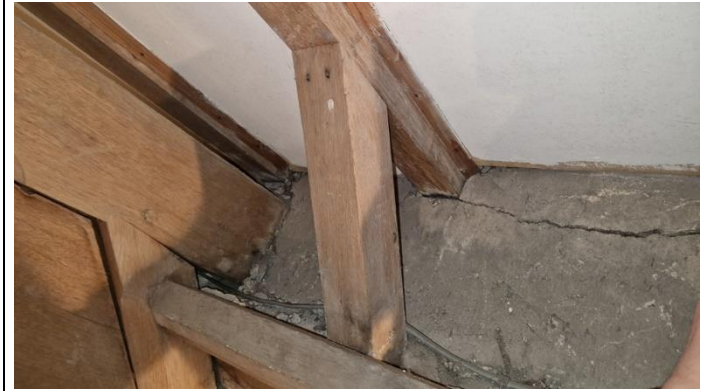
12

Comment as 11

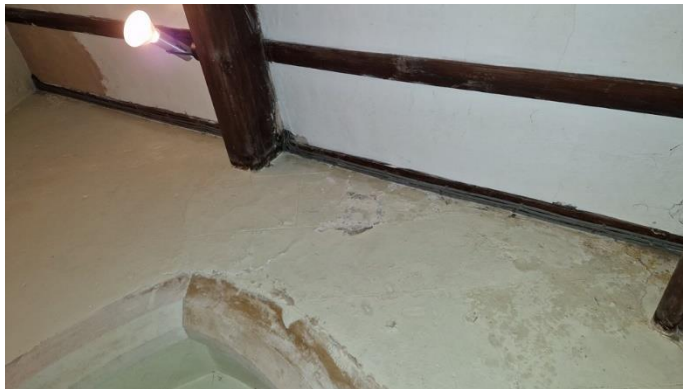
13

Signs of wetting of the W wall. The bearing of the purlin was micro drilled and found to be sound.

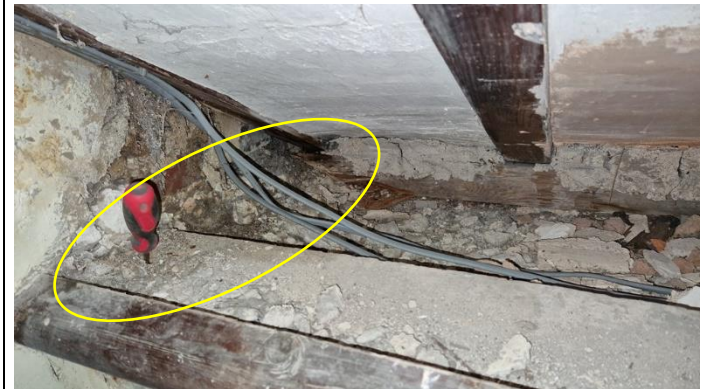
14

Ends of rafter plate and cornice decayed historically and locally – note screwdriver.

The arrangement is stable, so intervention not necessary.

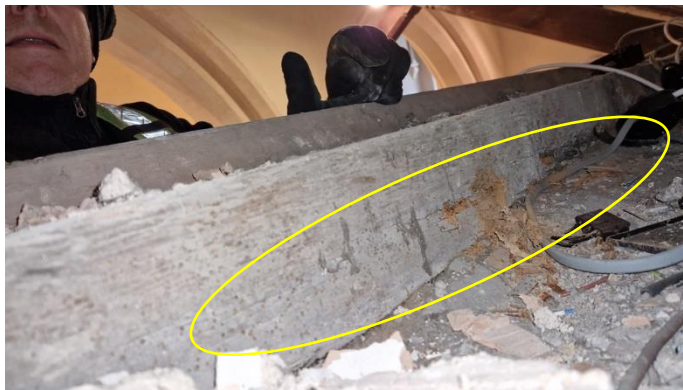
15

The back lower edge of the cornice plate is historically damaged by wood borer.

The arrangement is stable, so intervention not necessary.

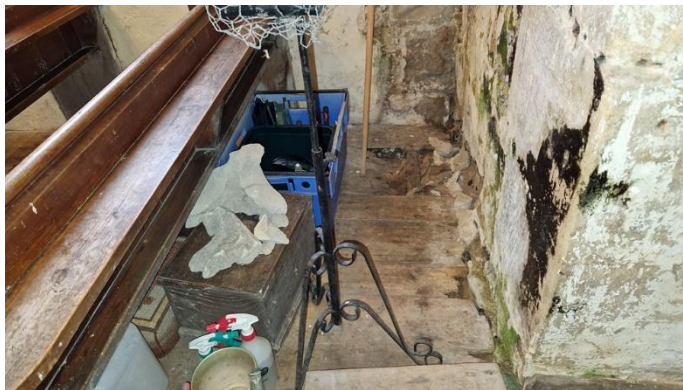
16
Approx. 2 – 3m² decayed
pew platform.

Moss growth indicating
masonry is very wet at
this point.

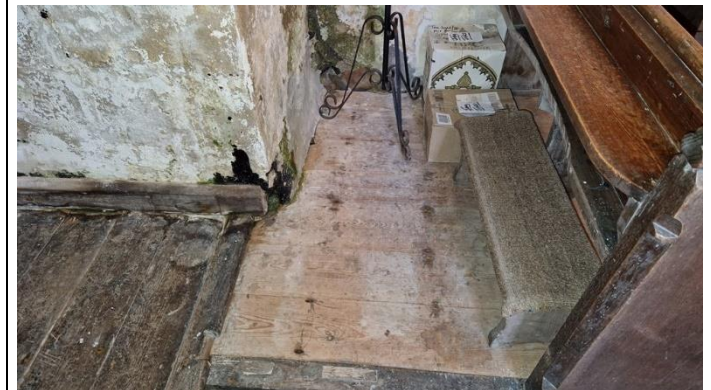
17
Again moss growth
indicating wet conditions
and replacement
boarding showing
previous repair.

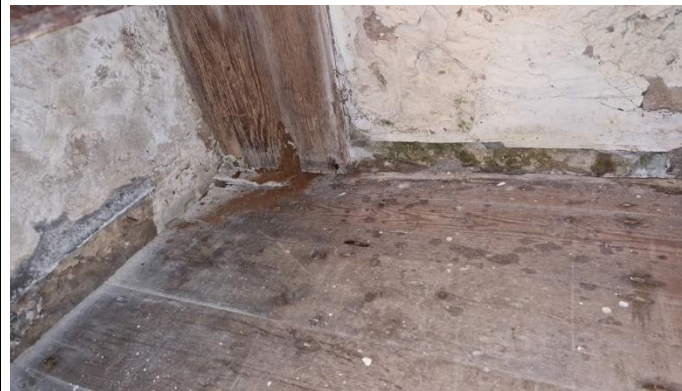
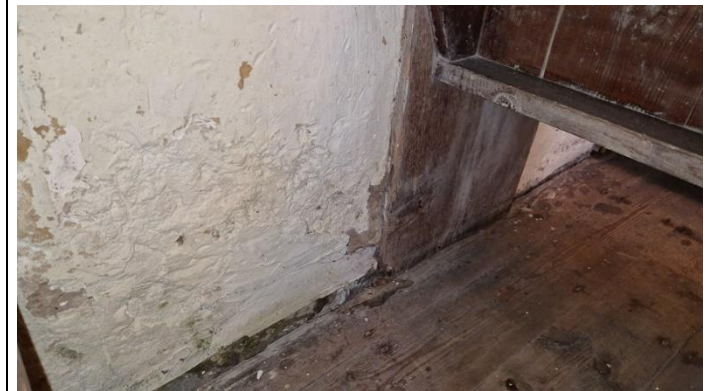
18
The floor is sagging and the bench ends in contact
with the external wall have been damaged
historically (and possibly currently) by wood borer
and low level fungal decay.

The floor structure has almost certainly been
decayed, which has caused the sagging.

Eventually use of a lime-based plaster would be recommended, to allow the walls to dry at their bases. However, the wall response to any external works is unpredictable. As a minimum, the floors should be stabilised – especially on the N elevation (obs 18/19), with all decayed material replaced in oak.

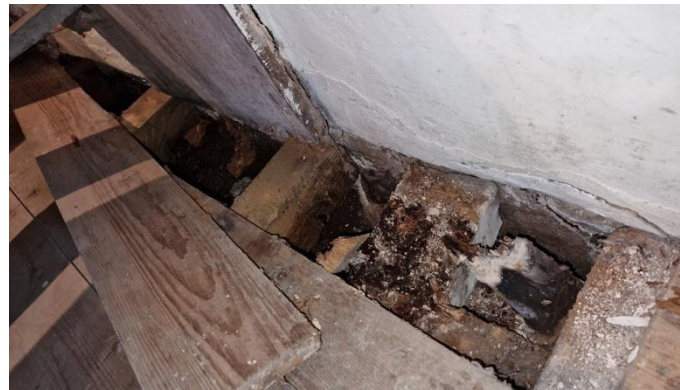
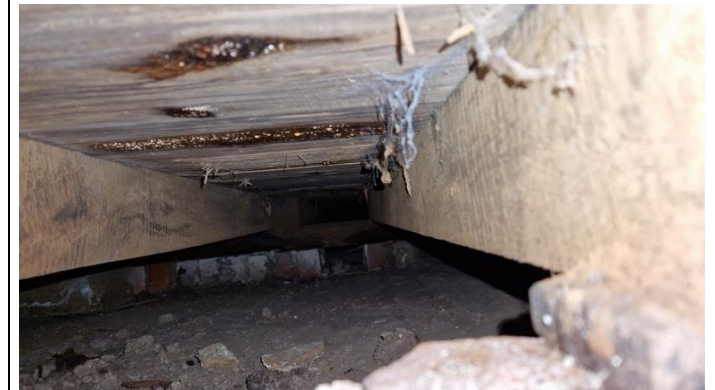
19

Area very wet. A board was lifted showing oak joists on sleeper walls

The softwood boards are decaying at their edges, together with wedges previously used to stabilise them.

The sub floor is wet.

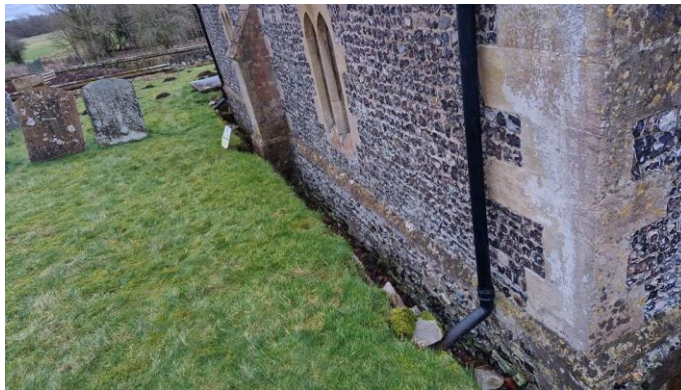
The wettest areas internally correspond to the positions of the downpipes externally.

The problem, as with many churches of this type, is rising external ground levels wetting up the wall floor junctions. The only way to address this is to remove the wet ground from against the external wall. Dry well areas have been tried unsuccessfully in this case (obs 20 – 22). They can be successful if the channel surface is able to efficiently collect and discharge any water entering it – which in this case it can't.

The preferred system is already in place – albeit not very well executed. The drains are probably blocked. In this case the existing system should be over hauled to work as initially intended. This will require formation of a lined channel base and confirmation of all sub surface water pathways and drainage points.

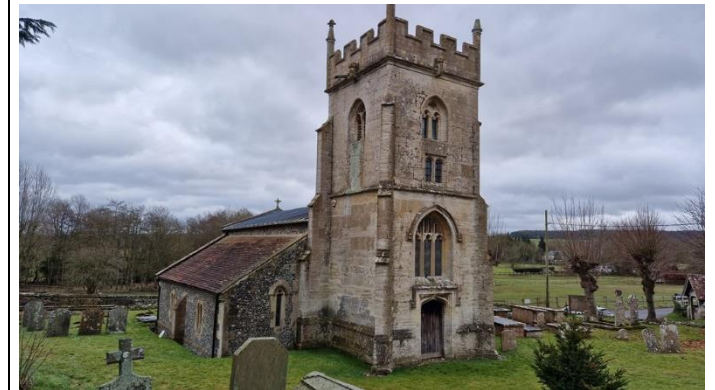
21

High external ground levels around the W end of the church.

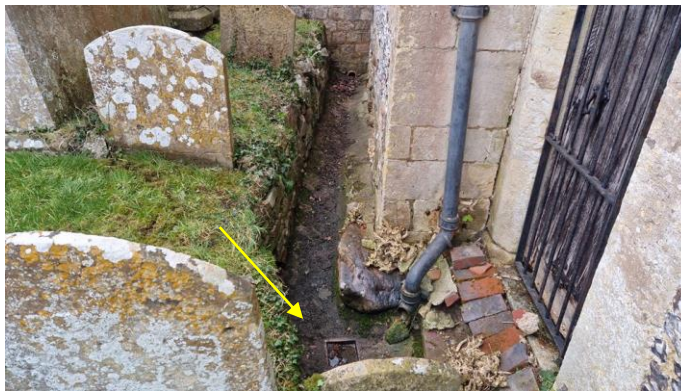
22

Although external ground levels reduce around the SE quadrant of the church, a rainwater gulley – arrowed – was found to be blocked – possibly representative of the system as a whole. See discussion.
