Bat Management Plan

St Mary the Virgin, Clothall

On behalf of The Bats in Churches Project

October 2021

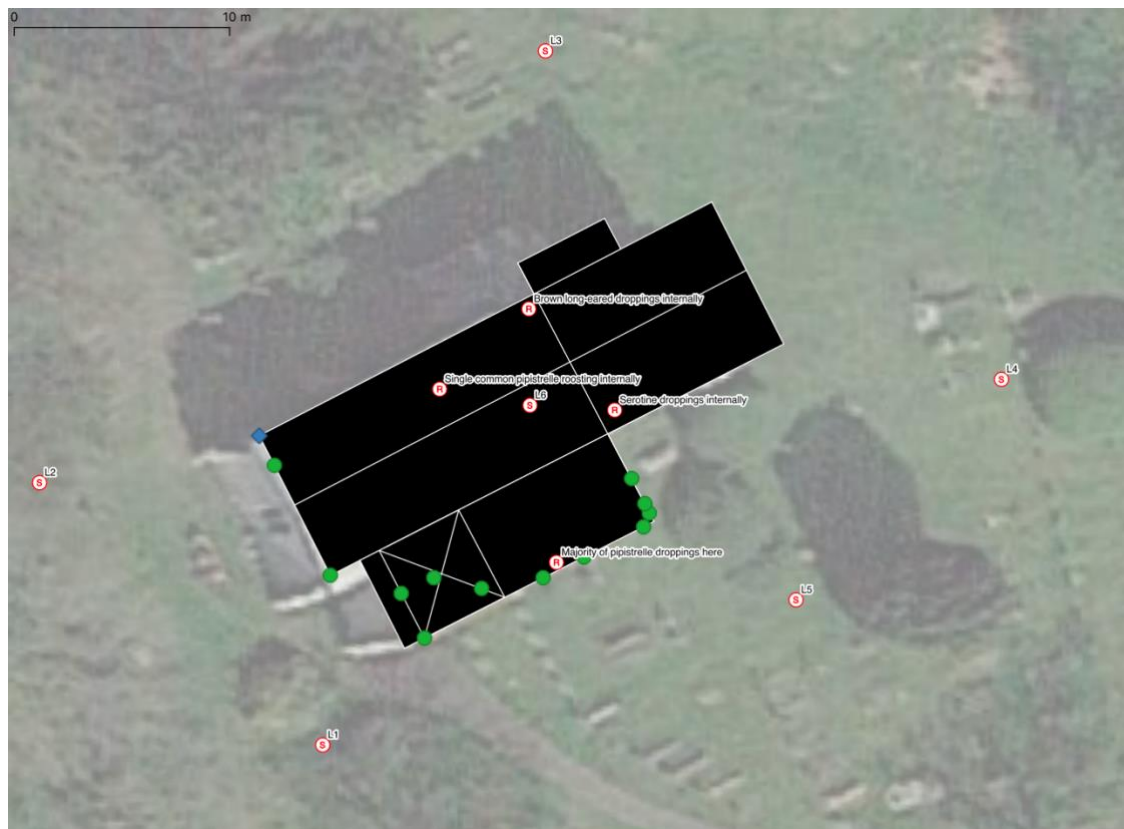
Figure 1: Surveyor locations (S) and indicative roost locations

4.3.1 On 03 June 2021 28 common pipistrelle bats emerged from six different features:

- under the barge boarding on the western aspect of the church
- from the southern aspect of the belfry roof (under a tile and from the eaves)
- under the eaves on the southern aspect of the lady chapel

- a gap under the roof on the eastern aspect of the lady chapel
- separate gaps in the stonework of the wall on the eastern aspect of the lady chapel

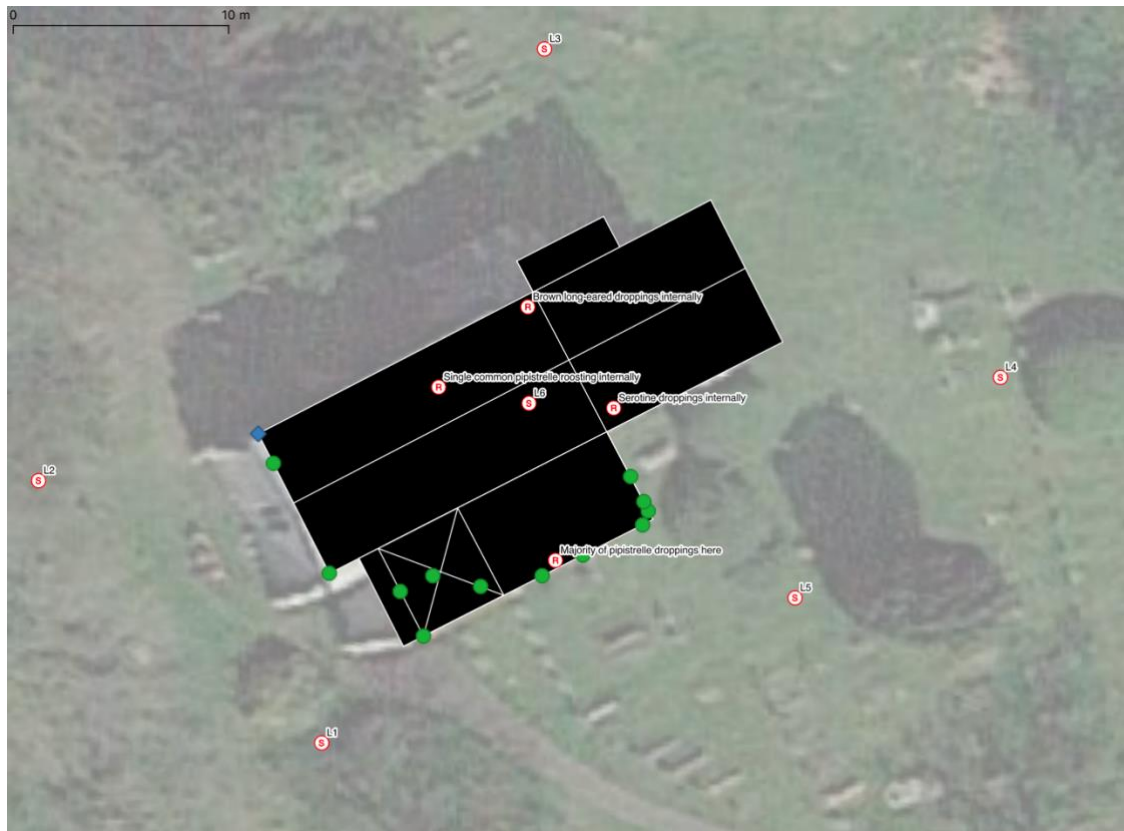
Figure 1: Surveyor locations (S) and indicative roost locations

Dusk 03.06.21

An individual common pipistrelle was recorded emerging from under the barge boarding on the western aspect of the church at 21:35.
