THE CHURCH OF ST ANDREW, WOOD DALLING, NORFOLK

BAT MANAGEMENT PLAN

Report ref: P2021-20 R2 **FINAL**

Date: 30th October 2021

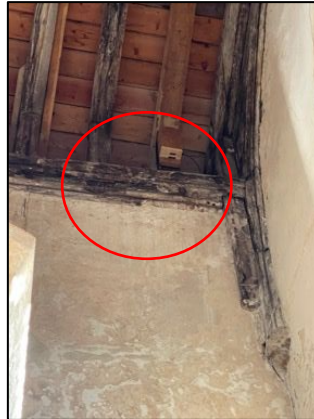
Figure 3 – Internal mortise box installed in the nave. Others were installed in the tower

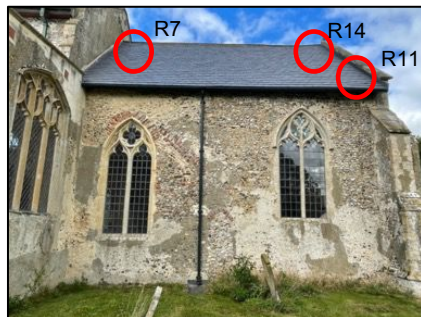
3.5 As part of the chancel roof repairs in 2017, 5 no bat lead bat slots were created in the chancel roof (refer to Figure 4) – 2 on the north and 3 on the south side. These replaced any lost bat roosting potential under the slates as part of the repair works. Several oak Kent bat boxes were installed on trees around the churchyard but these have not been maintained and are starting to vegetate over.

Figure 4 – Lead bat slots put into the chancel as part of the 2017 repair works

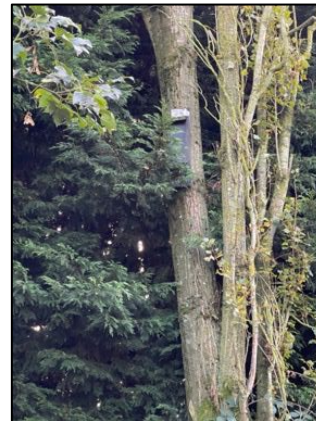
Figure 5 – Kent bat box on tree, access partly obstructed by vegetation

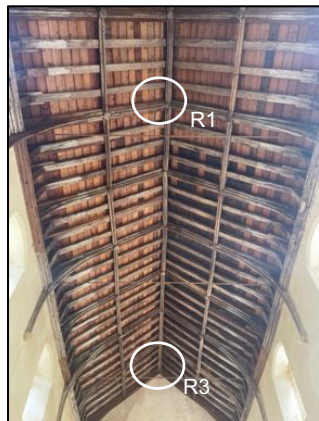
Figure 8 - The nave roof structure provides a multitude of roosting opportunities including principal areas roost R1 and R3

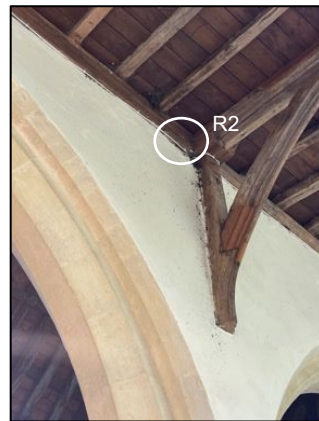
Figure 9 – Roost R2 located in the south aisle. This was re-created under licence as part of the south aisle re-roofing works in 2012

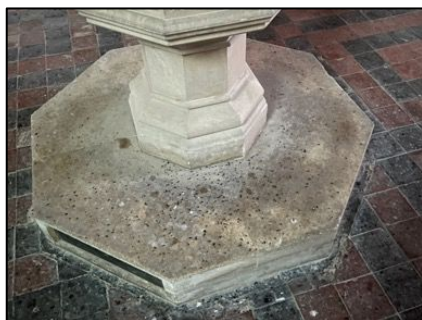
Figure 10 – Droppings at the base of the font during the June survey below roost R1

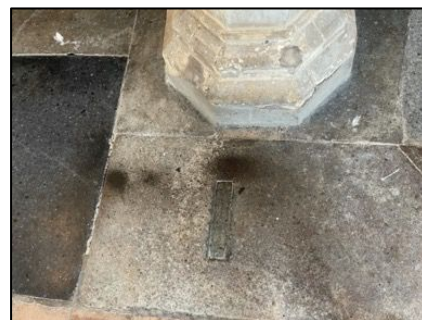
Figure 11 – Droppings and debris below roost site R2 in the south aisle

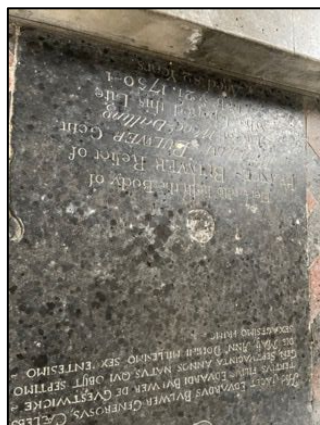
Figure 12 – Droppings and urine on ledger stones below the chancel step – August 2021- Roost R3

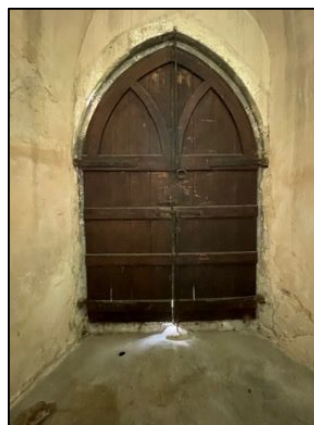
Figure 13 – West door is the main access (A3) for the pipistrelles from the church

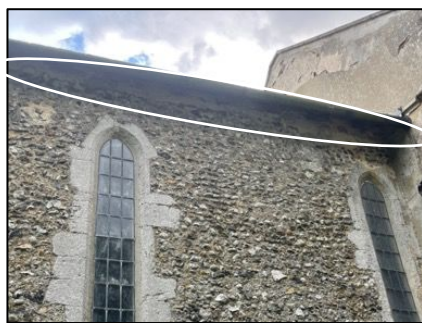
Figure 14 – Location of access point A2 (principal access for natterer's). Small numbers of common pipistrelle also emerged (but these did not appear to have come from the inside) and were considered to have roosted beside the rafters

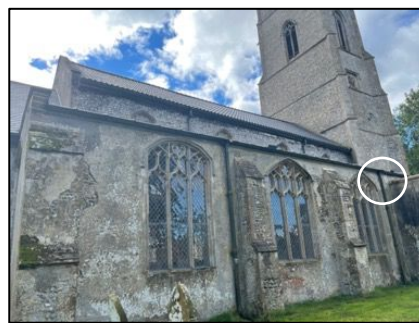
Figure 15 – North aisle and nave, showing the location of principal natterer's access point A1

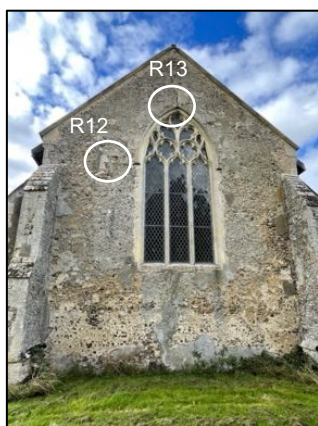
Figure 16 - Eastern wall of the chancel showing the location of the various roost sites

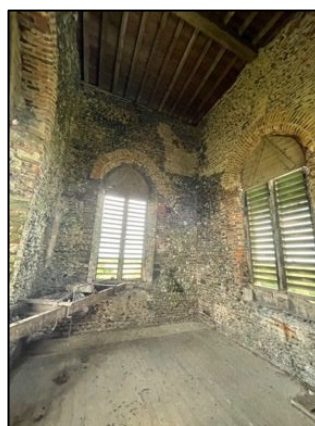
Figure 17 – Bat access is possible to both the silence and bell chamber although there is limited evidence of use. Until recently both areas were heavily impacted by pigeons (these have only recently been excluded)

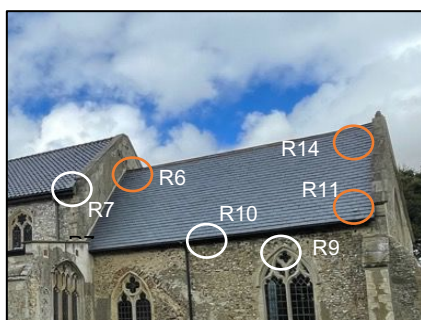
Figure 18 – South side of the chancel roof showing the various bat roost areas (bat slots shown in orange)

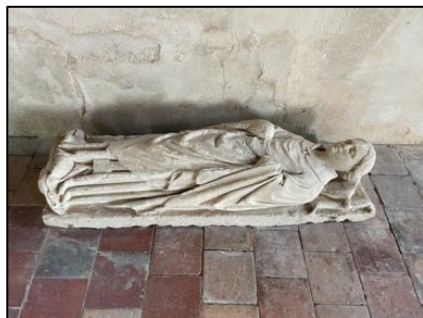
Figure 20 – Marble effigy in the north aisle is of high significance. This is in an area where the bats fly before leaving the church via access A1

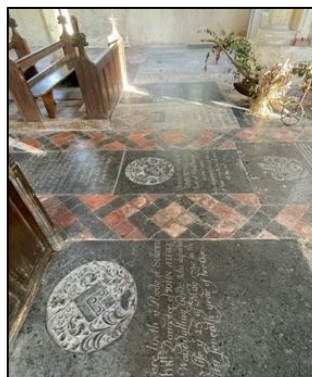
Figure 21 – Ledger stones in the nave of high significance. These show a high level of historic and current bat urine damage. These are shown close to roost R3 and therefore suffers significant damage

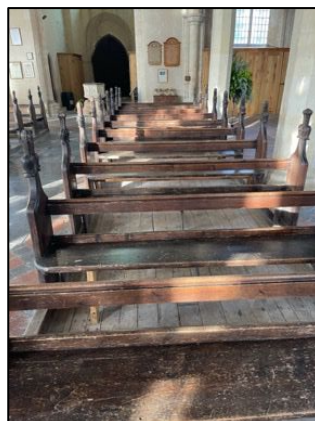
Figure 22 – Medieval pews in the nave. These show significant urine staining

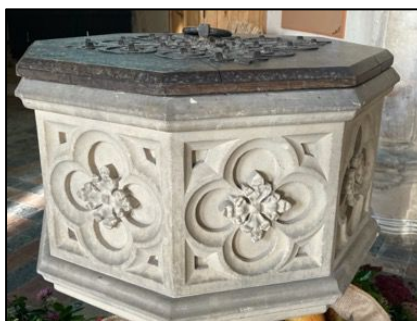
Figure 23 – The font sits directly under one of the bat roosting areas

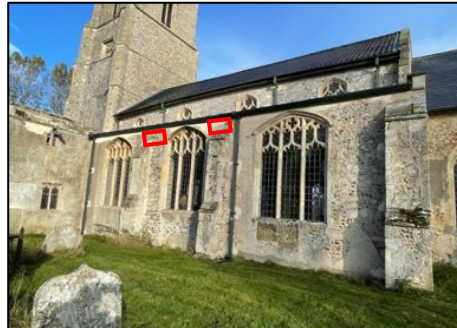
Figure 25 – Potential locations of bat boxes on the south aisle

- 7.9 Consideration could be given to attaching two of the above boxes to the south aisle wall, possibly between the top of the buttress and the eaves where they would be least visible, as shown on the following photograph extract.

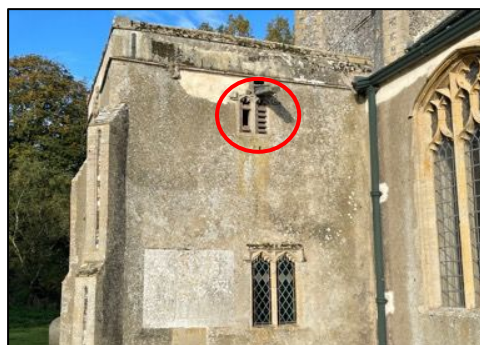
Figure 26 – Potential location for bat boxes behind louvres on the parvise

- 7.10 The parvise to the south porch has no internal access but has two louvred windows on the eastern and western elevations, part of which leads internally to the sealed parvise void and the other apparently to a barn owl box. Another location for the void boxes could be to set one into each of the windows on the parvise.

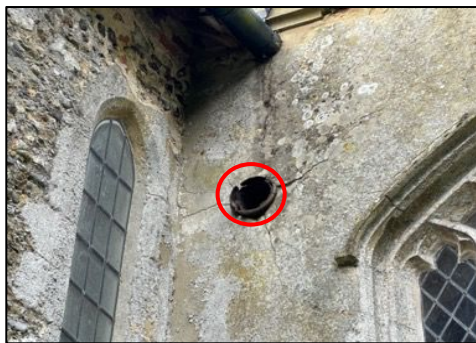
- 7.11 On the eastern side of the north aisle, a disused flue pipe is present. This was used by natterer's for roosting in June 2011. The architect would ideally like to block this flue to prevent water ingress. This provides the opportunity to incorporate a cavity box into the end of the pipe and seal up around. As this would involve blocking an existing roost, it would require registration under BiCCL.

Figure 27 – Location of flue pipe on the west side of the north aisle
