## Bats in Churches Project:

All Saints' Church

Swanton Morley

Ecology End of Project Final Report

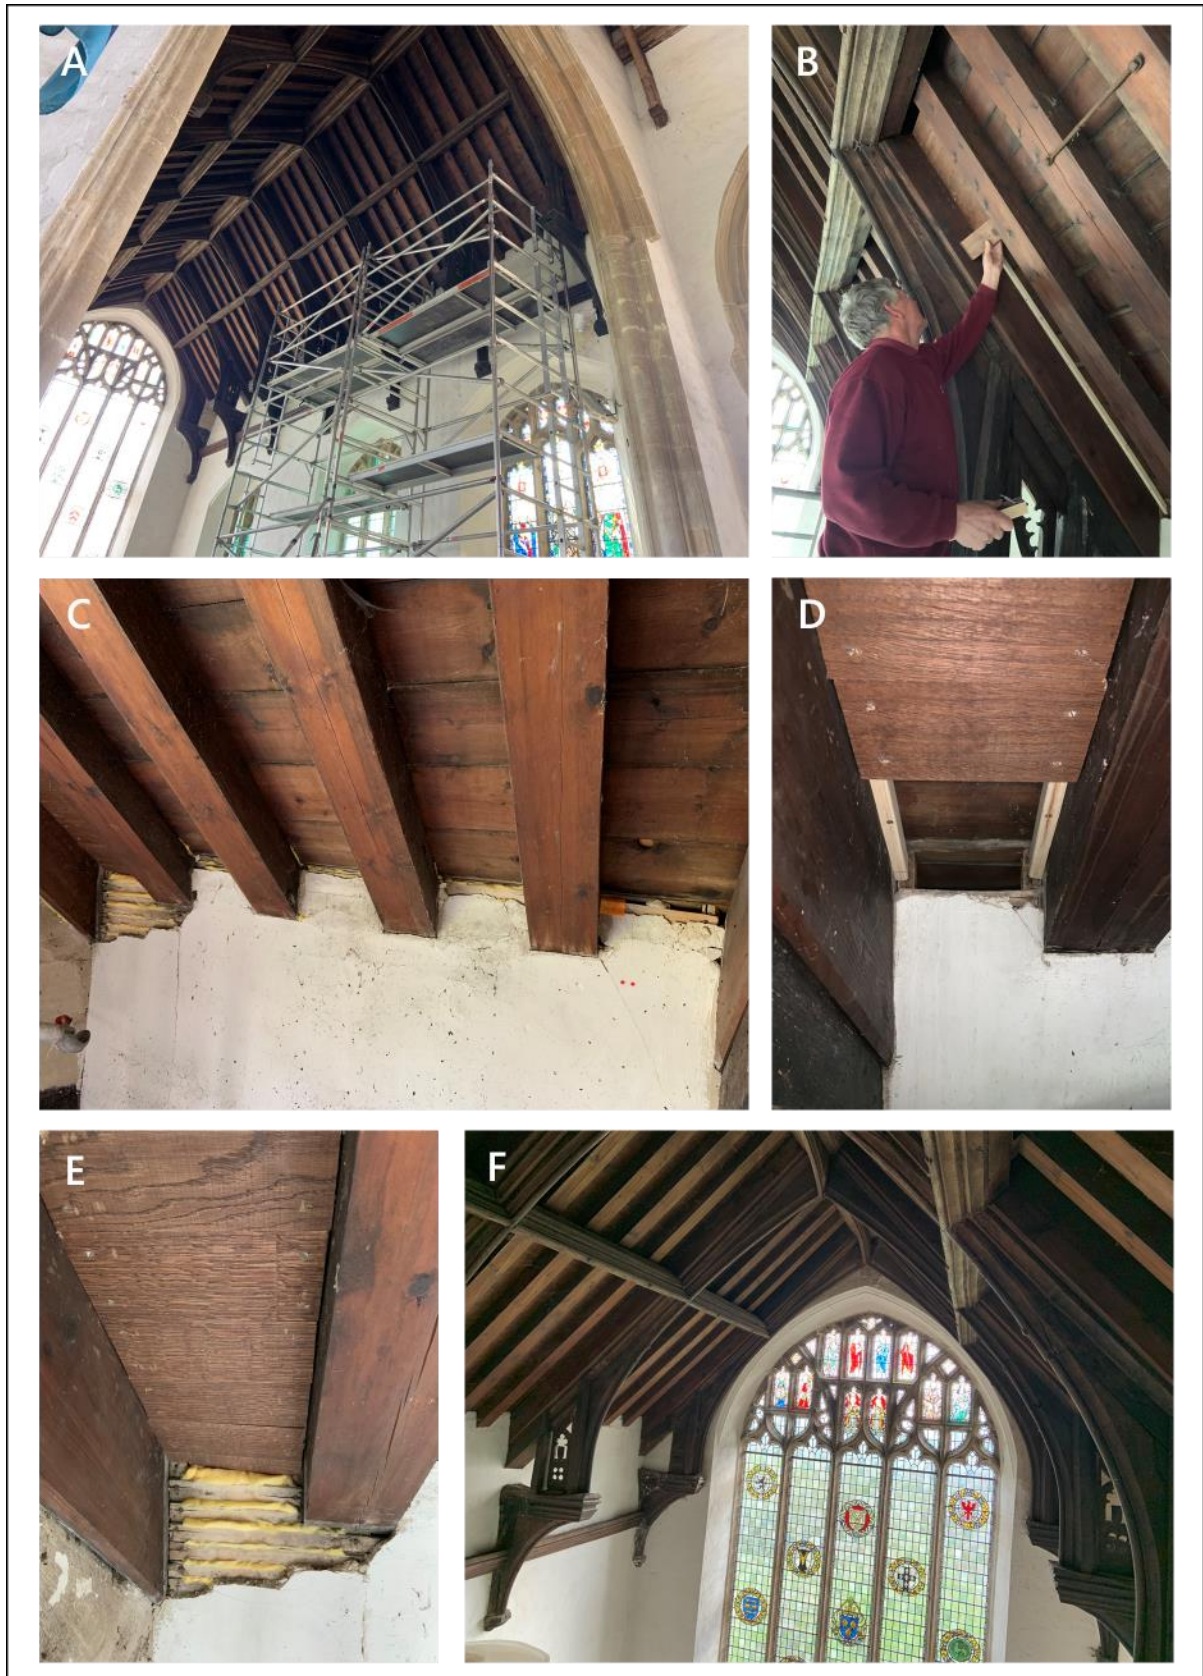
**Figure 1.** Photographs of interior works (chancel) – rafter bat boxes (south side) and blocking of gaps in plasterwork through to eaves roof void.

The first phase of works involved construction of three rafter bat boxes in the roof of the south side of the chancel. These extended from the interior side (see Figure 1 B.-E. through to the eaves roof void (ending at exterior eaves level, see Figure 2 K.). A variety of other roost features were constructed in the eaves roof void, along with four tiny 'no glow' infrared cameras (Figure 2 I.) to enable monitoring of use of the rafter bat boxes/roost features. Interior gaps through to the south and north chancel eaves voids were temporarily blocked with foam sponges (Figure 1 C. & E.). On the south side, two gaps were left open to maintain access to the church interior for one season/allow the bats to get used to the modifications. Two additional access points on the south side were fitted with one-way excluders (enabling bats to pass from the church interior into the eaves roof void but not back into the church at these locations, Figure 2 J.). A large bat box was also fitted at the south-east corner of the nave (adjacent to the south chancel) to provide additional roosting options (Figure 2 L.).

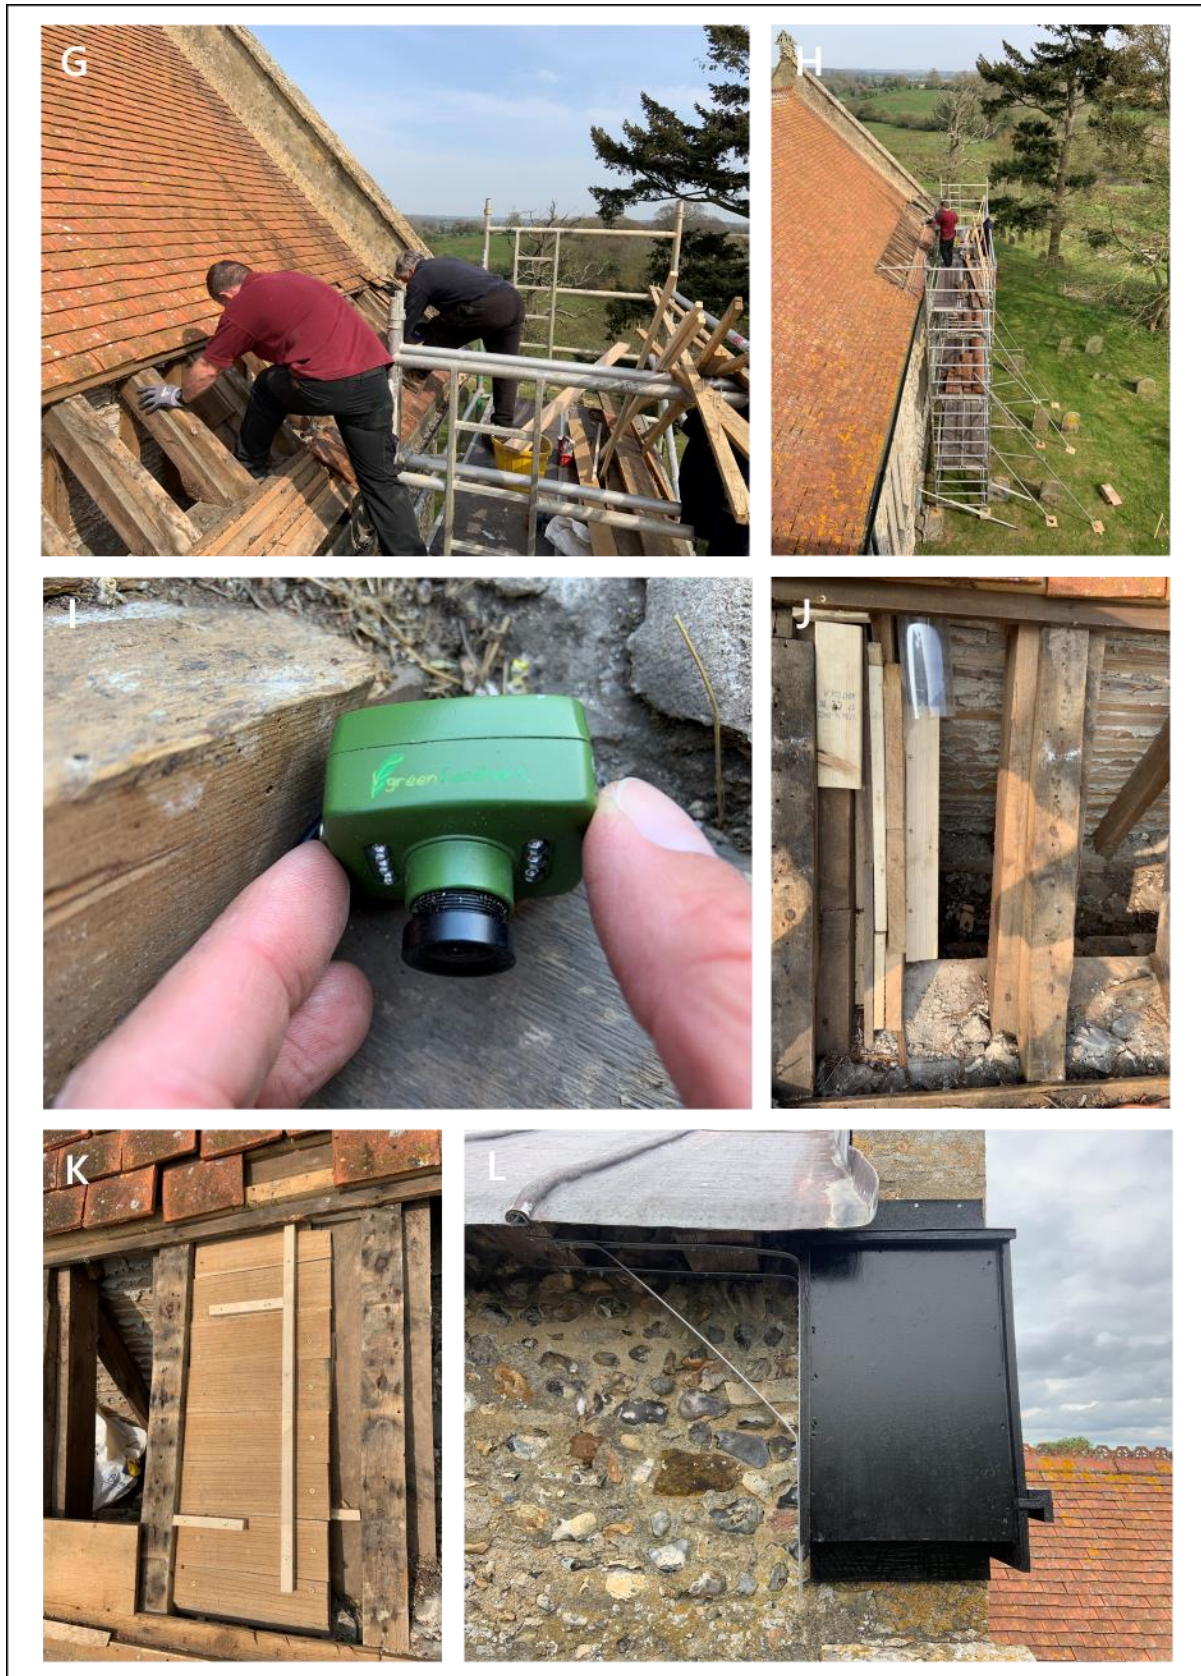
**Figure 2.** Photographs of exterior works (south side of chancel) – variety of roost features built into eaves roof void, including continuation of interior rafter bat boxes (K). Roost monitoring cameras installed (I). Large bat box fitted at south-east corner of nave (L).

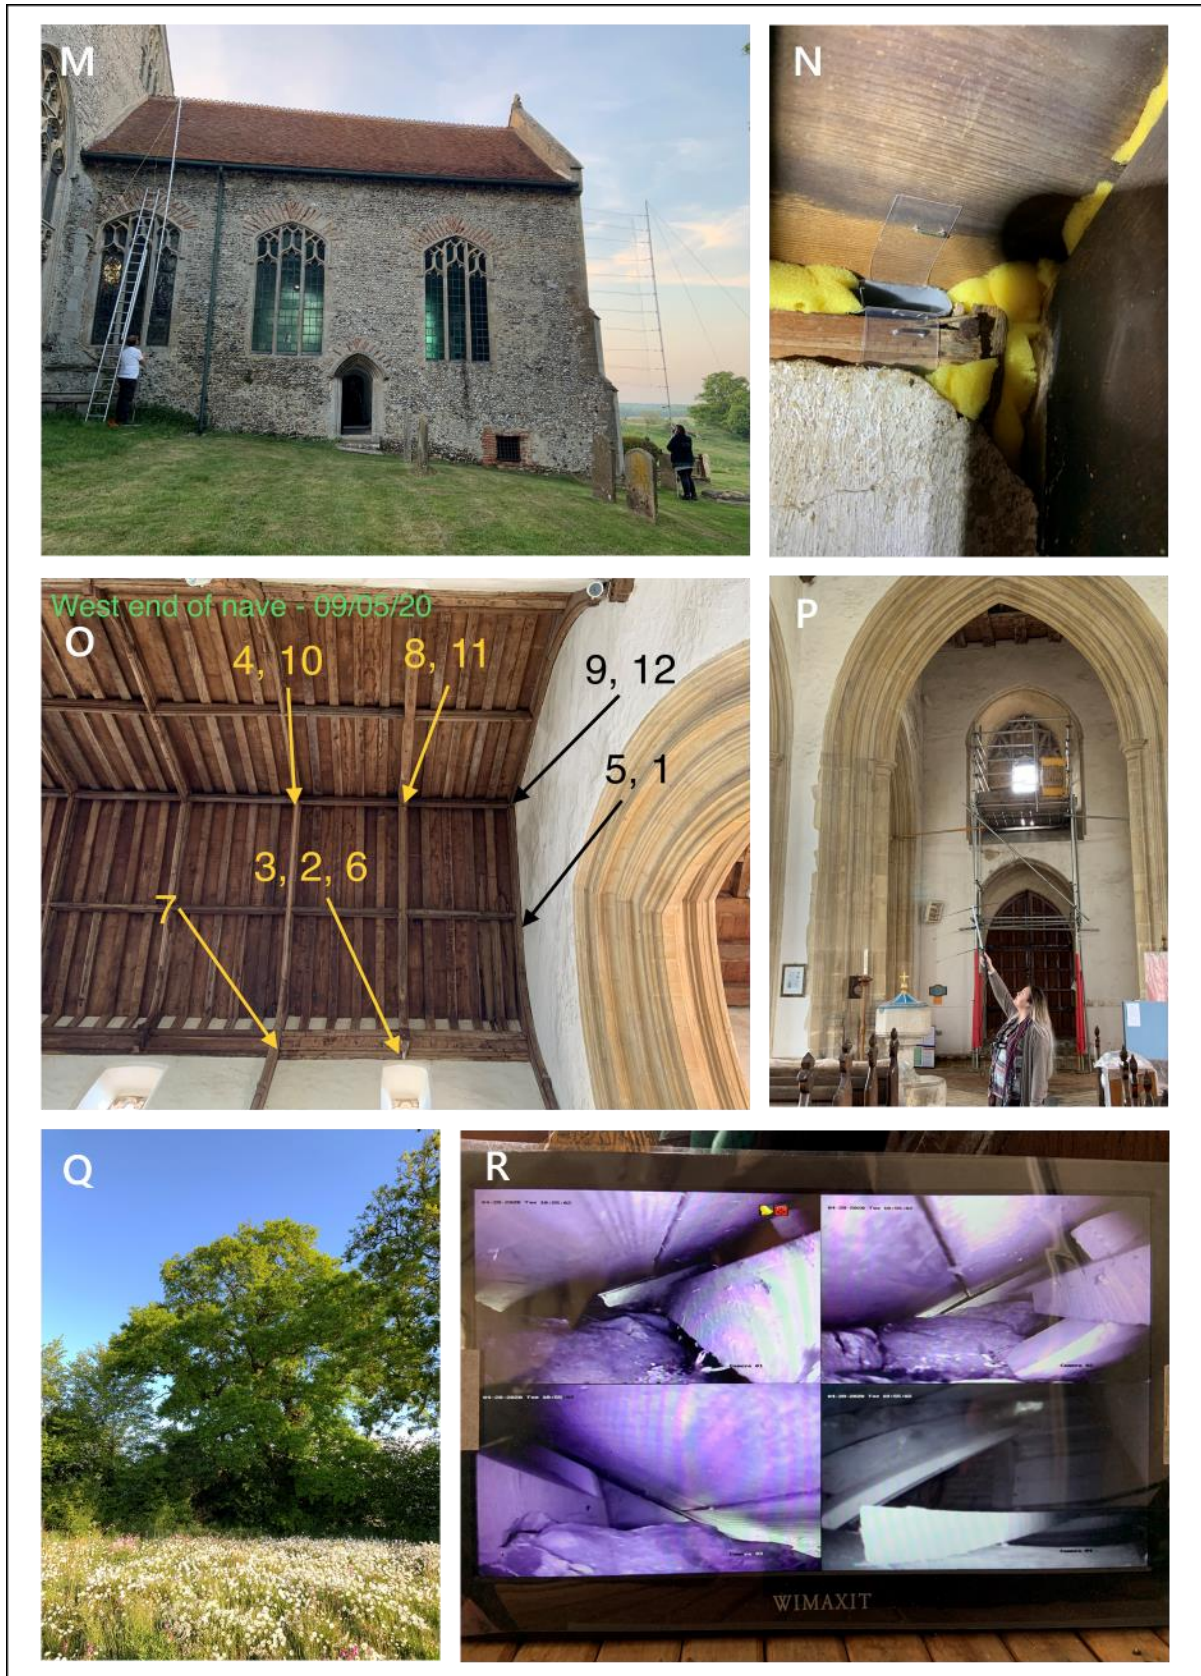
**Figure 3.** Monitoring of bats post-Phase 2 blocking with one-way excluders (N), trapping Natterer's bats for radio-tagging (M), radio-tracking inside the church (P), example (from 9<sup>th</sup> May 2020) of roost locations of radio-tagged bats inside (O) and outside (Q) the church and roost monitoring cameras (R).

In the second phase of works, the two 'two-way' access points were fitted with one-way excluders post-emergence (Figure 3 N.), thereby blocking bat access back into the church interior at these locations. Subsequently the temporary foam blocking of the plaster gaps on the north and south sides of the chancel were permanently blocked with plasterwork repairs, following the church architect's specifications.

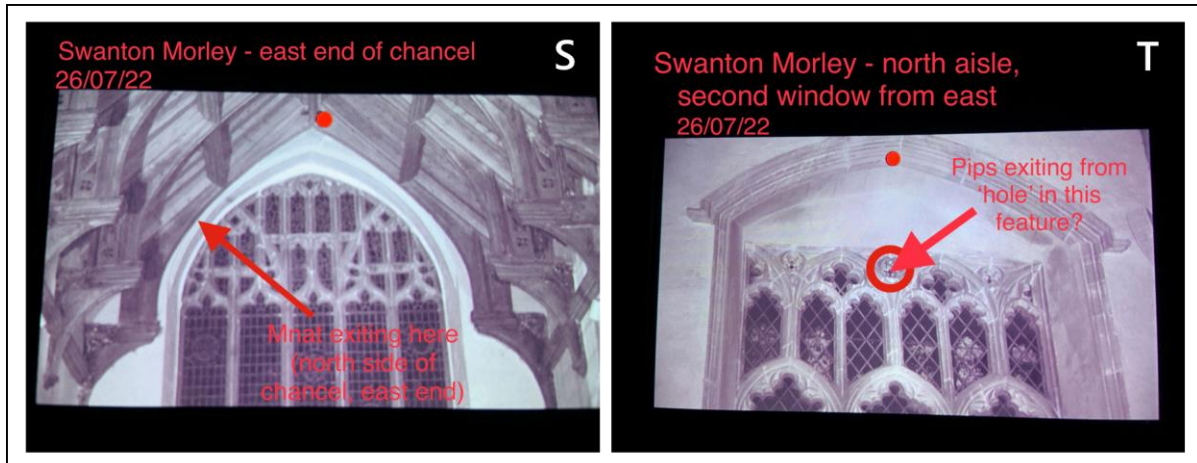
In 2022 it was apparent that several further access points were being used: the east end of the north side of the chancel (see Figure 4 S) and also via a very small missing piece of glass in the feature at the top of the second window from the east in the north aisle (predominantly pipistrelles, see Figure 4 T). Repair of the missing glass is currently being considered. This should be preceded by fitting the gap with a one-way excluder in either spring or autumn (for at least one week of sunset temperatures suitable for bat activity), avoiding the main maternity period of mid-May to end of August. This will help to ensure that bats for which this may be their only known access point do not become trapped inside the church when the glass is replaced. Unfortunately, at the current time blocking of the other new access routes (used by the Natterer's bats) does not seem feasible.

**Figure 4.** Additional bat access points identified during monitoring surveys in 2022 (photos of infrared camera screen annotated during surveys).
