BATS IN CHURCHES

SAILING TO SUCCESS

ST MARY MAGDALENE, BRAMPTON, CAMBRIDGESHIRE

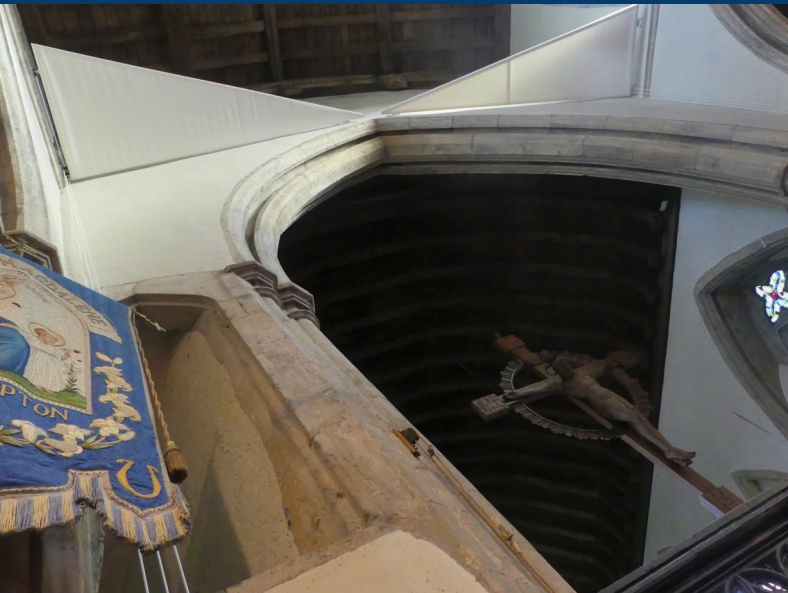
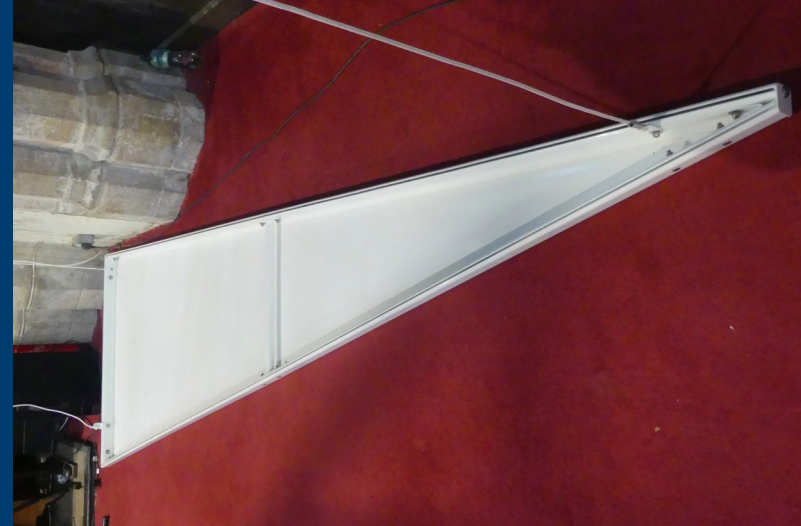
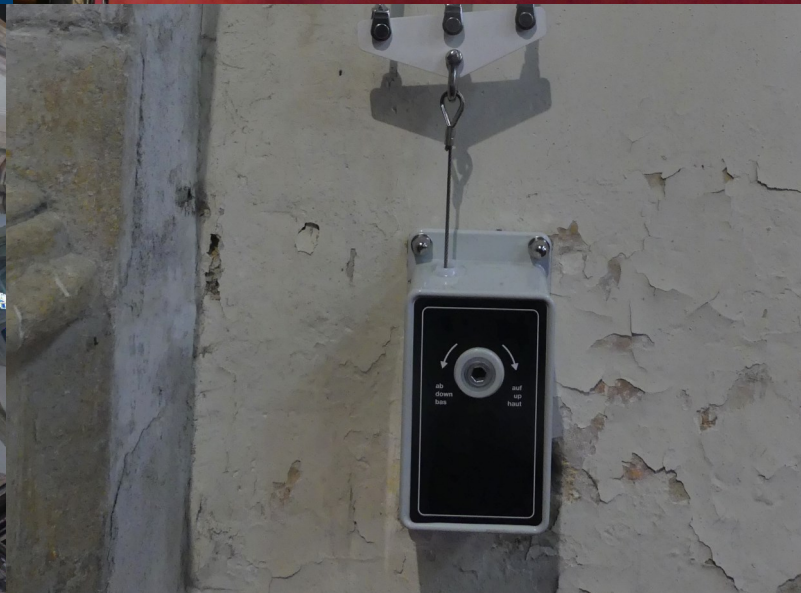
ArchAngel used their experience with sailing boats to suggest a design for two triangular sails that could be winched up and down from ground level.

The final design for the sails consisted of an aluminium frame with sail stretched around it. This helped the sails sit flush to the wall and created a lip around the sail to prevent droppings falling out.

They also provided a winching system which is lockable with a removable handle to prevent anyone from moving or lowering the sails.

The sails were installed by two workmen over the course of two days. The most difficult part of the process was adjusting the rope system to make sure the sails came down level without dipping on either side and tipping out the bat mess.
