St Bartholomew's Church, Brisley Norfolk

Condition Survey of the Wall Paintings Bats in Churches Project

November 2020

Bats in Churches Project: Condition Survey of the Wall Paintings

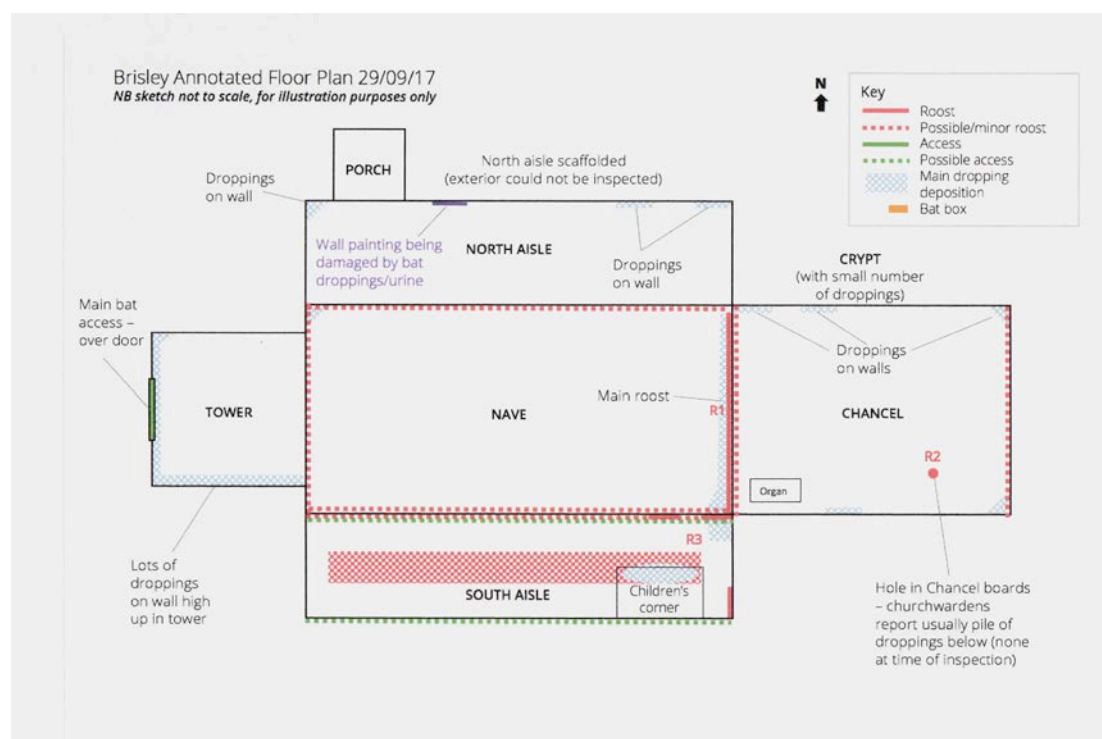
Figure 4: Bats in St Bartholomew, Brisley: Insight Ecology plan of Bat Activity, Annotated Floor Plan, 29/09/17

Figure 4 indicates the bat activity in Brisley Church, as surveyed in 2017. The report acknowledges a serious problem with bats and the impact their excreta has on the furnishings, fittings and wall paintings within the church. When I visited the church shortly after the first lockdown, 23rd June 2020, the amount and spread of excreta was shocking (plates 7-20, 25). The situation is so extreme that the Parish have to put coverings on the floor to collect the worst of the bat mess and issue warning signs to members of the public (plates 7-9). This is not excreta accumulated during lockdown but represents a depressing ongoing and serious problem at Brisley. Bat droppings are the readily visible evidence of bat activity but it should be remembered that urine is extremely damaging and less obviously visible on porous surfaces (such as high value wall paintings). Cleaning is extremely onerous for the parishioners who care for the church. In normal years, they are cleaning daily, clearing sheets and generally sweeping other areas at the height of the season. The older, more vulnerable members of the community typically carry out cleaning and they are particularly concerned about the health and safety issues when cleaning urine.⁹

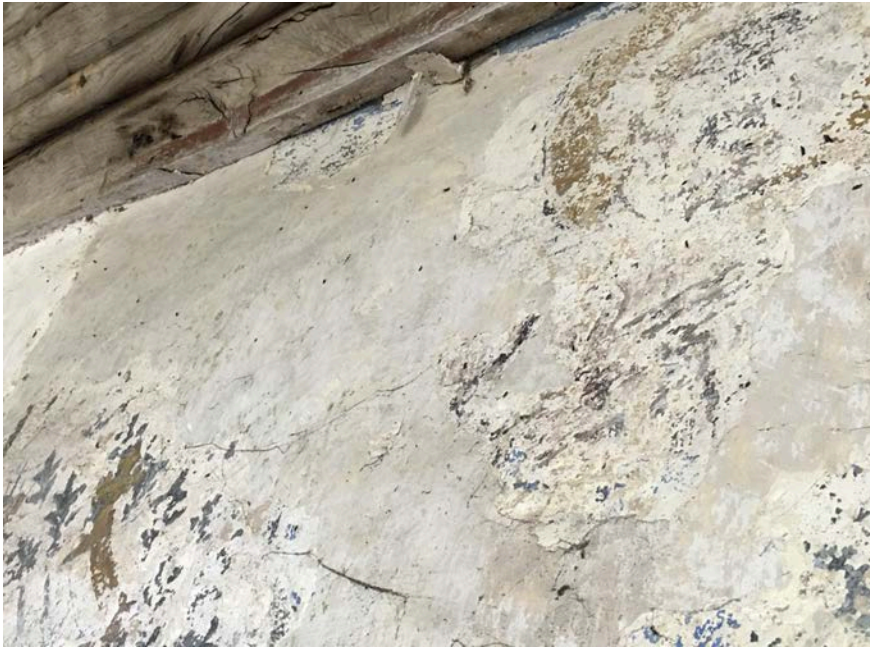
Plate 32

Above: detail of the painting towards the top left corner, showing bat faeces on the wall painting and the plaster repairs

- Remove the pink gypsum-based repair and fill with a plaster of lime putty and washed sharp sand, 1:3. The same lime/sand mix will be used for all cracks and small repairs.
- Modify the historic repair in the middle of Christopher and fill the crack.
- Secure detaching plaster with a grout of lime putty and sand.
- Remove overlying limewash overpaints where possible to reveal more of the upper part of the painting, using small handtools. Investigate and consider uncovering the remaining painting, if appropriate (It might not survive very well lower down or might not uncover well).
- Clean all surfaces. Remove loose dust and bat faeces with soft brushes. Removal of MBG with soft brushes if possible, or with small swabs of water if necessary.

- Readhere delaminating ground layers carrying the painted scheme with diluted limewash after pre-wetting with Isopropyl alcohol (IPA) in water 1:4.
- Delaminating paint layers can be fixed with Lascaux 1476 diluted in water. Tests on site will establish the proportions.
- Apply a toned limewash to new and old repairs.

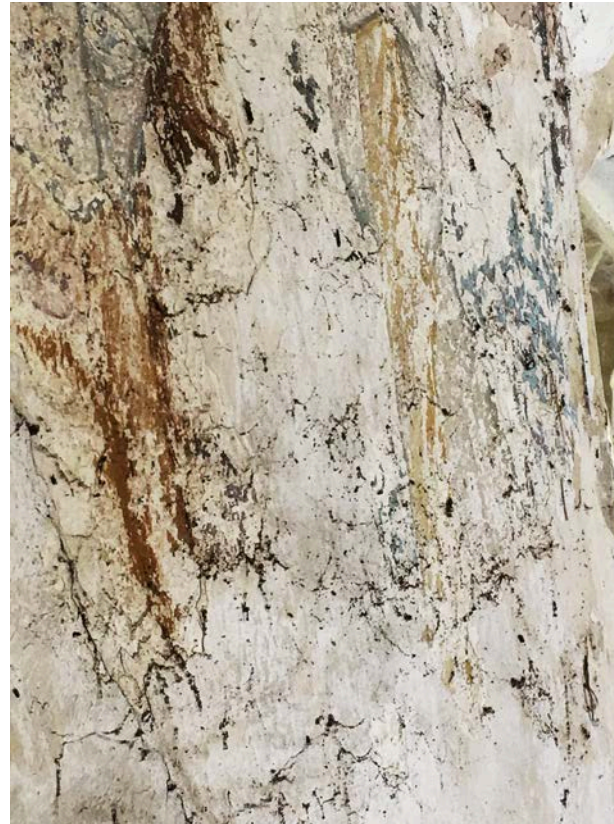
Plate 33

Top middle: detail of bat faeces on the wall painting. Bat faeces are visible but the urine soaks into the absorbent plaster

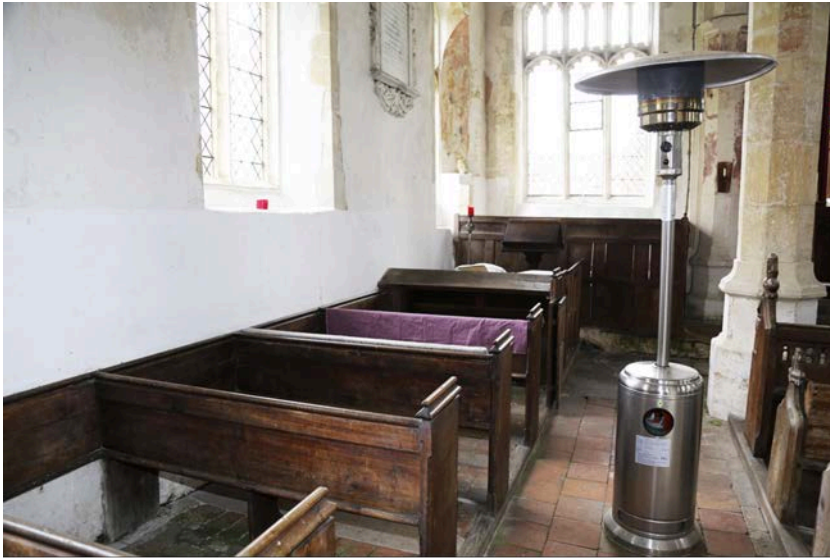
Plate 40

Above: view of the north aisle towards the east end. Patio gas heaters are to be replaced soon

The nave heating consists of undesirable gas cylinder patio heaters (eg plate 40) which are due to be replaced imminently with an under pew electrical system and enhanced with moveable two bar radiators.

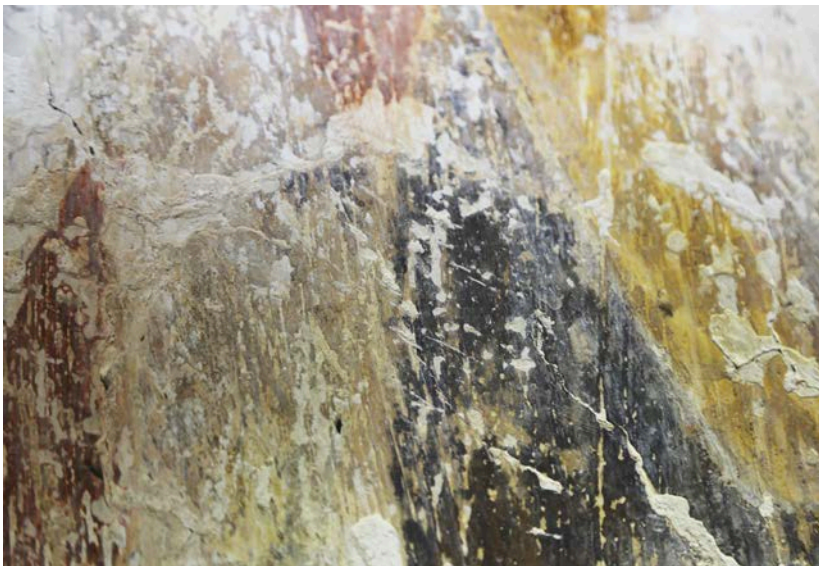
**Plate 45**

Top left: detail of the lower half of the painting showing the later plaster repair at the right.

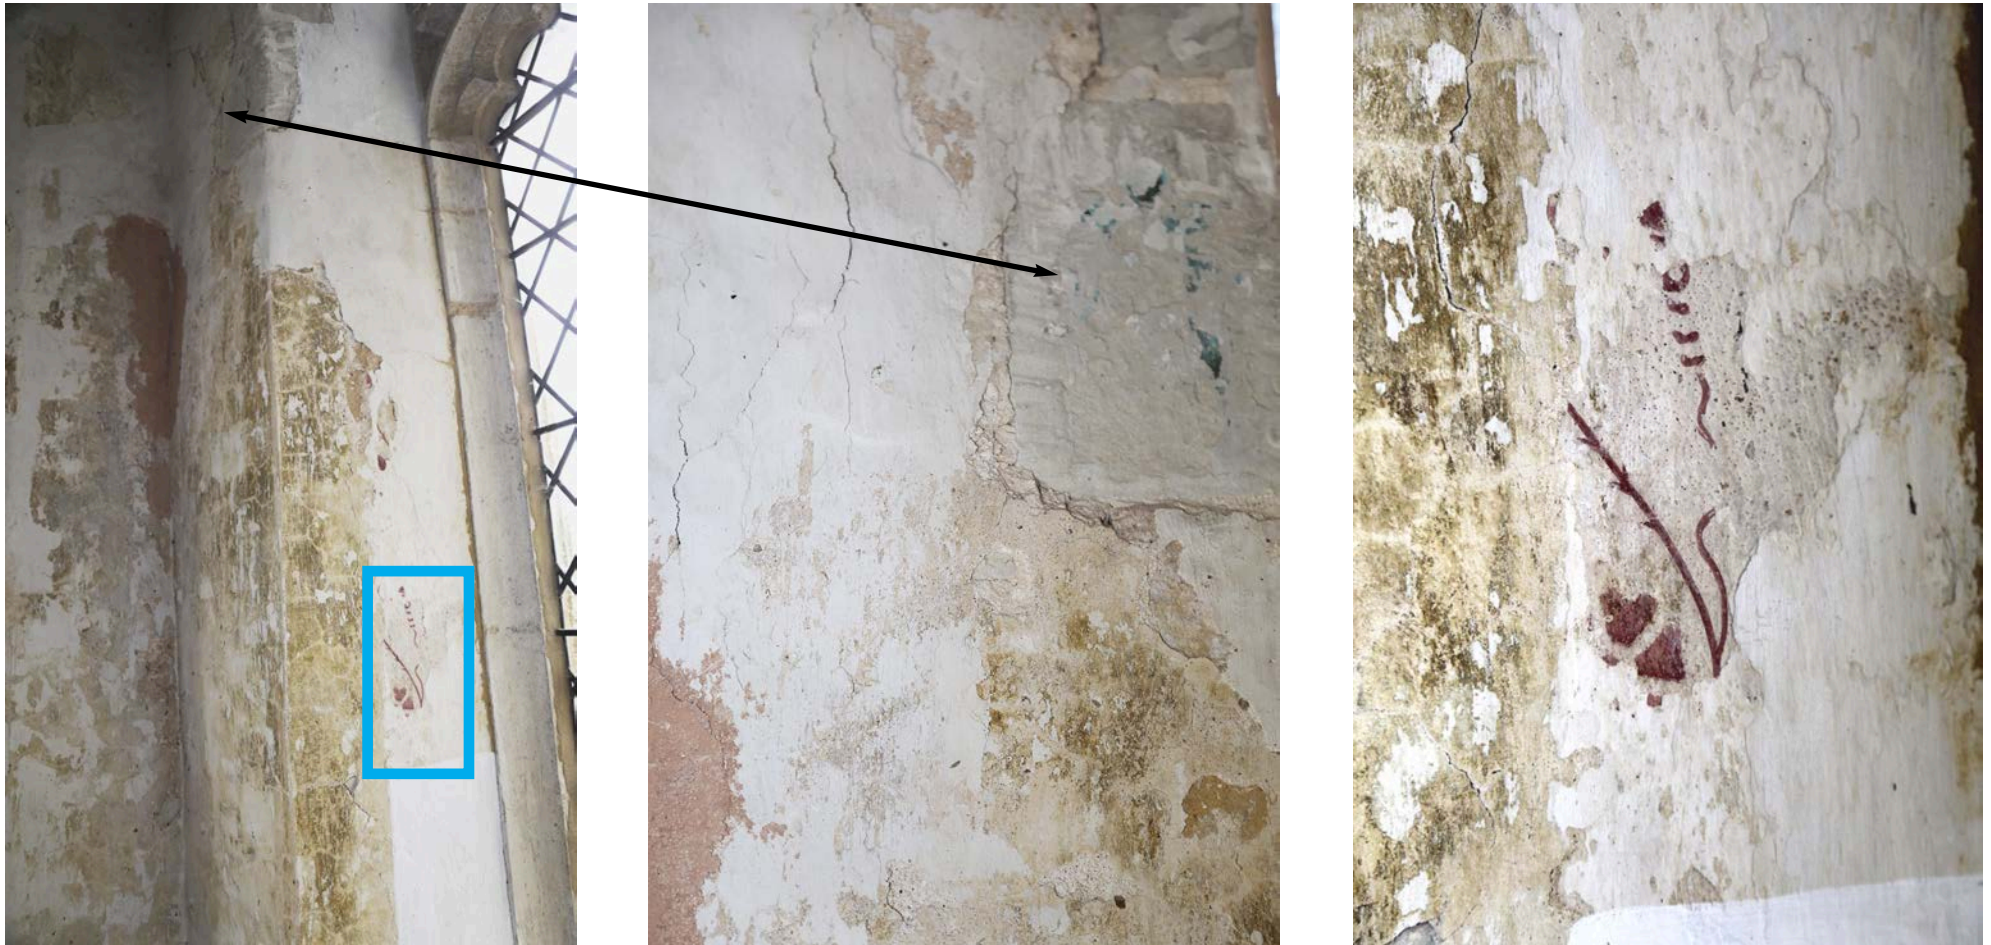
Plate 47

Top left: detail of the north east corner, showing the plaster repair. The earlier plaster carrying the floral scrollwork is partially visible in the window splay.

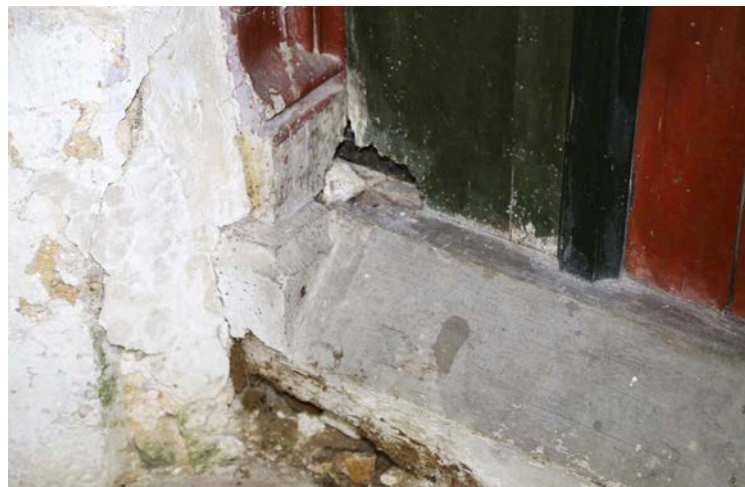
**Plate 53**

Above: detail of the north east respond. Medieval paint just visible. MBG at the base

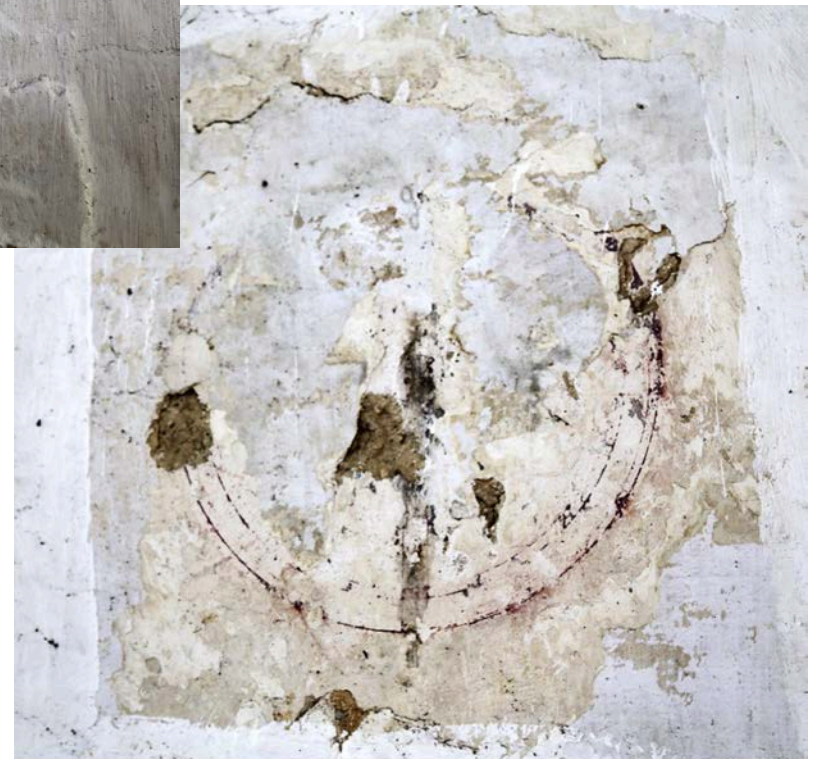
Plate 95

This is an unusually good, materials rich consecration cross in extremely poor condition.

*Below: Consecration cross, in poor condition
(All photos © A Kirkham 2020)*

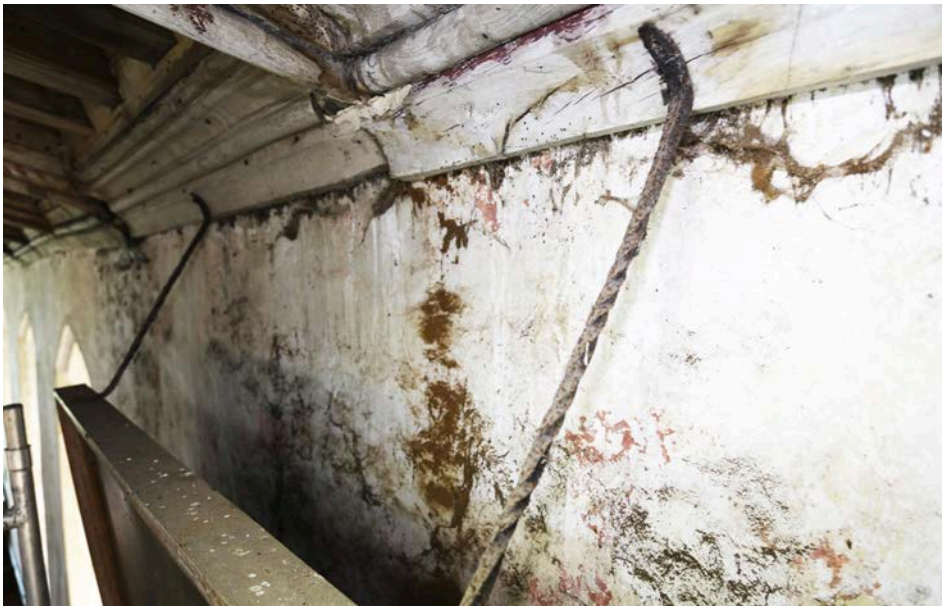
Plate 113

Above: detail showing staining from past water leaks, now repaired
(All photos © A Kirkham 2020)

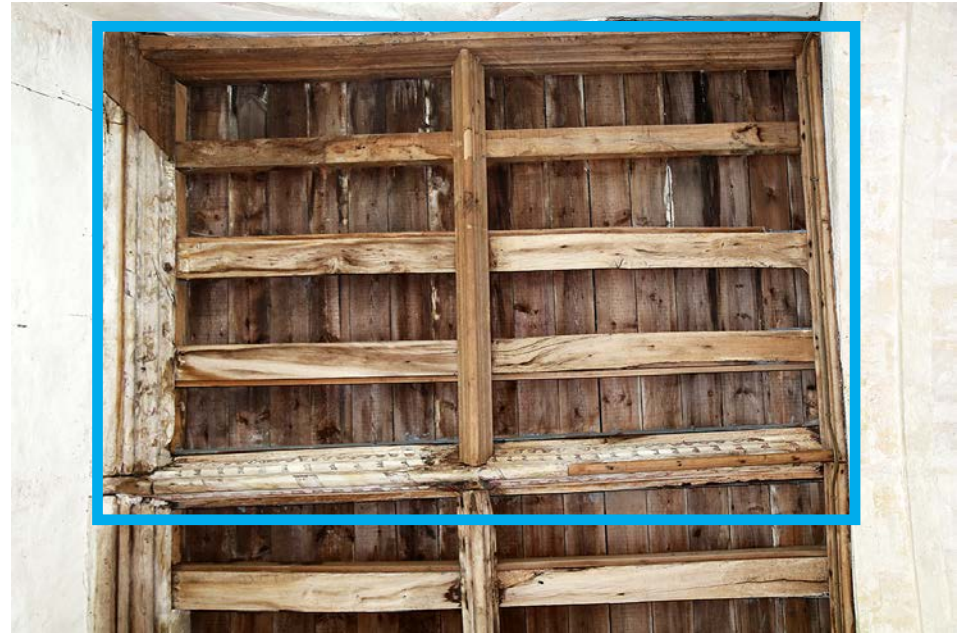
Plate 124

Top left: eastern end of the south aisle roof. Leaks in the roof were fixed in summer 2020

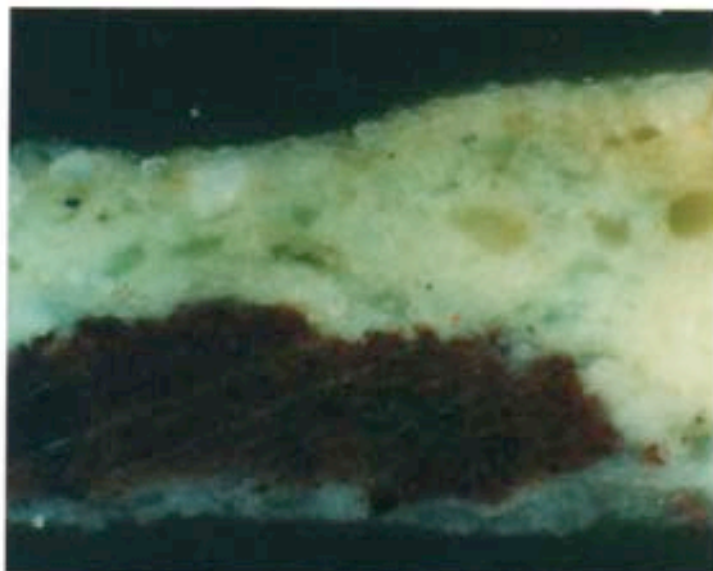
Pier of chancel arch

Patches of red decoration can be seen extending from the floor, right up the column. It apparently even extends onto the first of the aisle arches [however this was observed only from the floor, and no samples were taken from higher levels]. Samples taken from examples of south and north aisle columns identified the same early red [pp.23 & 25], and the decoration extended widely around the church.

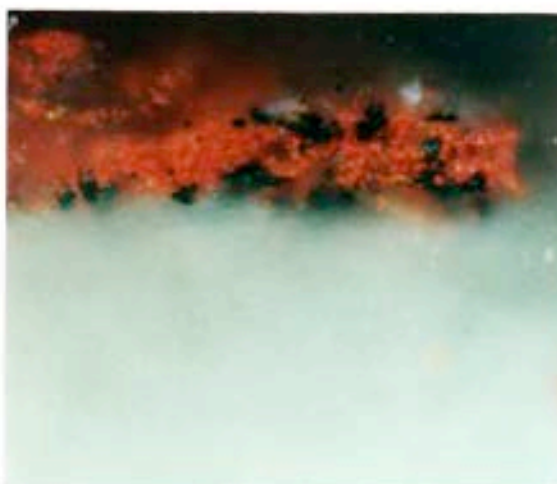
Angel in north window reveal

The painting is in poor condition, as it has been badly affected by mould and the effect of salts. The salts were analysed and found to be mostly calcium with a little sulphur. The mould forms a greenish brown film over many parts of the painting, but the cross-sections also show amorphous, dark brown organic matter, infiltrated between the limewash layers and under the paint.

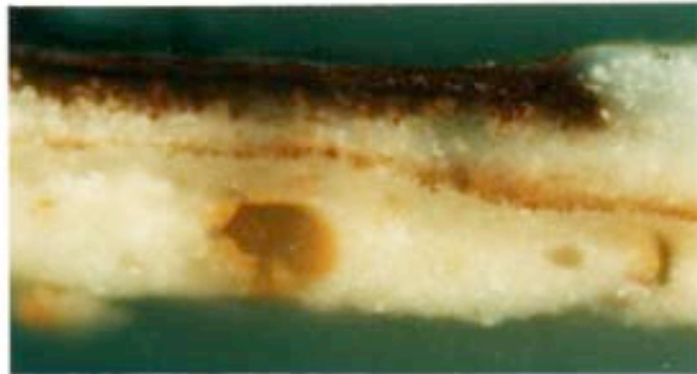
The staining between the
two layers of limewash is
organic and must be due
to mould.

upper
← limewash
ground
← mould
staining
← lower limewash
ground

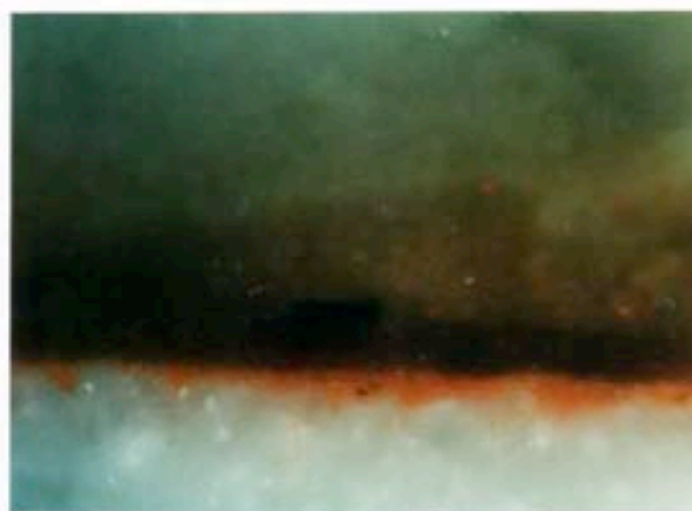
The mould layer on the
red has stained the
underside of the later
limewash.

← stained
limewash
← organic layer
← background
of angel
