**St Edmund's Church, Egleton**

**Bat Management Plan**

**November 2021**

Report title: St Edmund's Church, Egleton – Bat Management Plan

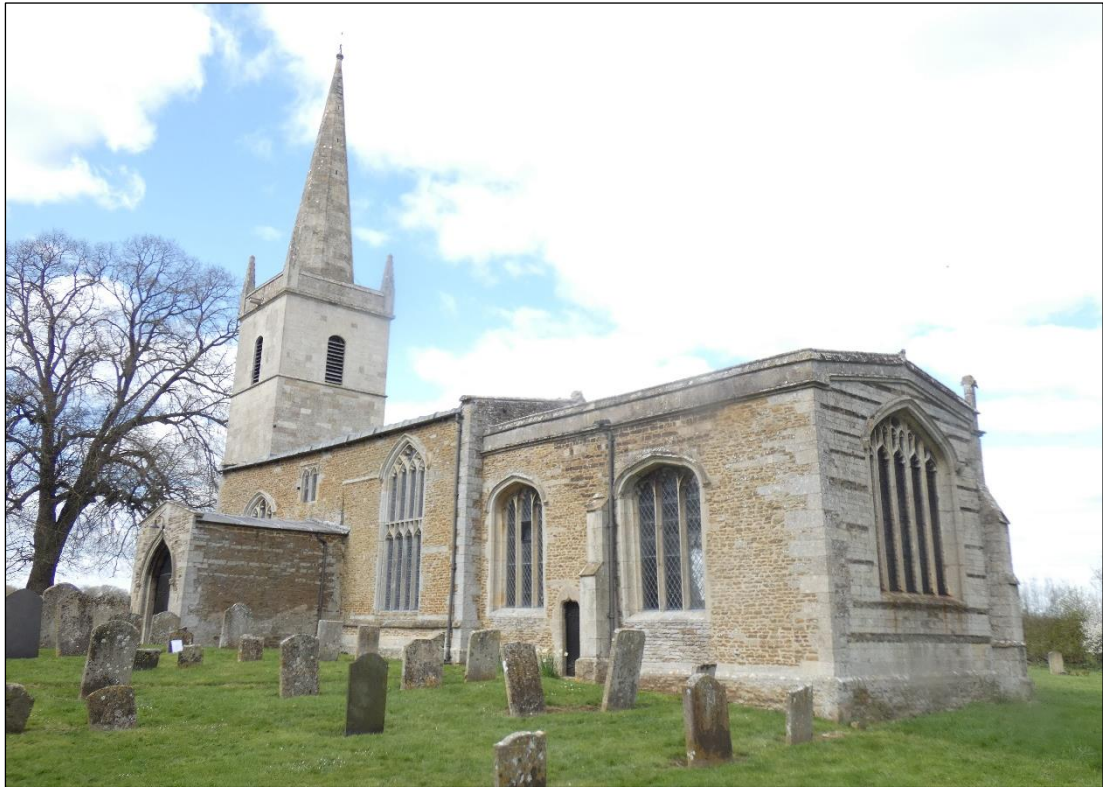
Photograph 1.2.1: St Edmund's Church, Egleton, viewed facing north-west from Church Road.

- 1.2.4 St Edmund's comprises a clerestoried nave, a tower with a spire adjoining the western end of the nave, a chancel adjoining the eastern end of the nave, and a south porch. The church has no aisles although there is evidence to suggest that a north aisle was once present as remnants of an arcade (now infilled with ashlar) are present within the nave north wall.

- 1.2.5 St Edmund's is constructed from local coursed ironstone rubble and ashlar with sandstone dressings. The shallow-pitched roofs of the nave, chancel, and south porch are covered with lead. This roofs of the nave and south porch are not parapeted, and the wall plate and some rafters are therefore visible along the eaves behind the guttering. The roof of the chancel is finished with a parapet wall and therefore the roof timbers are not visible.

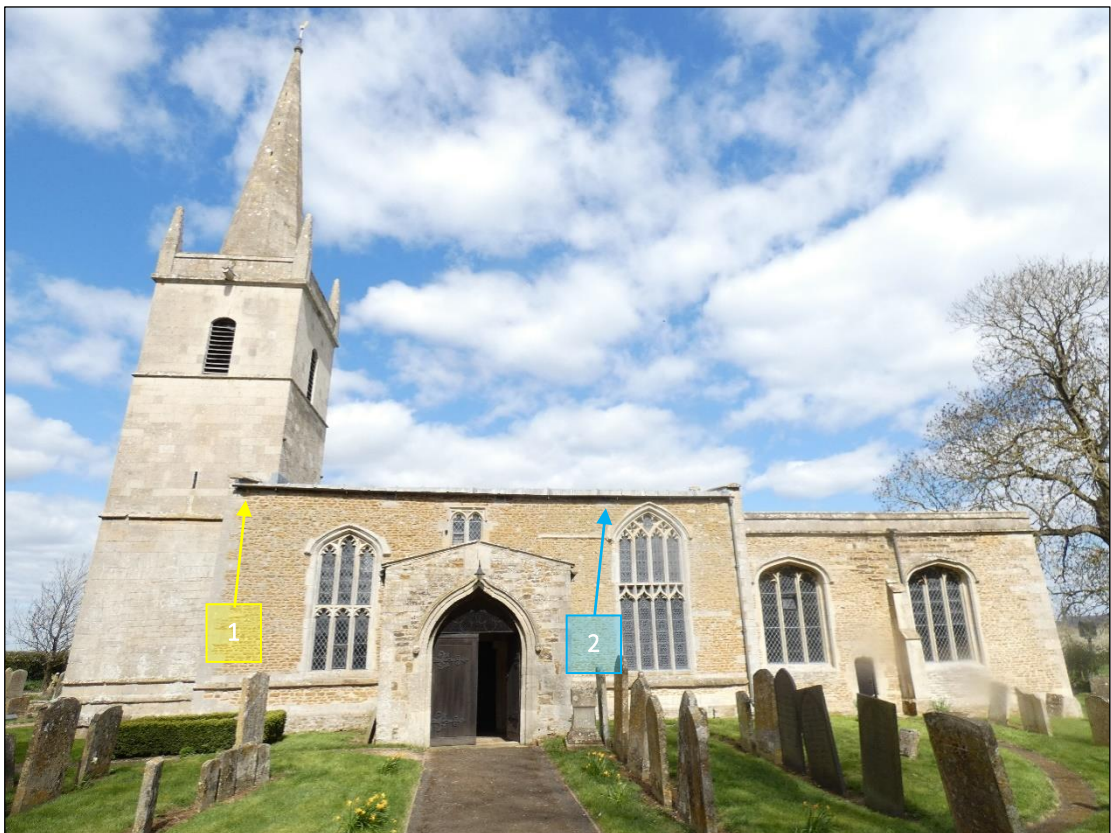
Photograph 3.2.1: There are two main features on the southern elevation of the church used by the soprano pipistrelles to exit the roost in the nave roof. These are shown by the two arrows below. Close-up views of these features are shown in photographs 3.2.2 and 3.2.3 respectively. Table 3.2.1 shows the numbers of bats using each feature on each dusk emergence survey completed in 2021.

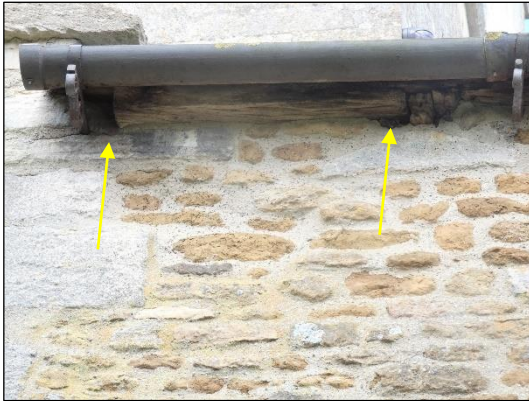
Photograph 3.2.2: Close-up view of the features shown by the yellow arrow in photograph 3.2.1 above. Of these two gaps below the wall plate the soprano pipistrelles predominantly use the one on the left, at the south-west corner of the nave.

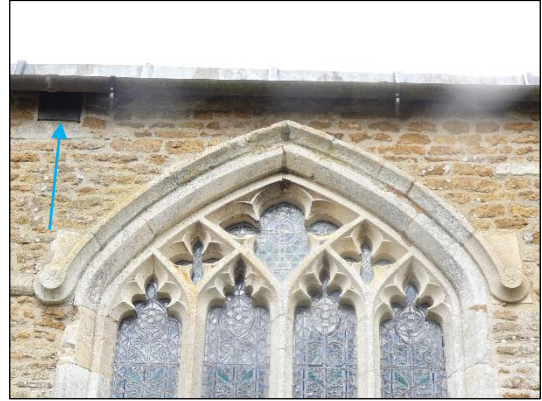
Photograph 3.2.3: Close-up view of feature 2 shown by the blue arrow in photograph 3.2.1 above. Of the features used by the soprano pipistrelles to access and egress the nave more bats use this than the others – see Table 3.2.1.

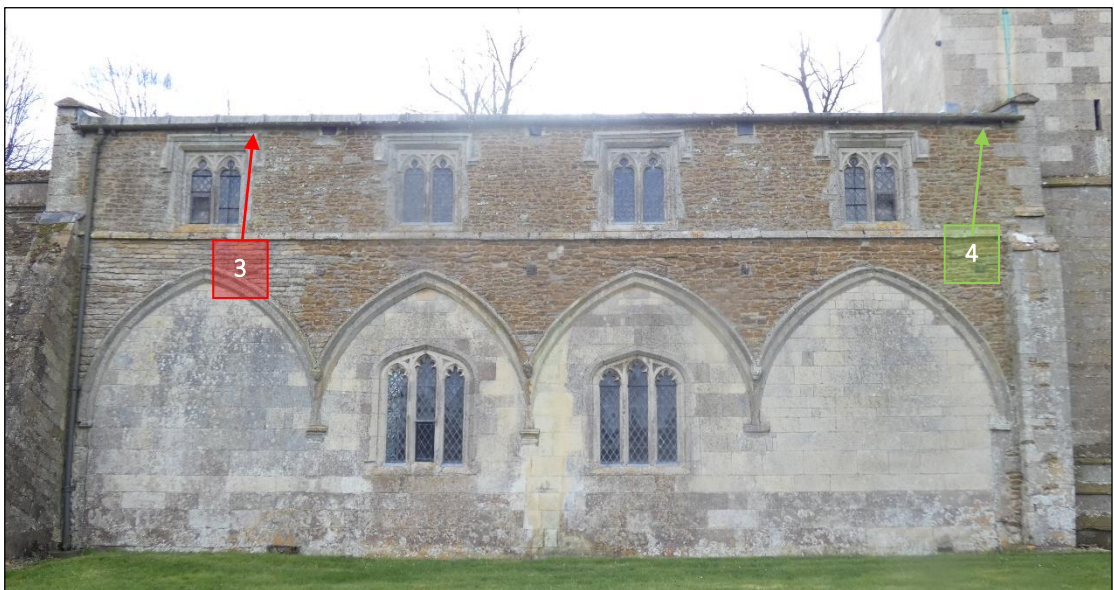
Photograph 3.2.4: There are two features used by the soprano pipistrelles on the northern elevation of the church to exit the roost in the nave roof. These are shown by the two arrows below. Close-up views of these features are shown in photographs 3.2.5 and 3.2.6 respectively. Table 3.2.1 shows the numbers of bats using each feature on each dusk emergence survey completed in 2021.

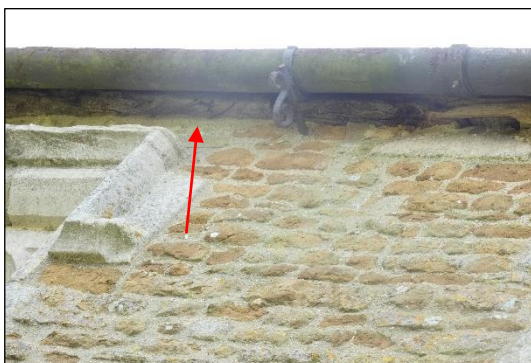
Photograph 3.2.5: Close-up view of feature 3 on the northern elevation of the church shown by the red arrow in photograph 3.2.4 above.

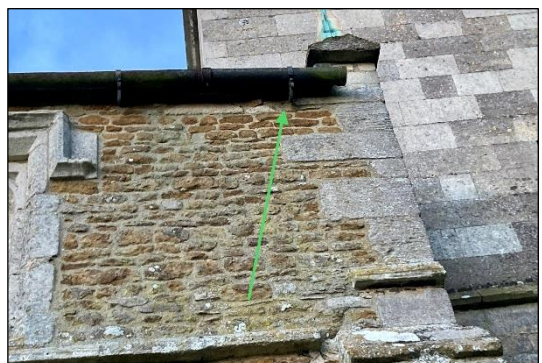
Photograph 3.2.6: Close-up view of feature 4 on the northern elevation of the church shown by the green arrow in photograph 3.2.4 above.

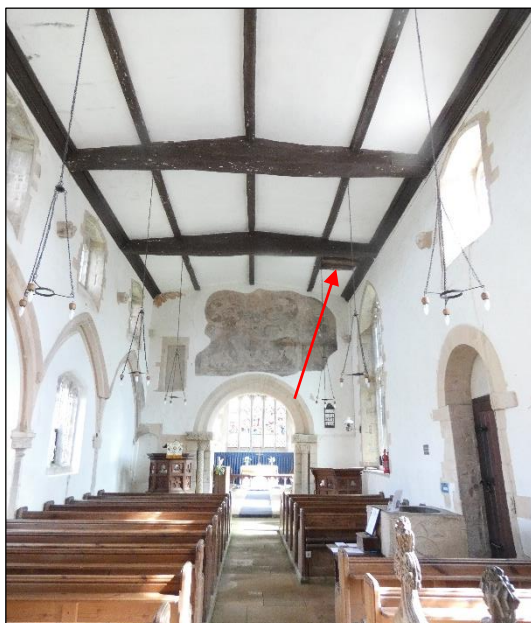
3.2.6 It is understood that until the last few years relatively few soprano pipistrelles accessed the church interior. Recently, however, part of the nave ceiling collapsed below the bat roost and more bats now frequent the inside of the church via this hole, which can be seen in photographs 3.2.7 and 3.2.8.

Photograph 3.2.7: The location of the hole in the nave ceiling is shown by the red arrow.

- 5.3.1 The final bat management option for St Edmund's comprises the recommended course of action – the ceiling inside the church should be repaired, or ideally replaced entirely, to prevent bats from accessing the church interior from their roost in the nave roof.

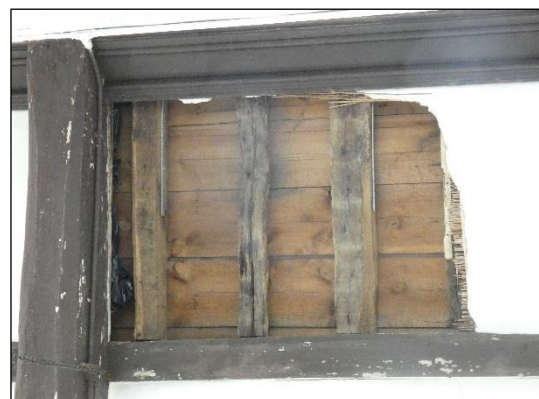
Photograph 3.2.8: Close-up view of the partially collapsed ceiling in the nave roof in the location shown by the red arrow in photograph 3.2.7. Bats that access the church interior predominantly do so via this hole in the ceiling. Many of these bats are then unable to return to the roost or exit the church via an alternative route.

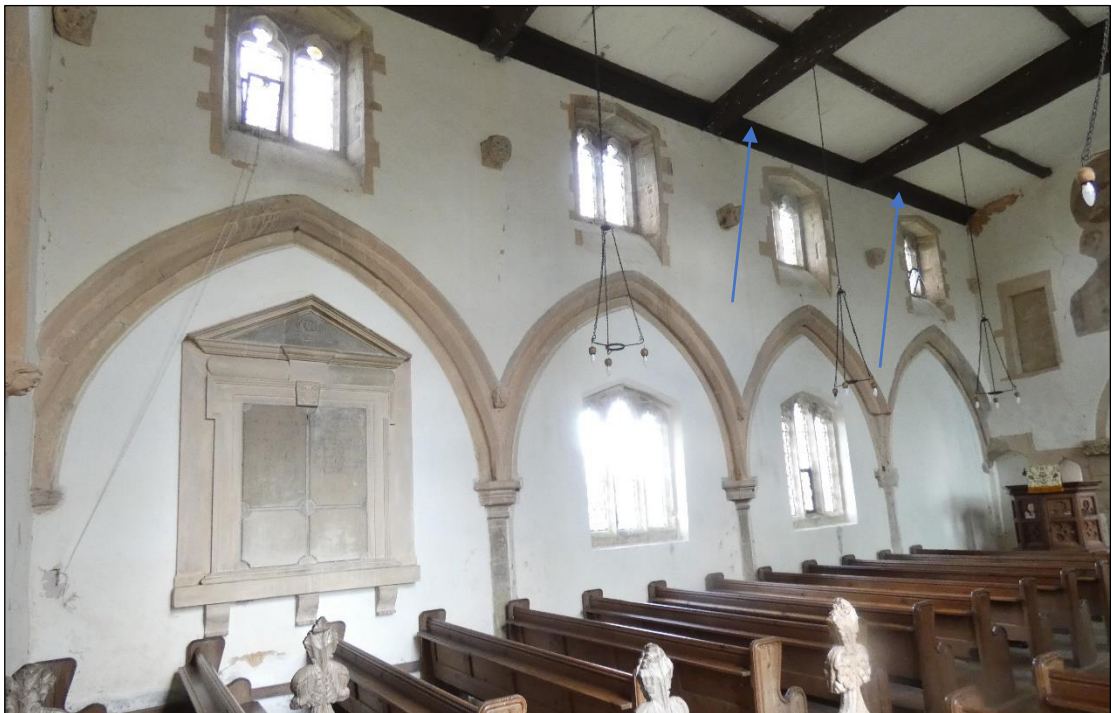
- 3.2.9 In addition to the hole in the ceiling described and shown above, a low number of soprano pipistrelles also occasionally access the church interior via a few small gaps along the wall plates of the nave roof; for example, along the southern elevation as shown by the arrows in photograph 3.2.9 and photograph 9.2.2 in the appendix. These small gaps presumably lead to the roost above the nave ceiling.

Photograph 3.2.9: A low number of bats access and egress gaps along the wall plates inside the church; for example, in the locations along the southern elevation shown by the two blue arrows.

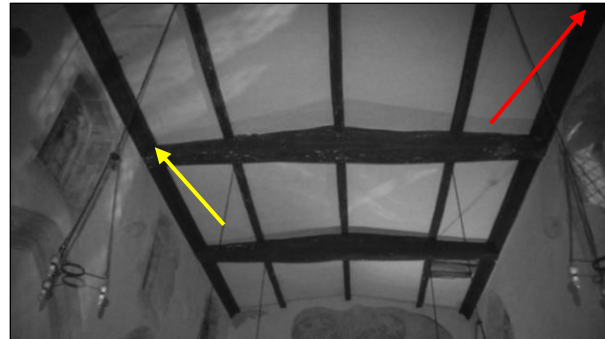
Photograph 9.2.2: Location of some small gaps used by bats to access the church interior. View facing east.

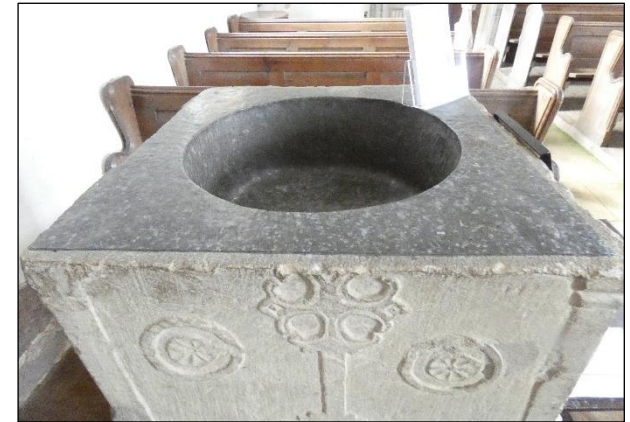
Photograph 9.2.3: Staining and pitting of the alabaster font at St Edmund's, likely caused by bat urine.

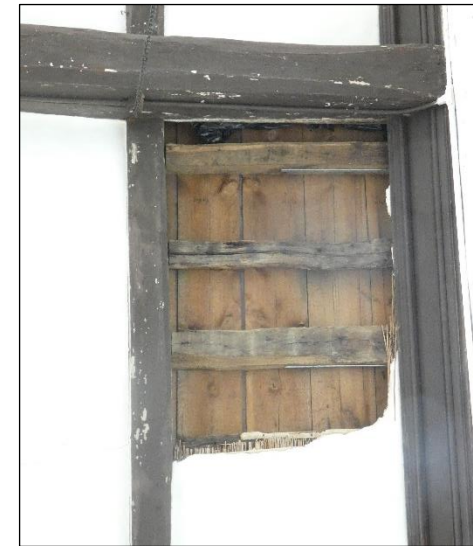
Photograph 9.2.6: The hole in the ceiling of the nave.
