**St Mary the Virgin Church, Greetham**

**Bat Management Plan**

**October 2021**

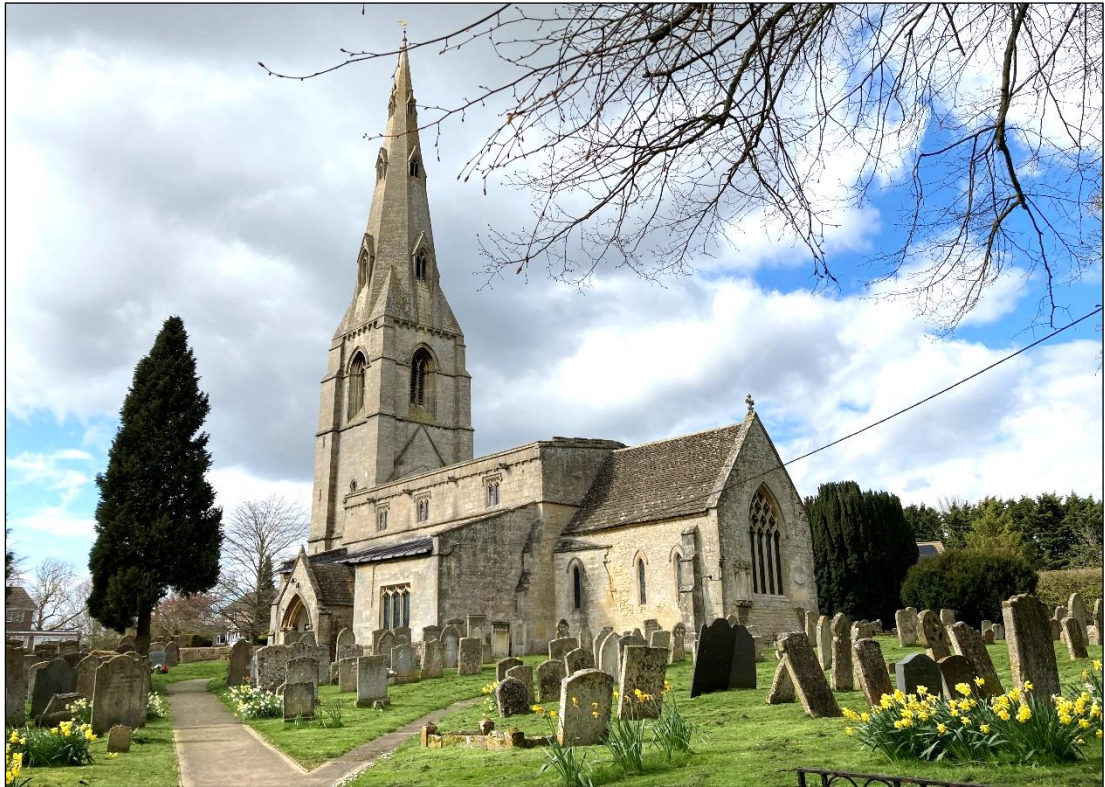
Photograph 1.2.1: St Mary the Virgin Church, Greetham, viewed facing north-west from Church Lane.

- 1.2.4 St Mary's comprises a nave with a clerestory; a tower (with a spire) adjoining the western end of the nave; a chancel adjoining the eastern end of the nave; a north aisle; a north vestry; a south aisle with a south porch; and a small south transept at the eastern end of the south aisle. Inside the church there is a toilet and servery at the western end of the north aisle. The organ is located within the south transept.

- 1.2.5 Most of St Mary's is constructed from coursed and squared stone and ashlar although the tower is constructed from ashlar only.
- 1.2.6 The shallow-pitched roof of the church nave, and the pent roofs of the aisles, are covered with lead or terne-coated steel. The roofs of the nave and the north aisle are finished with a plain parapet wall, whereas the lead roof of the south aisle overhangs the eaves on protruding rafters.

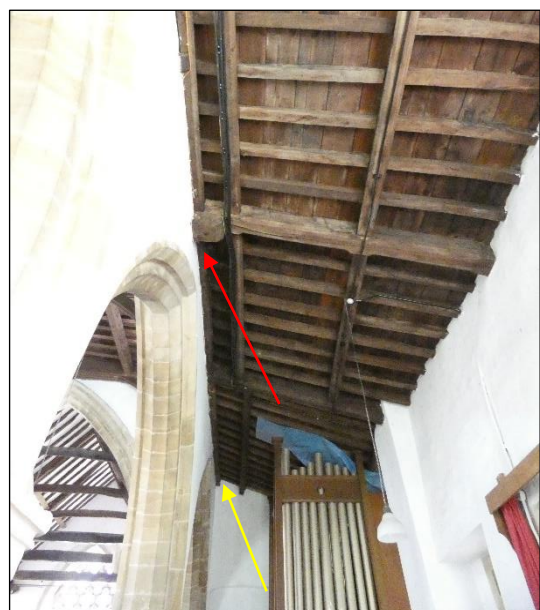
Photograph 3.2.2: Location of the other two main Natterer's roost access / egress features – red and yellow arrows - at the opposite eastern end of the south aisle (where it joins the south transept) near the south arcade.

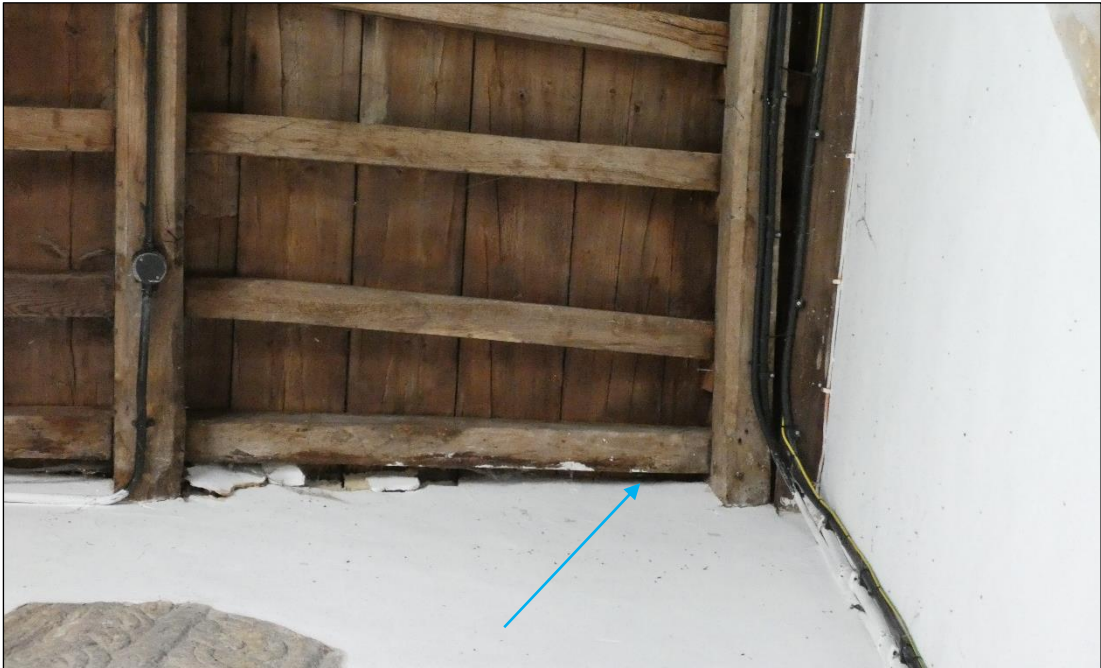
Photograph 3.2.3: Close-up view of the area shown in photograph 3.2.1. The blue arrow shows where the Natterer's bats egress and access their roost, between the roof timbers and wall top at the western end of the south aisle. There are bat droppings visible on the wall below.

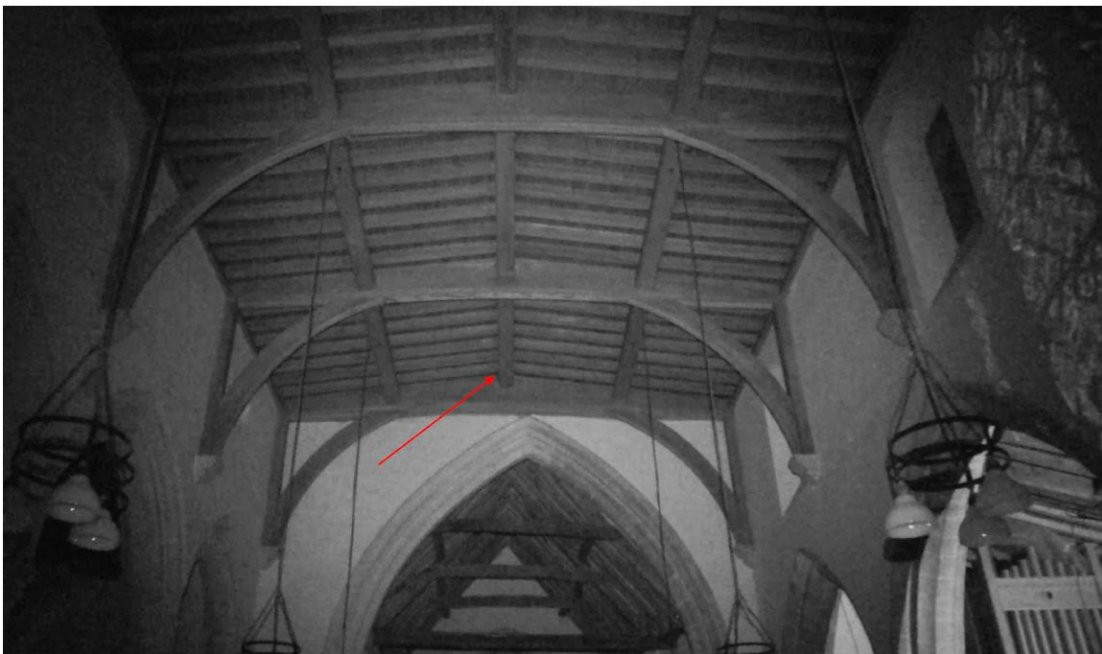
- 3.2.3 Breeding Natterer's bats also occasionally roost within the nave at St Mary's. On the 5 June pre-dawn survey, for example, at least seven Natterer's bats were recorded returning to a roost above the central purlin within the nave roof, near the chancel arch, in the location shown in photograph 3.2.4. In addition, on the 5 August dusk emergence survey at least six Natterer's bats emerged from a roost above this same purlin but in a different location, as shown in photographs 3.2.5 and 3.2.6.

Photograph 3.2.4: The red arrow shows where at least seven Natterer's bats returned to a roost shortly before dawn on 5 June 2021.

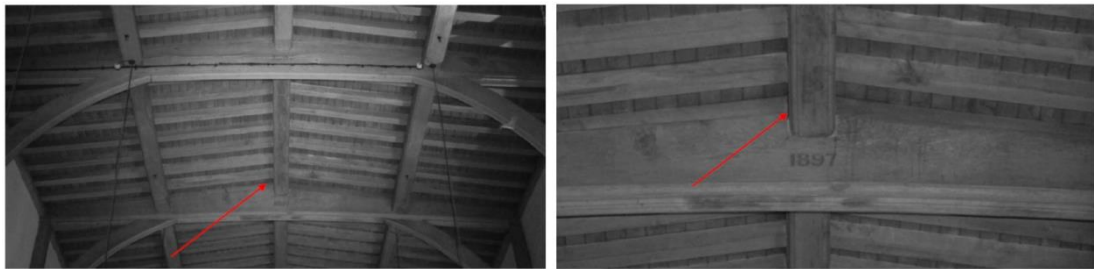
Photographs 3.2.5 and 3.2.6: The red arrows shows where at least six Natterer's bats emerged from after dark on 5 August 2021, above the date inscription in the western half of the nave roof.

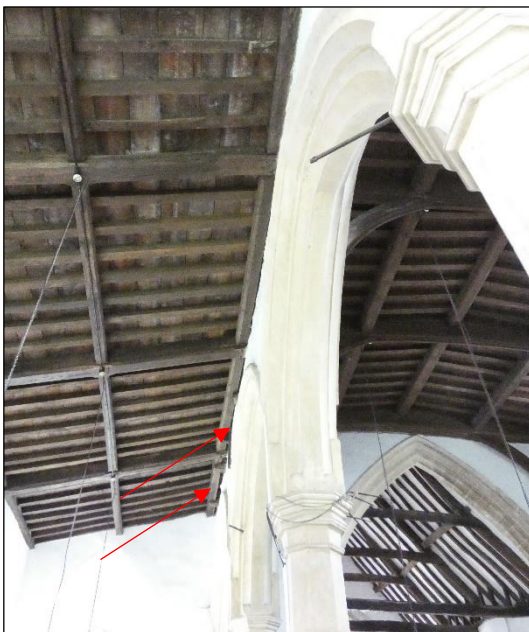
- 3.2.4 Low numbers of Natterer's bats also make use of secondary roosts in the north aisle in the locations shown in photograph 3.2.7, accessing and egressing these roosts where the roof timbers meet the wall tops above the north arcade.

Photograph 3.2.7: Locations of secondary roosts at the eastern end of the north aisle, shown by the two red arrows.

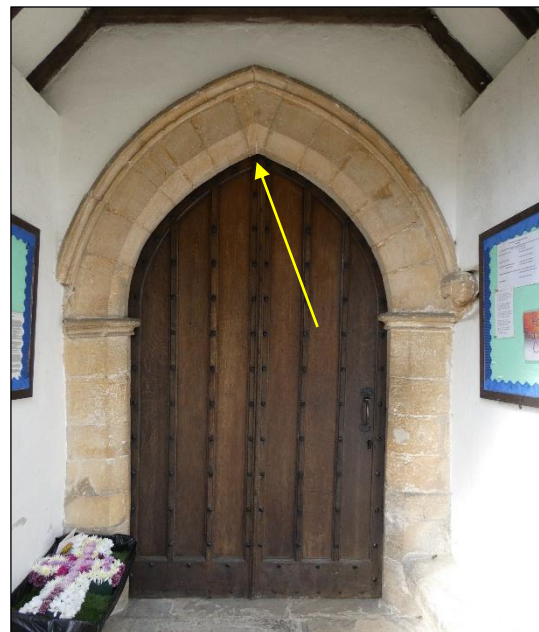
Photograph 3.2.8: View of the south porch door from outside the church. The yellow arrow shows where the bats egress and access the church.

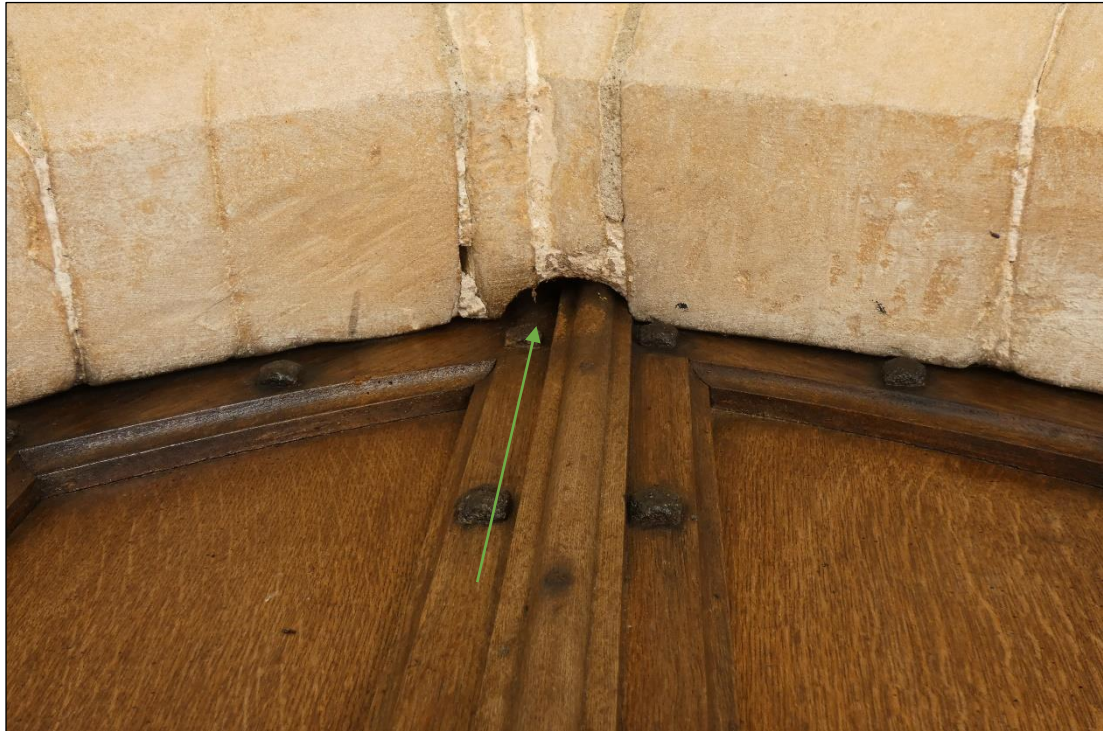
Photographs 3.2.9: The aperture in the stonework at the apex of the south door – green arrow - which is used by the Natterer’s bats and common pipistrelles to egress and access St Mary’s church.

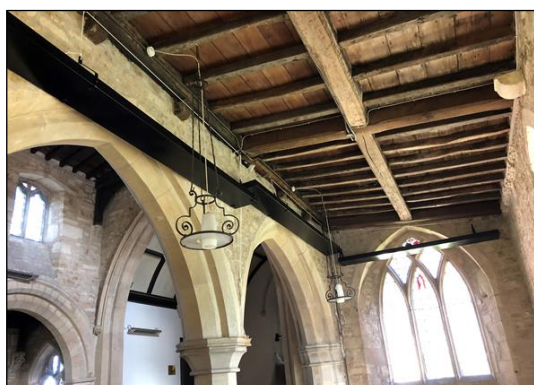
Photograph 5.3.1: Catch-boards installed within the aisle of another BiC Project church, in Leicestershire.

- 5.3.2 The catch-boards can be as basic or ornate as the church specifies and Faculty permission allows. Photographs 5.3.1 and 5.3.2 show two examples from other BiC Churches. A pulley system can be incorporated so that the boards can be lowered for cleaning.

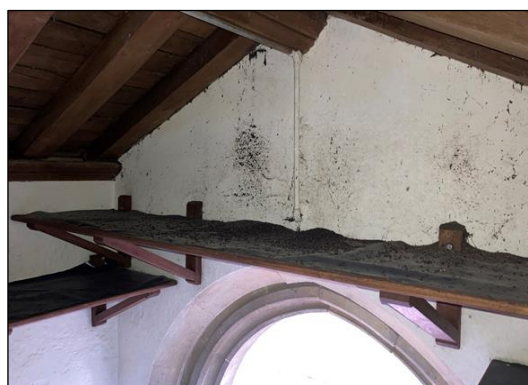
Photograph 5.3.2: Catch-boards (with droppings) installed within the porch of another BiC Project church, in Essex.

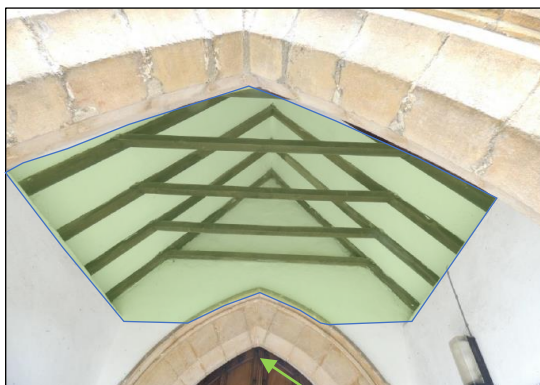
Photographs 5.6.1 (below) and 5.6.2 (right): The area shaded green shows where the new bat loft would be created for the Natterer's bats at St Mary's, in the void of the south porch. The green arrow shows the aperture used by these bats to egress and access the church.

- 5.6.5 This approach has several advantages. The bats would be 'contained' within the porch and bat activity inside the main parts of the church would be prevented, which therefore means that there will be no further issues with the deposition of bat droppings and urine inside. It is also anticipated that the capital cost of creating this bat loft would be low (<£5k).

- 5.6.6 This approach should also have a minimal impact on the visual appearance of the church and its entrance because the false ceiling would be integrated within the porch interior. It is also anticipated that this approach would not have a significant impact on the church's heritage.

- 5.6.7 The merits of this approach in respect of the bats are that the new bat loft would be created in immediate proximity to the existing egress / access feature, it is of a suitable volume and attic-shape for Natterer's bats, and it is south-facing so that it will be naturally warm and will not require an artificial heat source. Favourable conditions would also be incorporated as described above.

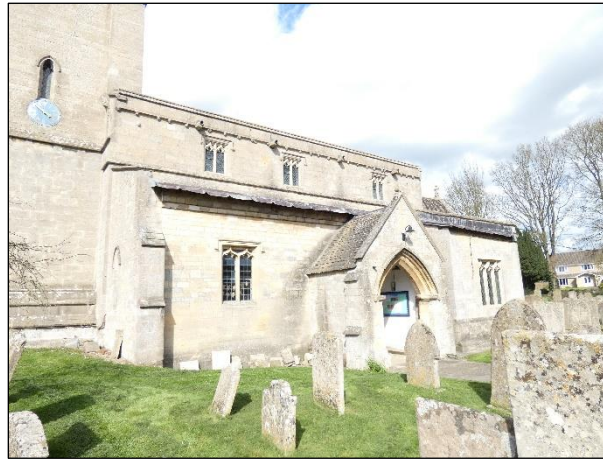
Photograph 9.2.2: View of the south aisle and south porch at St Mary's, with the clerestory and tower also shown.

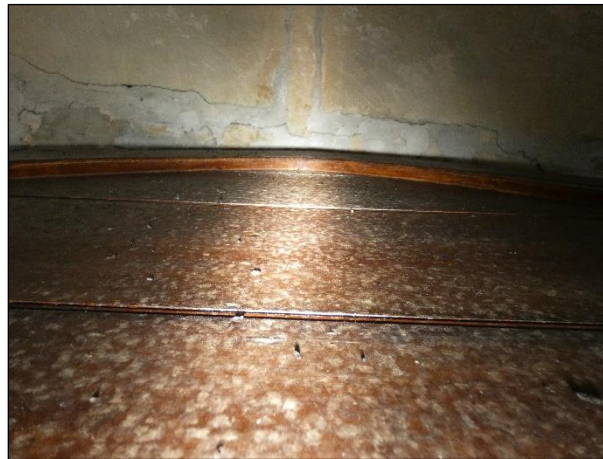
Photograph 9.2.5: Bat urine and droppings on the south door of St Mary's.

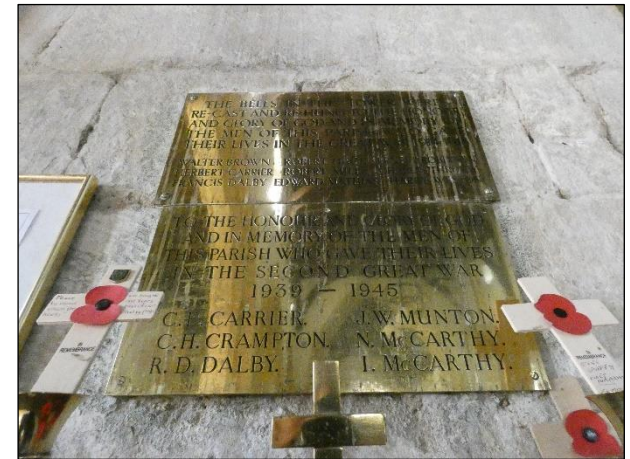
Photograph 9.2.6: Bat urine on a brass memorial inside St Mary's.
