St Mary the Virgin, Wetherden Suffolk

DEFRA and Bats in Churches Project

31st December 2022

Site:	St Mary the Virgin, Wetherden, Suffolk, IP14 3LB
Grid reference:	TM0085462780
BiC Class Licence:	WML-CL32
Your Site Reference:	B32RC006-5A
Licence Period:	01 March 2020 to 31 December 2023
Licence Monitoring:	2020 - 2023

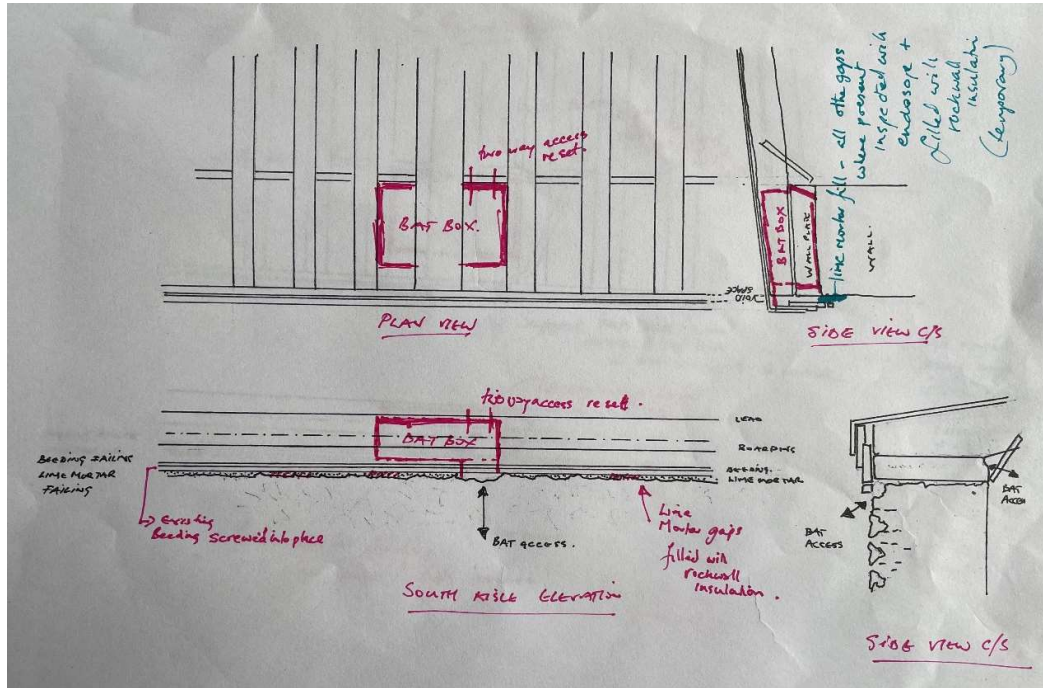
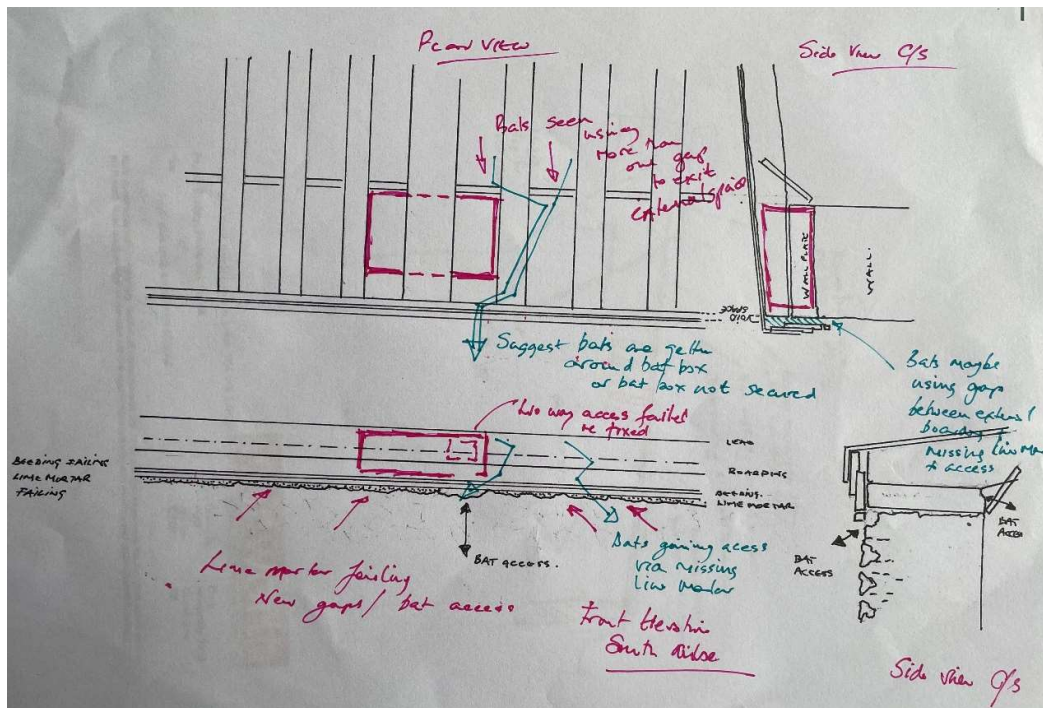
Appendix 6. Notes/Observations following 2022 exclusion attempt.:

A further exclusion period was attempted in early September 2022. The external elevation of the south aisle roof, where the lead roof overlays eaves boards that sit in front of the brick and flint wall were inspected with torches and endoscope. Examination revealed that areas of lime and hair mortar had locally fallen to create numerous gaps between the eaves board and stonework. Some eaves board beading was unattached.

It appears, despite reclosing the bat box and infilling cavities with Rockwall, that bats continue to gain access via and/or around the middle eaves bat box.

South Aisle Internal endoscopic investigation saw abundant bat droppings
Bat Box 2 however gaps in closed up bat access point and along internal
 eaves level would indicate bats are getting both through and
 around this bat box

Following inspection of the cavities and behind the external south aisle eaves boarding, where not associated with the two bat boxes, were temporary filled using Rockwool. In one location untreated seasoned oak was affixed with screws.

An exclusion devise (one way plastic bags) was re fitted to the bat access points on the south aisle to allow bats to safely leave the building over a two night period. Following this period the one way closure, previously glued in place, was affixed with oak baton and screws.

A meeting between the PCC, project architect, licensed ecologist and the Bats in Churches Project reviewed the findings and it is proposed to tender a more detailed investigation and corrections of faults in early 2023 although full funding is to be determined based on tender return costs.
