St Mary the Virgin Church, Dalham, Suffolk

Bat Management Plan

Report for Natural England

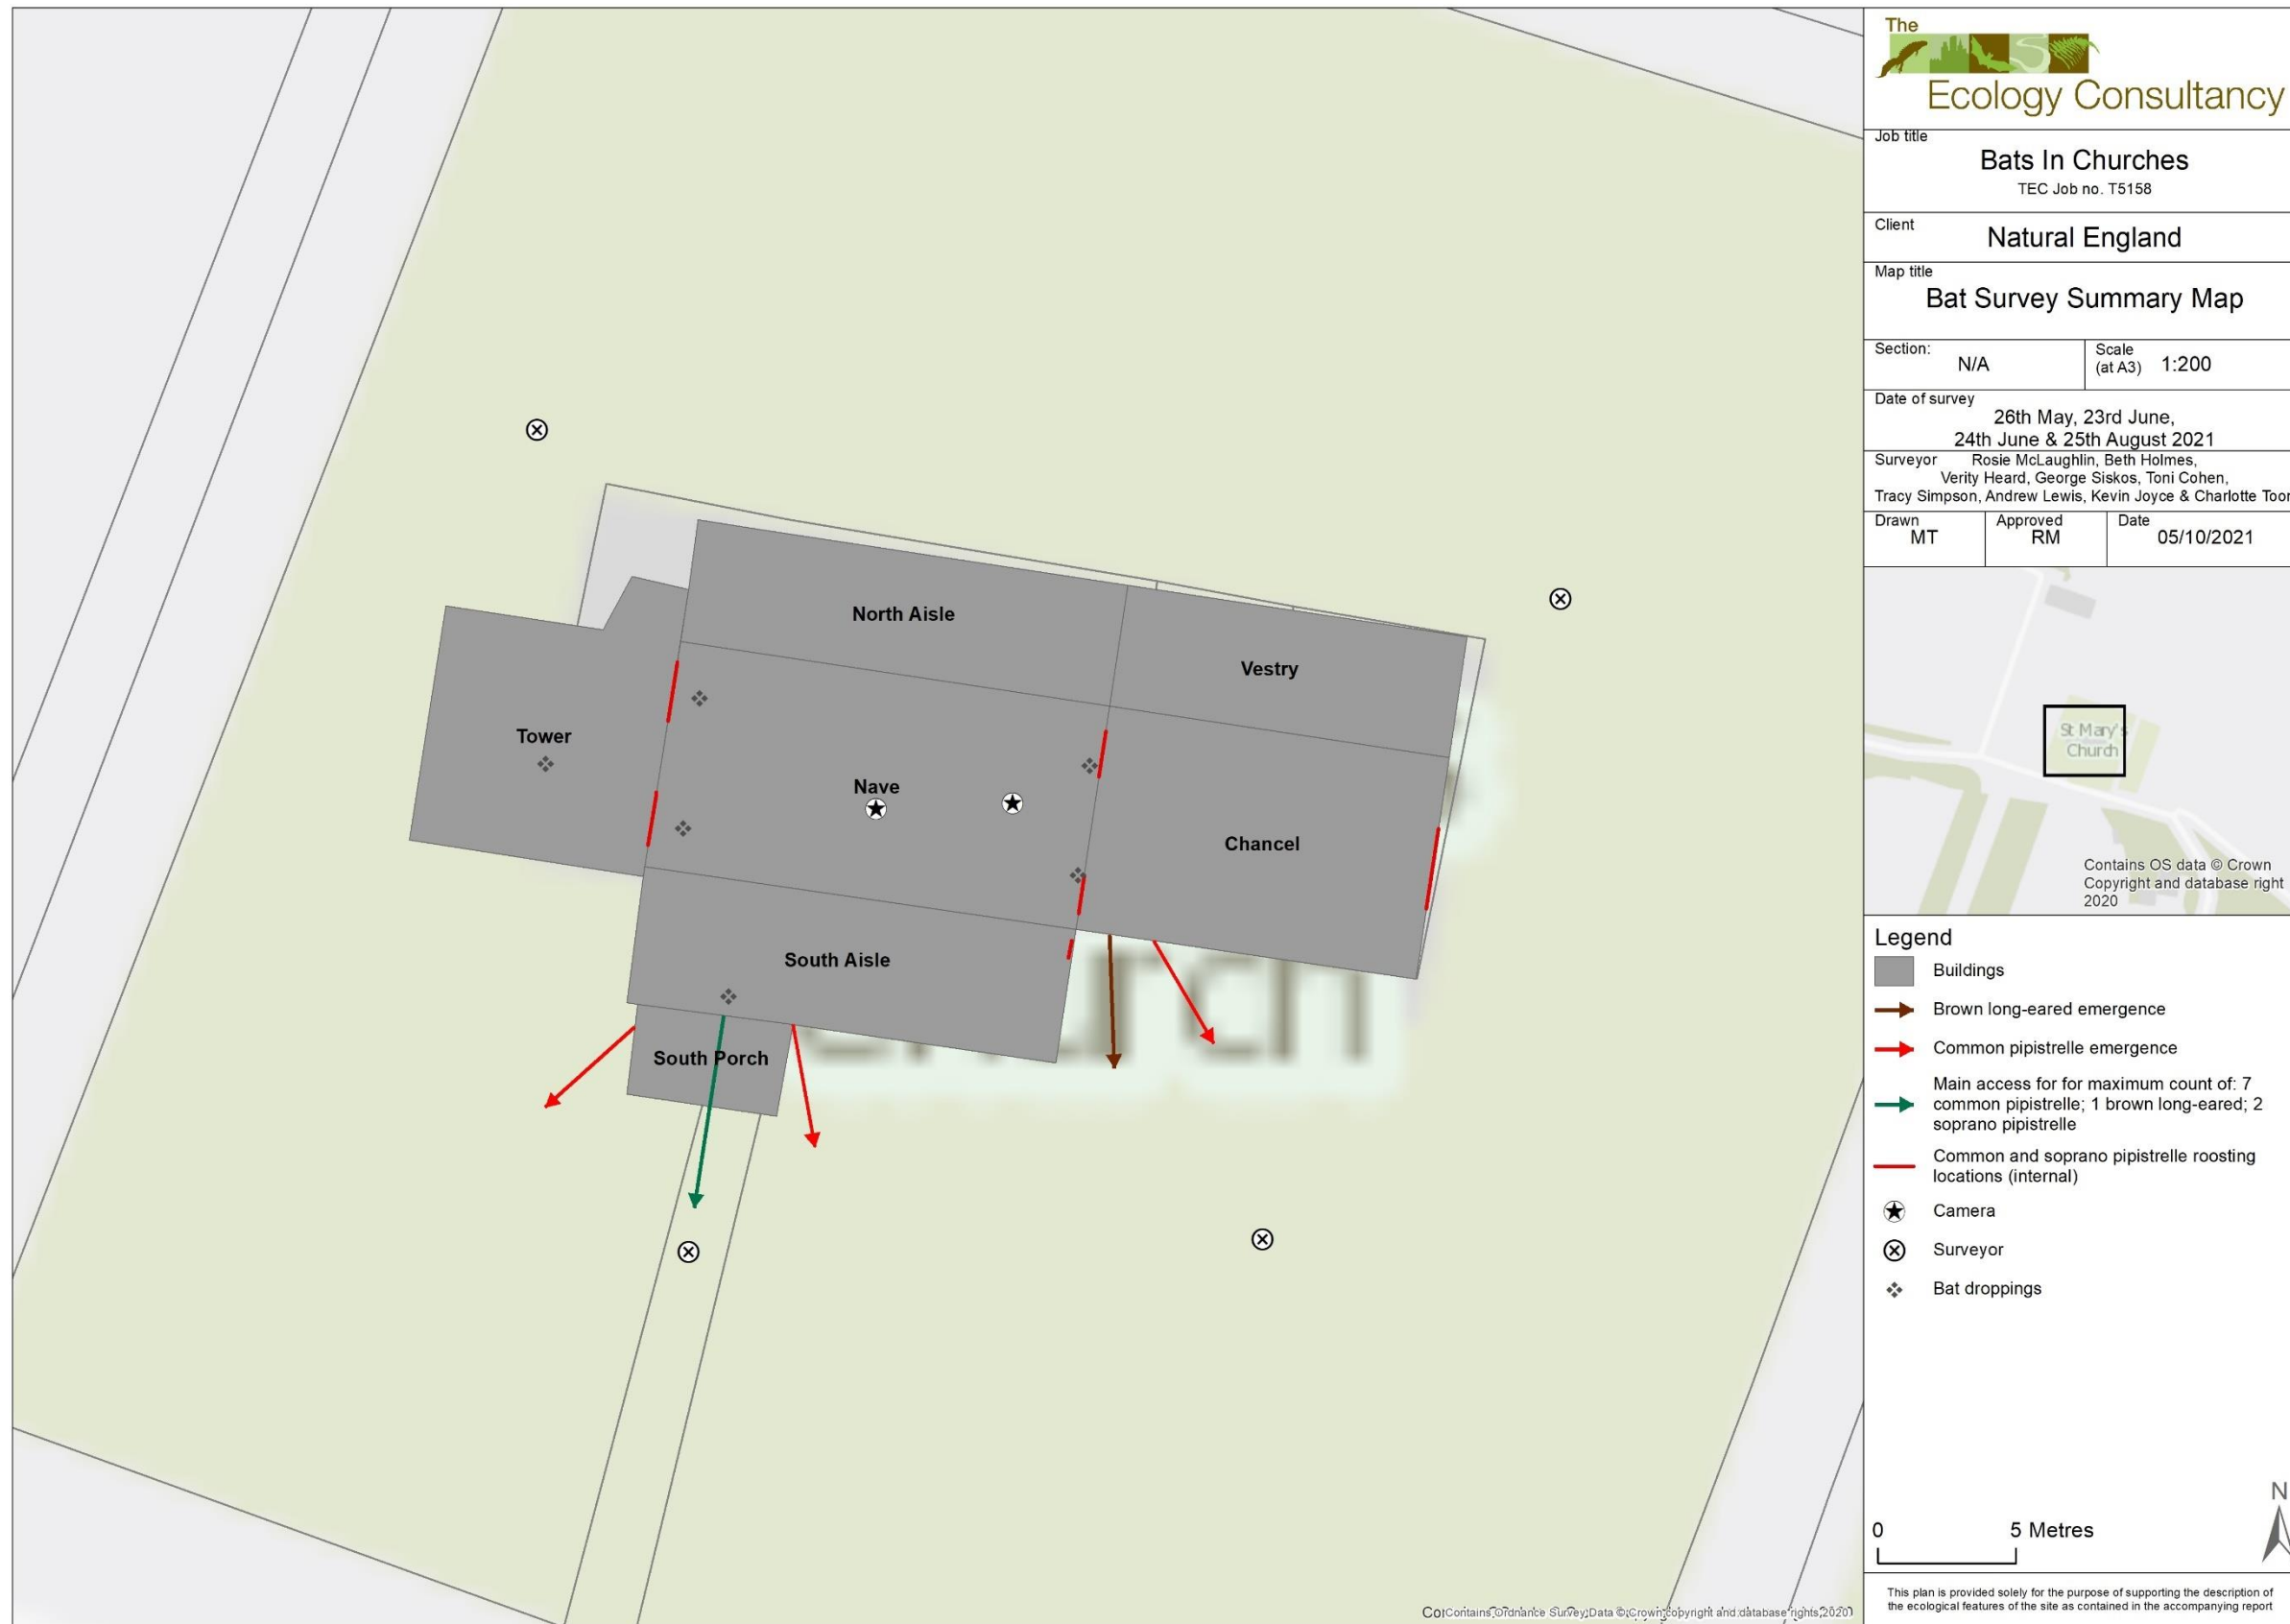
Figure 1: Bat Survey Map

- One soprano pipistrelle emerged from the main door of the church on the southern elevation but the internal roosting location was not confirmed by the surveyor or camera inside the church;
- One common pipistrelle emerged from an unconfirmed location on the eastern elevation of the porch, likely to be from gaps in the stone or flint, or around the guttering;
- No bats were observed emerging from any other aspects of the church;
- Noctule, *Myotis* sp., common pipistrelle and soprano pipistrelle bats were all recorded foraging or commuting within the grounds of the church.

- Seven common pipistrelle emerged from the main door of the church on the southern elevation. The internal roosting location was not confirmed for all bats but common pipistrelle bats were recorded roosting between the timbers and the wall at both the eastern and western elevations of the nave;
- One brown long-eared bat emerged from the main door of the church on the southern elevation. The internal roosting location for this bat was not confirmed;
- One soprano pipistrelle emerged from under a roof tile on the southern elevation of the church, adjacent to the door to the chancel;

- Eight common pipistrelle emerged from the main door of the church on the southern elevation. The internal roosting location was not confirmed for all bats but common pipistrelle bats were recorded roosting between the timbers and the wall at both the eastern and western elevations of the nave;

- One soprano pipistrelle emerged from the main door of the church on the southern elevation but the internal roosting location was not confirmed;
- One brown long-eared bat emerged from the main door of the church on the southern elevation but the internal roosting location was not confirmed;

- Four common pipistrelle emerged from the main door of the church on the southern elevation. The internal roosting location was not confirmed for all bats but common pipistrelle bats were recorded perching below timbers and the wall at the eastern end of the south aisle;
- One soprano pipistrelle emerged from the main door of the church on the southern elevation but the internal roosting location was not confirmed;

- One brown long-eared bat emerged from under a roof tile on the southern elevation of the church, adjacent to the door to the chancel;
- One common pipistrelle emerged from under a roof tile on the southern elevation of the church, adjacent to the door to the chancel;
- One common pipistrelle emerged from an unconfirmed location on the western elevation of the porch, likely to be from gaps in the stone or flint, or around the guttering;
- Noctule, *Myotis* sp., brown long-eared, common pipistrelle and soprano pipistrelle bats were all recorded foraging or commuting within the grounds of the church.

- Four common pipistrelles re-entered the church via the main door and were recorded returning to roost between the timbers and walls at the western end of the chancel, eastern end of nave, and eastern end of the south aisle;
- Two soprano pipistrelles re-entered the church via the main door;
- *Myotis* sp., brown long-eared, common pipistrelle and soprano pipistrelle bats were all recorded foraging or commuting within the grounds of the church.

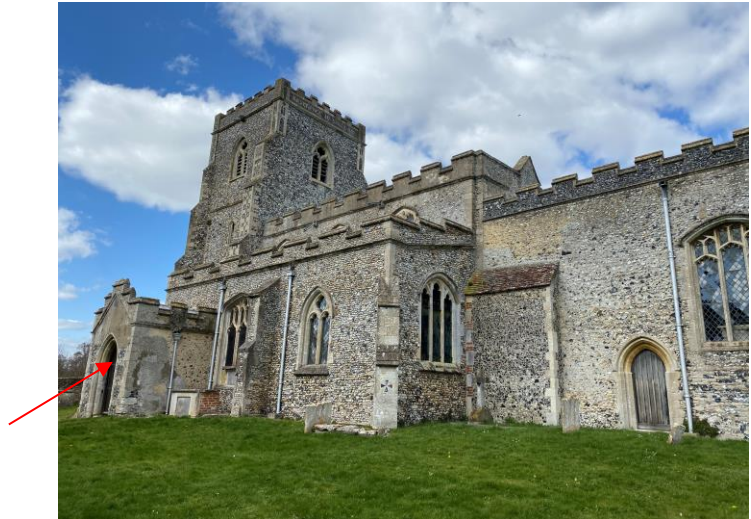
Photograph 1
Southern elevation of church,
with main access location for
bats at the porch shown by the
arrow

- It is recommended that a wall mounted bat box is installed above the known bat access point into the church, above the door in the porch, to encourage bats to roost in an alternative location.

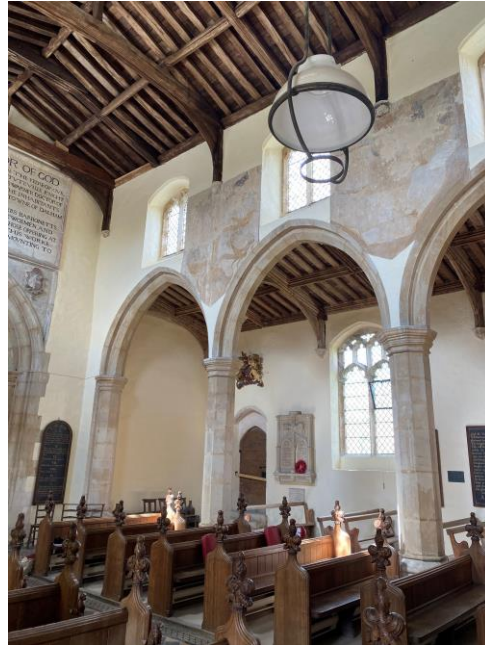
Photograph 5
Internal roosting areas between
wall and timbers

- The baffles should be installed in known and likely bat roost areas (refer Figure 2) and by a competent tradesman, installed under the supervision and guidance of the licensed bat ecologist and in accordance with the architects drawing. Baffles should be made from or coated in material that will allow droppings to slide off, and should be located at least 1m below the top of the gap behind the timbers to allow the bat access locations to remain the same.

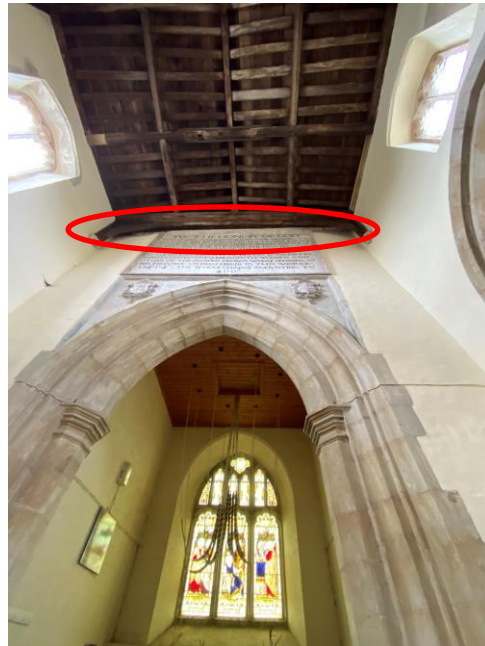
- 3.2 Internally, the church was devoid of any roof voids and comprised timber rafters and walls rendered in a smooth plaster finish. Gaps were present between the walls and timber beams throughout the church.

- The roosts within the church are recommended to be retained *in situ*. Modifications to the areas beneath the main roosting locations between the timbers and walls are recommended in the form of baffles, to help reduce the impact associated with bat droppings accumulating on the walls of the church. The premise being that droppings will slide off the baffles, landing on the floor rather than the walls, making cleaning of hard to reach areas easier, and reducing impacts of staining on the walls and artefacts.

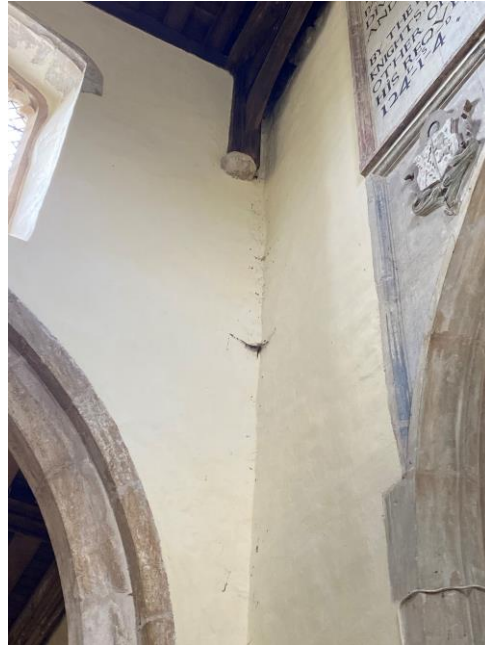
Photograph 6

- 3.4 Scatterings fresh and old bat droppings (approximately 20 droppings per area), attributed to pipistrelle species of bats, was evident on the floor and walls at both the eastern and western elevations of the nave, and the eastern and western elevations of the chancel. Roost were considered likely to be located under gaps between the walls and timber beams at these locations.

Bat droppings on wall below gaps between wall and timbers

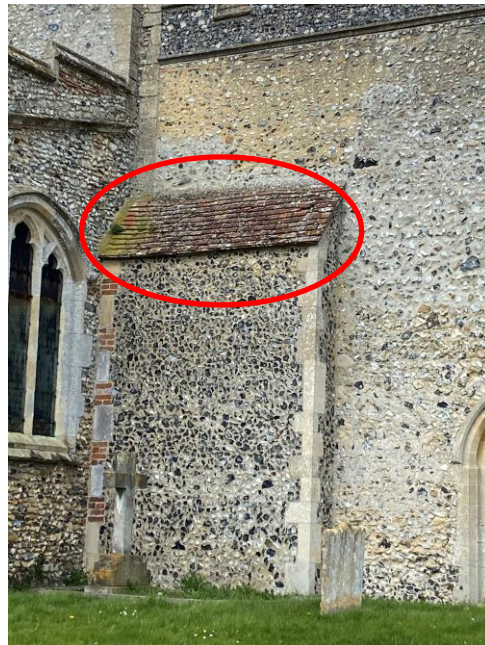
Photograph 7

- on the western elevation of the porch likely in gaps in flintwork or stone, or around the guttering; and
 - under roof tiles on small section of roof tiles on southern elevation of church.

- under roof tiles on small section of tiles on southern elevation.
- 3.25 These roosts were used occasionally, with the roost within the church used during two of the four surveys, and the roost under the roof tiles used during one of the surveys. These day roosts are considered to be of value at a **site level of importance**.

Location of roof tiles where individual common pipistrelle, soprano pipistrelle and brown long-eared bats were recorded emerging, on southern elevation of church
