# Bat Management Plan

St Nicholas' Church, Arundel

On behalf of The Bats in Churches Project

October 2021

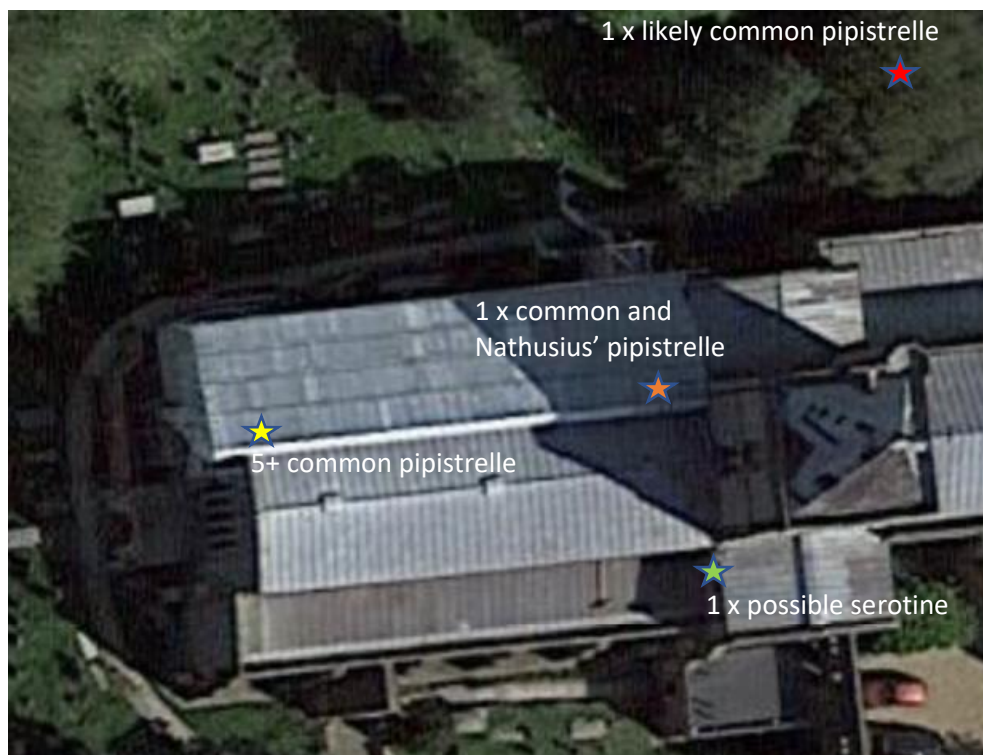
**Figure 2:** *Confirmed roost locations*

4.3.2 Externally, roosts have been recorded at three locations as follows:

- One roost on the northern aspect used by an individual common pipistrelle and Nathusius' pipistrelle. It is possible that the bats roosting at this location gain internal access to the building.
- 5+ pipistrelle bats within the northern hopper. There is no evidence that the bats roosting at this location gain internal access to the building.
- One serotine possibly emerged from southern aspect of the Church or eastern wing of building (Fitzalan Chapel). It is possible that the individual gains access to the inside of the Church via the Fitzalan Chapel.

5.1.2 The fascias on the southern aspect will be removed in sections with the intention of creating enclosed features for roosting bats between the rafters. In order to maintain ventilation, a stainless-steel mesh with a small gauge such as a 6.35mm Aperture<sup>1</sup> or a greenhouse mesh (a solid fine mesh plastic which is available from garden centres) will be used at the rear of the feature to prevent bats gaining access to internal areas of the Church.

5.1.3 Should modification of the south fascias be successful, those on the northern aspect will be modified in the same way when funds allow. Modification of the northern fascias is most critical given they are the most likely internal access point for bats into the church.

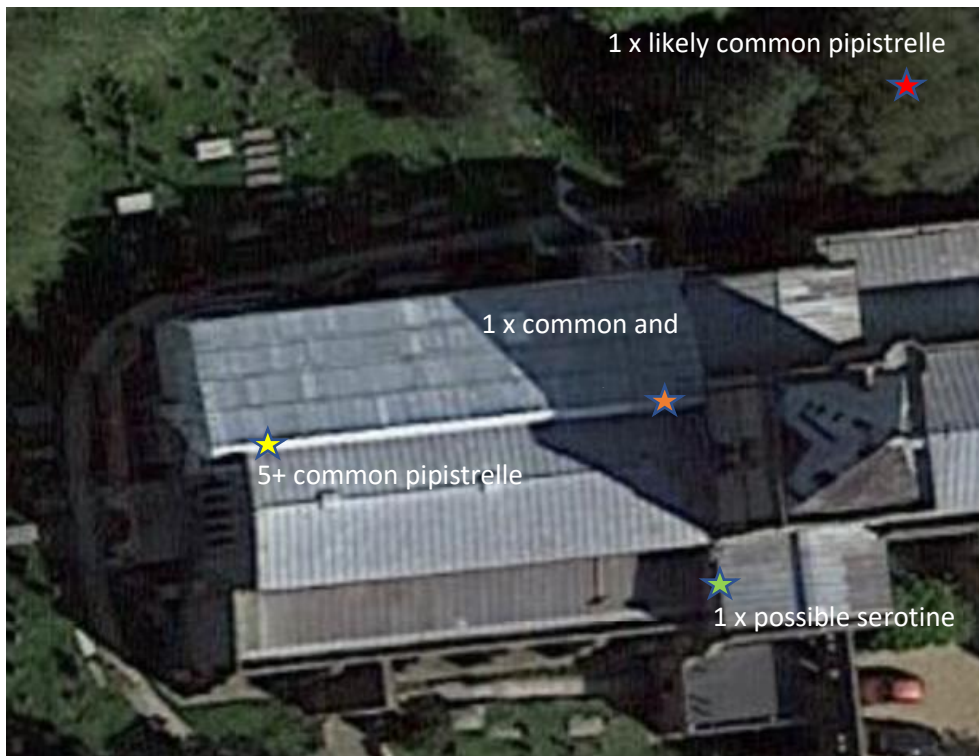
**Figure 2:** *Confirmed roost locations*

The locations of roosts are indicated on Figure 2. Within the following descriptions, a sound file of a bat detector containing a bat call sequence is defined as a pass.

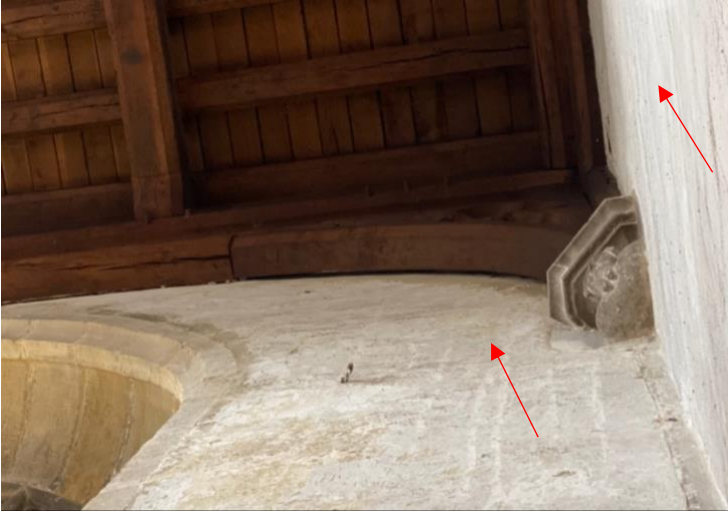
- **Common pipistrelle** - rarely active within church (flew for one pass, 4 minutes and 15 minutes), potentially an occasional roost on the internal western gable where droppings are present

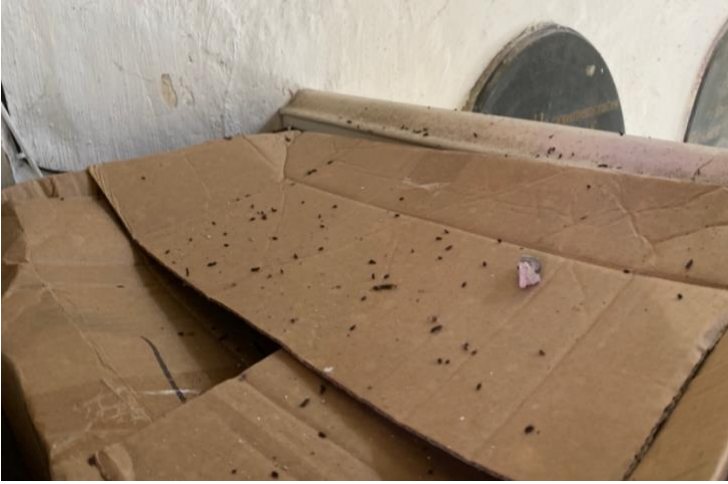
- **Serotine** - rarely active within church (flew for one pass, 30 seconds (twice) and 4 minutes), a likely occasional roost internally in south-western corner, likely one bat

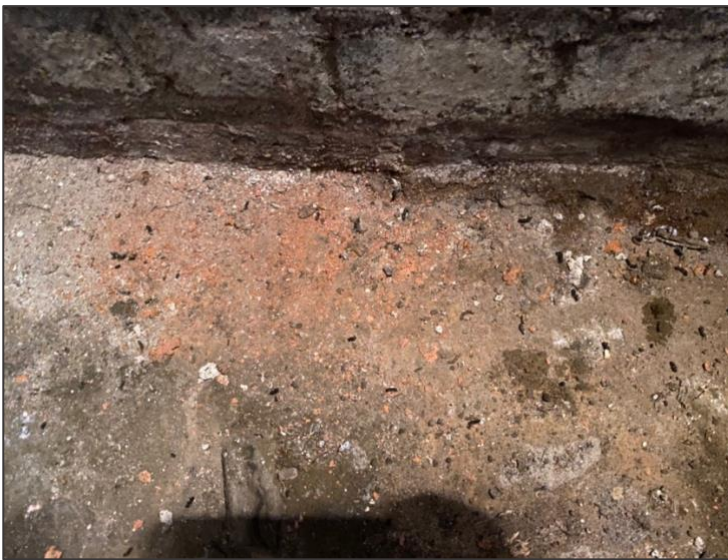
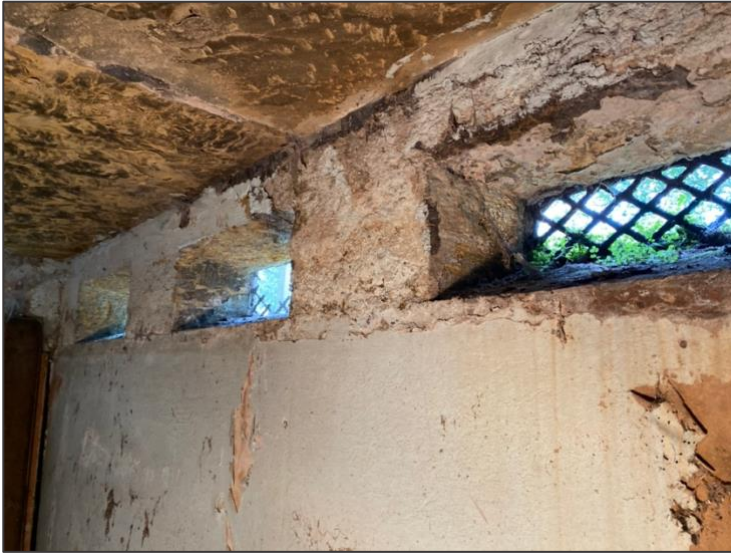
- **Brown long-eared bat** - no evidence within church itself, roost of likely one hibernating bat in basement

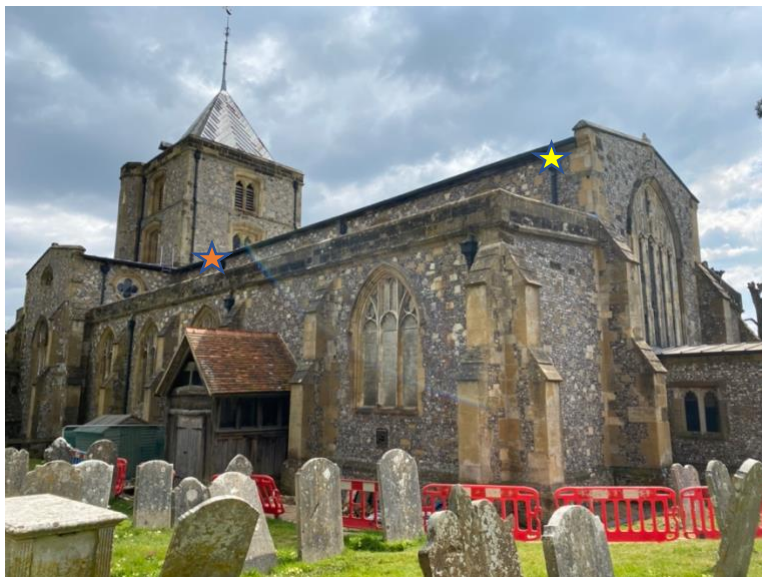
Externally, roosts have been recorded at three locations as follows:

1. One roost on northern aspect used by an individual common pipistrelle and Nathusius' pipistrelle ★
2. 5+ pipistrelle bats within hopper ★

There is no evidence that the bats roosting at these locations gain internal access to the building.

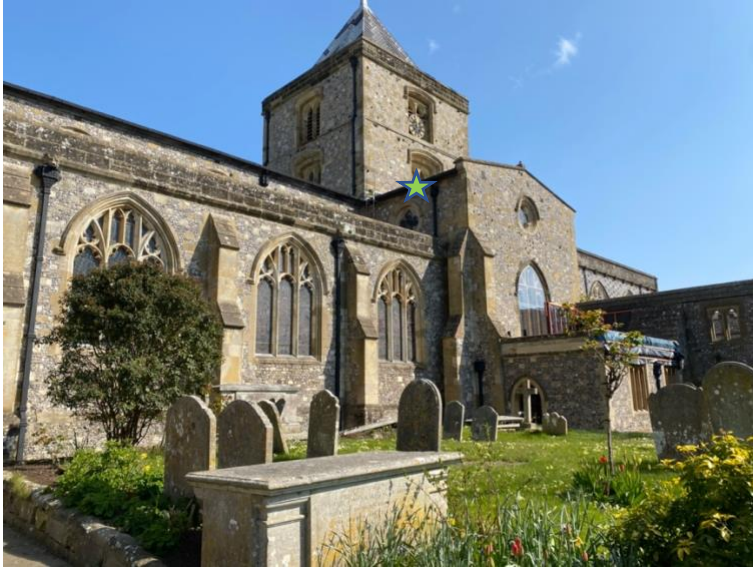
3. One serotine possibly emerged from southern aspect of the Church or eastern wing of building (Fitzalen Chapel) ★ It is possible that the individual gains access to the inside of the Church via the Fitzalen Chapel.
