BAT SURVEY REPORT  
**ST. ANDREWS'S CHURCH,  
BLAGDON, SOMERSET**  
NATURAL ENGLAND

| September 2021 | BR0547/B/A |

**Document Title:** Bat Survey Report

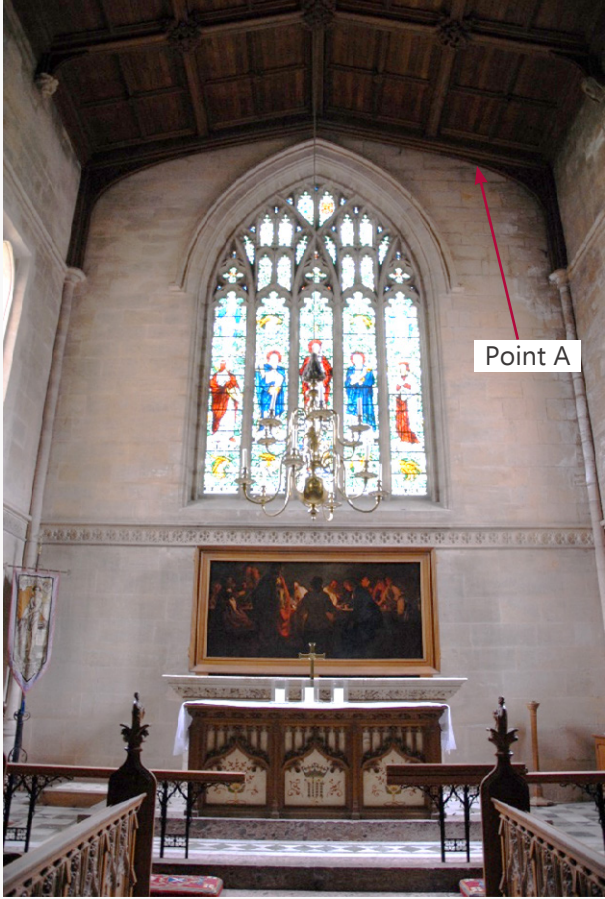
REF.	DESCRIPTION	IMAGE
Chancel & Point A	<p>Chancel of Church looking eastwards at the end wall showing the Moser painting and alter.</p> <p>Point A access shown by red arrow. Common Pipistrelle bat entered gap between end roof timbers and wall.</p>

The damage to the Moser painting on the eastern wall of the Chancel is a result of deposition of bat droppings and urine, likely when bats have been circling the end of the Chancel and/or flying up to the access point identified between the roost timbers and the eastern wall. Although the preferred solution for those responsible for maintaining the Church is for blocking the bat access point at the top of this wall to stop or, at least, reduce the deposition of droppings and urine in this area, it is considered that Satisfactory Alternative solutions exist and so proposals to modify, damage or destroy roosts would not pass the three mitigation licence legal tests.

It is considered that the impacts of bats on the painting can be avoided by shielding the painting either by a permanent transparent covering (e.g. glass) over the front of the painting, by installing a ledge above the painting, or by adding curtains that are drawn between dusk and dawn each night. These options are discussed in the Bats in Churches Roost Visit Report Form produced following the 2017 Light Touch Survey by RSK and were also discussed during the LTS in May 2021.

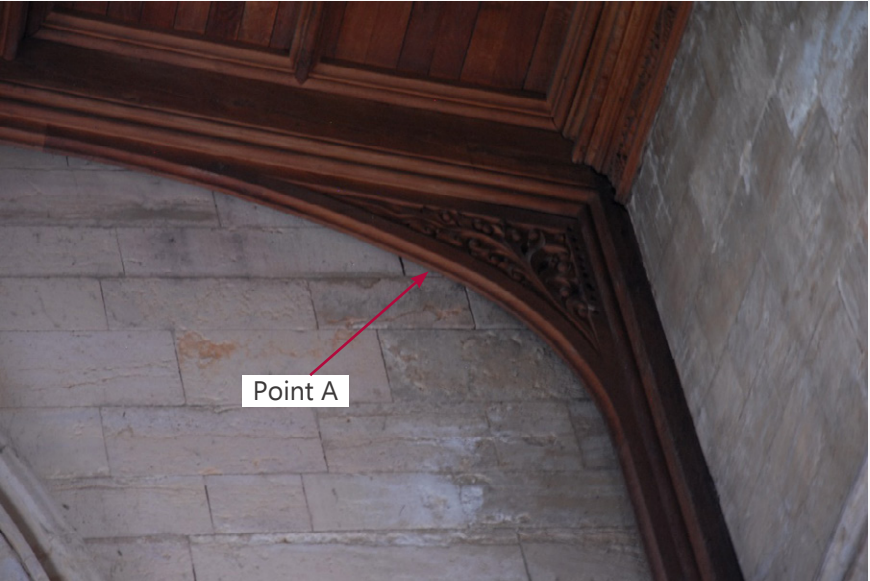
Point A	<p>Close up view of Common Pipistrelle access in south-eastern corner of the chancel.</p>

A single Common Pipistrelle *Pipistrellus pipistrellus* was recorded flying inside the chancel of the Church at 21:40 and promptly entered the gap between the roof timbers and eastern wall at the south-eastern corner of the chancel. It was not seen where the bat emerged from inside the Church prior to this. The bat was observed emerging outside the Church.
