BATS IN CHURCHES

St Mary Magdalene BRAMPTON Huntingdonshire

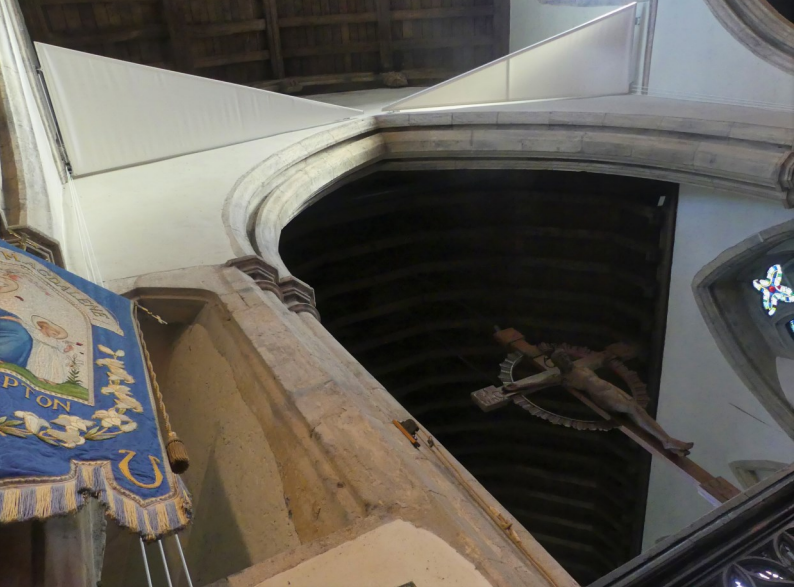
A maternity colony of Common Pipistrelle were using the entire church, but primarily roosting under the chancel arch. This caused a build up of droppings in a very important part of the church including smell, rot and maggots caused by urine soaking in to the carpet
