Bats in Churches Project: All Saints' Church Braunston-in-Rutland Ecology End of Project Final Report February 2023

Document type	Bats in Churches Project – Ecology End of Project Final Report
Version	1.0
Author	Dr Charlotte Packman PhD
Client	Natural England
Site address	All Saints' Church, Braunston-in-Rutland, Oakham, Leicestershire, LE15
	8QS.
Site grid reference	SK 83259 06589
Report date	February 2023

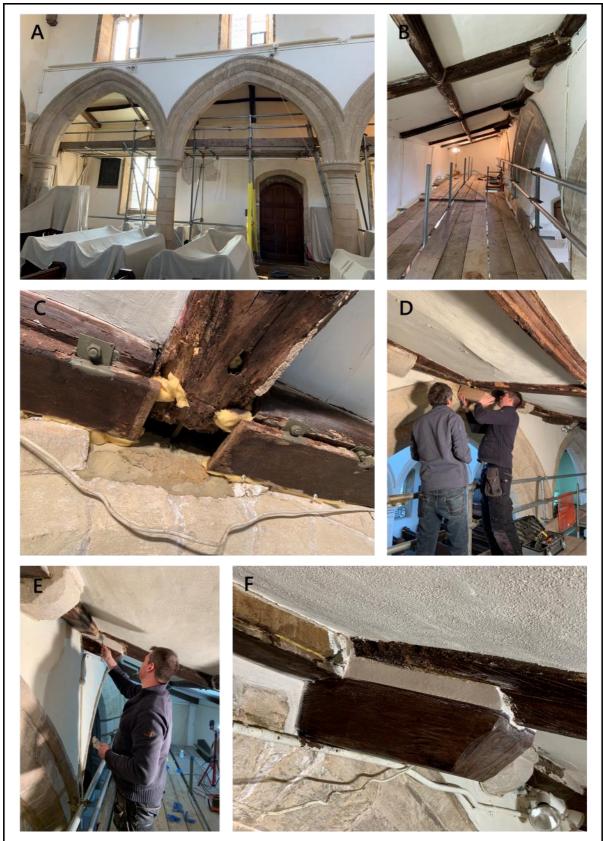
Figure 1. Photographs of works to block bat access from the roof roosts to the church interior (in 2018 temporary blocking with foam sponges, in 2019 made permanent with repair works to close-up bat access gaps in the south aisle).

The first phase of works involved temporary blocking of all identified and potential bat access points between the roost areas in the south aisle and south chancels roofs and the church interior. This work was carried out by the ecologist and builder working together (see photographs in Figure 1). Access points were primarily blocked using foam sponges (these are easy to fit into irregularly shaped gaps, expand to fill the gaps, do not involve any potentially harmful substances for the bats, do not harm the church fabric and can easily be removed if needed). Gaps along the chancel eaves (north and south sides) were also blocked as a precaution.

The second phase of works involved making the successful temporary blocking (see 3.3 Monitoring) undertaken in Phase 1 permanent. This had to be carried out in a manner/materials that were appropriate for the Grade II* listed building, with the specifications drawn up by the church architects (Purcell, specifications provided in Appendix 4 of the 2018 Ecology Report). See photographs in Figure 1.

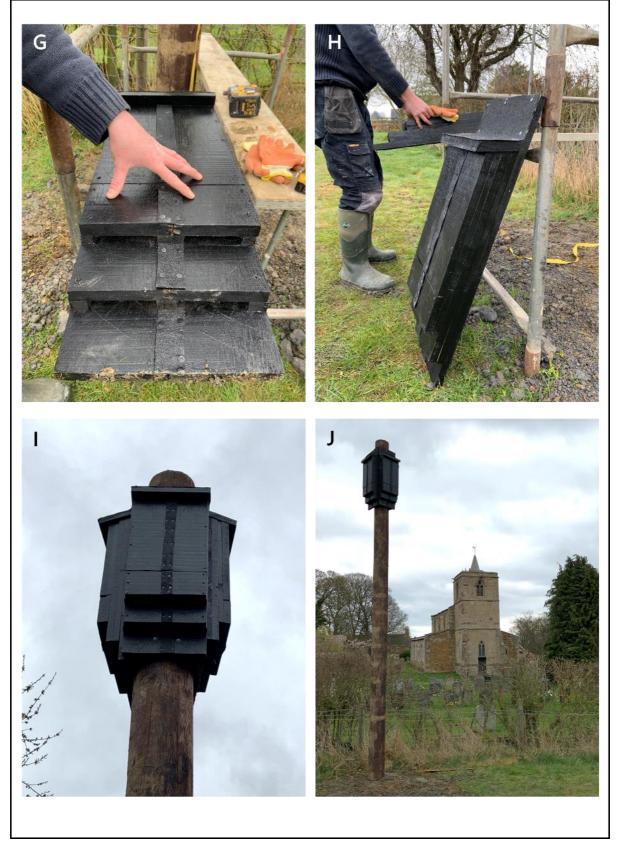
Figure 2. Photographs of the pole-mounted triple aspect crevice bat boxes. Pole positioned on a hedgeline adjacent to the churchyard (western boundary).

In addition, three large Kent style (crevice) bat boxes, suitable for use by pipistrelles, were erected on a pole adjacent to the churchyard, to provide additional bat roosting opportunities (see photographs in Figure 2).

The pole-mounted triple aspect bat boxes (located on the boundary of the churchyard) have been checked during each monitoring visit and small numbers of soprano pipistrelles have been recorded roosting inside them, which is promising given that uptake of new bat boxes can take many years.

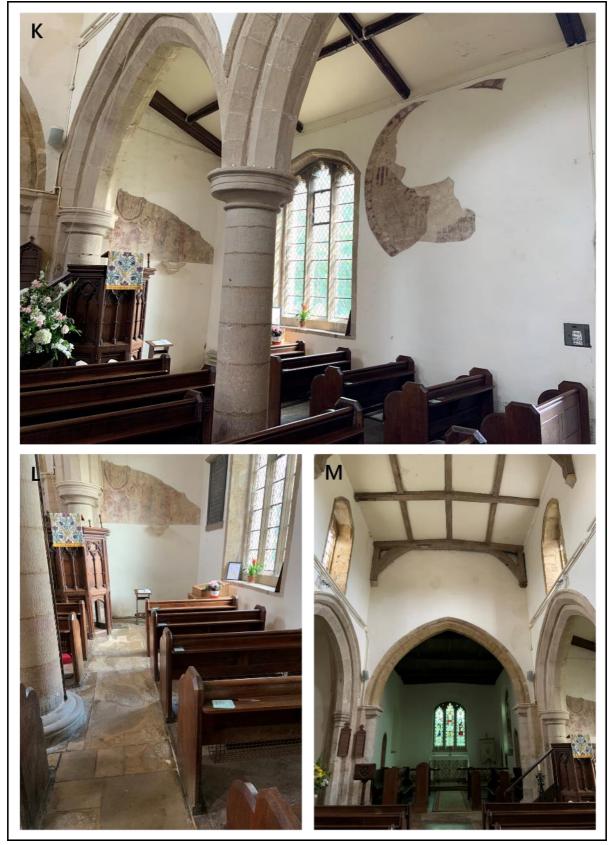
Figure 3. Photographs of the church post-works. Medieval wall paintings can be viewed and no longer need to be covered/protected from bat droppings and urine (K), church interior without piles of droppings on floor of the south aisle (L), interior clean and free of bat droppings/urine marking walls, floors and pews (M).

The implemented measures have been highly effective in reducing the impact of bats on the church. Bat activity inside the church has been reduced to almost nil, with only very occasional bat access to the interior by individual bats. Consequently the impacts experienced by the church have been entirely resolved, with there no longer being any accumulations of bats droppings or damage from urine/droppings to walls/floor/pews/wall paintings/monuments etc. The unpleasant smell from bat droppings/urine has also gone. The churchwardens report being very pleased with the outcome and to have regained full use of the church. As there is no longer a need for any protective covers, the medieval wall paintings can also now be viewed and the important heritage features of the church can be enjoyed by residents and visitors. See photographs in Figure 3.
