Bat Mitigation Plan

St. Mary the Virgin

Bruera

31st October 2021

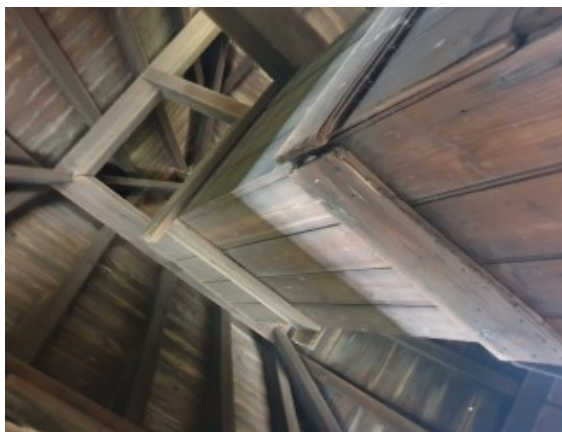
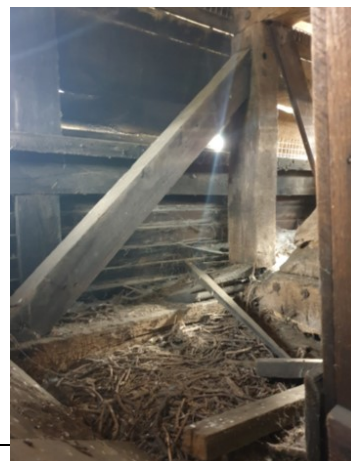
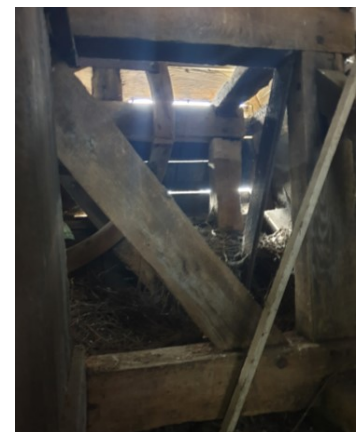
Figure 4 photos of interior of the tower

The church St. Mary the Virgin founded in 1662 contains Norman elements, it has been subjected to alterations and modifications, particularly in 1896. The church has a timber framed tower projecting above the main body of the building its only access from a hatch in the main ceiling.
The building is located at NGR SJ437605.

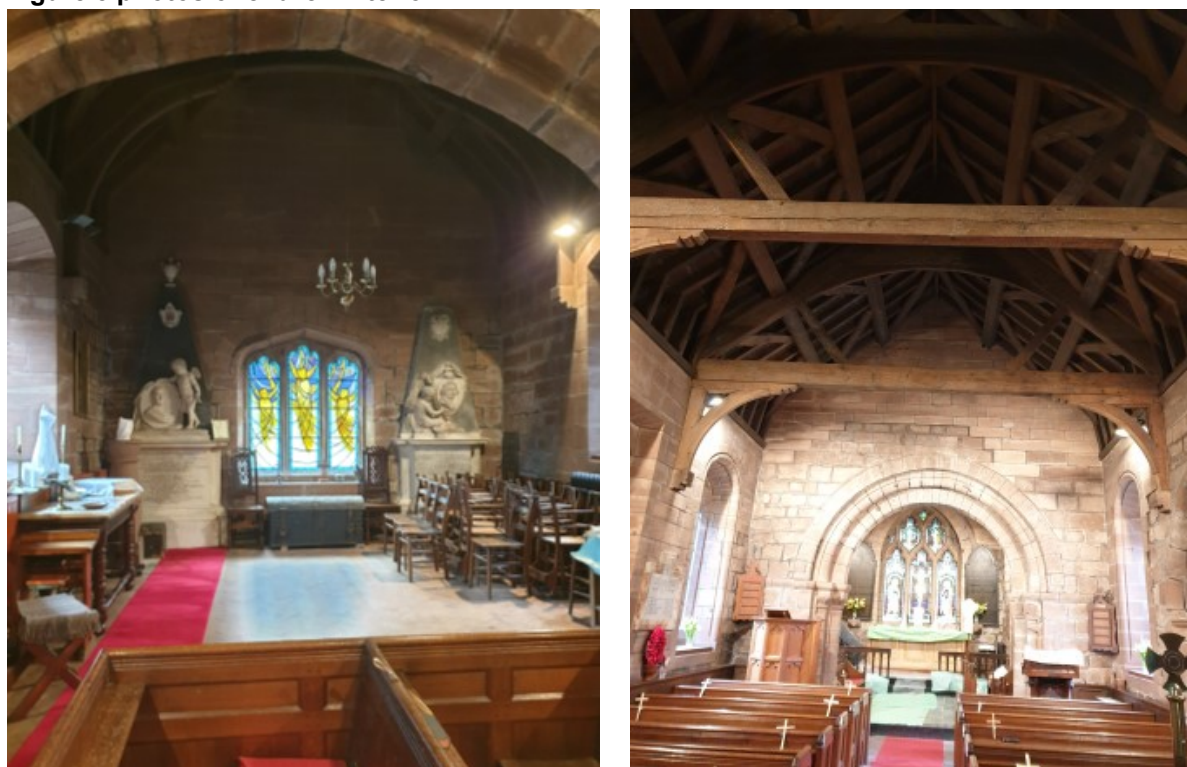
Figure 5 photos of church interior

The bats use of the interior has caused damage to the fabric of the church, monuments, fixture and fittings, and widespread urine staining particularly in the eastern half in the chancel.

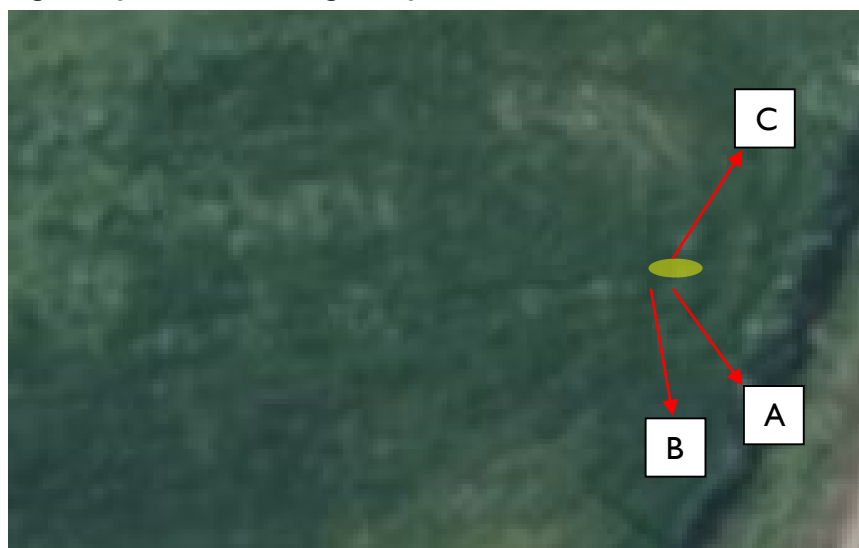
Figure 9 plan of bat emergence points

Three Soprano pipistrelle bats emerged from eastern roof from 'A' & 'B'

Five Long eared bats emerged from eastern roof from 'C' area

Species	No.	Location	Exterior exit route
Soprano pipistrelle	3	In eastern roof	Eastern roof apex south side
Long eared	5	In eastern roof	Eastern roof apex north side

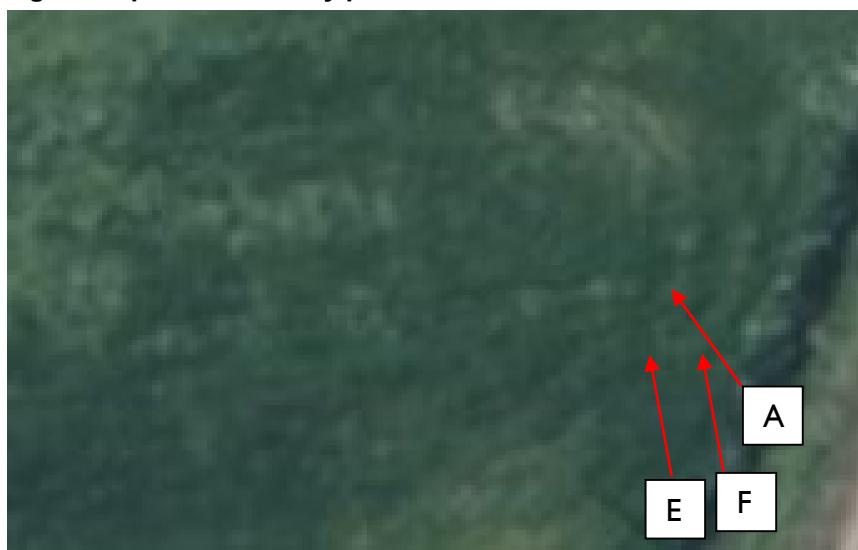
Figure 10 plan of bat entry points

One Common pipistrelle bat entered into slit in eaves below east parapet wall 'F'

Four Long eared bats entered from eastern roof from 'C' area

One Soprano pipistrelle entered into roof south side near ridge 'A'

Species	No.	Location	Exterior exit route
Soprano pipistrelle	1	In eastern roof	Eastern roof apex south side 'A'
Long eared	6	In eastern roof	Eastern roof eaves 'E'
Common pipistrelle	1	In eastern south roof wall top	Eastern roof eaves 'F'
