St John the Baptist Church, Cold Overton

Bat Management Plan

January 2020

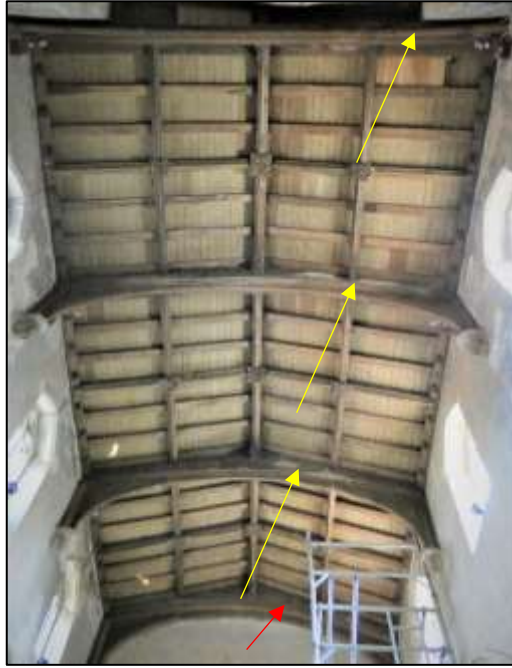
Photograph 3.1.1: The location of most of the bat roosts within the nave of the church.

- 3.2.3 Figure 10.1 in the Appendix provides a plan of the key findings in respect of bats in 2019. In 2019 both the soprano pipistrelles and the Natterer's bats roosted among the roof timbers of the nave, accessing and egressing their roosts via apertures alongside the span beams. The soprano pipistrelles roosted in several locations nearest the western half of the nave roof, predominantly on the southern side, whereas the Natterer's bats roosted at the eastern end of the nave roof above the chancel arch. Photograph 3.1.1 shows most of the locations where bats have accessed roosts among the nave roof timbers over many years, indicated by the characteristic wear on the span beams. The yellow arrows on this photograph show the locations of the soprano pipistrelle roosts used in 2019 (feature 1, Figure 10.1), and the red arrow shows the location of the roost used by Natterer's bats in 2019 (feature 2, Figure 10.1). Photograph 3.1.2 shows the droppings that had aggregated below one of the two main soprano pipistrelle roosts within the nave over 3-4 weeks in July 2019. Photograph 3.1.3 shows a close-up view of one of the main soprano pipistrelle roosts used in the nave in 2019

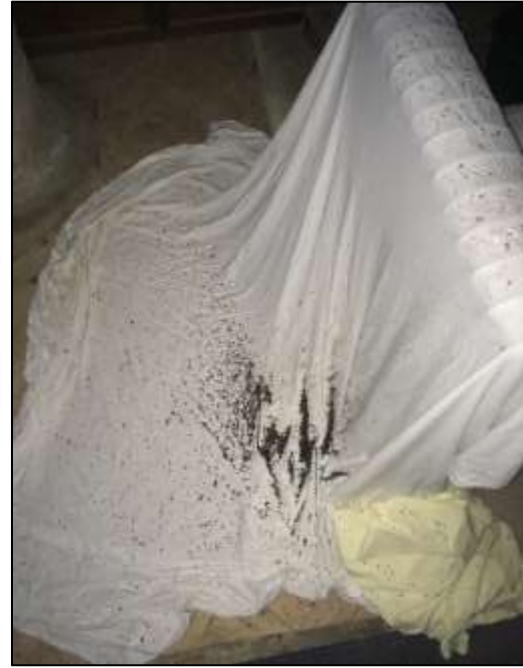
Photograph 3.1.2: Soprano pipistrelle droppings on a sheet below a roost in the nave.

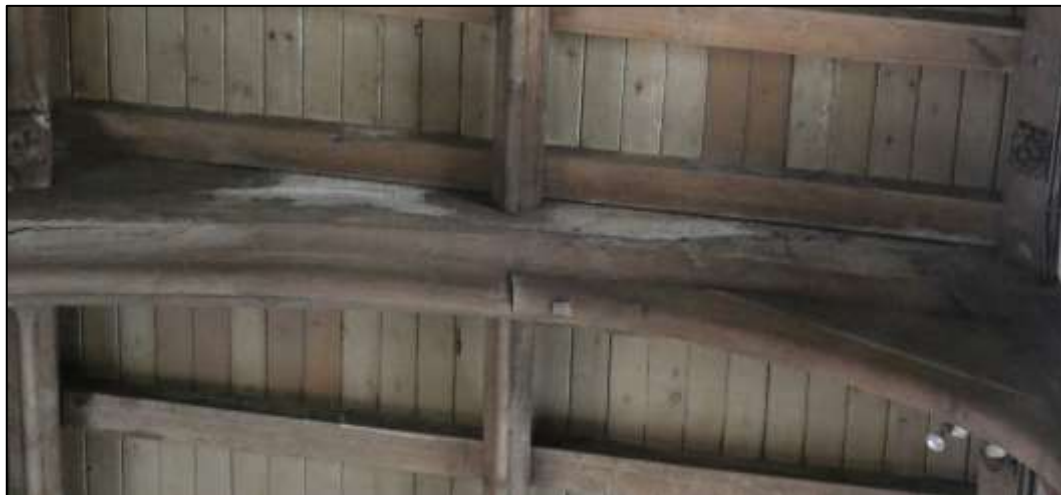
Photograph 3.1.3: One of the main soprano pipistrelle roost features within the roof of the nave, above a span beam. The wear caused by the bats accessing and egressing their roost is apparent.

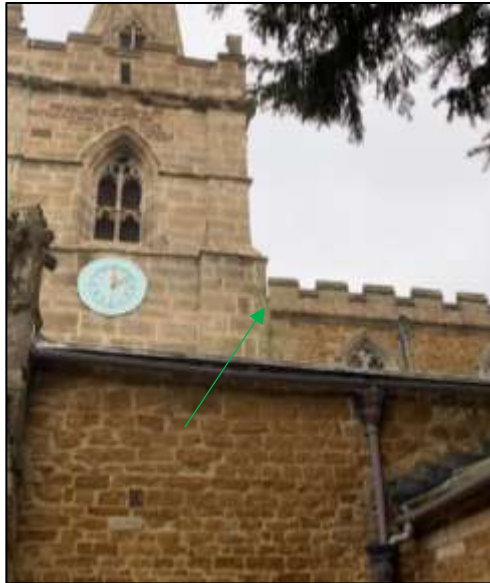
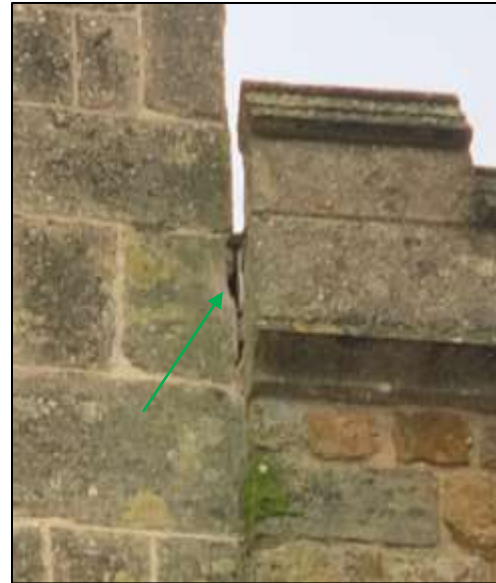
Photographs 3.1.4 and 3.1.5: The south-facing aperture in the external stonework (green arrow) where the clerestory meets the tower, which is used by approximately two thirds of the soprano pipistrelles to exit and return to the church. The bats that use this feature access and egress the church interior in the location shown by the green arrow in photograph 3.1.11.

- 3.2.5 The suite of nocturnal surveys undertaken in 2019 identified two features used by the soprano pipistrelles to access and egress the church, both of which comprise apertures in the stonework between the parapet wall of the clerestory and the tower. One of these features, which was used by approximately two thirds of the colony is located on the southern elevation of the church (feature 3a, Figure 10.1; photographs 3.1.4 and 3.1.5) and the other feature, which was used by approximately one third of the colony, is located on the northern elevation (feature 3b, Figure 10.1; photographs 3.1.6 and 3.1.7). Almost all of the soprano pipistrelles that were recorded exiting these two features in 2019 commuted in a general westerly direction once they had emerged, towards the woodland adjacent to the churchyard.

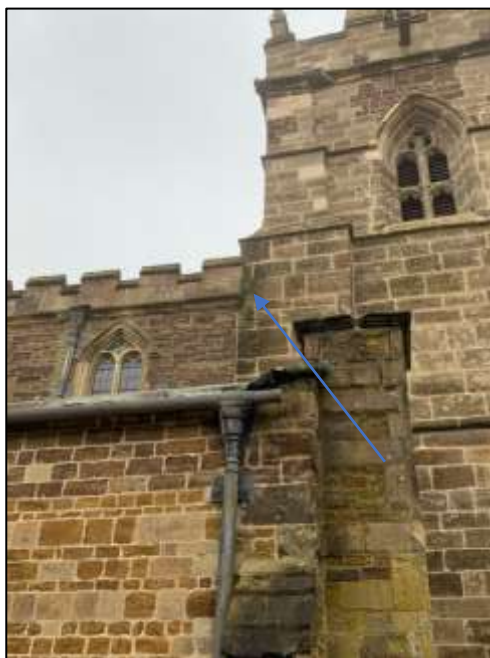
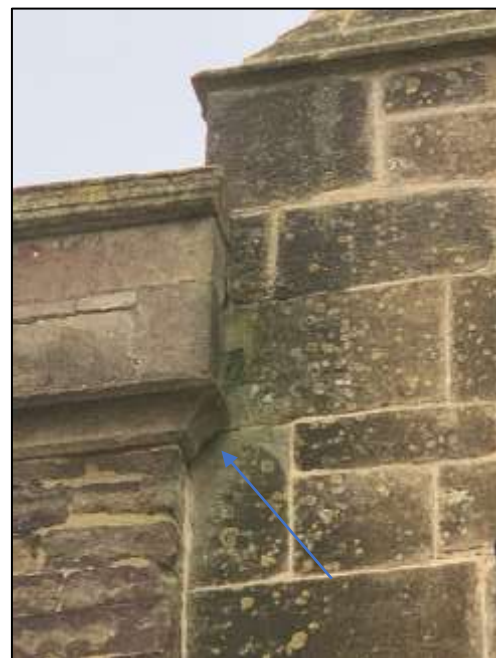
Photographs 3.1.6 and 3.1.7: The north-facing aperture in the external stonework (blue arrow) where the clerestory meets the tower. This is used by approximately one third of the soprano pipistrelles that roost in the church. The bats that use this feature (feature 3b, Figure 10.1) access and egress the church interior in the location shown by the blue arrow in photograph 3.1.11.

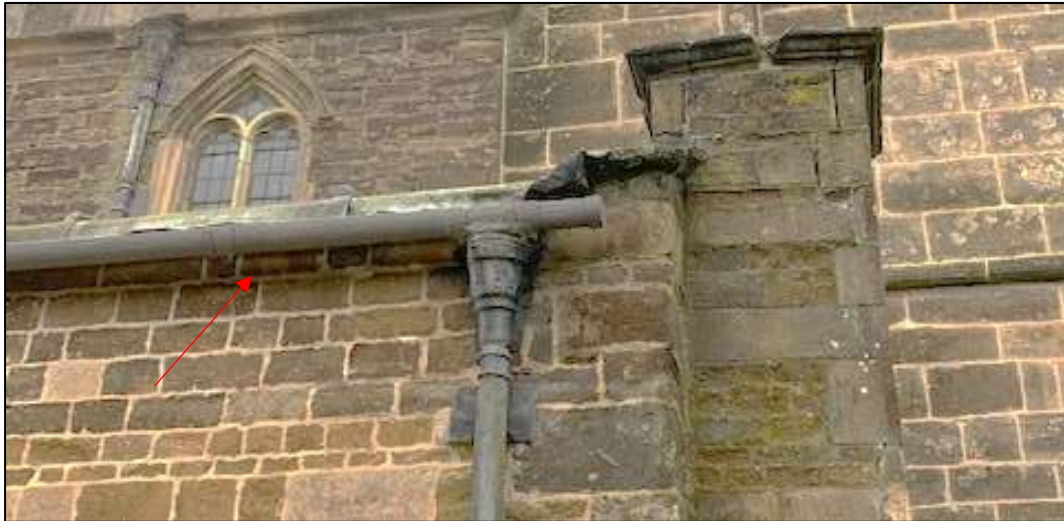
Photograph 3.1.8: The Natterer’s bats (re)enter the church via three gaps at the eaves of the north aisle. The red arrow shows the external location of one of these features – feature 4a, Figure 10.1.

- 3.2.6 The 2019 nocturnal surveys also identified three features used by the Natterer's bats to access and egress the church, all of which comprise apertures in the stonework below the eaves of the north aisle alongside protruding rafters. Two of these features (features 4a and 4b, Figure 10.1; photographs 3.1.8 and 3.1.9) are at the two opposing corners of the north aisle, and these were used by most of the Natterer's bat colony to access and egress the church. The third feature (feature 4c, Figure 10.1) is located approximately halfway along the north aisle eaves; this was used by only three Natterer's bats to exit the church on one survey.

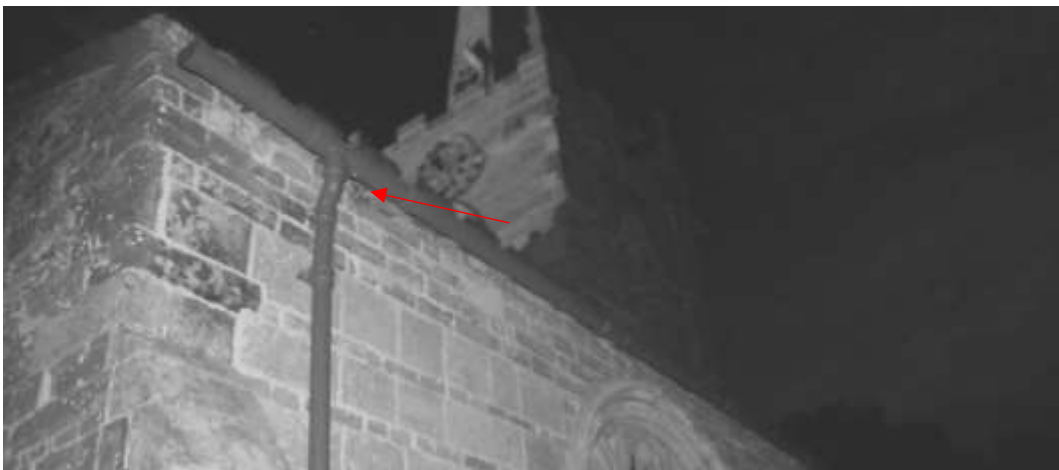
Photograph 3.1.9: The Natterer’s bats (re)enter the church via three gaps at the eaves of the north aisle. The red arrow shows the external location of one of these features - feature 4b, Figure 10.1.

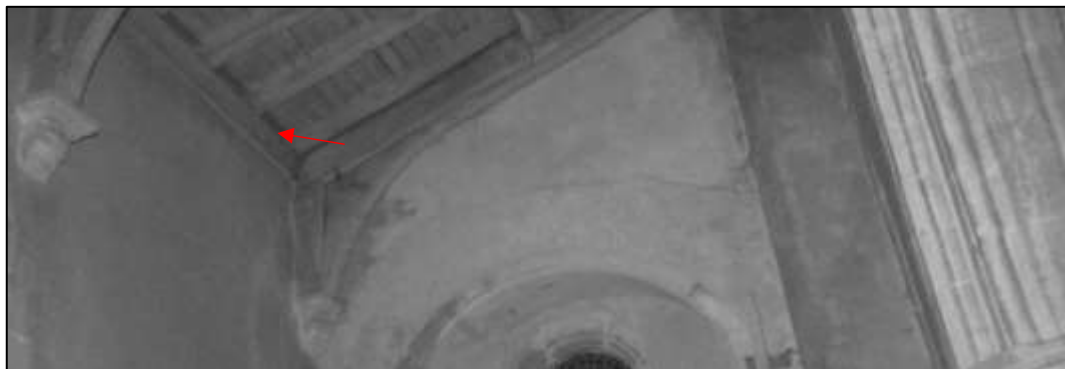
Photograph 3.1.10: The Natterer’s bats (re)enter the church via gaps at the wall plate of the north aisle. The red arrow shows an internal view of one of the three features used (feature 4b, Figure 10.1), in the north-east corner.

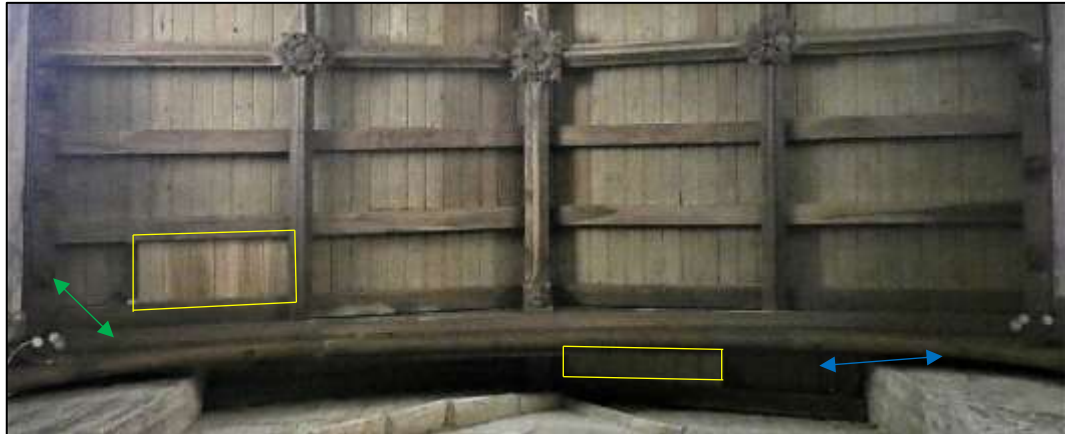
Photograph 3.1.11: The two bespoke bat boxes within the nave roof of the church are shown by the yellow boxes. The arrows show the two main locations where the soprano pipistrelles egress and access the church, on the southern elevation to the left and the northern elevation to the right.

3.2.11 In 2018, two bespoke bat boxes were installed within the roof timbers of the church nave as bat mitigation / compensation measures to accompany previous church renovations. These bat boxes are shown in Photograph 3.1.11. They were designed to a specification provided by Philip Parker Associates and located opposite the two main features used by the soprano pipistrelles to egress and access the church - see Photographs 3.1.4 to 3.1.7 above. There was no evidence that either of these boxes were used by bats during the 2019 bat surveys and they do not appear to have altered the behaviour of either bat colony that uses the church.

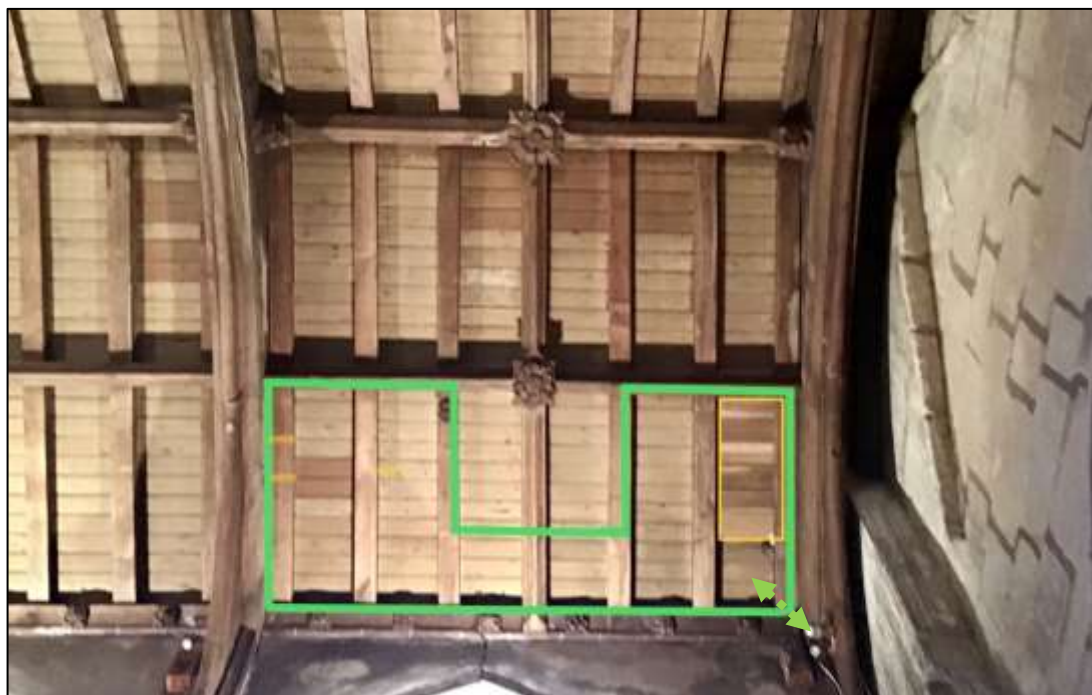
Photograph 6.7.1: The proposed location for the bespoke bat compartment to be created for the soprano pipistrelles within the southern elevation of the nave roof is shown by the green box. The location of the access / egress feature used by the soprano pipistrelles is shown by the green arrow.

6.7.2 Photographs 6.7.1 and 6.7.2 provide a visual representation of how and where the two bespoke bat compartments will be installed. The yellow shapes represent the existing bespoke bat boxes as they were installed at the church in early 2019, opposite the main soprano pipistrelle access and egress features on the northern and southern elevations, and the green shapes represent the locations of the two bespoke bat compartments that will be created by extending the original boxes.

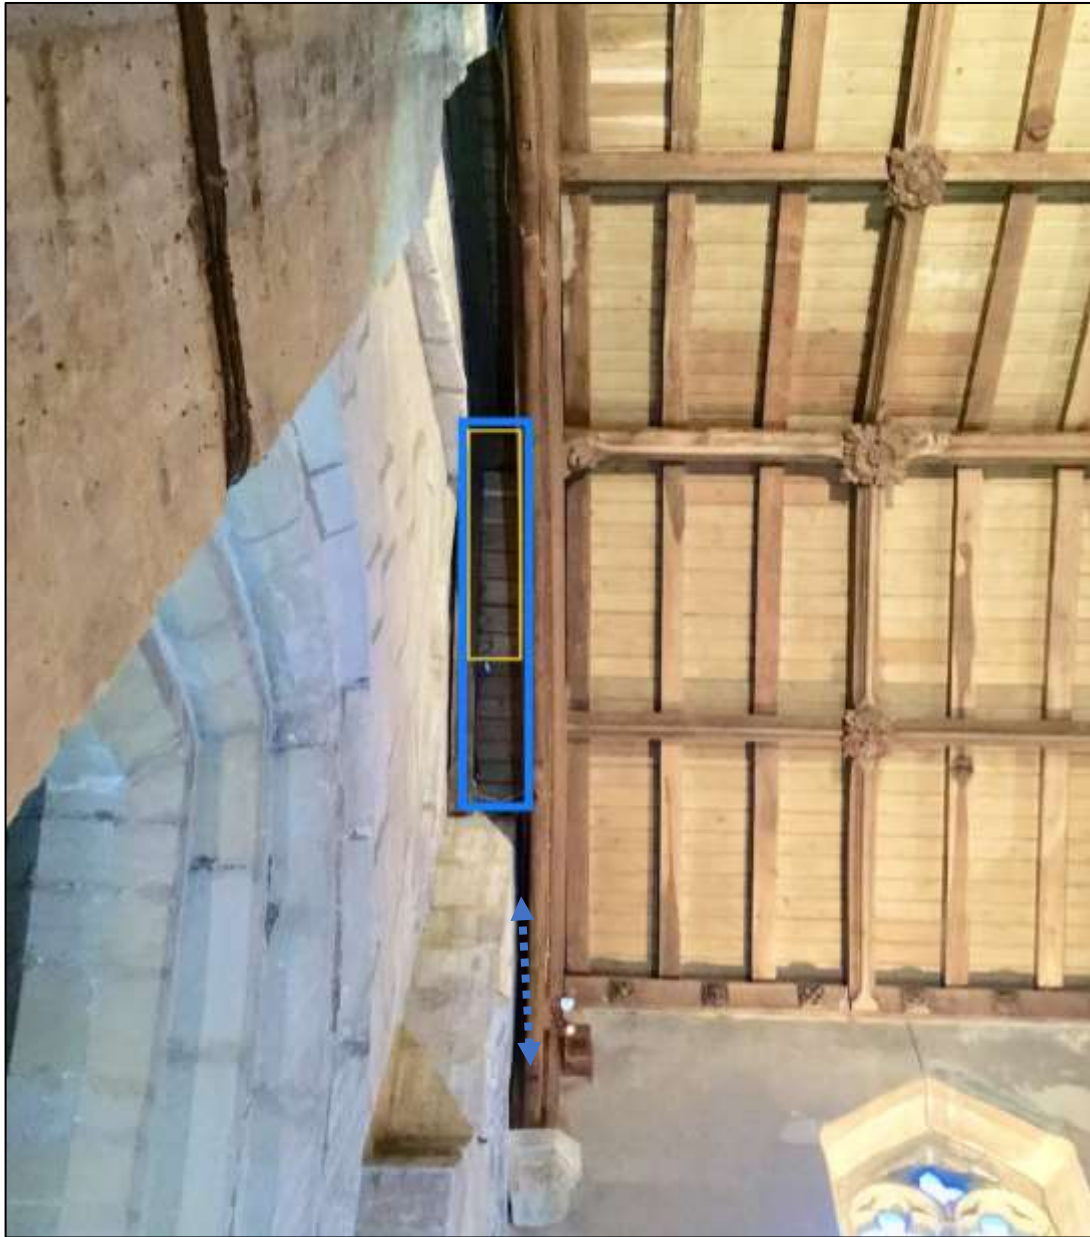
Photograph 6.7.2: The proposed location for the bespoke bat compartment to be created for the soprano pipistrelles within the northern elevation of the nave roof is shown by the blue box. The location of the access / egress feature used by the soprano pipistrelles is shown by the blue arrow.
