Bat Mitigation Plan

St. Michaels Archangel

Compton Martin

DRAFT V1

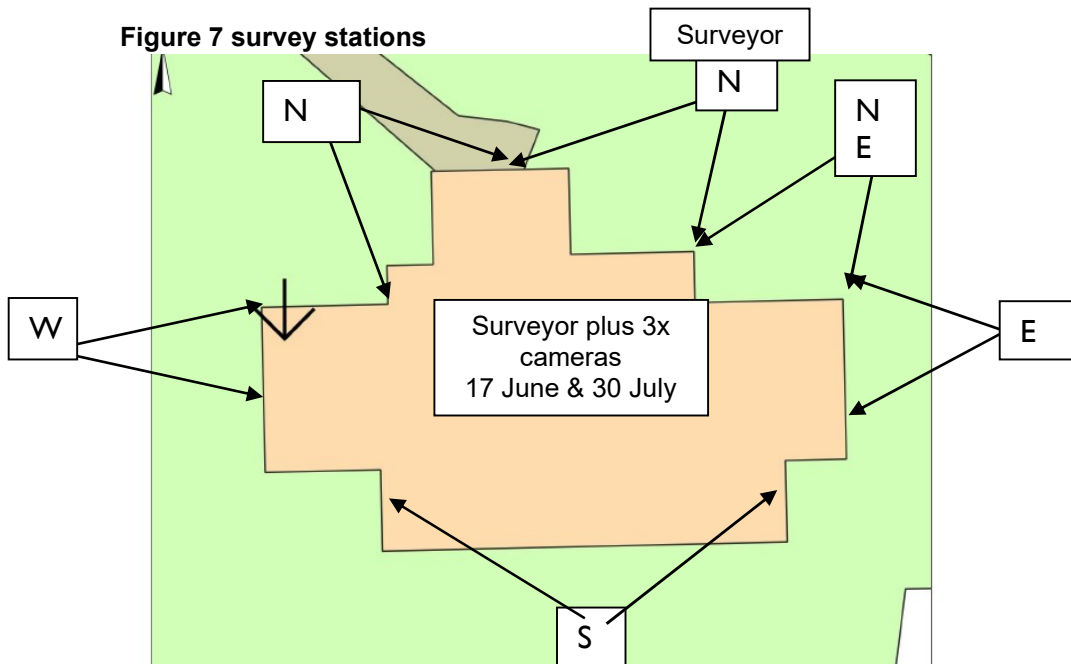
Figure 7 shows the survey points used for surveyors/ equipment
