St Mary Magdalene Brampton Cambridgeshire

Bats in Churches: Bat Management Plan

DEFRA

DEFRA-BiC-21.DEFRA12 (Issue 1)

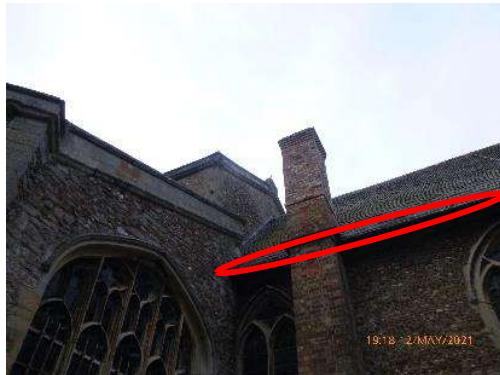
Figure 1. South eastern corner of the church eaves provide bat access points (red).

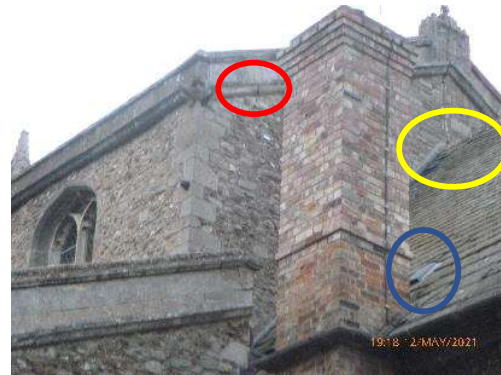
Figure 2. South eastern corner of the church, showing the raised roof tiles (yellow), possible Morris lead bat slate (blue) and a possible bat entry point in the cornice (red).

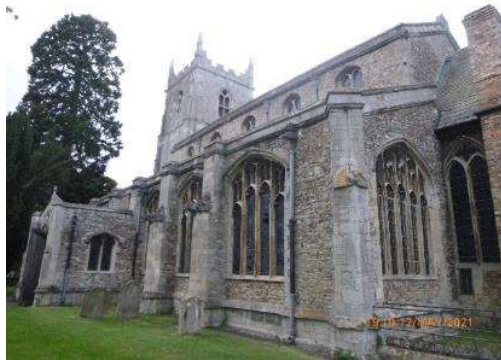
Figure 3. Southern aspect of the church, showing the south aisle, southern porch and the tower.

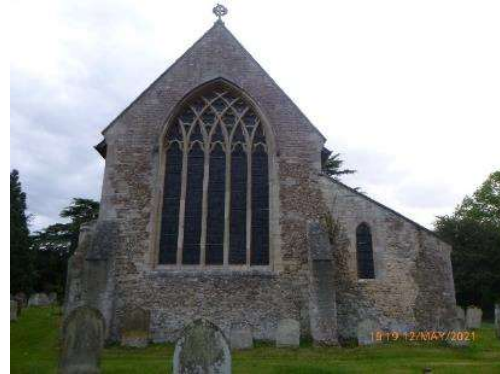
Figure 4. Eastern aspect of the church, showing the chancel and the eastern aspect of the vestry.

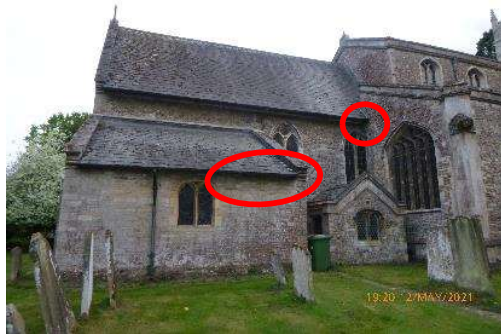
Figure 5. Northern aspect of the church, showing the roost access points in the north vestry and the chancel eaves.

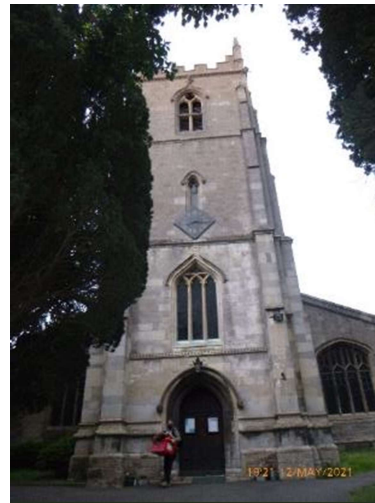
Figure 6. The western aspect of the church, showing tower, and north and south aisles.

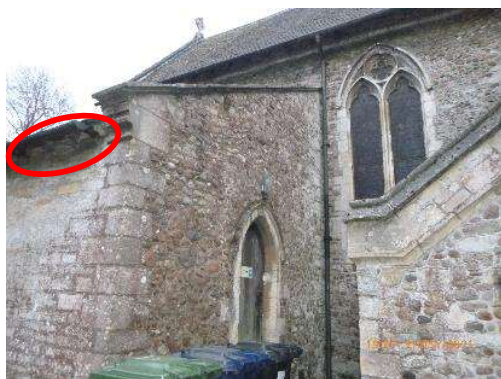
Figure 7. Walkway between the north vestry and the store. North vestry eaves provide roost access points (red).

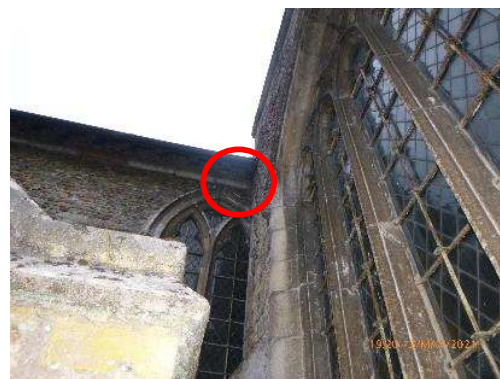
Figure 8. North eastern corner of the church provide roost access points (red).

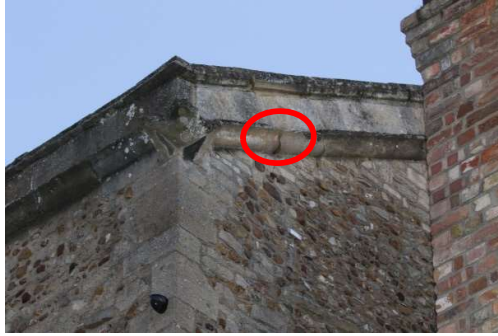
- 5.4 Bees were observed using a potential bat access point during the 2017 Light Touch Survey where there is a broken cornice on the external south eastern corner of the nave (Figure 9) from June 2021 onwards. Their presence is likely to have effectively prevented its use by bats this year.

Figure 9. Cornice gap in the east nave wall.

Closing up the bat access on east side of the nave to prevent bats and bees accessing the internal area of the church.

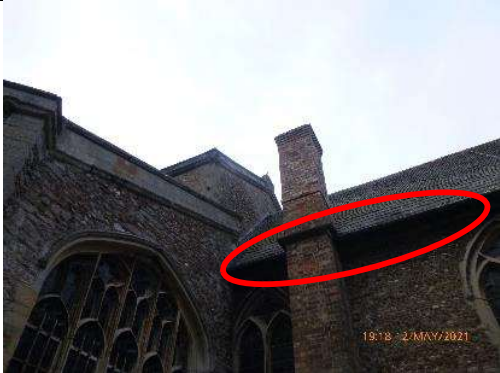
Species	Roost Location	Access Point Locations	Peak Counts	Photo
Soprano pipistrelle	Southern wall of the chancel	Under the eaves on the south eastern corner of the chancel	35 bats on the first survey, twelve bats on the second survey and ten on the fourth survey

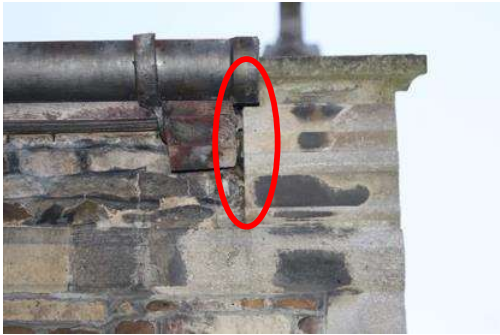
On the south eastern corner of the western gable	Seven bats on the fourth survey

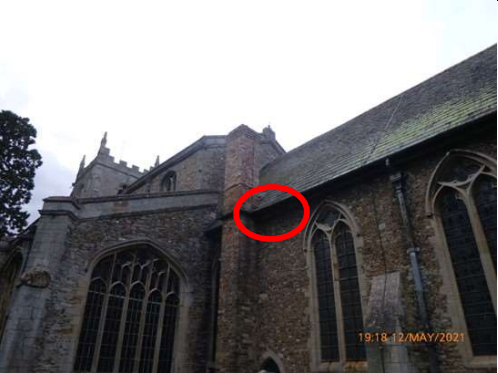
Species	Roost Location	Access Point Locations	Peak Counts/ Evidence	Photo
Soprano pipistrelle	Southwest corner of the chancel/ north eastern corner of south aisle	Under the southern eaves east of the chancel chimney	Four bats on the fourth survey

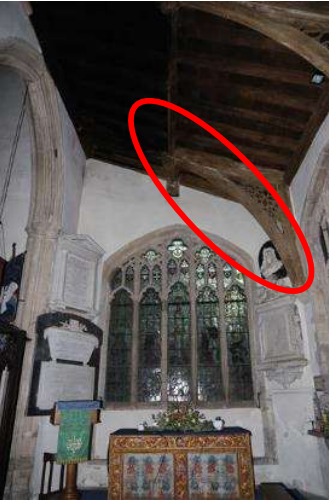
Gaps behind the marble statue in the corner of the south aisle	Droppings present during building inspection

It is proposed that subject to architectural issues with timber masonry and beams, together with decorative wooden finishes, a discrete sealed box unit using untreated oak and 5mm ply is created to allow bats to continue to use the existing gap (bat access point) in the masonry to access a controlled sealed roost that would prevent bats accessing the internal area of the church.

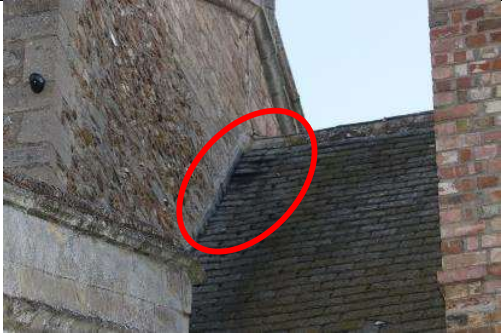
Species	Roost Location	Access Point Locations	Peak Counts	Photo
Soprano pipistrelle	Under the southern ridge rooftiles where the chancel meets the nave	Lifted rooftiles	Five and six bats on the second and fourth surveys, respectively

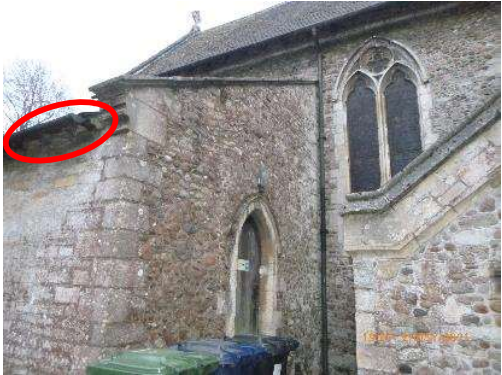
Mixed species (common and soprano pipistrelle, and brown long-eared)	North vestry	In the eaves	Three common pipistrelles on the second survey, three soprano pipistrelles on the third survey and one brown long-eared bat on the fourth survey

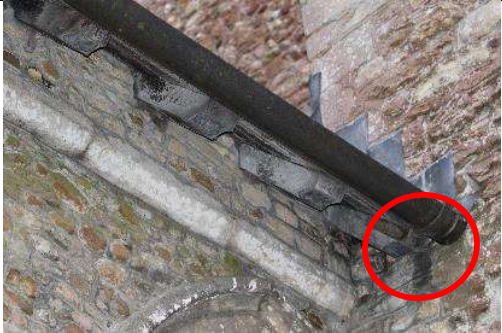
Species	Roost Location	Access Point Locations	Peak Counts	Photo
Brown long-eared bat	North western corner of the chancel	Corner between the north aisle and the chancel	Two bats in the fourth survey

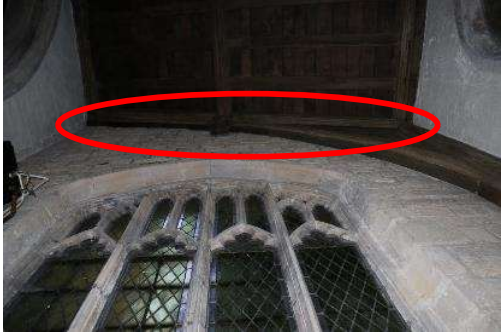
Brown long-eared bat	Western end of the north aisle	Gap in wooden beam	Droppings present during building inspection

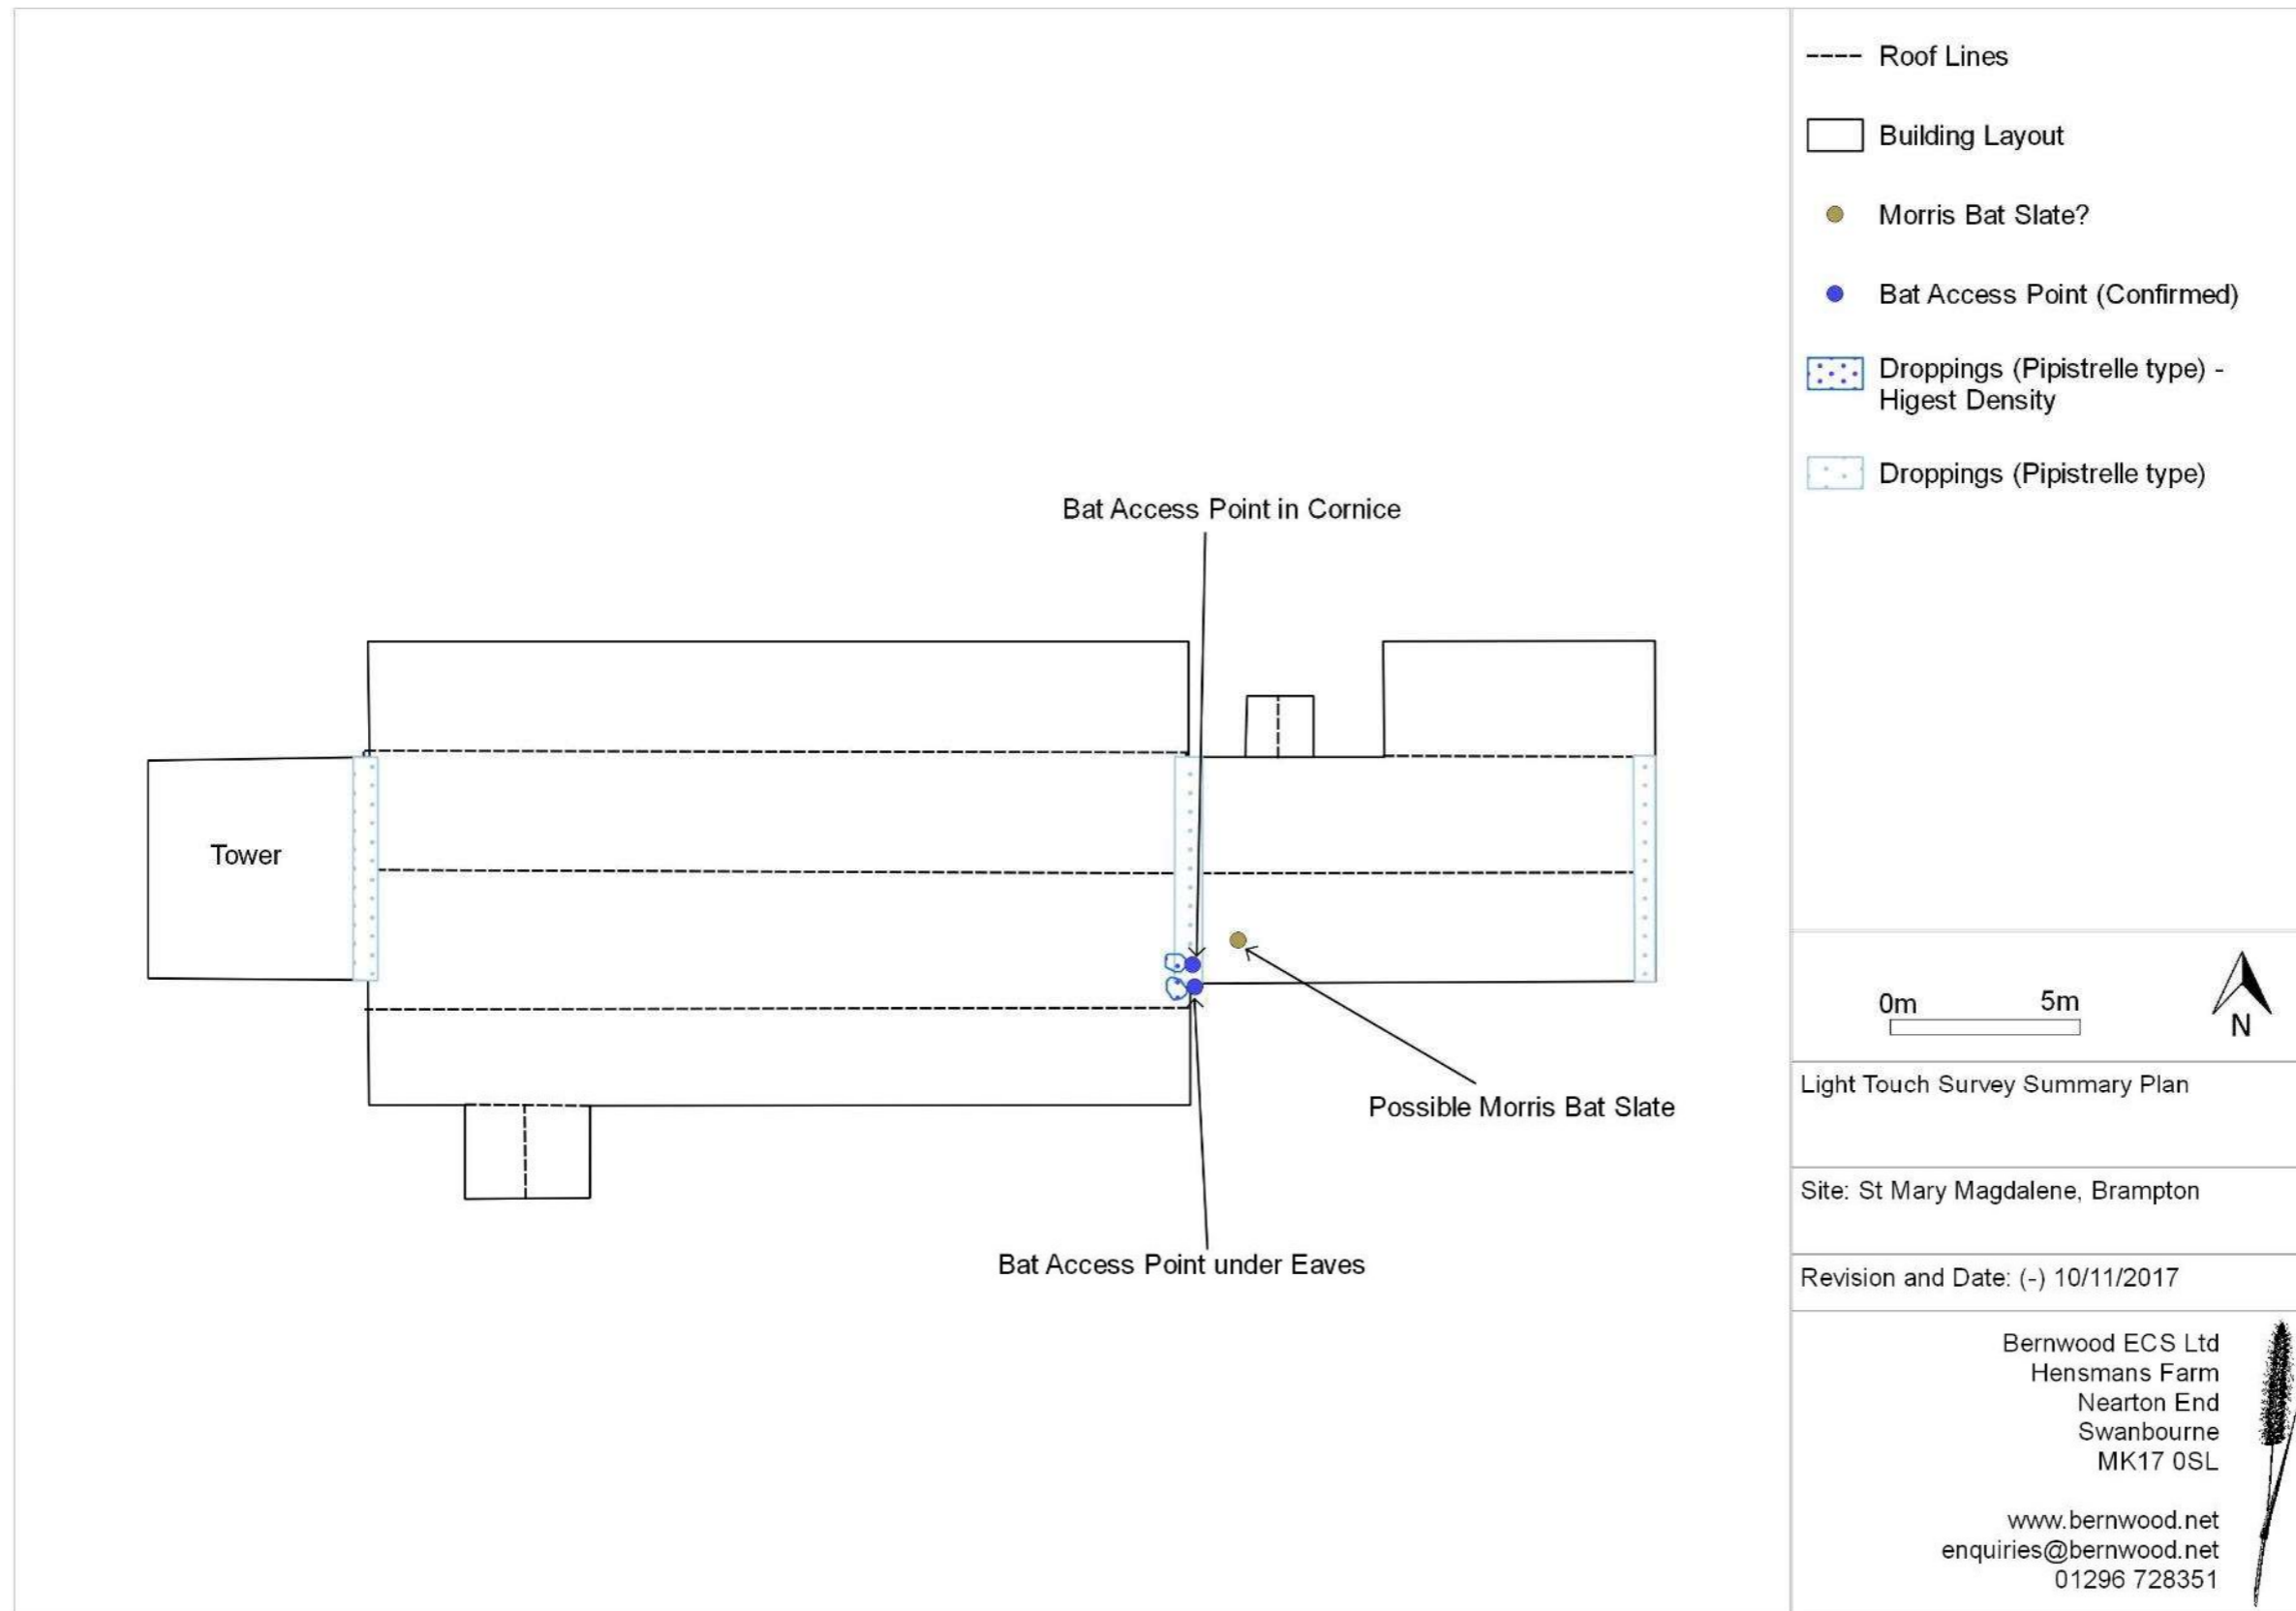
Appendix 3. Light Touch Survey summary plan (2017).

- 1.7 During a Light Touch Survey (LTS) by Bernwood Ecology on 24th August 2017, two bat access points were identified and dense accumulations of bat droppings were found underneath the archway between the tower and the nave, underneath the archway between the nave and the chancel, and on the windowsills behind the altar in the east end of the chancel (Appendix 3).

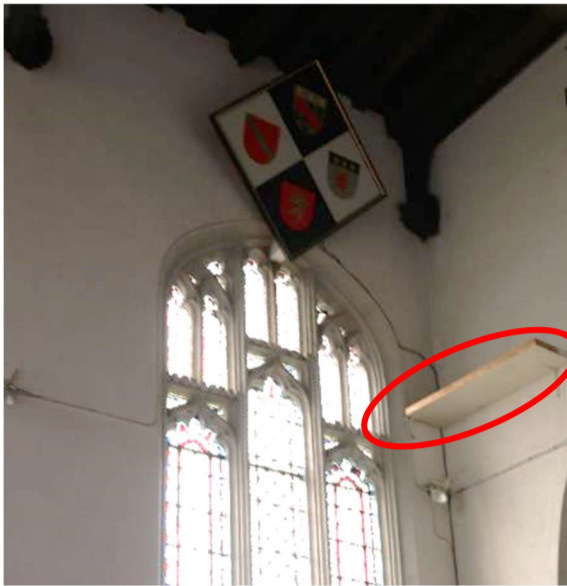
The addition of baffle/ catch boards below main roost points within the church

- To collect bat droppings at concentration points and reduce sight of unsightly accumulations.
 - Cat litter would reduce dampness and reduce smell.
 - Maintained by cleaning once a month during the peak summer activity period when bat droppings are obvious.

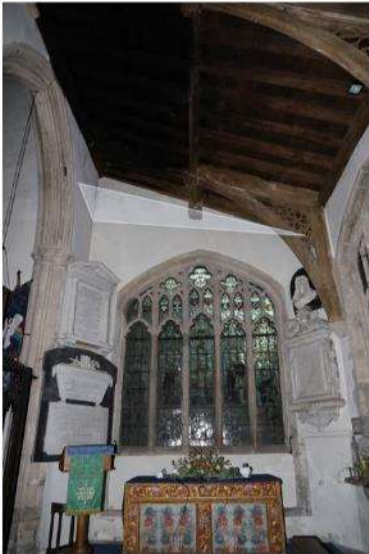
The addition of temporary sails, present during summer months only (in place of fixed baffle boards) below main roost points within the church.

Can bat access point be retained and control droppings by placing catch board below (red) or sails (light blue)?

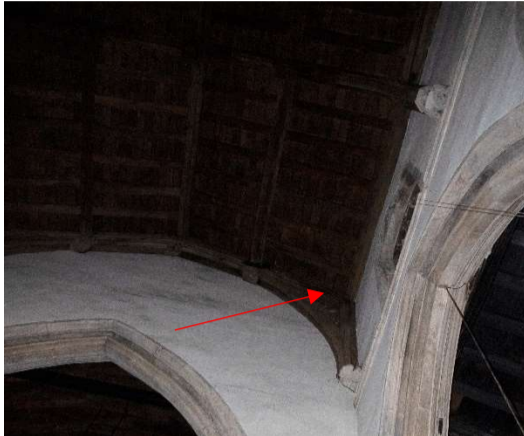
To allow bats to continue to use the bat access point (existing gap in the masonry) to access a controlled sealed roost that prevents bat accessing the internal area of the church.

The light touch survey (2017) identified a gap in the stonework above the nave roof (eastern end of the southern side). In 2021, this gap was used by bees and created issues within the church throughout the summer.

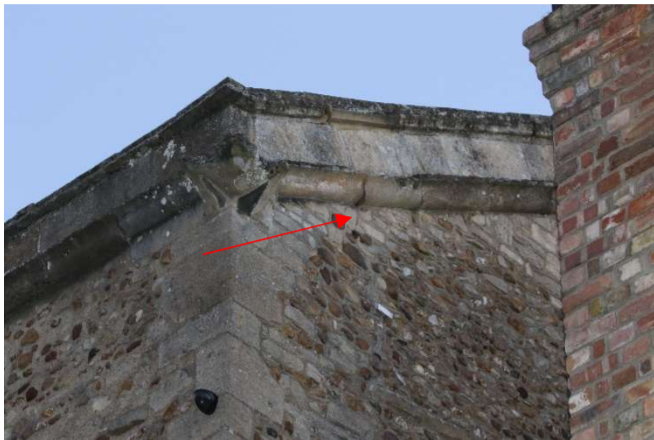
To restrict bat and bee access to the internal area of the church.

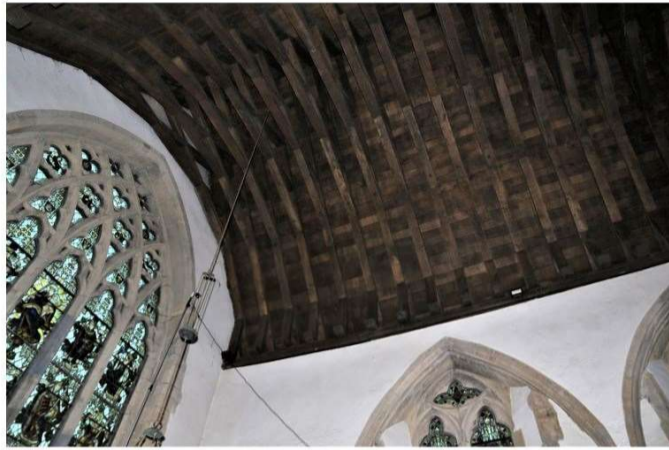
Option: Box in chancel eaves at bat access point?

It is proposed that subject to architectural issues with timber masonry and beams, together with decorative wooden finishes, a discrete sealed eaves box is created on the south side of the internal scissors braced ceiling eaves using untreated oak and/or 5mm ply. Once created the bats can continue to the exiting gaps (bat access points) in the south eastern corner and in the vicinity of the discussed chimney. The sealed eaves box will need to prevent bats accessing the internal space of the church.

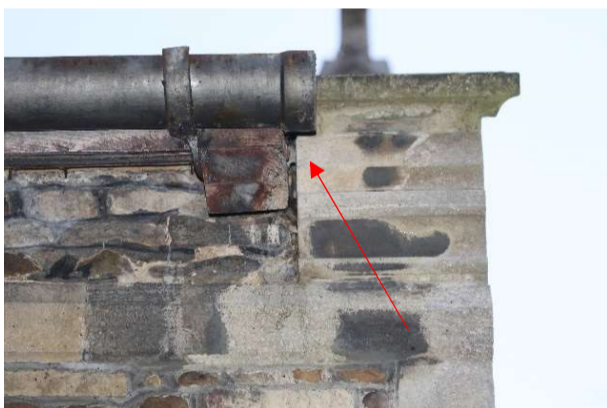
Bat access points via eaves on south side of chancel

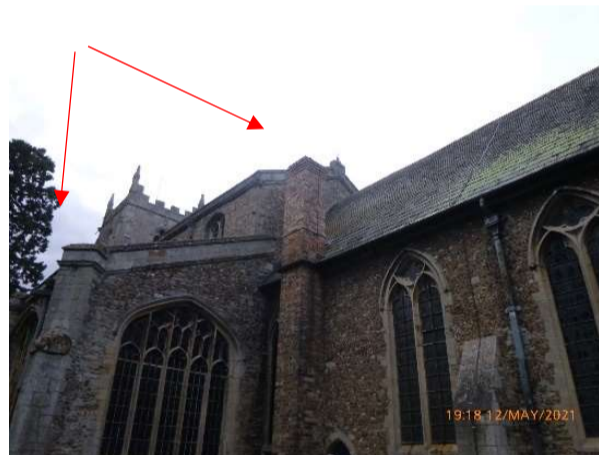
To allow bats to continue to use the bat access points (south eastern corner and chimney area) to access a controlled sealed roost that prevents bat accessing the internal area of the church.
