Bats in Churches Project:

St Andrew's Church

Deopham

Bat Survey & Management Plan Report

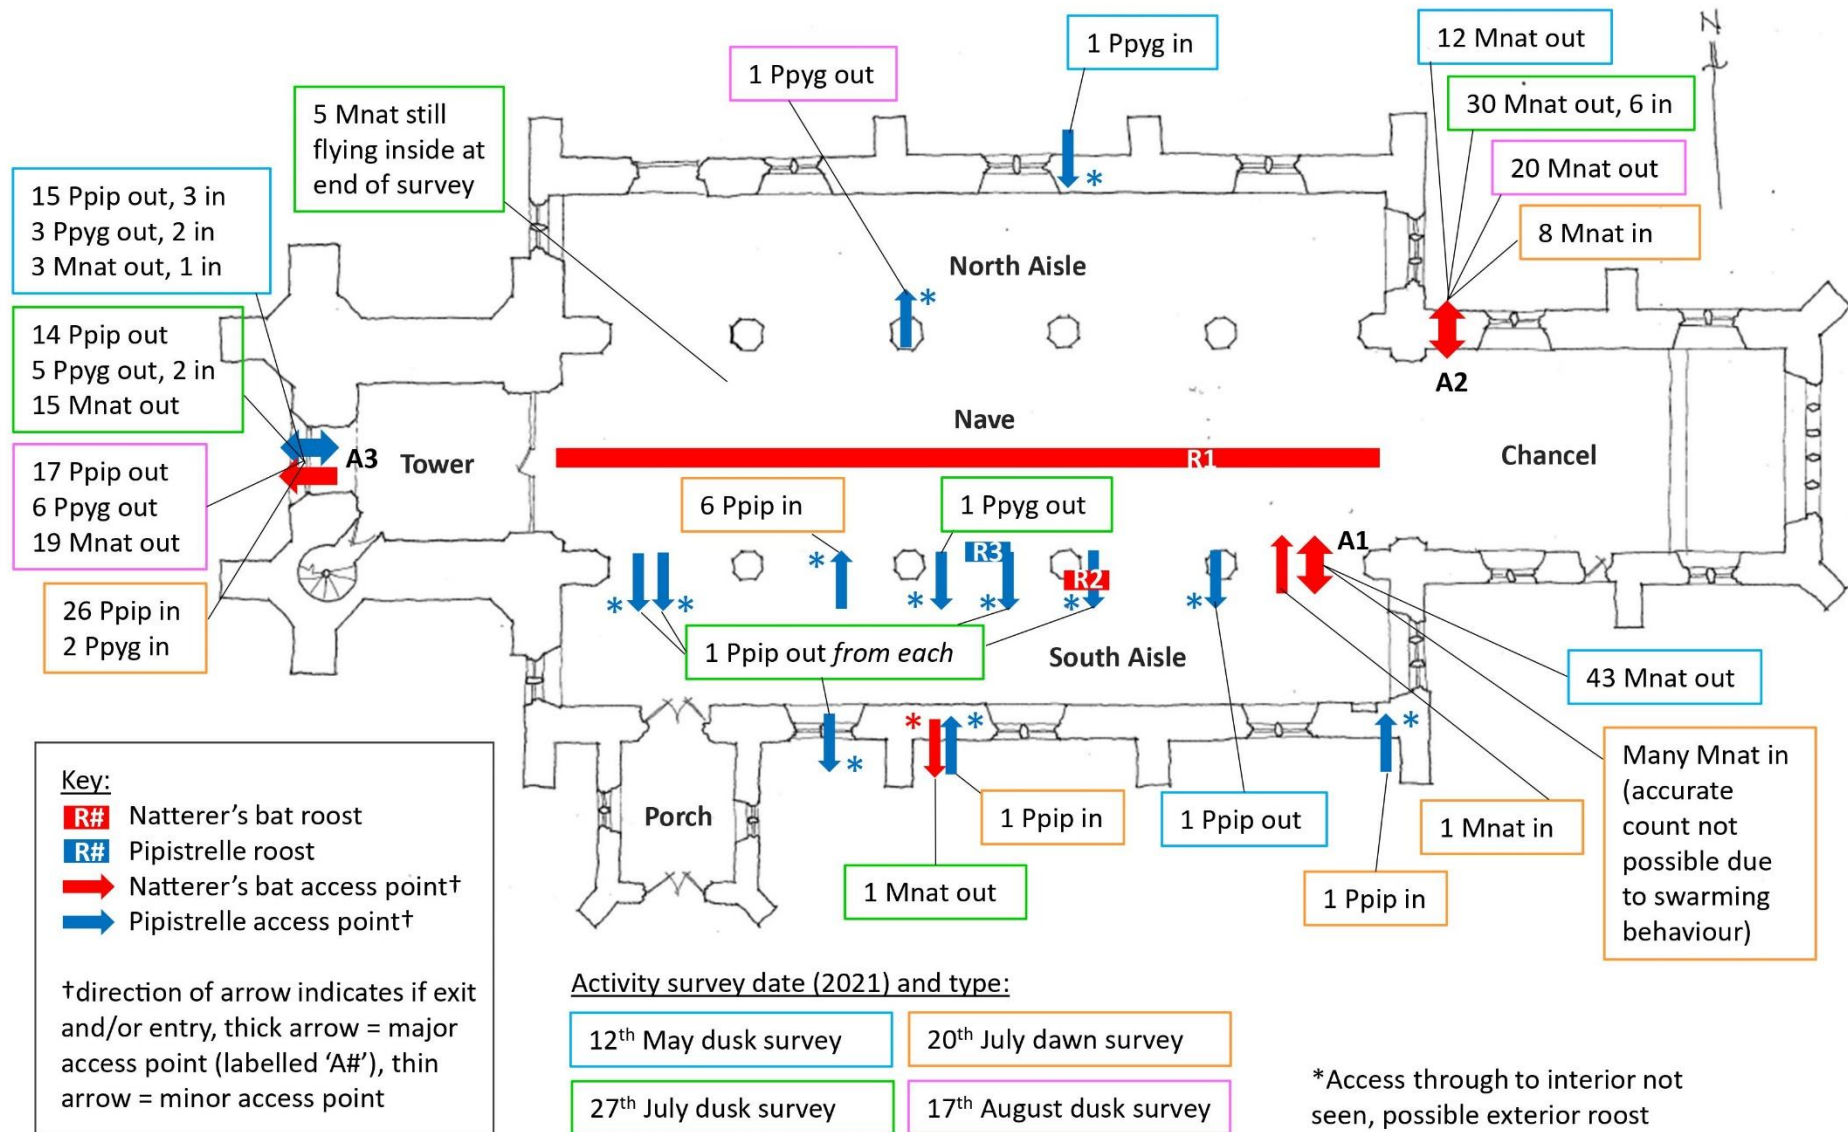
The highest count for Natterer's bats was recorded during the 27th July dusk survey. A total of 58 Natterer's bats were counted. The behaviour of the bats indicated that the young were volant at this stage and most were emerging from the church. The main roost areas for the Natterer's bats are above the central ridge beam of the nave (mostly at the truss apexes) and in particular the eastern end appears to be favoured (R1 in Figures 4 & 5A). There is also a roost in the south aisle, on the north wall, eastern end (R2, Figure 4 & 5B).

The Natterer's bats utilise three main entry/exit points to/from the church interior: at eaves level at the east end of the south side of the nave (labelled A1 on Figures 4 & 5A), at eaves level at the west corner of the north side of the nave (A2, Figures 4 & 5C and over the tower/west door (A3, Figures 4 & 5D). The preferred entry point is A1, which was also the preferred exit during the first (May) survey only (no observed use during subsequent emergence surveys). Smaller numbers also entered at A2. For the July and August dusk surveys, A2 was the preferred exit location, with smaller numbers also existing from A3.

The highest count for common pipistrelles was 34, during the July dawn re-entry survey. Most of these re-entered over the tower door (A3, Figures 4 & 5D). Smaller numbers recorded re-entering from the exterior on the south side of the nave and aisle (see Figure 4) were not recorded re-entering on the interior side, suggesting these may be exterior roosts. The major exit point for the common pipistrelles was also at the tower door (A3), with individual bats also exiting at multiple locations along the south side of the nave (and aisle), which are thought to be possible exterior roosts (see Figure 4). A small pipistrelle roost was confirmed on the south side of the central nave at a truss (R3, Figures 4 & 5A) during the dawn survey.

A maximum of six soprano pipistrelles were recorded, during the August dusk survey, with smaller numbers present for the other surveys. Their main access point is over the tower door (A3, Figures 4 & 5D). Individual soprano pipistrelles were observed exiting/entering from the exterior side at the north and south sides of the nave and north aisle, which may be exterior roosts only (see Figure 4).

Figure 4. Bat activity survey results: access points (exit and/or entry indicated) by species (see key) and numbers observed for each survey. Main roost areas identified during activity surveys are also shown by species. Species abbreviations: Mnat = Natterer's bat, Ppip = common pipistrelle, Ppyg = soprano pipistrelle. Results shown on church plan by Birdsall, Swash & Blackman Ltd.

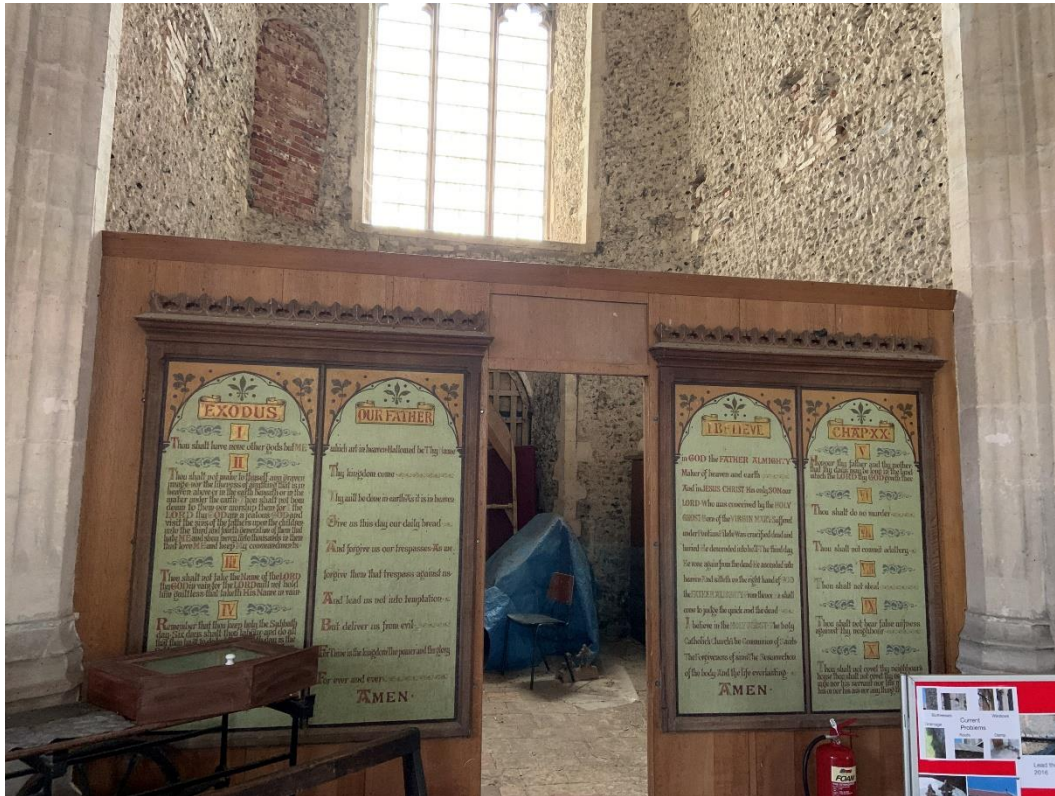
Photo 7. Decalogue boards (between tower and west end of nave).

- Deflector 'hood' to be fitted over decalog boards to reduce staining/bleaching from urine and dropping deposition by flying bats.
- Rood screen sections to be placed together and protected by a deflector 'hood' or cover to prevent staining/bleaching from urine and dropping deposition by flying bats.

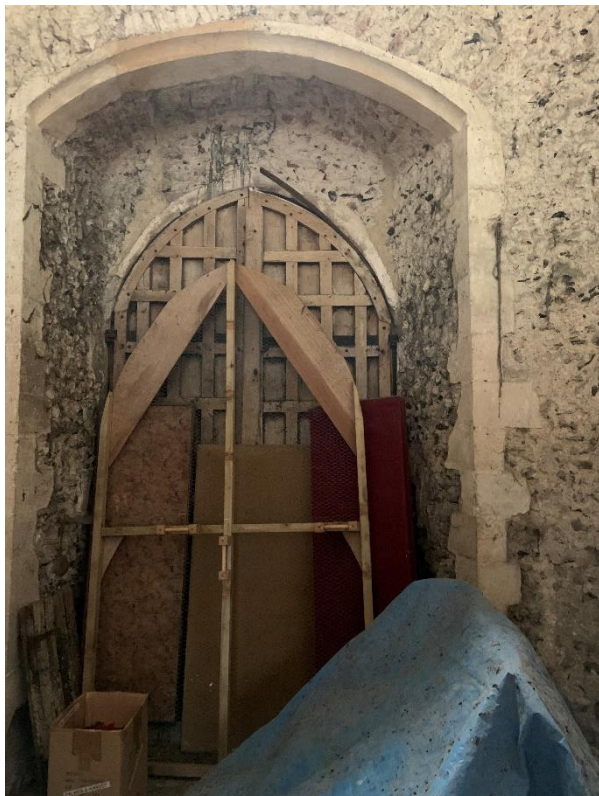
Photo 8. Tower/west door (main pipistrelle access, also used by Natterer's bats). Potential location for false doors to create an enclosed pipistrelle roost area between the two sets of doors (with the addition of a large, heated bat box).

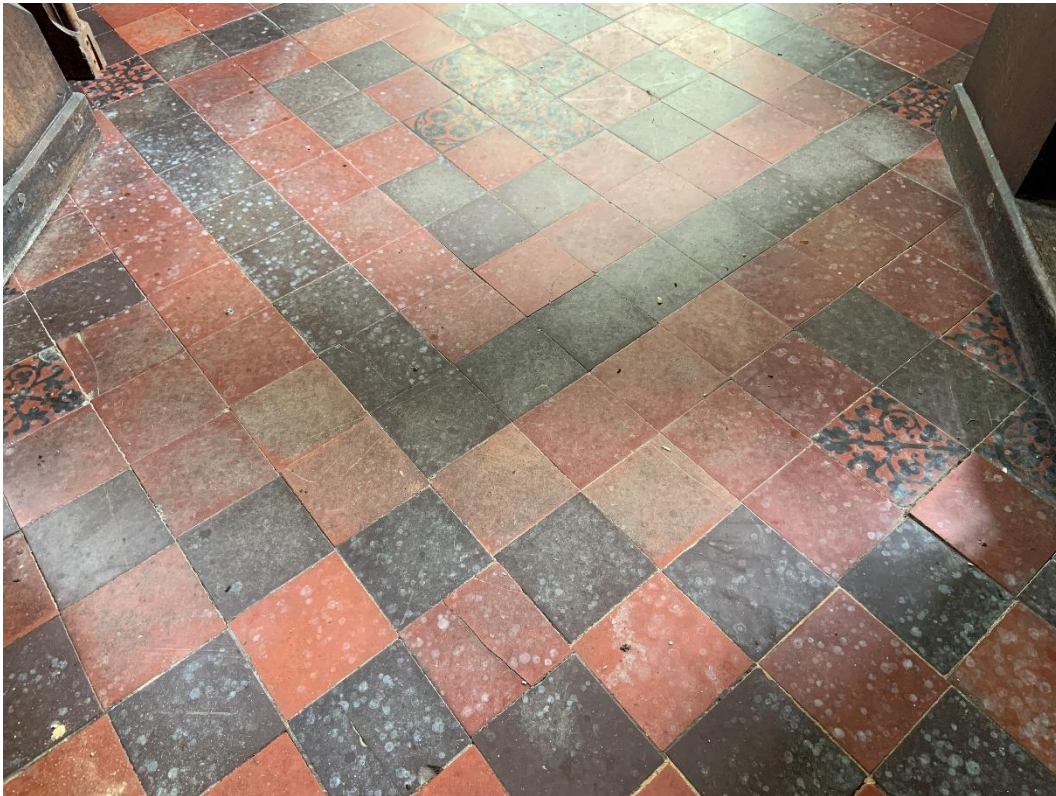
Photo 11. Urine bleaching to floor tiles.

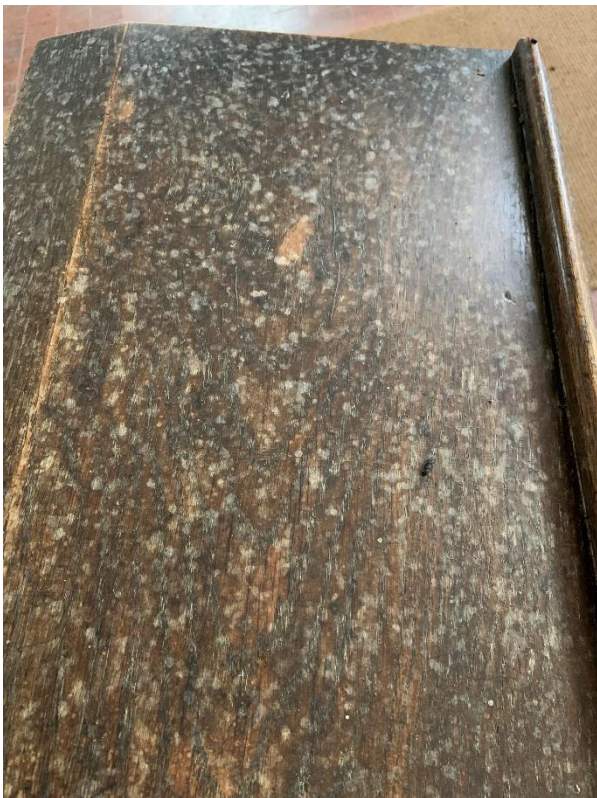
Photo 12. Urine staining to pews.

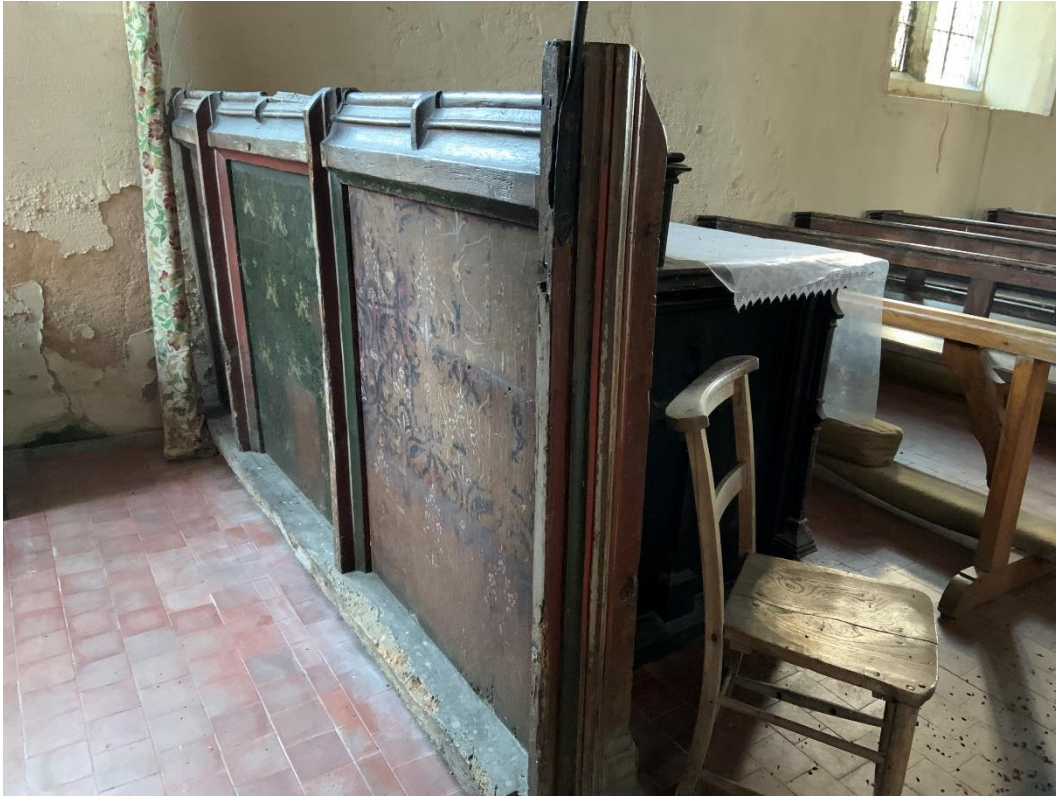
Photo 13. Section of rood screen.
