Bats in Churches Project: St Remigius Church, Dunston Bat Survey & Management Plan Report January 2020 (revised v1.1 June 2020)

Document type	Bats in Churches Project – Bat Survey & Management Plan Report
Version	1.1
Author	Dr Charlotte Packman PhD CEcol MCIEEM
Client	Natural England
Site address	St Remigius Church, Stoke Lane, Dunston, Norfolk, NR14 8PE.
Site grid reference	TG 22854 02243
Survey period	May – August 2019
Report date	10 th January 2020, updated 9 th June 2020 (v1.1) with revised Schedule of Works needed due to Covid-19 restrictions

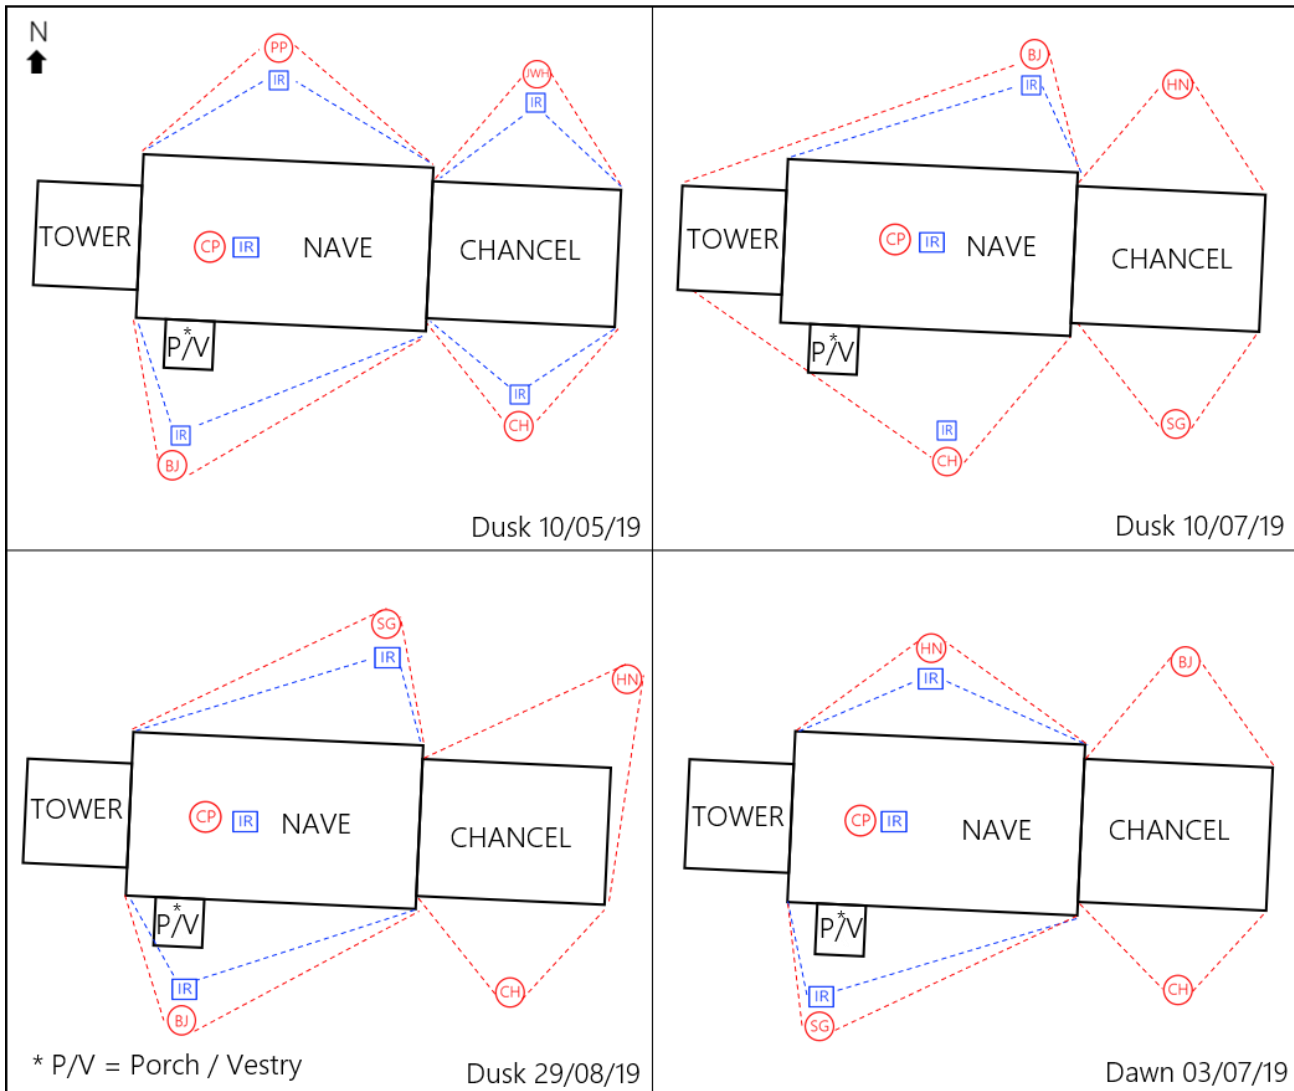
Figure 3. Bat activity survey locations of surveyors (red circles with surveyor initials (see Table 1), fields of view indicated by red dashed lines) and infrared cameras (blue squares labelled 'IR', fields of view indicated by blue dashed lines) overlaid on simplified church plan (not to scale). Surveyors and cameras positioned outside the church remained in fixed locations for the duration of the survey. The surveyor located inside the church moved around to observe behaviour and assess access points into/out of the church interior, equipped with a mobile infrared camera set-up.

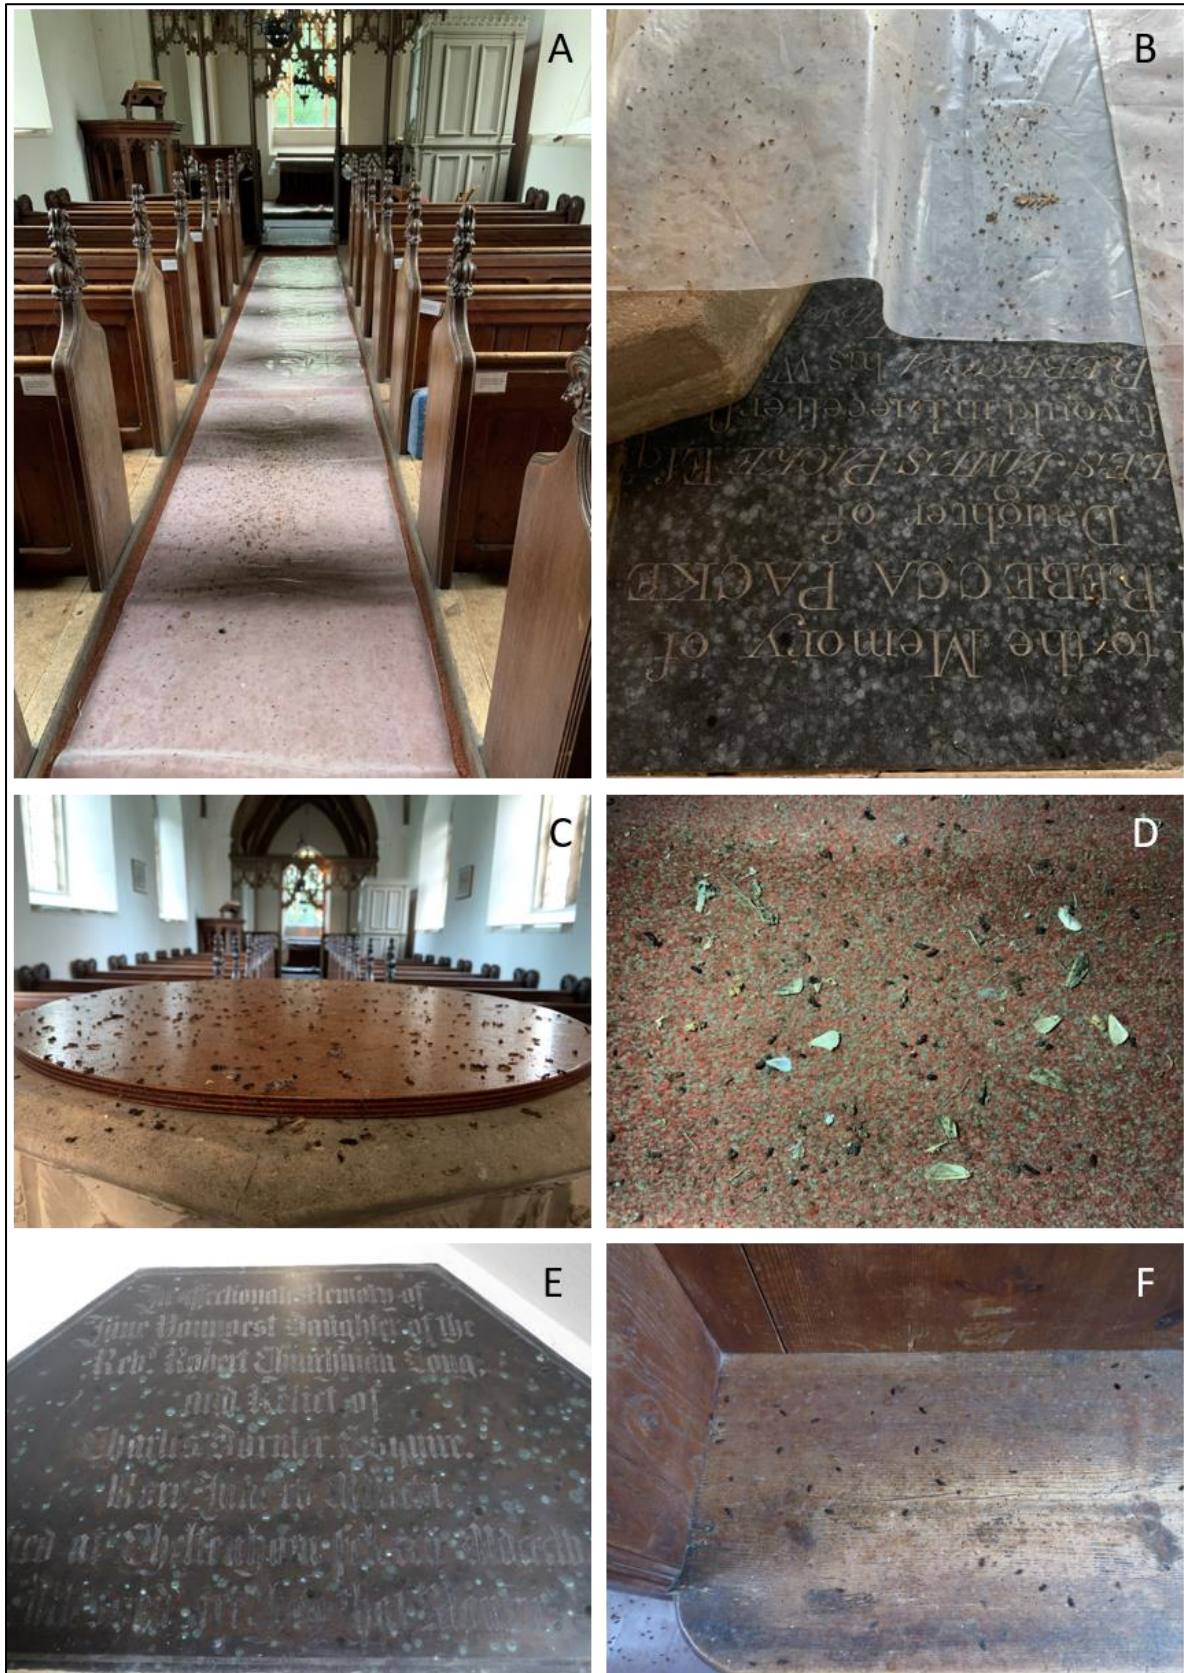
The church representatives described concerns about bat droppings and urine (and the substantial cleaning burden they create, limiting usage of the church) and damage to furnishings, artefacts and memorials.

Figure 5. Photos illustrating some of the impacts of bats on the church. A. Plastic sheeting on the nave floor, with bat droppings and urine. B. Bleaching to ledger stone from bat urine. C. Bat droppings on the font. D. Brown long-eared bat feeding remains (moth wings) and droppings. E. Bat urine bleaching on a wall memorial. F. Bat droppings and urine bleaching on a pew.

Measures taken to date to try to manage the impact of bats on the church include plastic sheet coverings (nave and chancel floors, altar) and cleaning. Coverings and cleaning are not sufficient to mitigate the damage from droppings and urine (especially with regards to the walls and memorials, which cannot be easily protected) and given the level of impact, are not sustainable or manageable in the long-term.

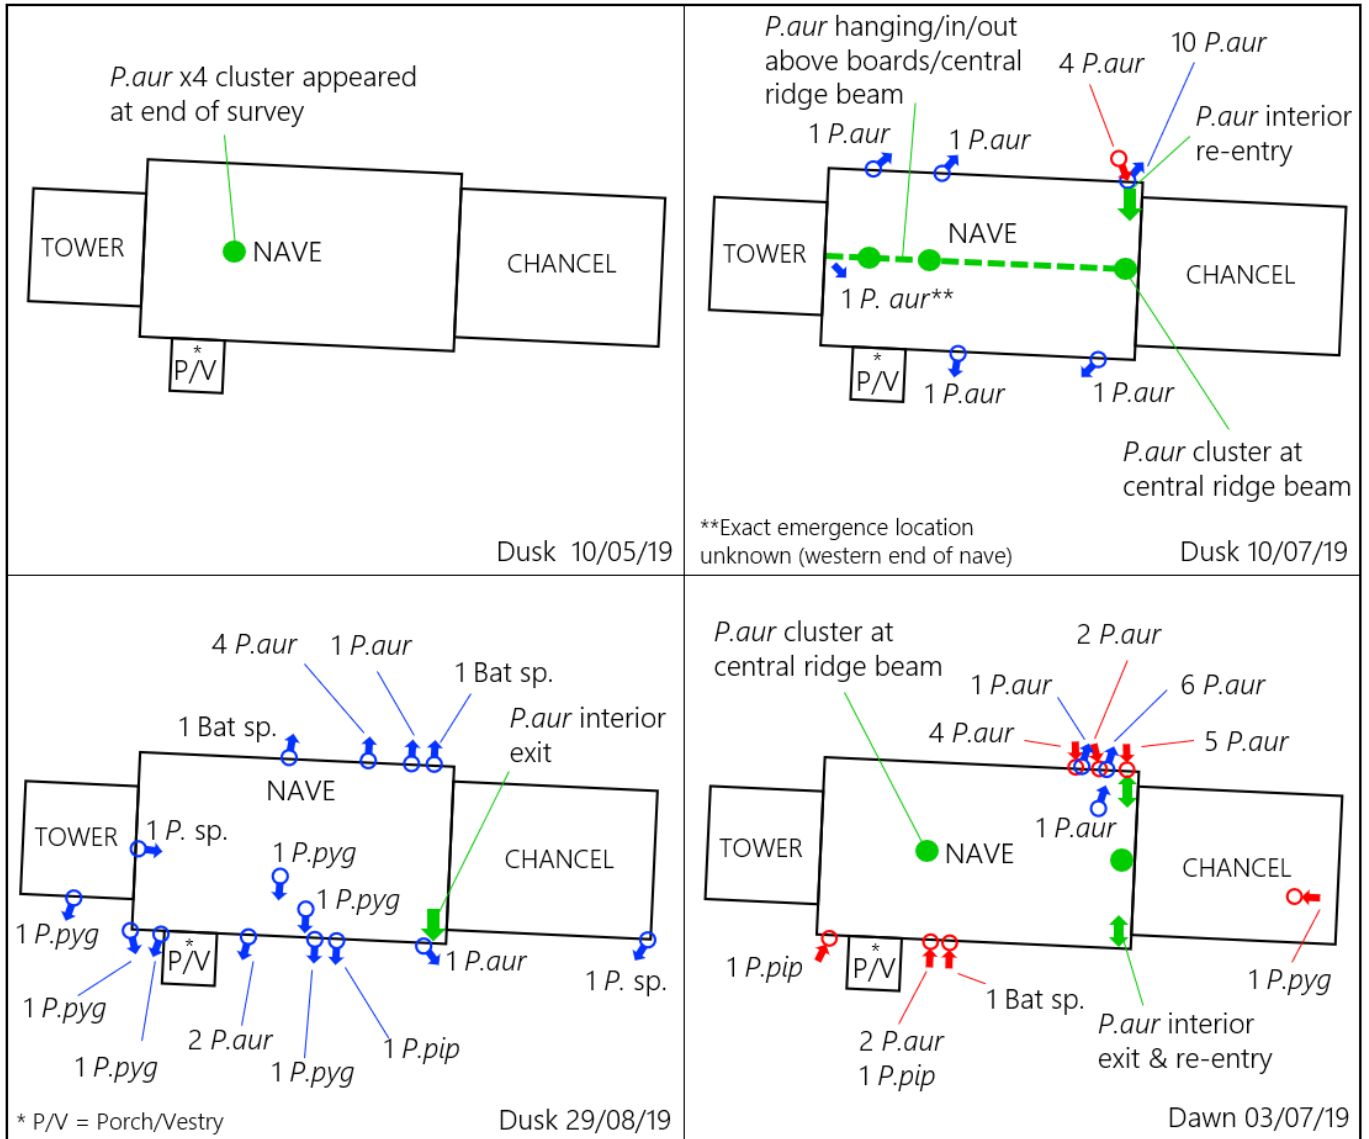
The main exterior access point for the brown long-eared bats is at eaves levels at the east end of the north side of the nave, with smaller numbers accessing the church on the south side of the nave and occasional access also further west on the north side of the nave (see Figures 6 & 7). Inside the building, brown long-eared bats were observed exiting and re-entering at the east end of the nave (north and south sides, see Figures 6 & 7) between gaps in the boards/rafters at eaves level. However, most notably on the south side, this did not usually tally with where the brown long-eared bats emerged on the outside (further west), suggesting that they were travelling along the eaves void before emerging on the exterior side.

The pipistrelles emerged/re-entered on the south side of the nave (and to a much lesser extent, the chancel), mostly at eaves level, with occasional emergence/re-entry from under roof tiles. Two pipistrelles also emerged from the tower louvres (east and south sides). See Figures 6 and 7.

The brown long-eared bats were roosting above the nave central ridge beam/sarking boards at various locations along the length of the nave. Feeding remains (multiple large yellow underwing (*Noctua pronuba*) moth wings with bat droppings, see Figure 5 (D)) were evident at the east end of the nave, a favoured spot for brown long-eared bat clusters to form during the survey.

Figure 6. Results from the bat activity surveys (dusk 10th May, 10th July and 29th August 2019 and dawn 3rd July 2019) shown on a simplified plan of the church (not to scale): emergence (blue circle & arrow)/re-entry (red circle and arrow) locations, species and numbers. Green arrows show brown long-eared bat interior access locations, green dots main brown long-eared bat clusters and dashed green line main area of brown long-eared bat activity inside the building (along the nave central ridge beam).

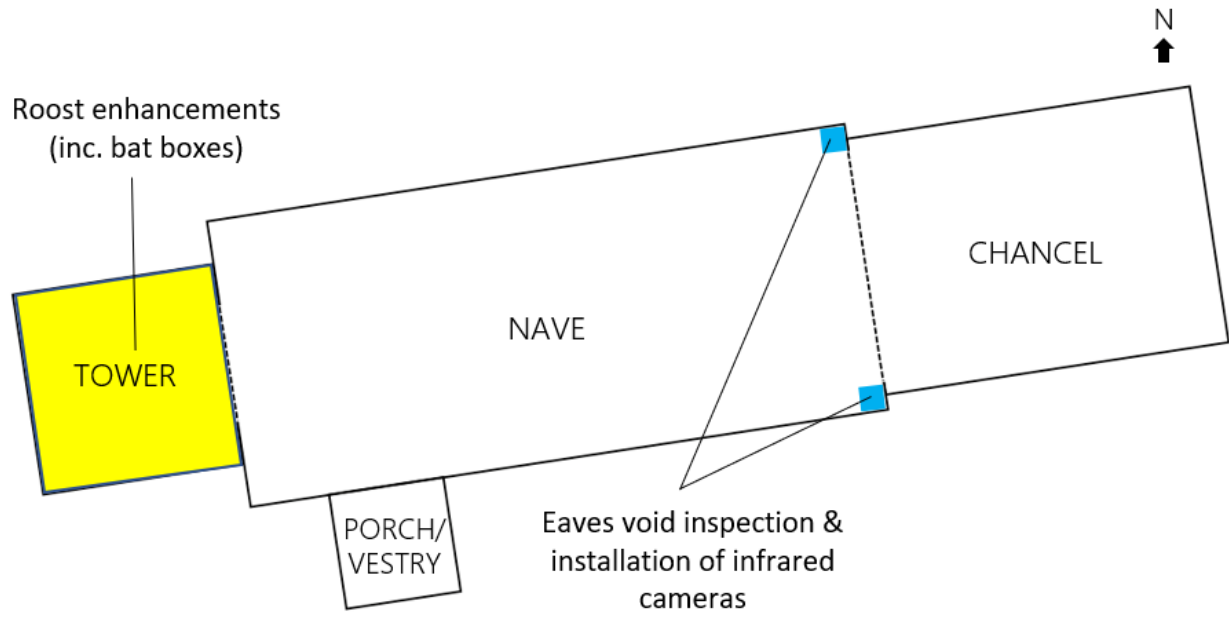
Figure 8. Annotated church plan (not to scale) showing locations of the proposed management interventions/Phase 1 exploratory works.

Nave eaves void roof inspection and installation of cameras (see Figure 8)

- Opening up of a small section of the nave eaves roof void to allow inspection (a similar inspection was carried out to inform management approaches at Swanton Morley Church in 2018). This is likely to take a day and would require a mobile scaffold tower and builder to work with the ecologist.
- If suitable (depending on the findings from the inspection), install an infrared camera at the east end of the north and south nave eaves roof voids to allow monitoring of bat activity/use of the space.

Roost enhancements to tower (see Figures 8 & 9)

- Static bat detector to be placed in the tower to monitor activity.
- Installation of suitable bat boxes/roost features in the tower (first floor).
- Check adequate bat access into tower.
- Some blocking of draughts may be needed.
- Blocking of light from the window would be needed.

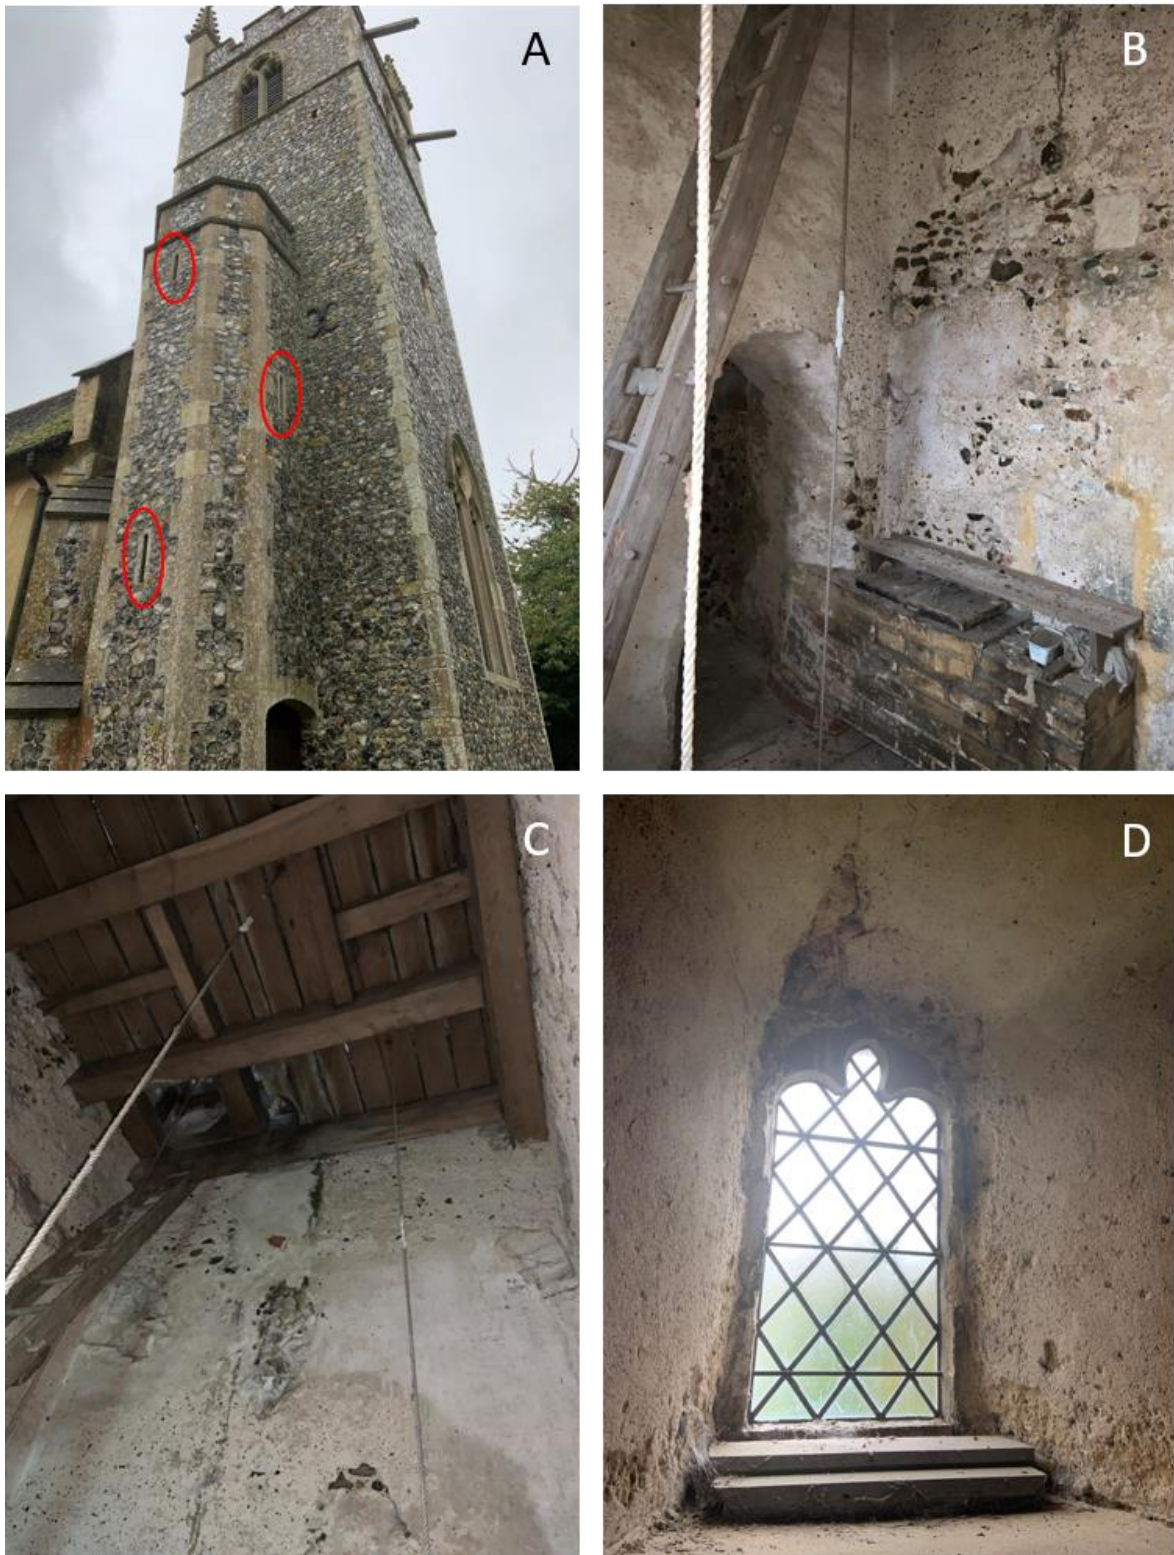
Figure 9. Photos of the tower, where roost enhancements are proposed. A. Tower exterior (entrance and first floor), potential bat access circled in red. B. First floor interior of tower (with doorway from stairway where slits are present, allowing bat access). C. First floor looking up to second floor (may be possible to fix bat boxes onto wooden floor structure). D. First floor window (will need covering on the inside to reduce light levels).
