**A BAT SURVEY REPORT FOR
ST. MARY'S CHURCH
EDGEWORTH**

A report to:
The Bats in Churches Project,
The Diocese of Gloucester and
Edgeworth Parochial Church Council

January 2020

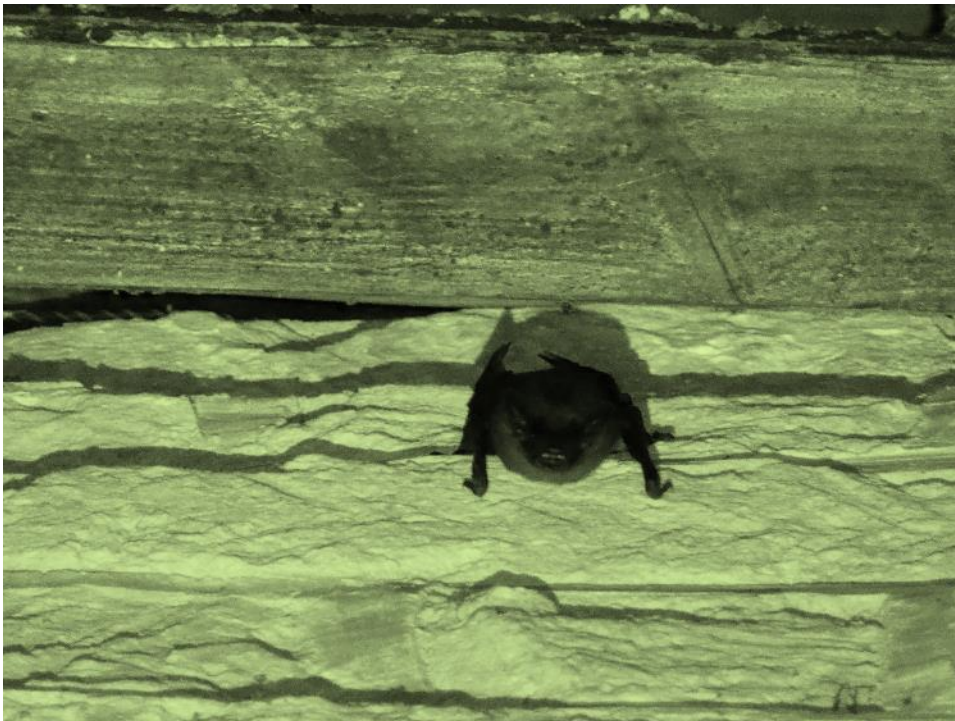
Photo 4.1 – serotine bat night roosting on the west end wall of the Nave.

- 4.19. This was an emergence survey. No bats were recorded inside the church for the duration of the survey. However, the lead surveyor remained inside the church for two hours after the end of the emergence survey in order to determine, as had been suspected, whether or not bats entered the building during the night. 35 minutes after the end of the survey (which ended 2 hours after dusk), a serotine bat was noted on the Chancel arch wall on the Nave side, above where the accumulations of droppings noted during the daytime inspections were located. This animal remained in place for nearly an hour and then flew to the opposite wall at the west end of the Nave, where it alighted again and remained in place until the surveyor left the building.

- 4.20. Two brown long-eared bats were noted flying in the Chancel 1 hour and 15 minutes after the end of the survey. These were flying high in the roof, up to the gable end wall and away, never actually alighting on any surfaces. These animals then flew in a manner that at the time was described as “sparring” i.e. the animals were chasing each other, social-calling very loudly. Additional noise heard suggested that the bats were either slapping their wings against each other or against the roof timbers. One of the bats briefly hung on a roof timber and then settled on the Chancel arch on the Nave side, where the serotine bat had previously been night roosting.

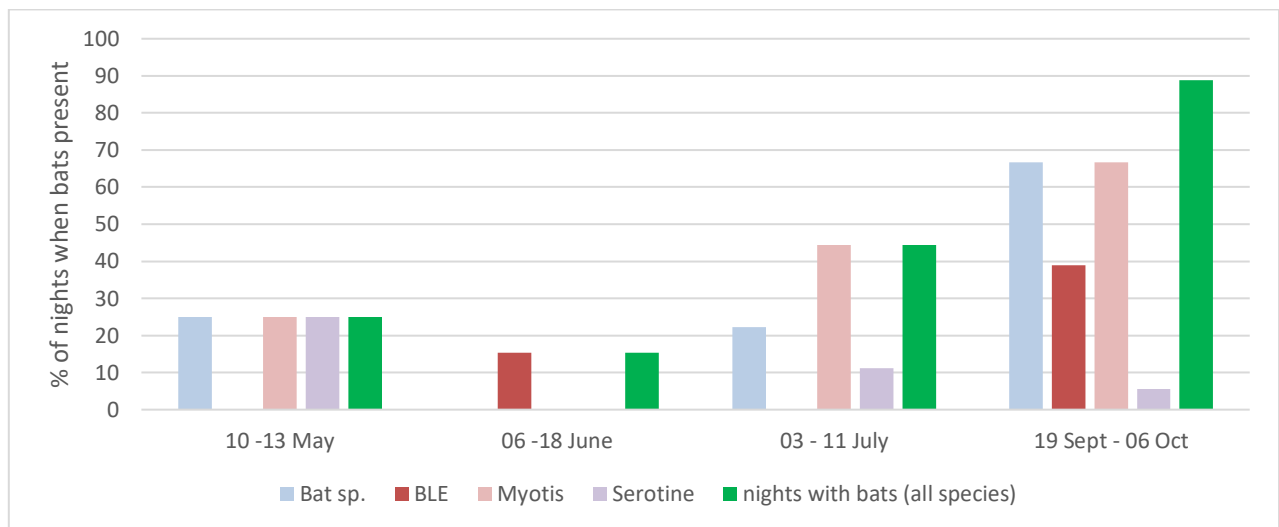
Chart 4.1 – percentage of nights when bats were present

4.25. It can be seen from the figures presented in this table, in Chart 4.1 below and in the tables in Appendix III, that use of the church by bats was most consistent (i.e. there were fewer nights when bats were absent) during the autumn (September to October) period. This pattern of use is consistent with the limited observations on 21st August of social behaviour by brown long-eared bats that suggest the church is mainly used as a minor swarming/ mating site. The relatively high number of calls from *Myotis* bats in May is unlikely to be indicative of this behaviour, but those in July might be, particularly if the species concerned are whiskered (*M. mystacinus*) and/or Brandt's (*M. brandtii*), two species known to start swarming behaviour earlier than other species (see Table 1 in Appendix III for data from both periods).

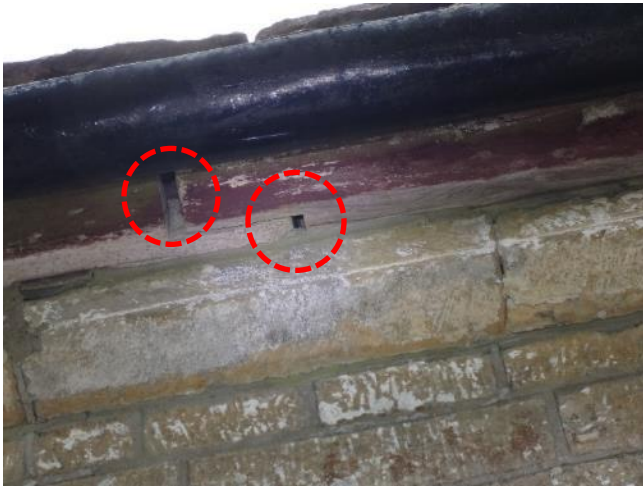
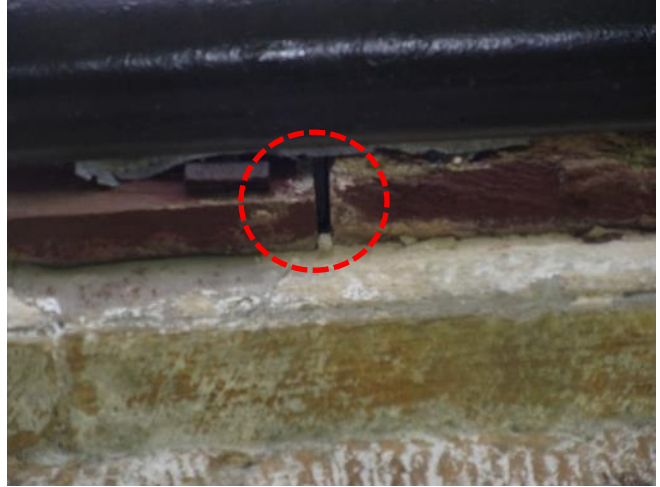
1. Gaps between wall plate timbers could allow bats to enter exterior crevices and/or provide a means of access into the interior of the church. However, no corresponding gaps were noted inside the building.

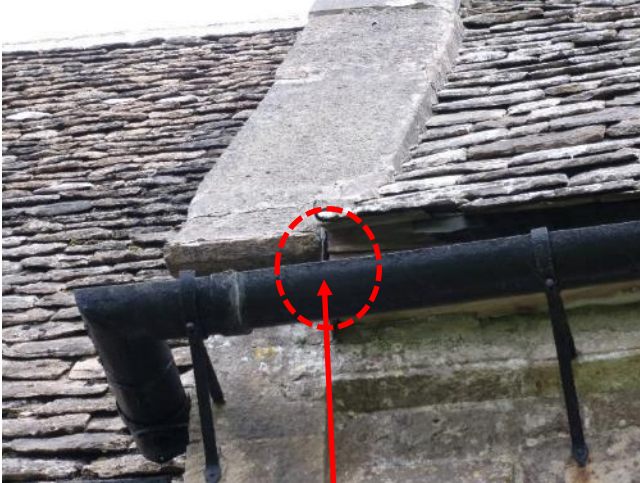
2. Gaps in the corners next to parapet walls of the Nave and Chancel.

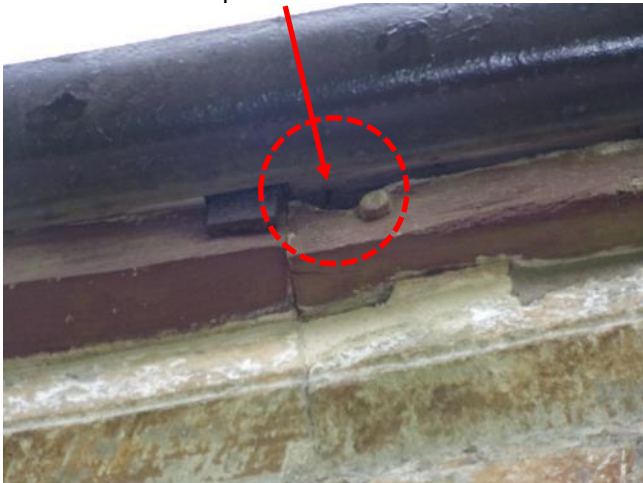
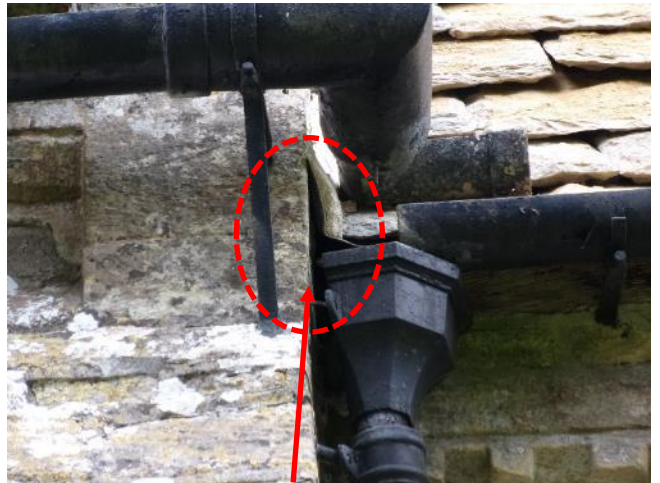
3. Gap between lead and slates at the corner of the Nave.
4. A rot hoe in a wall plate.

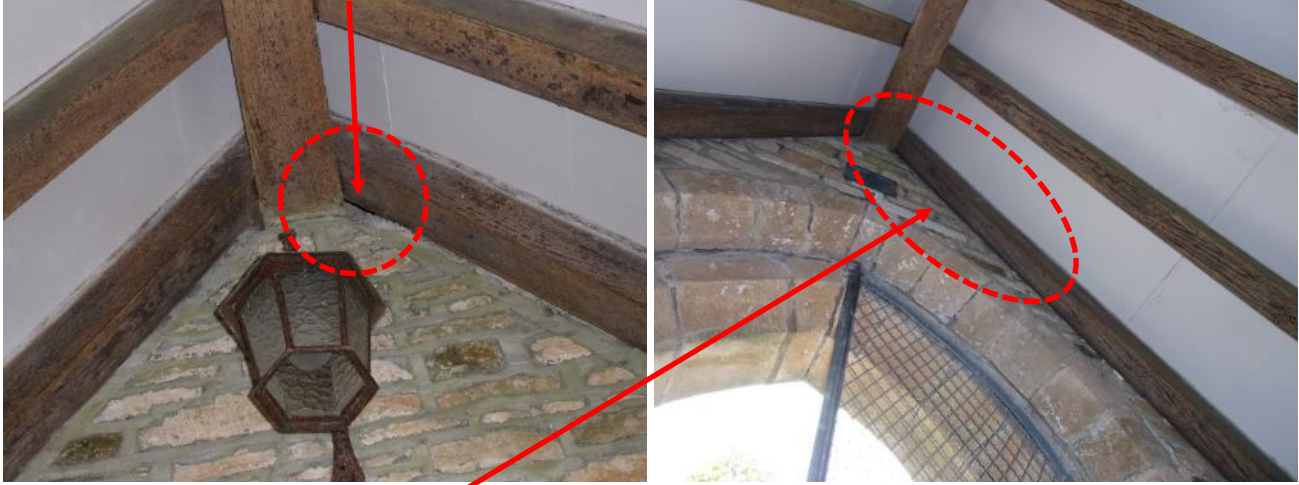
7. Gap between a rafter and the end wall of the porch.

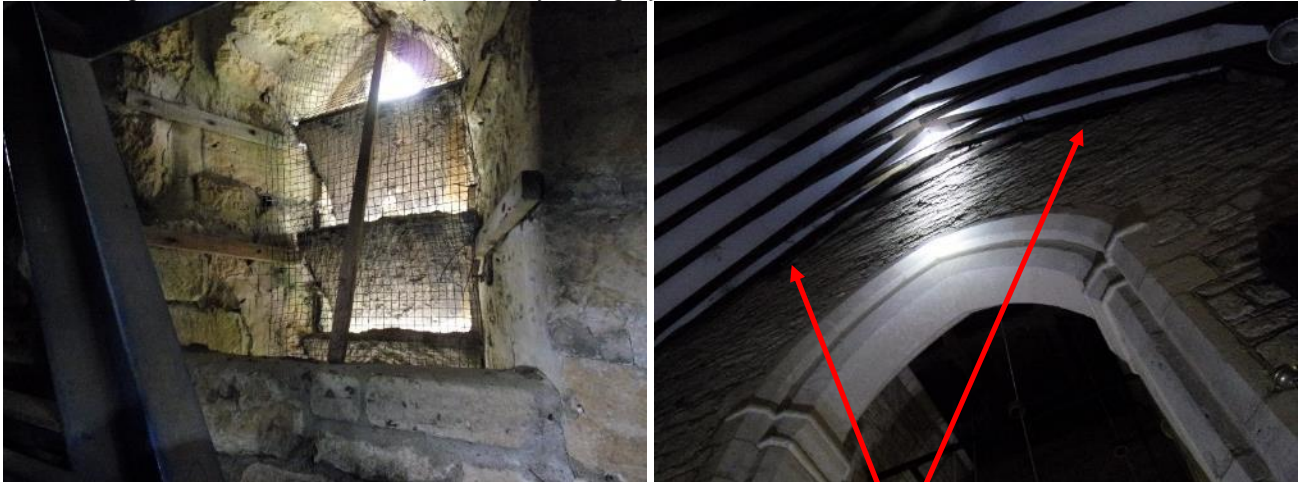
8. Gap next to ridge beam in the porch.
 9. Gaps behind and to the sides of the stone pillars in the porch.
 10. The tower has potential for bat roosting and there are crevices at the tops of windows on the floor below the bells. Bats could enter the tower via gaps around the mesh in the louvred windows of the bell housing but there were no signs and this feature was particularly draughty.

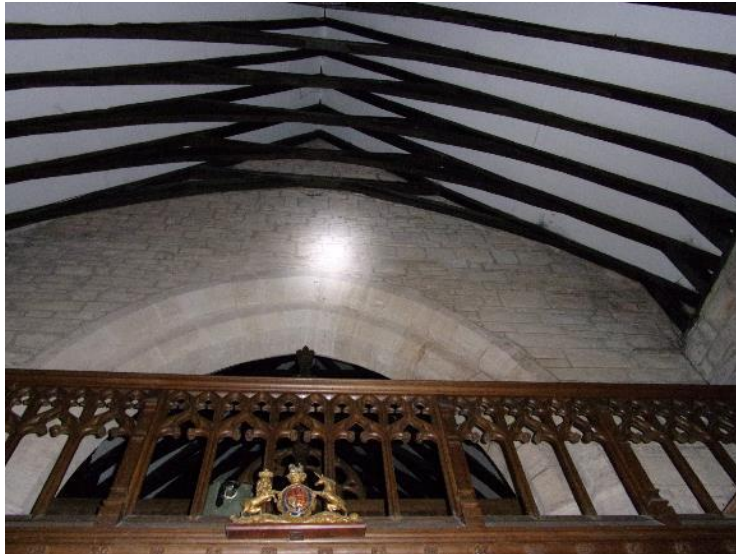
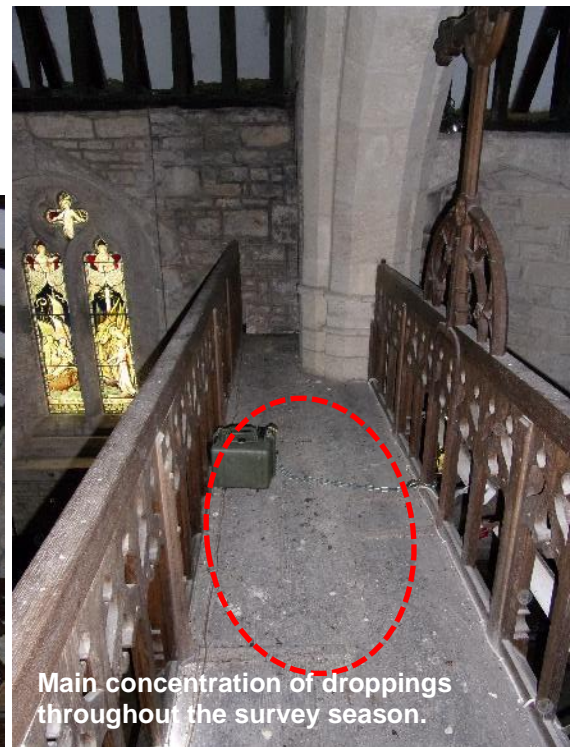
20 bat droppings found on the Chancel screen "loft" (a balcony – see photos below) above the pulpit and below the Chancel Arch wall, 11 of which were serotine droppings, and the remainder were possible long-eared bat droppings. The number of droppings on this feature gradually built up through the active season, with numbers of serotine droppings increasing at least threefold.

On the Chancel side, the gap between the plasterboard and wall is more evident and this was considered likely to lead to felt. There were no obvious signs of bats in association with this.

Main concentration of droppings throughout the survey season.

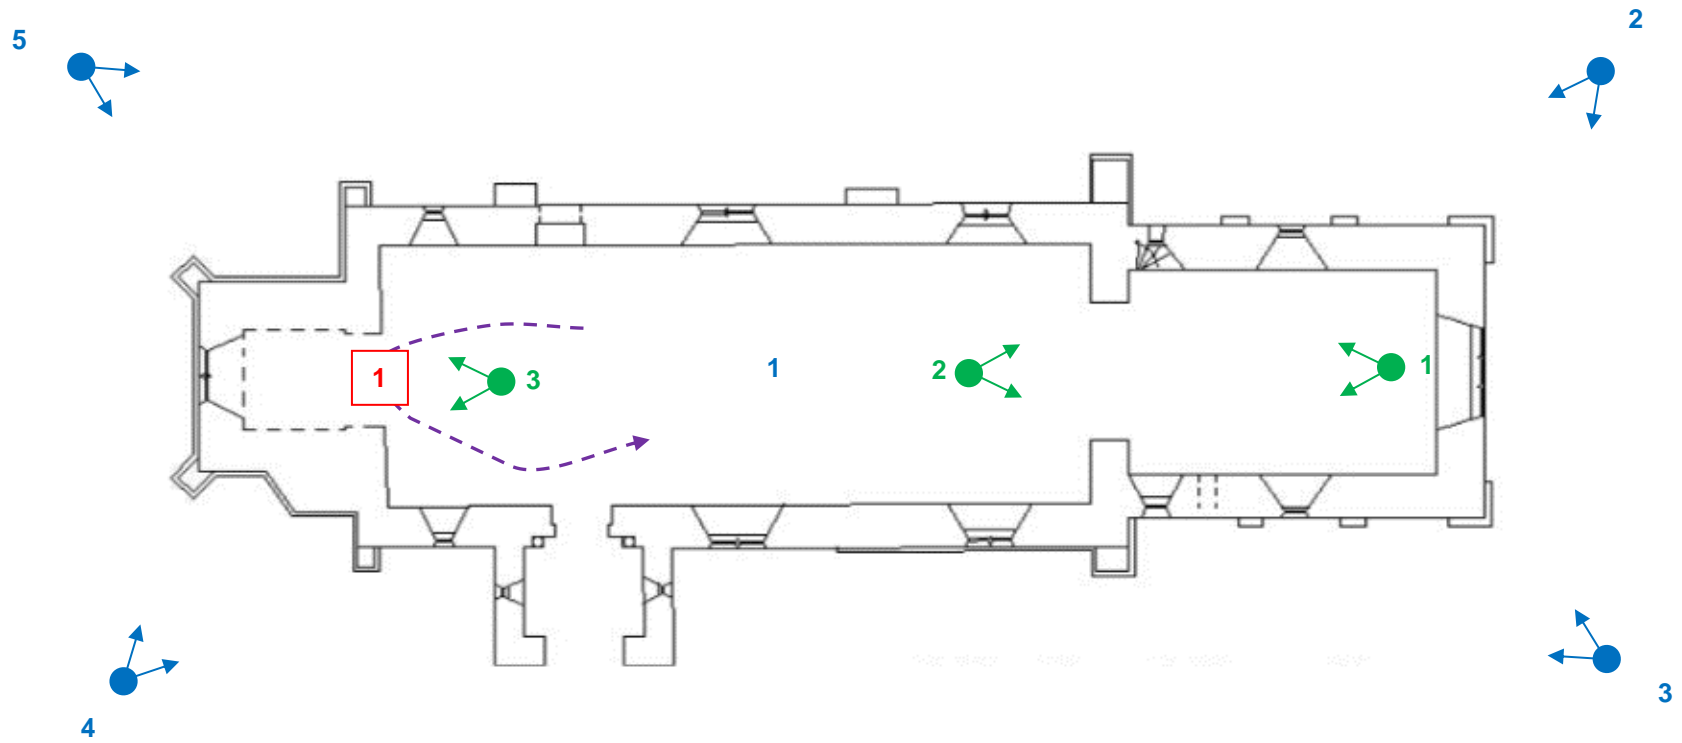
Bat activity survey 1 – 20th May 2019

1. Brown long-eared bat seen flying inside the church 1 hour and 20 minutes after dusk, alighting on the Nave west end wall five times in 3 minutes.

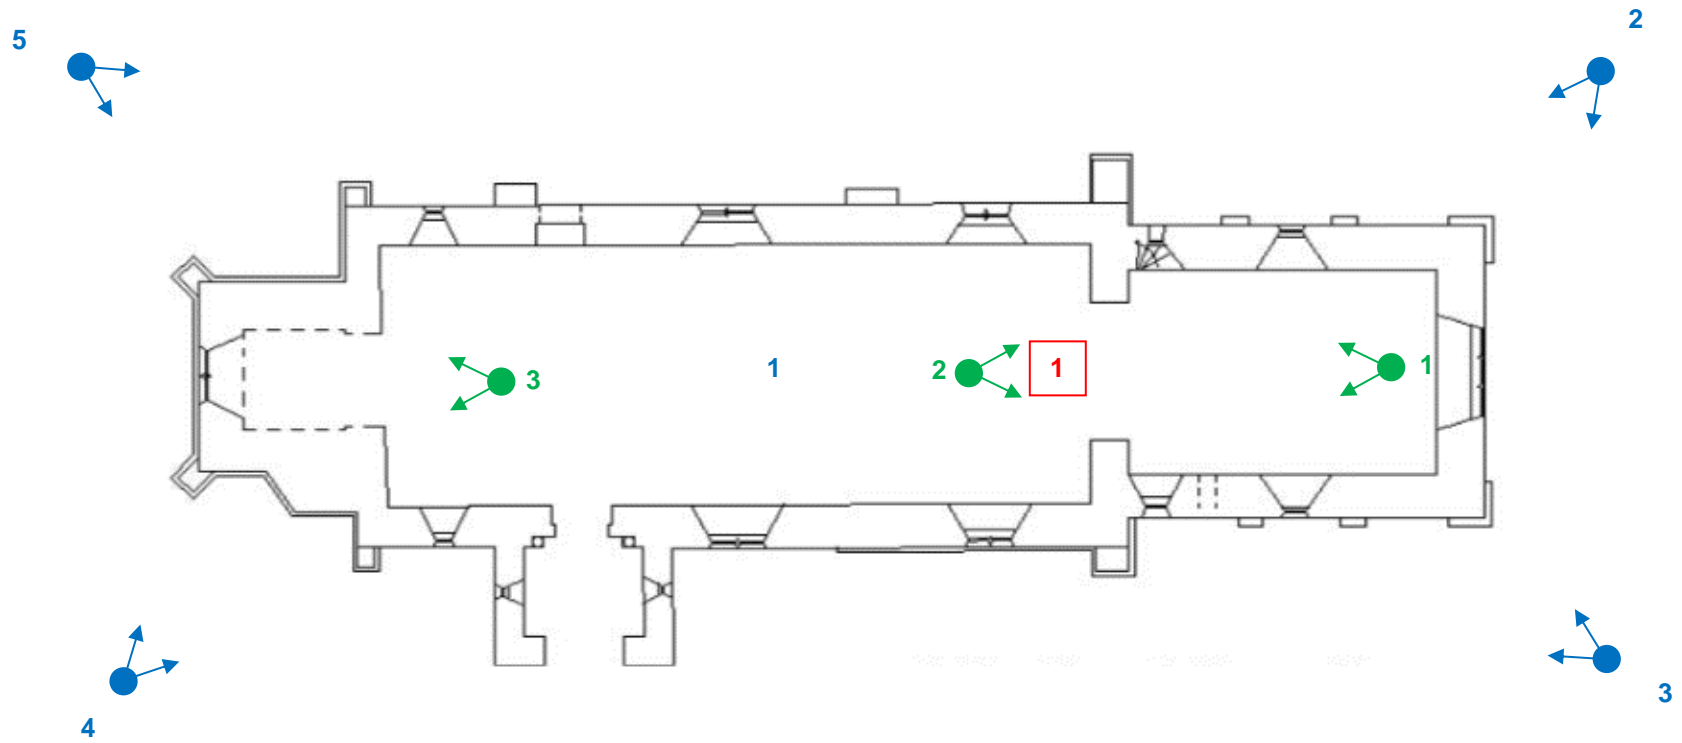
Bat activity survey 3 – 3rd July 2019

1. A common pipistrelle bat may have emerged from the ridge line of the Nave adjacent to the Chancel.

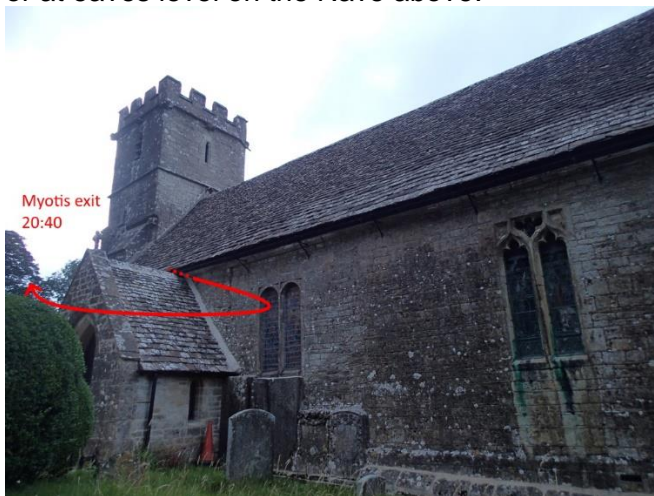
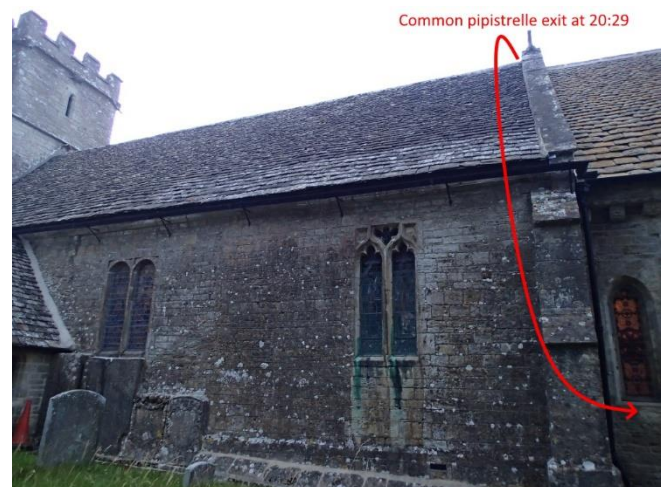
1. A common pipistrelle bat emerged from the ridge line of the Nave adjacent to the Chancel.
2. A *Myotis* bat emerged from a location in this part of the building – either the ridge line of the porch or at eaves level on the Nave above.

3. A common pipistrelle bat emerged from the ridge line of the Chancel.
4. A common pipistrelle bat may have emerged from this louvre vent on the tower.
5. A *Myotis* bat emerged from the ridge line of the porch.
6. A second *Myotis* bat emerged from the ridge line of the porch but from a different location.
7. Possible emergence of a serotine bat from the Nave ridge line. The surveyor who noted this was some distance from the feature and the observation was made some time after dark.

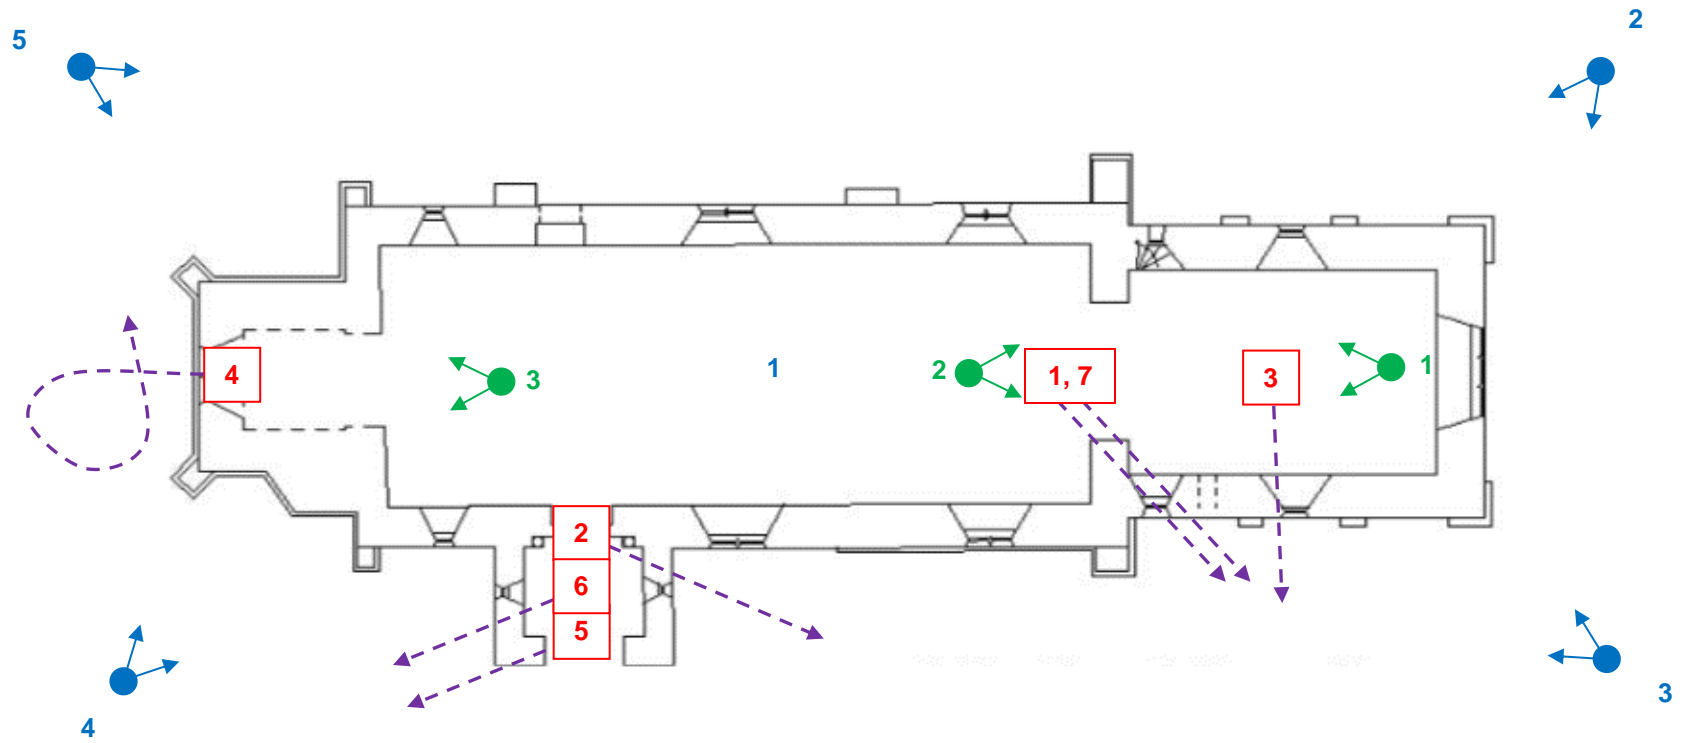
Bat activity survey 4 – 21st August 2019

- 4.21. On the exterior of the church, two common pipistrelle bats and three *Myotis* bats emerged from under ridge and roof tiles. A further two bats were noted possibly emerging – a common pipistrelle from the tower and a serotine from the ridge line of the Nave.
