St Nicholas Church, Fyfield – Bat Surveys

Bat surveys of St Nicholas Church, Fyfield were carried out by Ecology by Design as part of the Bats in Churches Project (Lot 17). This report presents the results of the surveys and interprets the survey findings. It was originally intended that only three surveys would be conducted in 2019 to inform the mitigation measures for the church, however, given what were assumed to be uncharacteristically low levels of activity in 2019, two further surveys were conducted in 2020 to enable a robust assessment to be made. Departure from the agreed methodology for the project was decided upon after discussion with the Churches project personnel and members of St Nicholas Church.

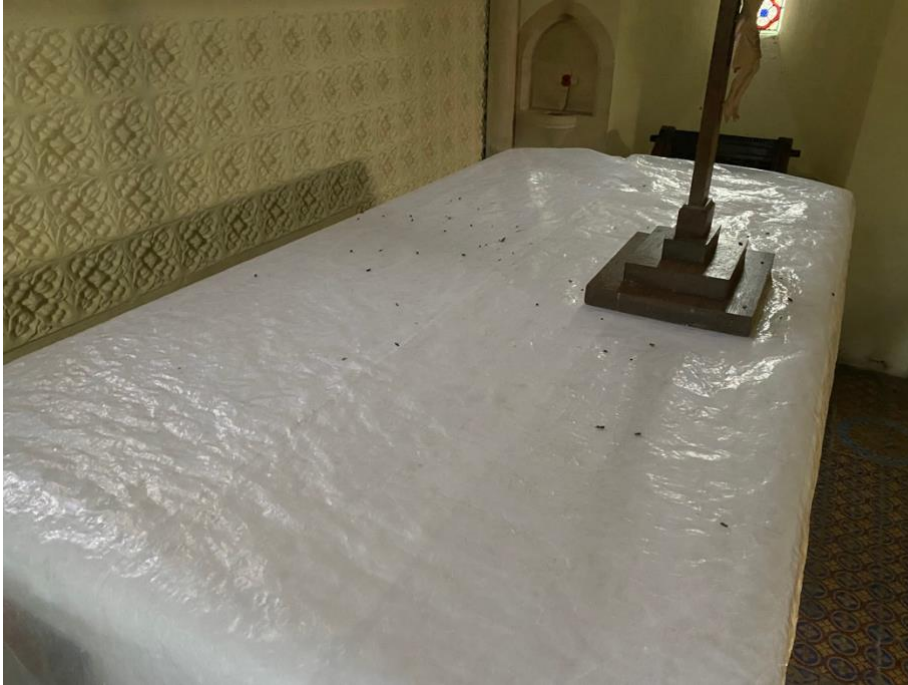
Photograph 1: Droppings accumulated on table in chancel

- Given the majority of evidence of bats was within the shorter pew on the south aisle and window ledges on the south side, we suggest making some bespoke fitted sheets and/or covers to protect these while the church is not in use, making cleaning before services less onerous;
- A bespoke unit could be created to house the visitor book, resources and hand sanitiser by the front door to include a perspex cover which can easily be cleaned and its' contents accessed; and
- An interpretation board could be produced to explain how roosting bats are using the church and measures which are being used to protect the historical artefacts and visitors of the church.

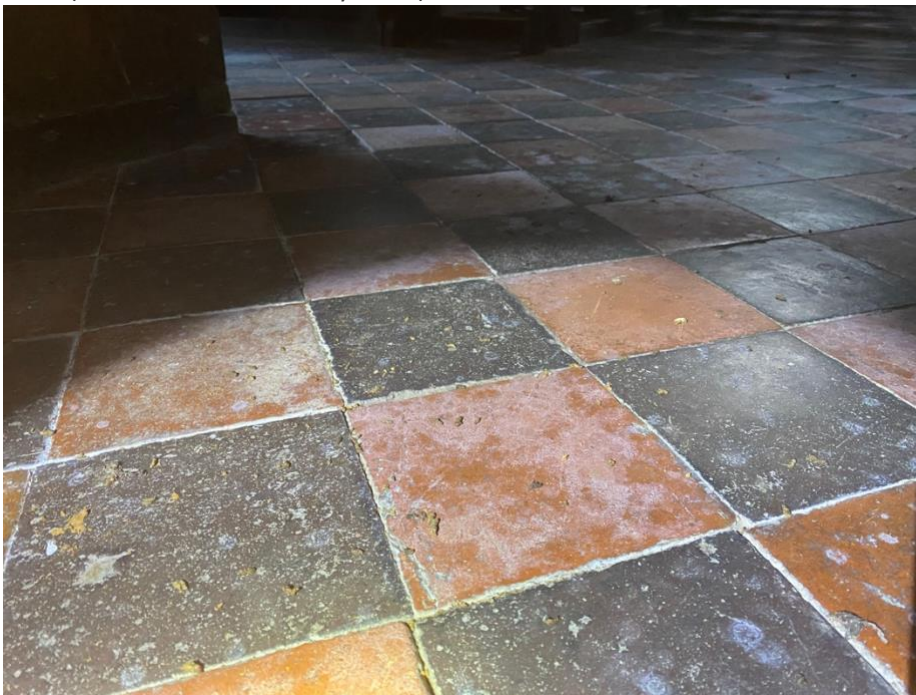
Photograph 2: c. 40 brown long-eared droppings accumulated beneath main roost (4 individuals on 07 July 2020) beneath central beam in south aisle

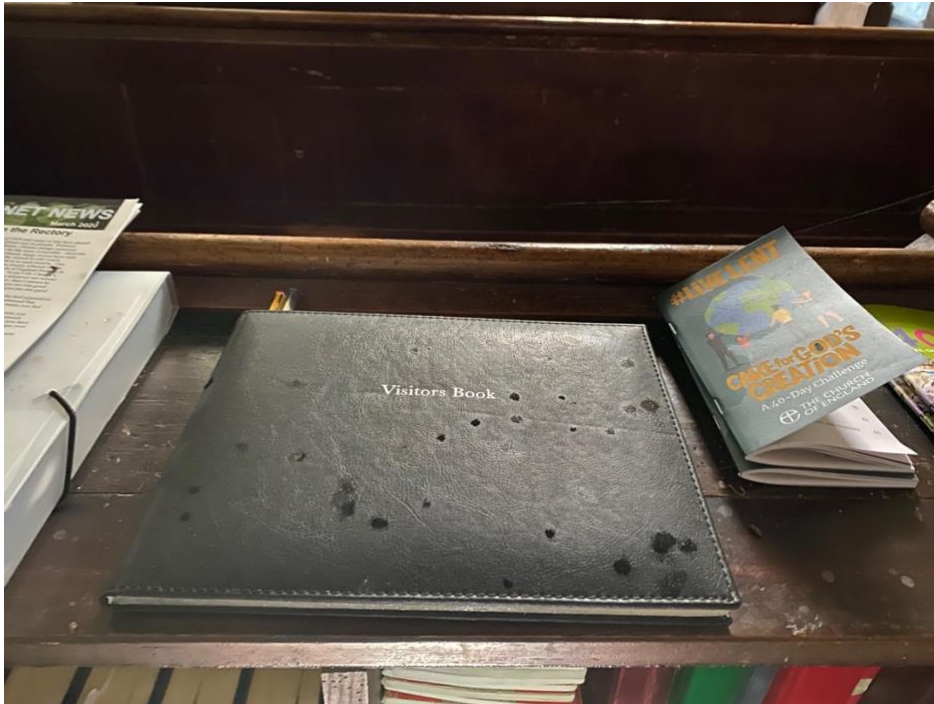
Photograph 3: Urine stains and droppings on internal shelf by front porch

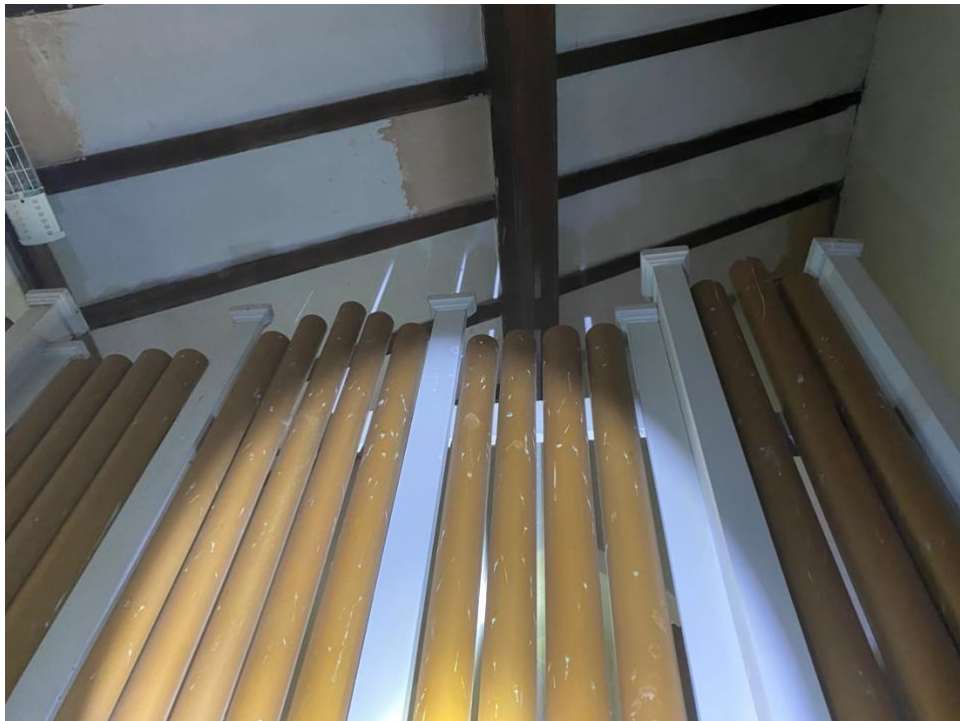
Photograph 4: Mainly historic urine stains on organ (no fresh droppings observed)
