# THE CHURCH OF ST MARY, GAYTON THORPE, NORFOLK

## BAT SURVEY AND MITIGATION PROPOSALS IN RESPECT OF THE HLF BATS IN CHURCHES PROJECT

**2<sup>nd</sup> DRAFT**

Report ref: P2019-31 R1 2<sup>nd</sup> Draft

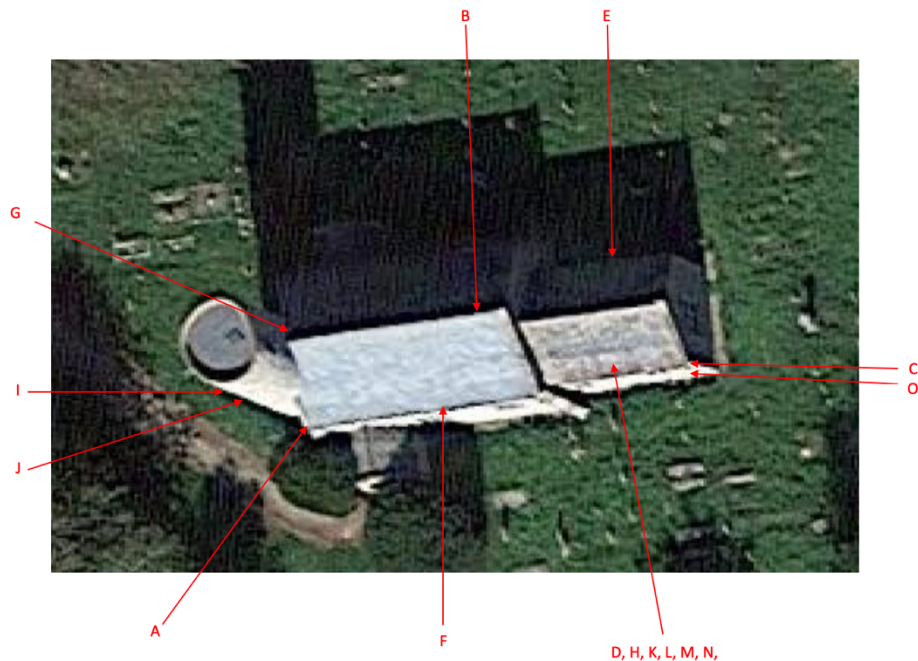
**Figure 3** – Location of identified roosting areas –  
Imagery © 2019 GeoEye, Getmapping plc, Infoterra Ltd & Bluesky

3.4 The location of the various roosting sites can be found on Figure 3 below the table.

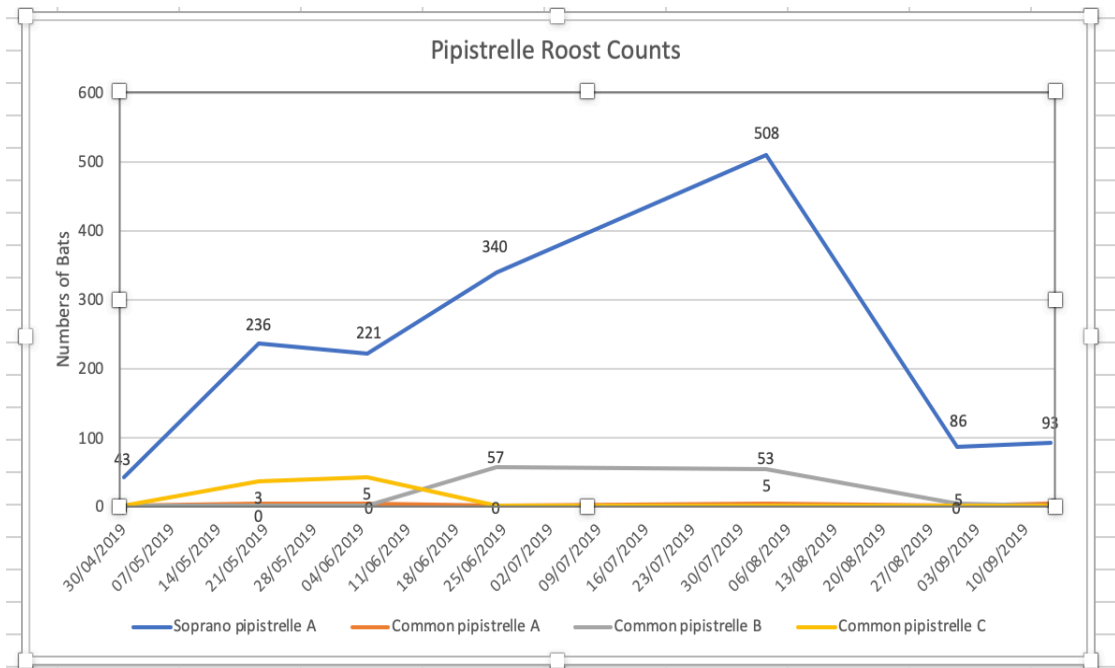
Figure 4 – Bat roost numbers in locations (see Figure 3)

3.5 The surveys across the principal roost sites (A, B and C) are shown in the following graph. This illustrates how the number of bats have varied across the course of the 2019 survey season. It clearly illustrates that the numbers of soprano pipistrelle in roost A increased from 338 on 24<sup>th</sup> June 2019 (when it would be expected they would be all adults) increasing to 508 on the 3<sup>rd</sup> August 2019 (which would include juveniles emerging). The graph also clearly illustrates that the main common pipistrelle roost moved between roost site B and C during the course of the summer. The fact that the common pipistrelles had largely left the church by the end of August whilst good numbers of soprano pipistrelles were still present is not entirely unexpected as common pipistrelles typically leave their roosts much earlier in the summer than soprano pipistrelles (Pers obsv).

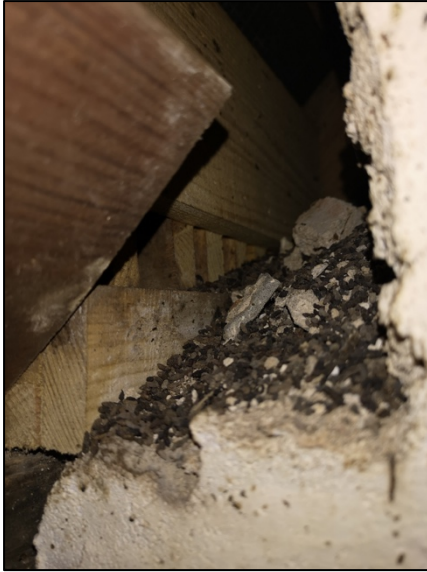
3.6 Although the numbers of bats being recorded in the provided roosting features have increased over the years, the numbers of bats roosting internally has decreased significantly. The maximum number of common pipistrelles recorded internally on any of the surveys was 4. These appeared to be roosting near to the font of the chancel area but it is clear that the common pipistrelles no longer use the inside of the church as a maternity roost site. One reason for this maybe is that access into the church has gradually become more difficult due to the numbers of droppings collecting close to the soprano pipistrelle maternity roost (refer to Figure 5). Small numbers of soprano pipistrelles were also noted to enter the church later in the season and usually in the middle of the night. These could potentially have been juveniles.

**Figure 5** – View of the back of the current bat box from inside the church(2019). There is a significant collection of pipistrelle droppings beneath the access point which may have deterred pipistrelle access into the church

- 4.2 The mitigation proposals are therefore to block off the access from the back of the box in location A to prevent the bats from entering the church. This will require registration under Bats in Churches Class Licence as this will be obstructing a proven bat access point. All of the alternative roosting locations (externally on the nave, chancel and the tower - 15 roosting sites in total will remain intact).
- 4.3 The exact location of the blocking needs to be considered. The opportunity exists to further enhance roosting provision on the wall top by extending the bat box by including more enclosed baffles and then blocking the inside. This proposal is illustrated in Figure 6. It is unlikely that this box will be visible from inside the church.

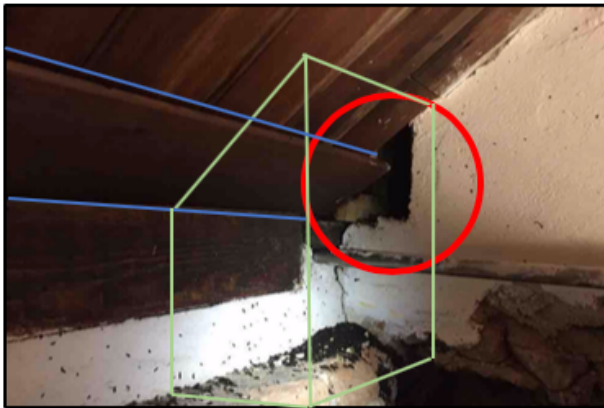
**Figure 6** – Bat access and bat box in the south-west corner of the nave. The access point into the church is marked in red, the proposed board removal to allow box to be cleaned out is shown in blue, the green line shows the proposed extension to the bat box. This should not be visible from inside the church.

- 4.4 The bats currently roost between the boards and the slate/felt as far as the first principal rafter. Overtime, the roosting area could become blocked with droppings so a method of clearing these out would be beneficial. This could be achieved by cutting the bottom section of boards (see blue line) along the wall top and then re-screwing to make them removable on a permanent basis.
- 4.5 At the time this work is done, the majority of the existing droppings will be removed (but not all so that the smell and integrity of the roost remains).
- 4.6 The box will also need an exclusion device to allow any bats within the church to be able to leave but not return. Surveys on the evenings following installation of the exclusion device will confirm this.

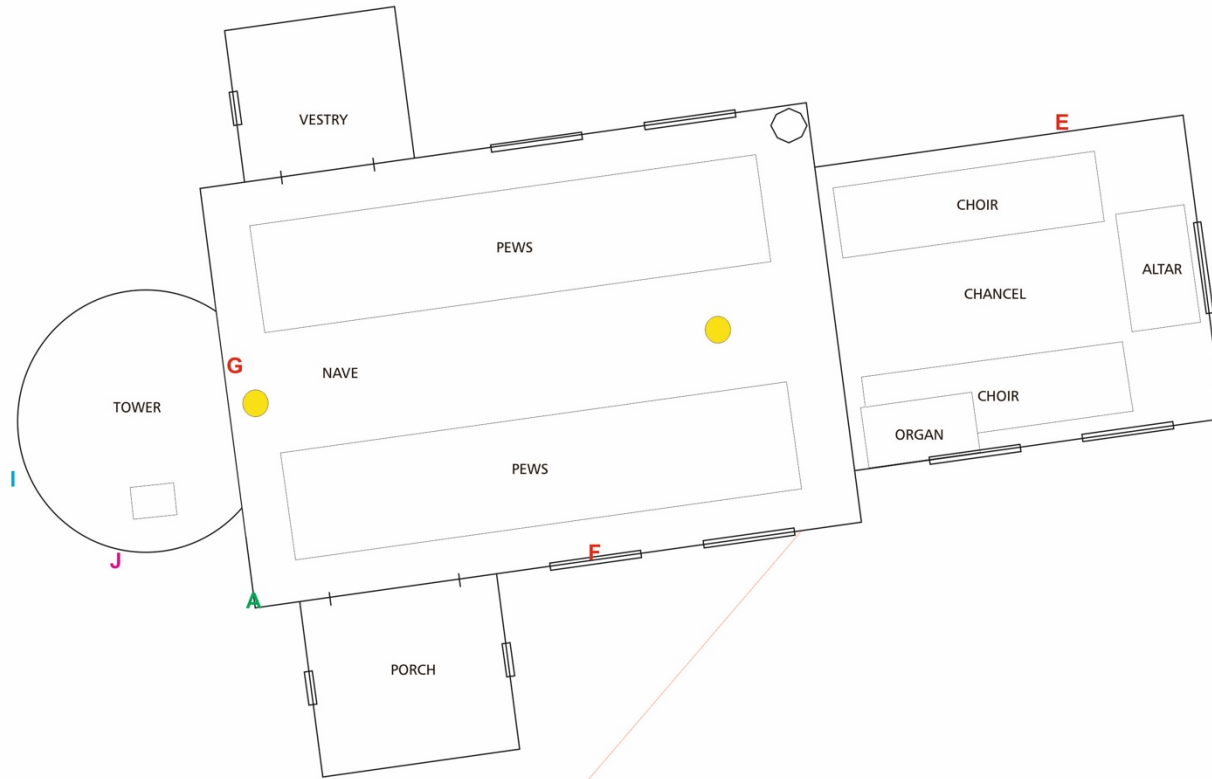
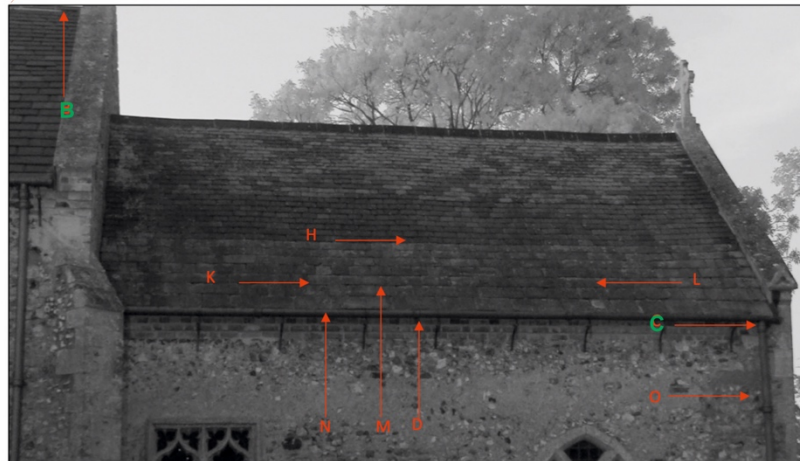
BAT ROOSTING SITES/ACCESS POINTS

As part of the repair works that were carried out in 2013, 2 bat boxes were installed into the nave roof structure. One box was also installed on the wall top behind the newly created bat access point (see Roost A on Drawing 3 and also illustrated in Figure 16) and the second (a bat slot) was created under a ridge tile at the eastern end of the nave (Roost B) and also illustrated in Figure 6.

- A Principle roosting sites
- D External roost sites
- I Access into silence chamber
- J Access into bell chamber
- Internal common pipistrelle roost

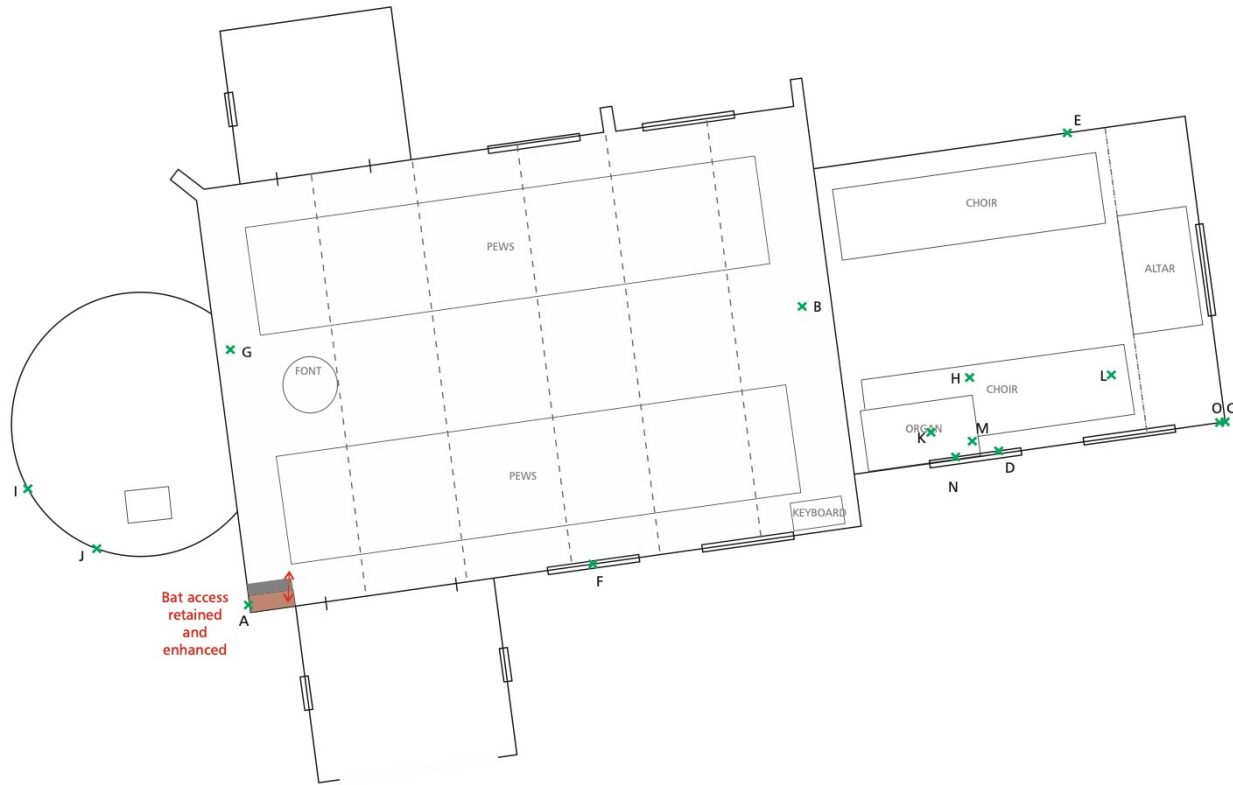
BAT MITIGATION PLAN

- Existing bat box to be enhanced
- Proposed bat box extension
- Bat access to be excluded
- X Bat access/roosts to be retained

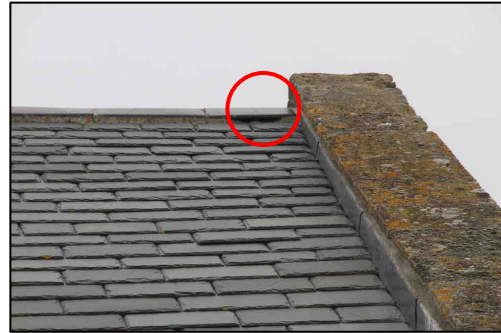
**Figure 9** – Nave ridge showing bat slot B installed as part of the re-roofing works in 2012/13 to replace lost roosting areas in the roof structure. A peak number of 57 common pipistrelles emerged from this location in June 2019

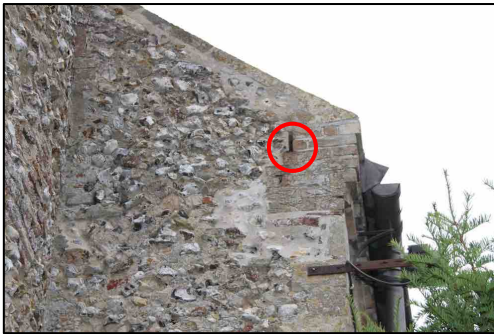
**Figure 10** – West end of the nave by the tower showing the bat access slot A, installed as part of the 2012/13 works. The bat box in figure 3 is immediately behind this slot. A peak of 508 soprano pipistrelles emerged from this slot on the bat night in August 2019

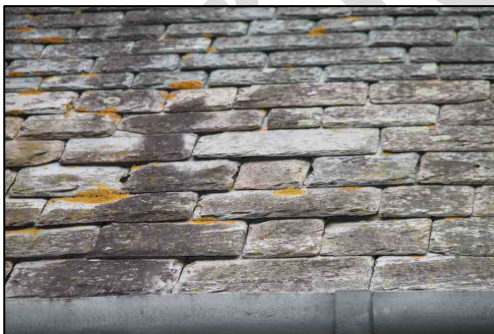
**Figure 12** – Gaps under slates on the chancel providing potential bat roosting areas for individual bats (only the nave was re-roofed in 2012)

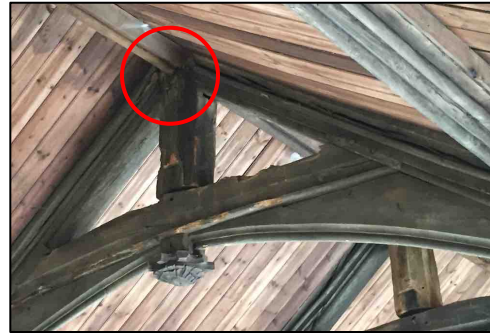
**Figure 15** – Detail of the principal rafter above which the common pipistrelle maternity roost previously roosted. However, this location is now only used by the occasional bat

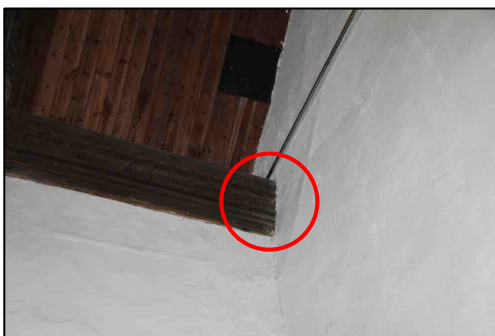
**Figure 16** – Bat access location viewed from ground level in the south-west corner of the nave

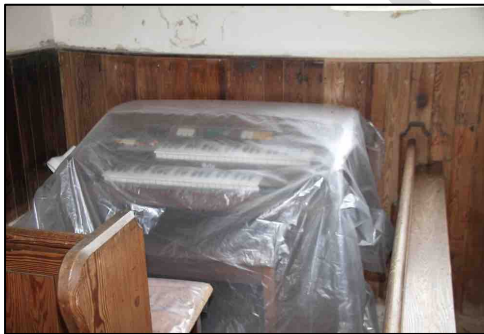
**Figure 18** – Modern organ covered with plastic sheeting to protect it from bat droppings and their urine

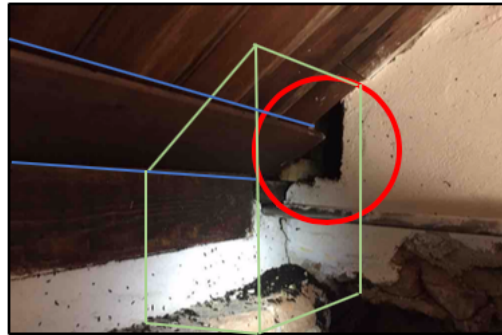
**Figure 19** – Bat access and bat box in the south-west corner of the nave – the common pipistrelles access the church in this location. The soprano pipistrelles use the box for roosting but also access between the boarding and the roofing felt as far as the principal rafter. Occasional soprano pipistrelles access the main body of the church for flying. It would be useful to be able to make the board (highlighted blue) removable to clear out droppings from the roosting area. A possible extension to the box is shown in green

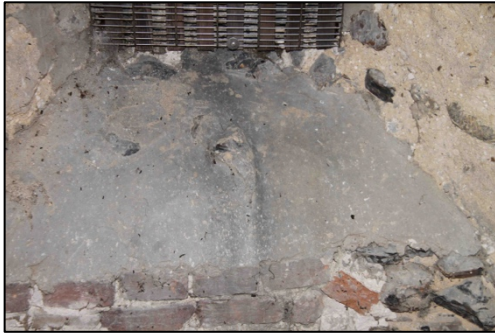
**Figure 20** – Droppings on the windowsill within the silence chamber. Bats are able to access around the mesh

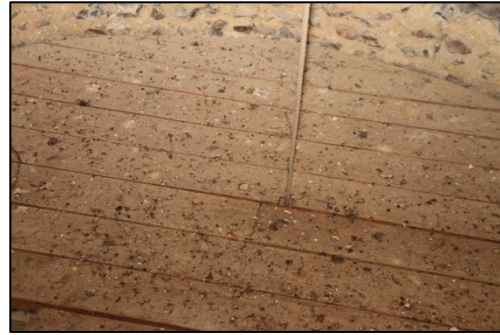
**Figure 21** – Good number of pipistrelle type droppings mixed with debris on the floor, still present in 2019

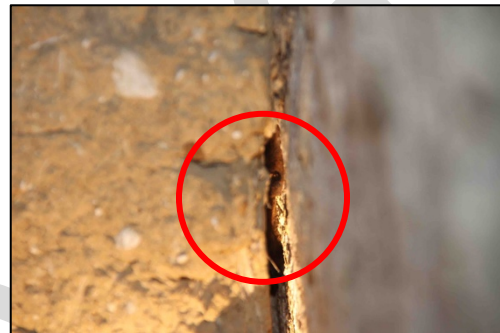
**Figure 23** – 2 pipistrelles in gap of sealed window in 2017, not present when inspected in 2019 but still considered likely to use

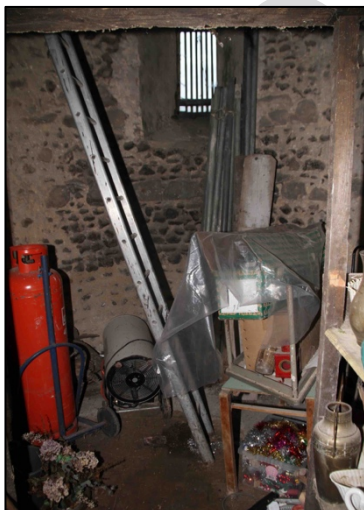
**Figure 24** – Base of tower – limited bat evidence

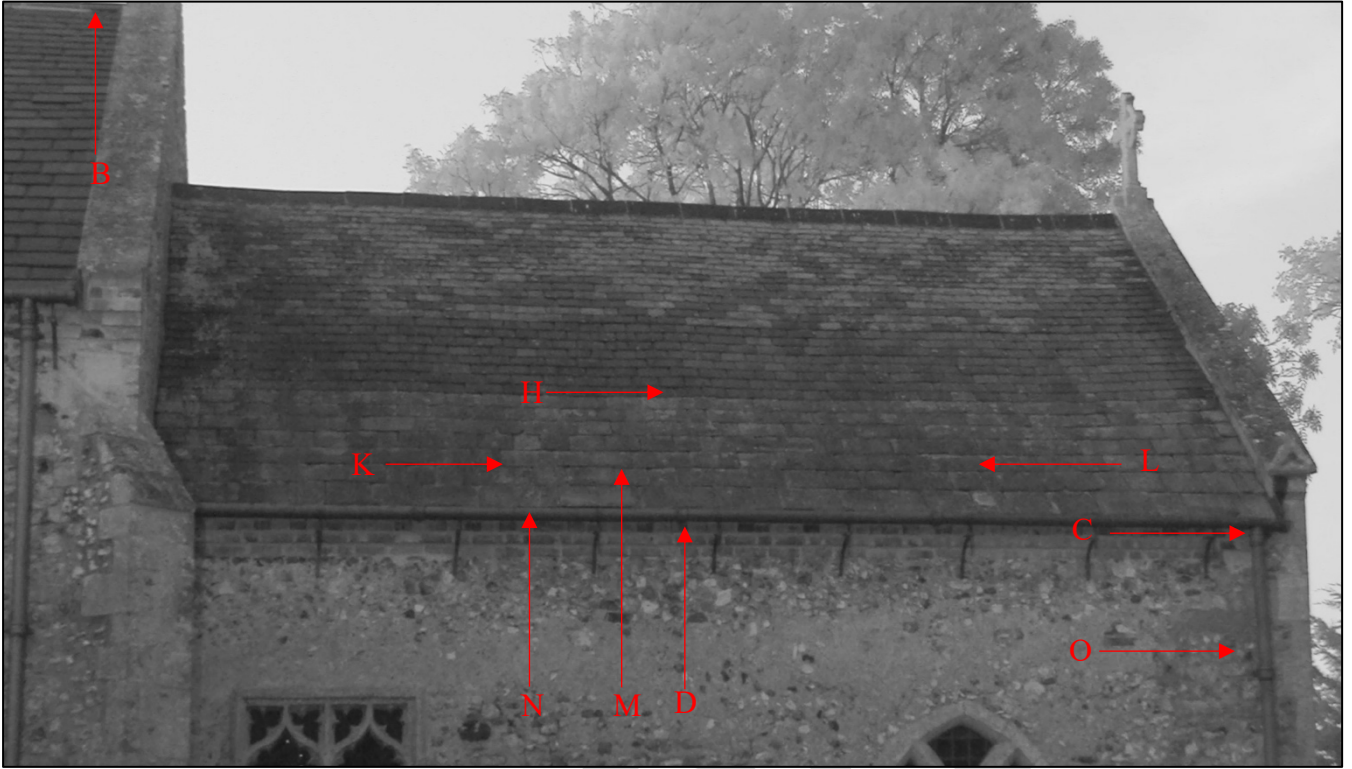
**Figure 26** – Bat roosting locations on the southern elevation of the chancel and west end of the nave
