Bat Survey of St Andrew's Church Grafham, 2021

Report dated 11 October 2021

Surrey Bat Group
4 Locke King Close,
Weybridge, Surrey, KT13 0TA
Tel: 01932 842636
e-mail: ross.lynn@zen.co.uk

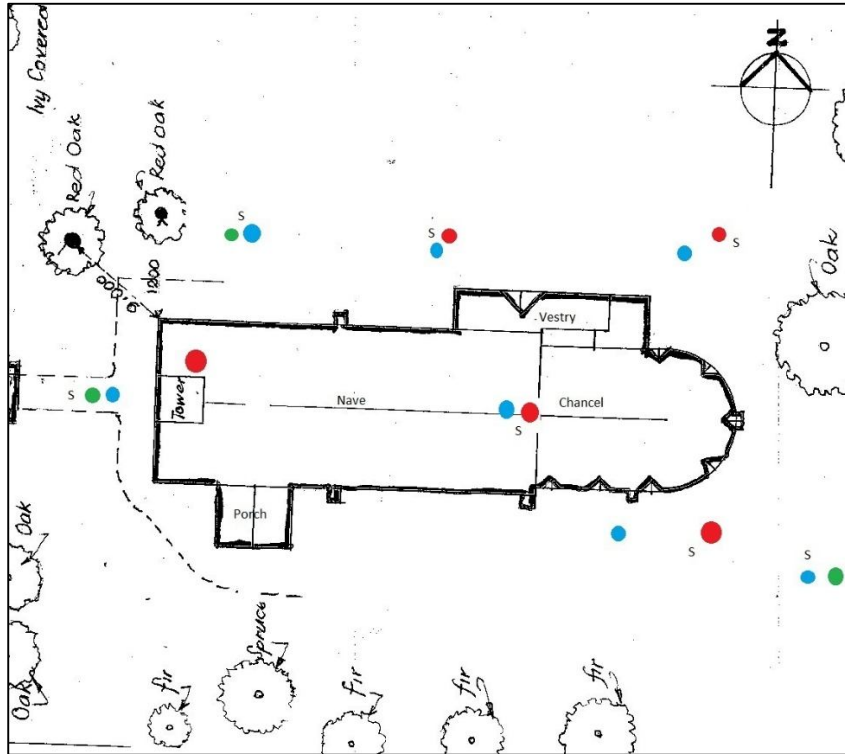
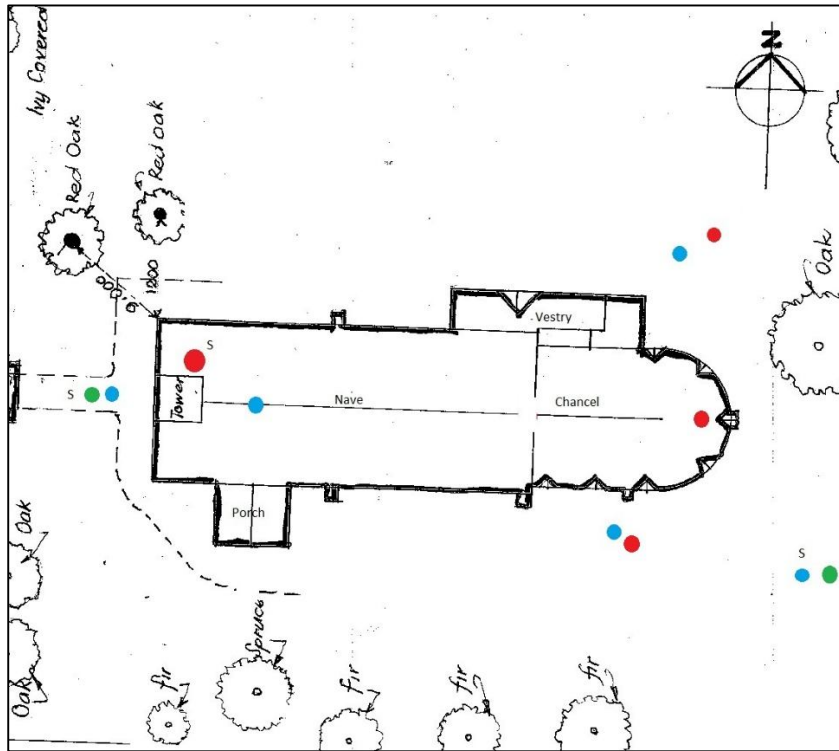
Appendix A – Surveyor, camera and detector locations during emergence surveys

The following plans show locations of surveyors (S), full-spectrum bat detectors (blue dots), infrared cameras (red spots) and thermal imaging cameras (green dots) during the emergence surveys.

Top: 26 May, middle: 28 June, next page: 9 September.

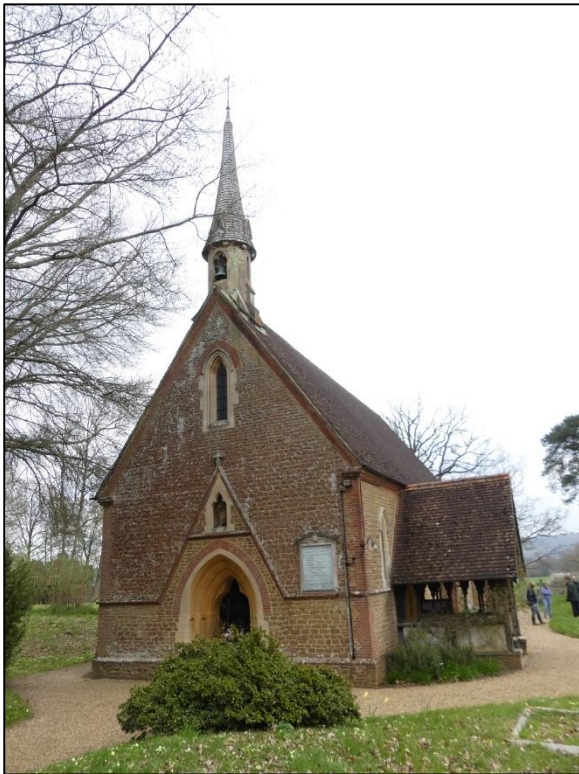
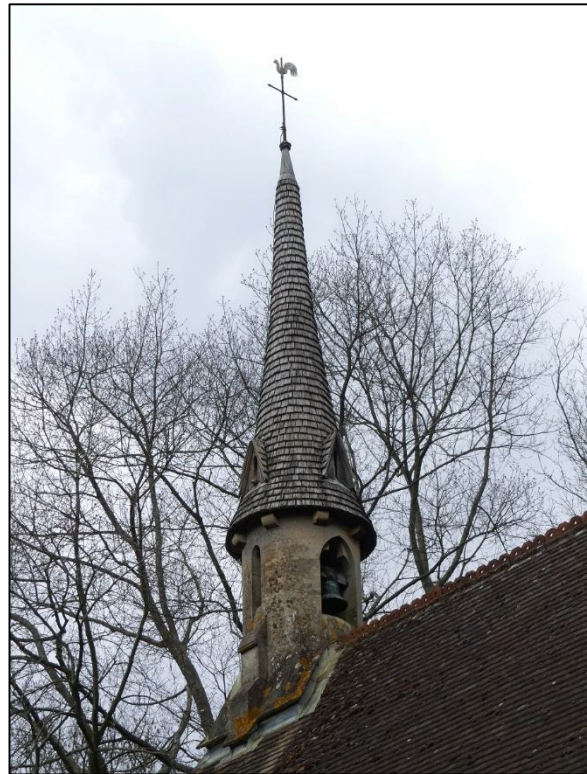
Left: west end of church and open porch on south side of nave. Right: close-up of bell tower.

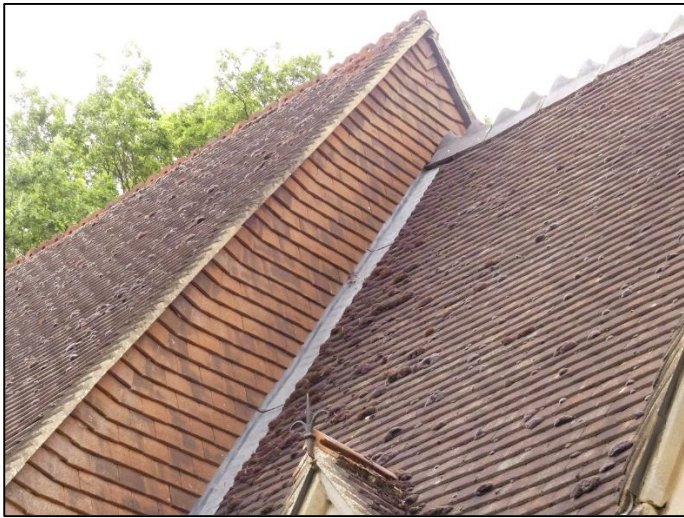
Close-up of hanging tiles on east end of nave gable. Note gap below the chancel apex, adjacent to the hanging tiles.

The roof tiles appeared to be generally in good repair, with the most likely bat access points thought to be between lead flashings and tiles, between hanging tiles, and under the edges of the ridge tiles. No signs of bats such as droppings or urine stains could be seen on the exterior, but these would have been difficult to spot against the mottled roof and walls, especially given the height of the roofs.

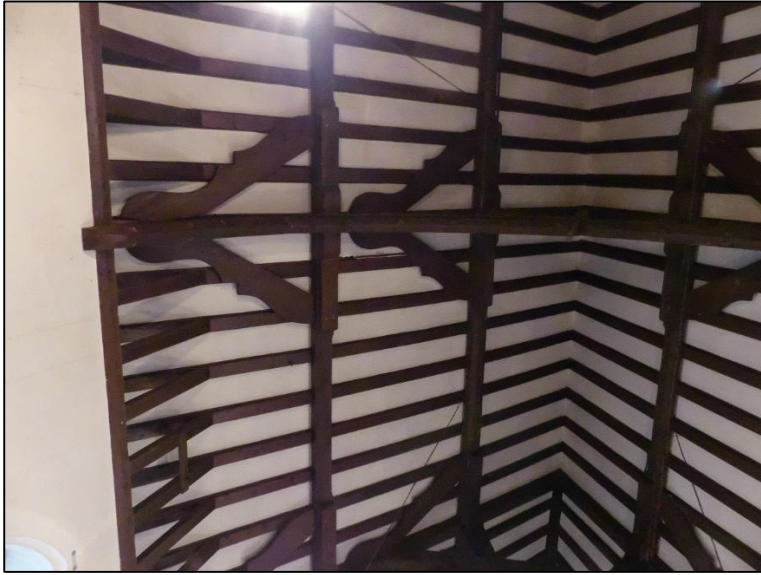
Nave ceiling.

Internally, there appears to be no separate roof void above the nave or vestry, with the ceiling following the roof line, and lined with lath and plaster. Angles between the nave ceiling and the roof supports offer a number of potential roosting sites for bats, especially if gaps exist between the supports and the ceiling, which is impossible to determine from ground level. The chancel ceiling is curved, so although there appears to be no loft space there is potentially some limited space between ceiling and roof tiles. The bell tower is separate from the nave, while the vestry is accessed from the chancel via an open door.

Scattered medium-sized bat droppings and spots indicative of bat urine were found throughout the nave, on both floor and walls, with relatively few droppings in the chancel and vestry. Slightly larger concentrations were noted at the east and west ends of the nave. That at the east end was immediately below a gap between one of the roof support beams and the nave wall: the gap had staining around it suggesting heavy use by bats.

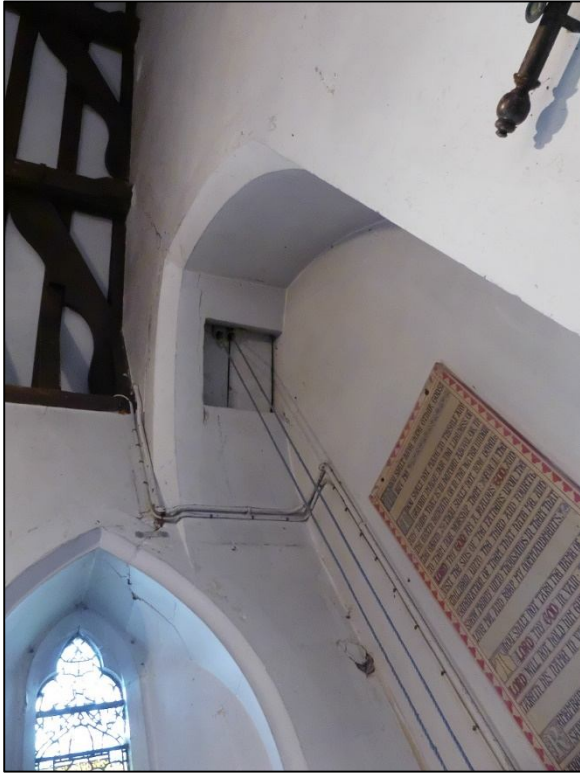
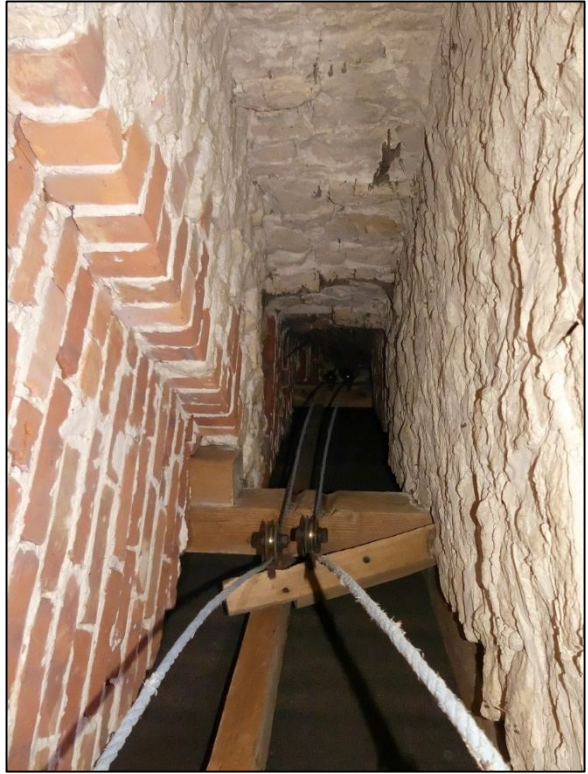
Left: hatch to the bell tower. Right: interior of bell tower base.

It was not possible safely to enter the bell tower, but an inspection was made from the loft hatch at its base: no bats could be seen at the time. However, a few bat droppings were found; this and the presence of old bird nesting material indicated that bat access was possible.

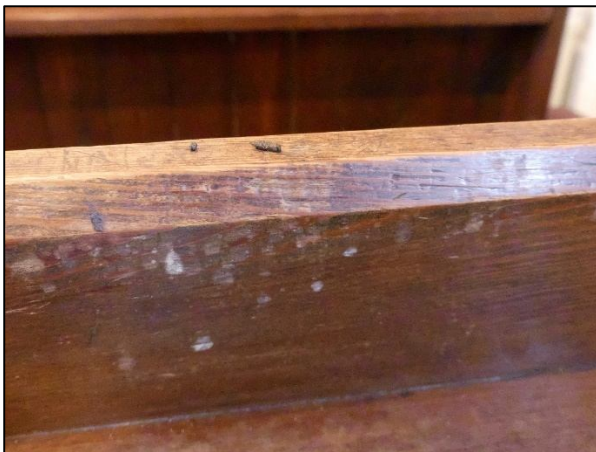
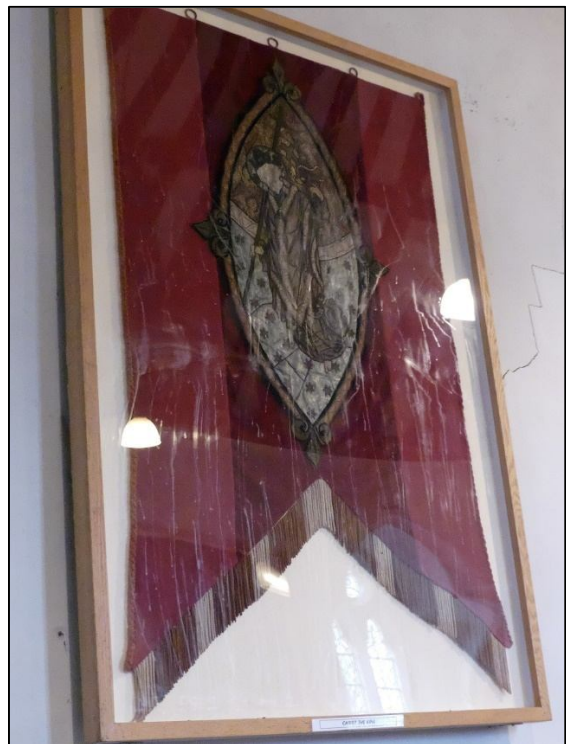
Examples of urine staining and droppings on pews and framed hangings.

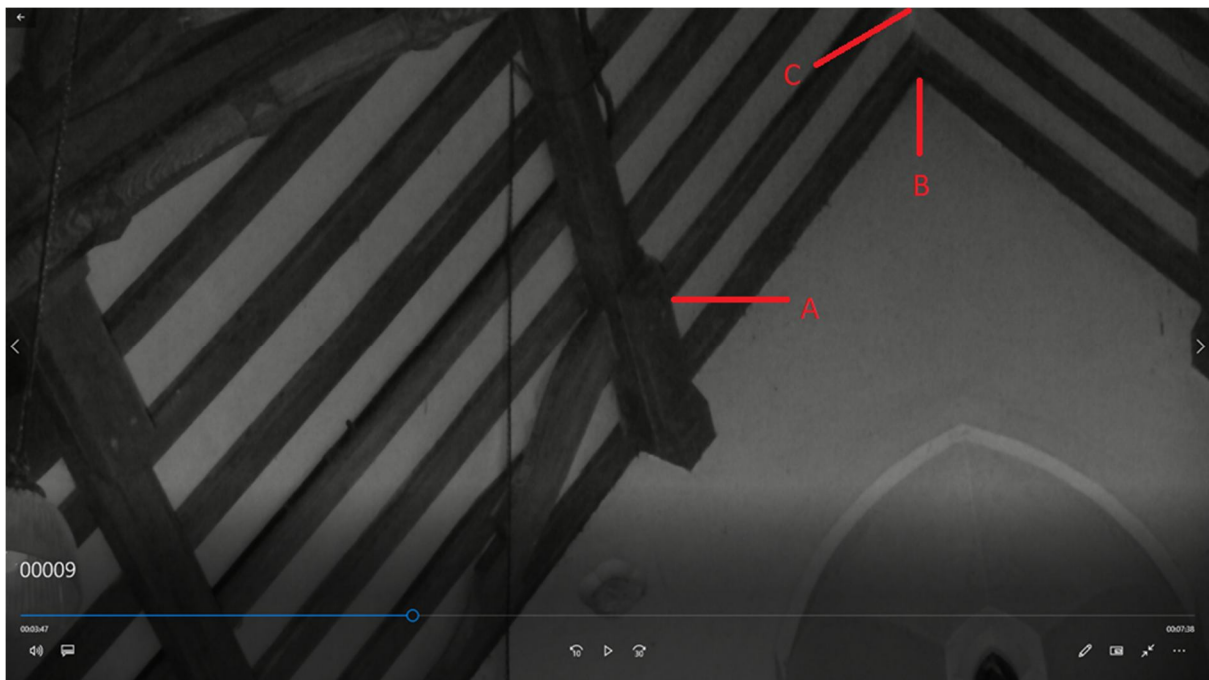
Brown long-eared bat internal roosting points, west end of nave. Number of bats emerging from each point: A-5, B-1, C-1.

Although swarming of bats inside the church made accurate counting difficult, it appeared that 14 brown long-eared bats emerged from various points in the ceiling and end walls of the nave, starting at 21.06. They spent some time flying within the church, perching occasionally on the ceiling, especially near roosting points. They then exited the church via the top of the double doors at the west end, via a small gap between the tops of the doors, after flying over the rail of the curtain in front of the doors. Unfortunately, as the gap was not obvious, the external camera at that end was initially focused on the bell tower rather than the door so that only a partial exit count was obtained. However, a count from one of the internal cameras indicated that between 12 and 15 bats exited via the door between 21.15 and 21.36.

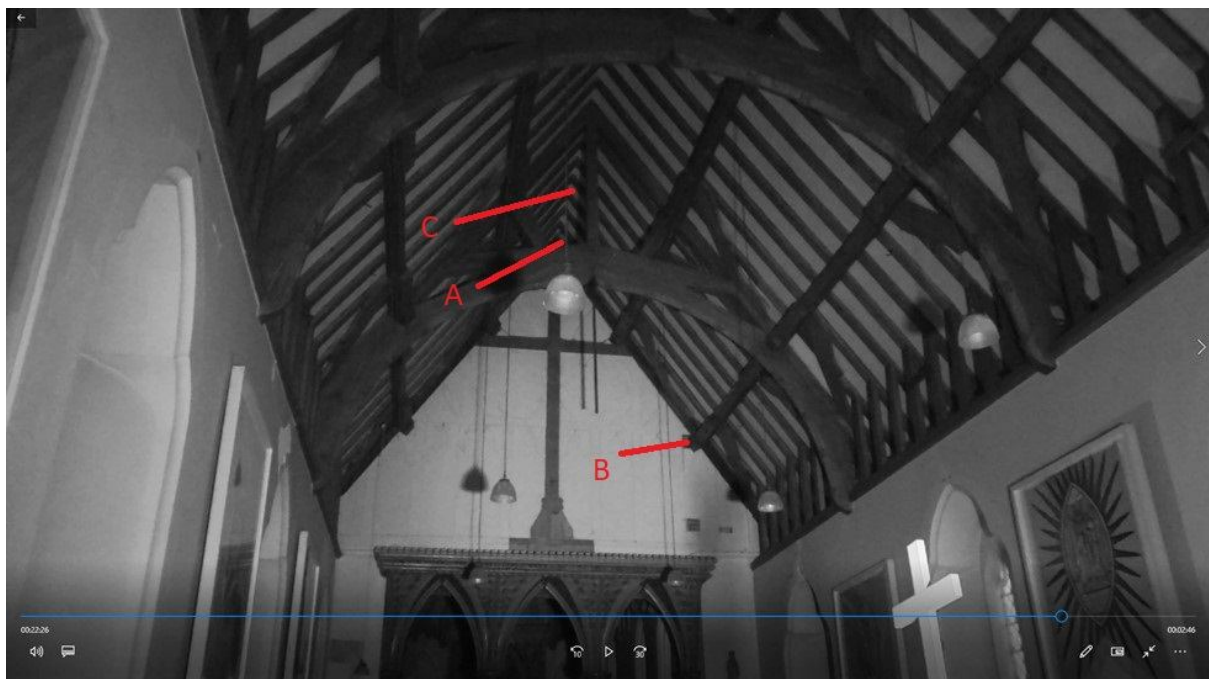
Brown long-eared bat internal roosting points, east end of nave. Number of bats emerging from each point: A-4, B-1, C-2.

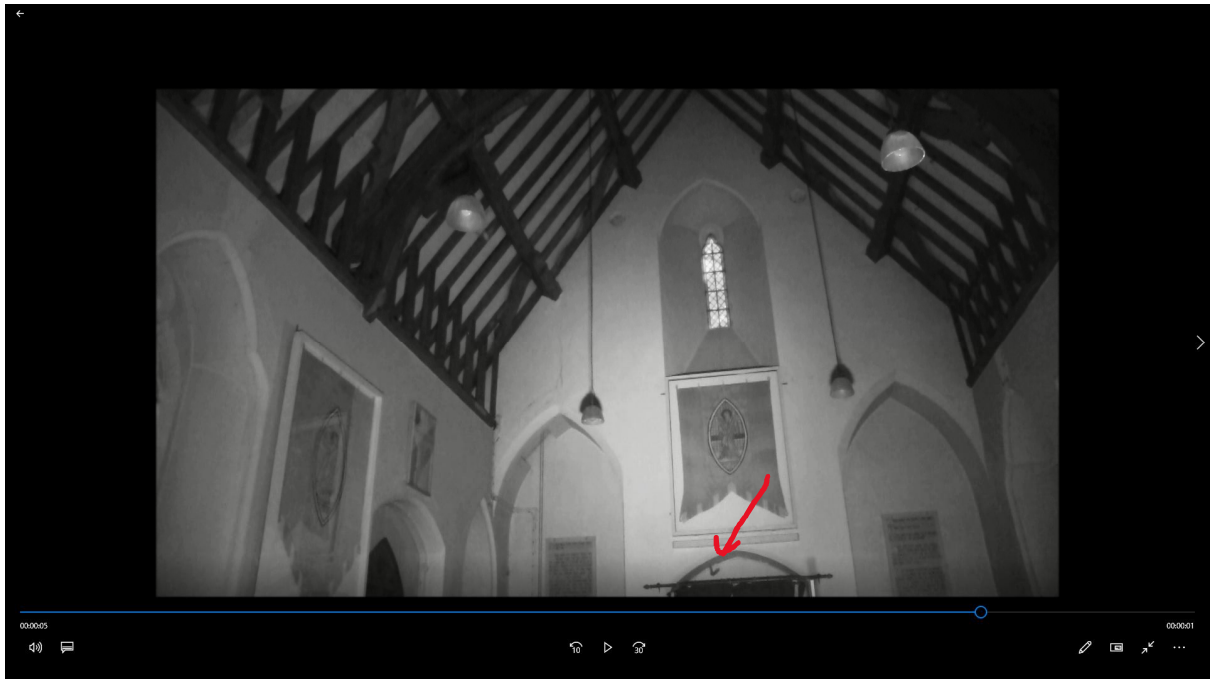
Video still showing a brown long-eared bat flying over the curtain at the west end of the nave prior to emerging via the doors behind.

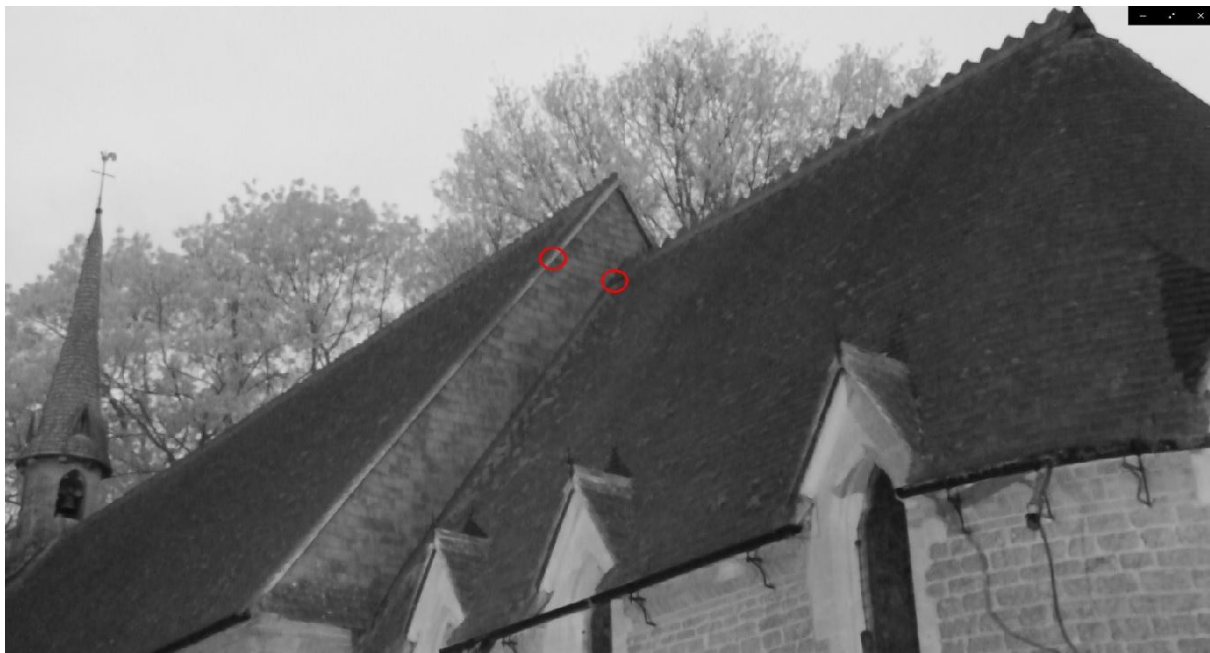
Emergence points of one soprano pipistrelle (left circle) and two brown long-eared bats (right circle).

Two brown long-eareds⁵ also emerged from the ridge of the chancel roof at 21.25 and 21.32 respectively, and one soprano pipistrelle (*Pipistrellus pygmaeus*) emerged from the south edge of the nave roof at 21.31. After the end of the survey a few brown long-eareds were also observed clustered in the porch roof.

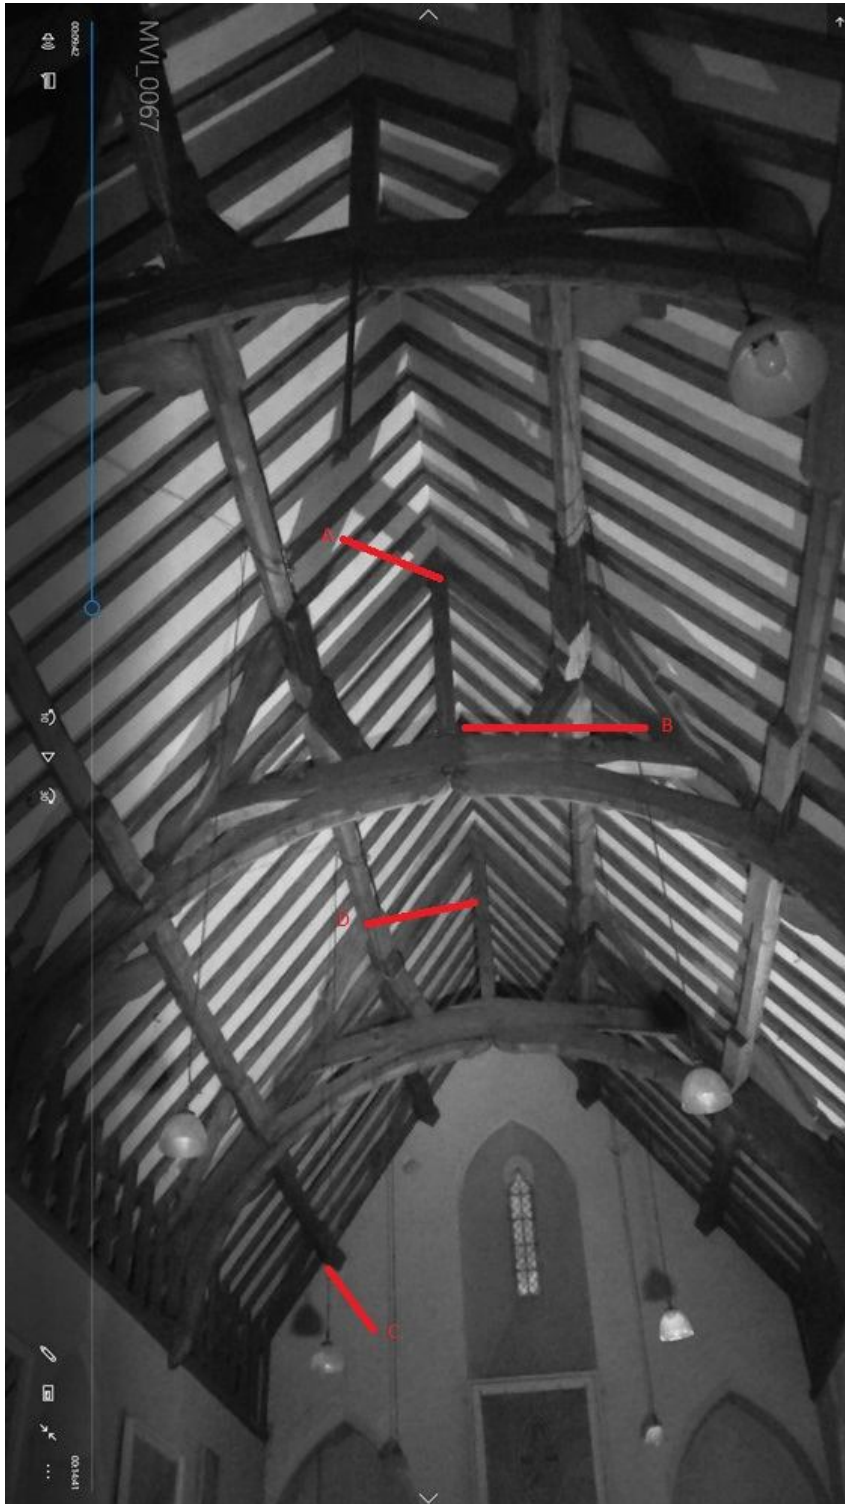
Brown long-eared bat internal roosting points, west end of nave. Number of bats emerging from each point: A-1, B-2, C-1, D-1.

On this occasion 21 brown long-eareds were recorded emerging from the ceiling and walls of the nave into the church, starting at 21.26. A video camera was trained on the western doorway this time, and 21 bats were counted emerging between 21.36 and 22.32.

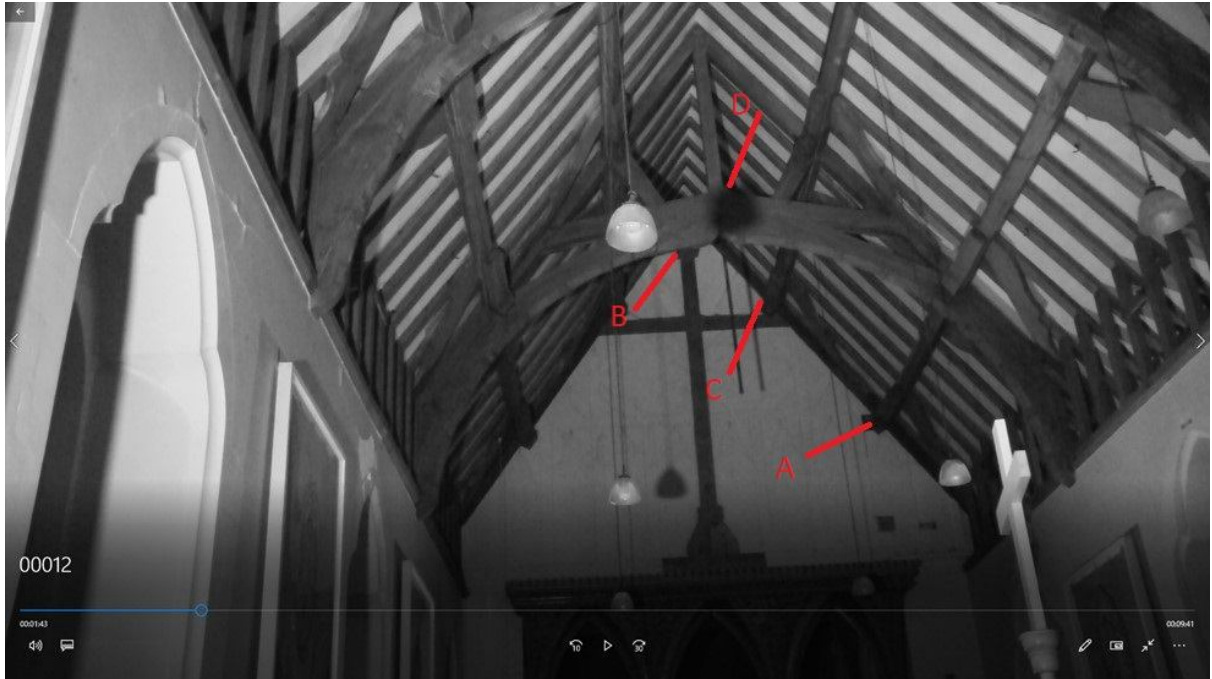
Brown long-eared bat internal roosting points, east end of nave. Number of bats emerging from each point: A-10, B-1, C-4, D-1.

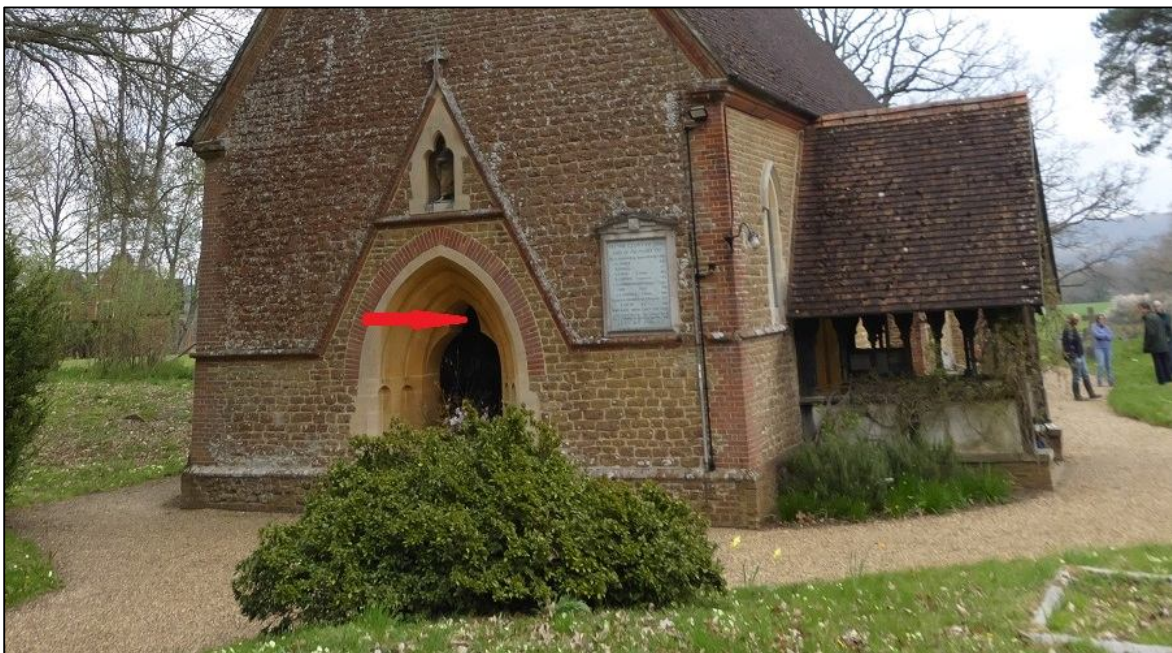
West door where bats emerged from church interior during all surveys (location arrowed).

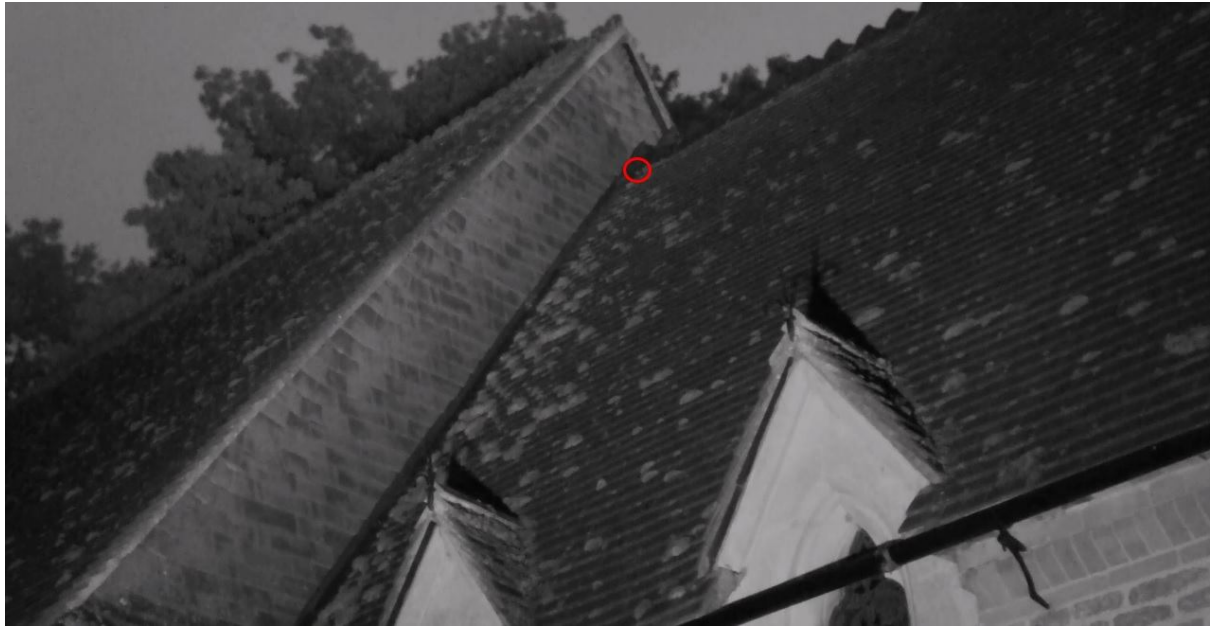
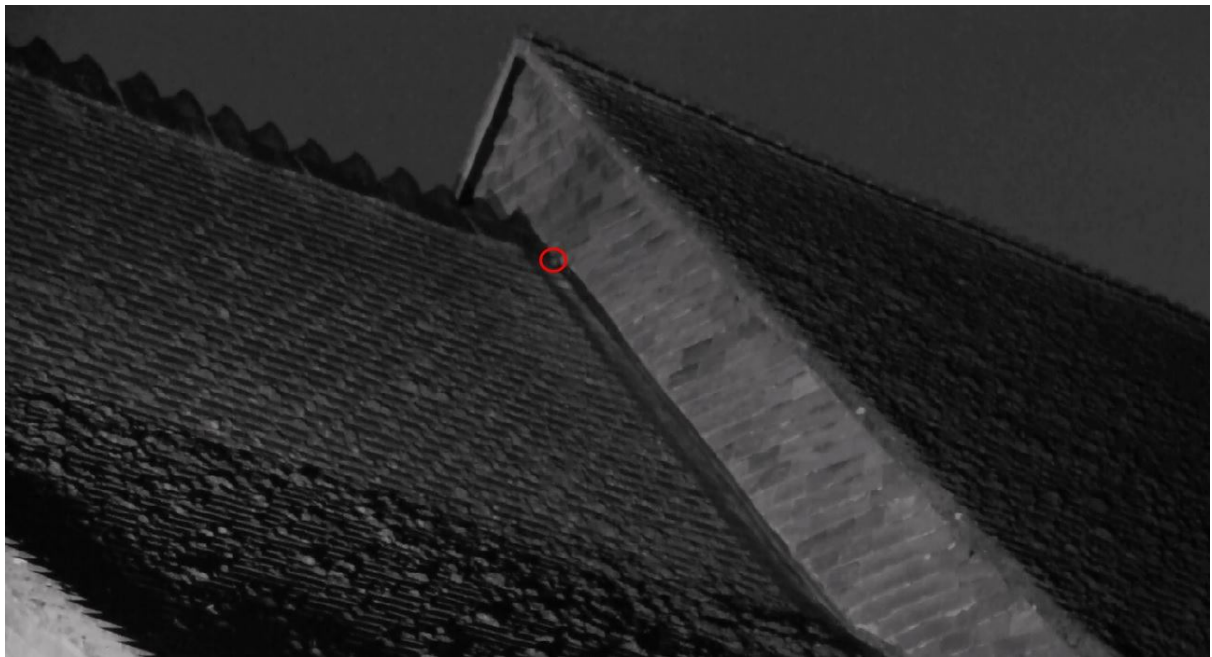
Emergence points (circled) of brown long-eared bats from the chancel roof.

In addition, 10 brown long-eareds emerged from the base of the roof ridge above the chancel between 21.55 and 22.22, nine from the south side and one from the north.

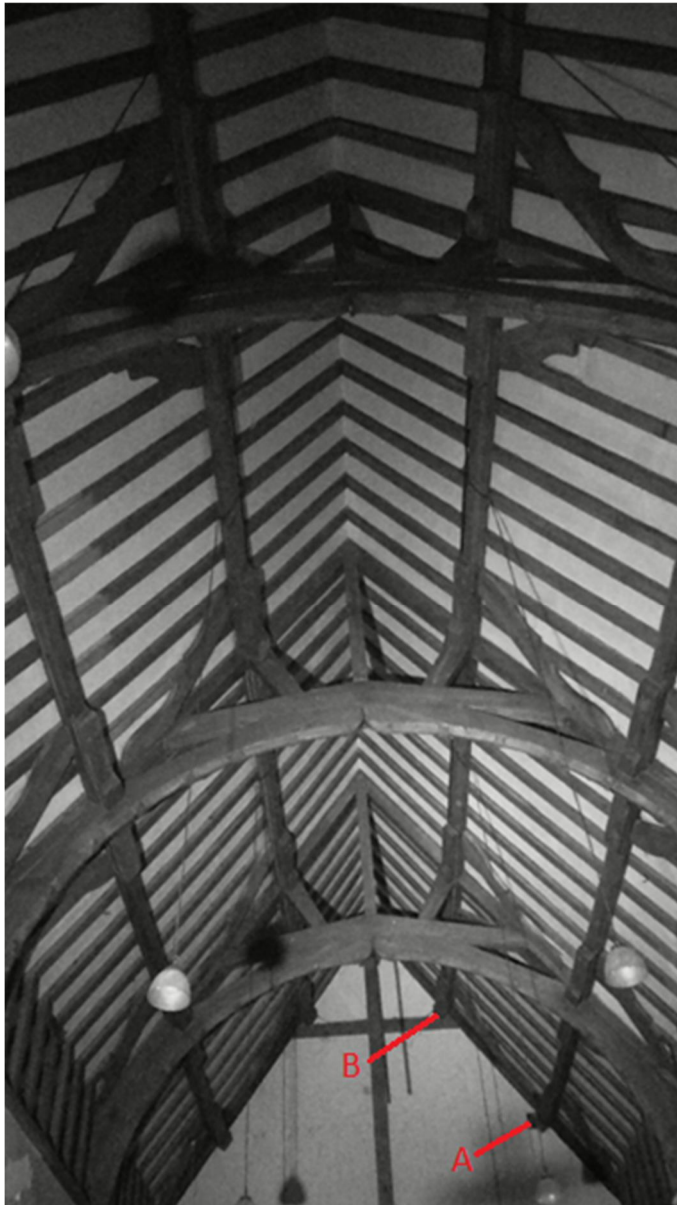
Brown long-eared bat internal roosting points, east end of nave. Number of bats emerging from each point: A-19, B-9.

Around 28 brown long-eareds were recorded emerging into the church, this time from just two points in the east wall of the nave, starting at 19.37. However, bats often re-entered the same gaps, and once or twice appeared to enter gaps from the other side of the wall (i.e. from the chancel), which probably resulted in some double-counting. Only 24 bats were counted out of the west doors of the nave, between 19.56 and 20.28.

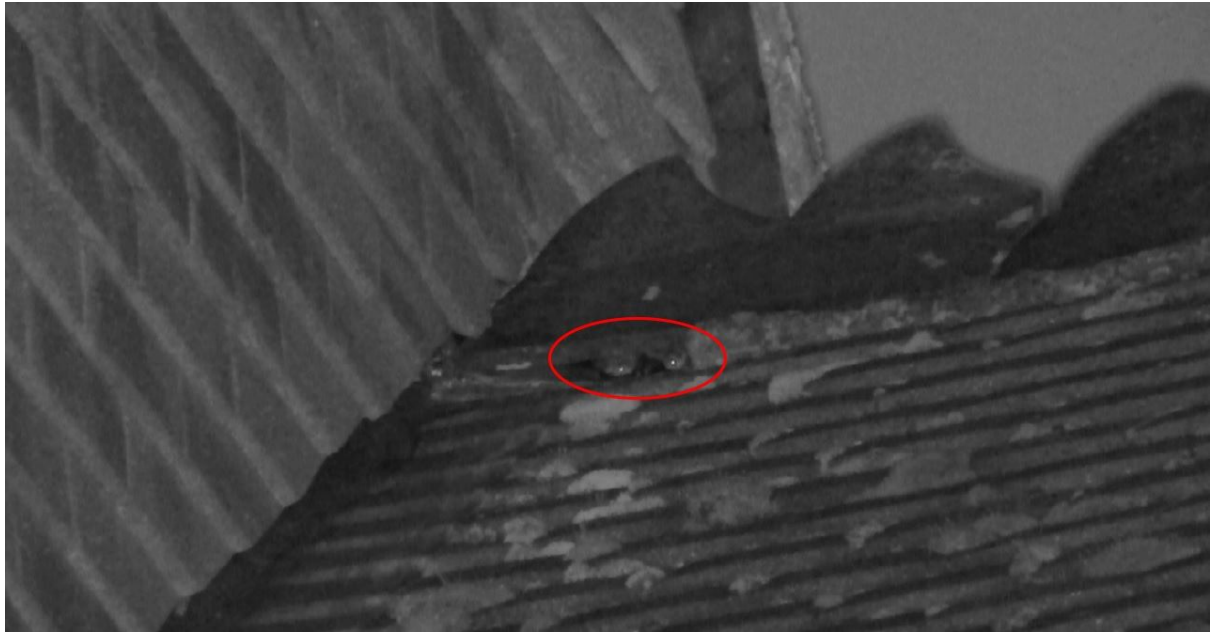
Two brown long-eared bats (circled) preparing to emerge from the south side of the chancel roof. Twelve bats emerged from this side and two from the north side (same location as for the June survey).

A total of 14 brown long-eareds also emerged from the base of the roof ridge above the chancel, 12 from the south side and two from the north side, between 19.58 and 20.24. Two common pipistrelles also emerged, one from the west end of the nave roof, near the tower, at 19.40, and one from under hanging tiles on the east end of the nave (north side) at 19.41. A soprano pipistrelle entered a gap in the hanging tiles (south side) at 20.51.

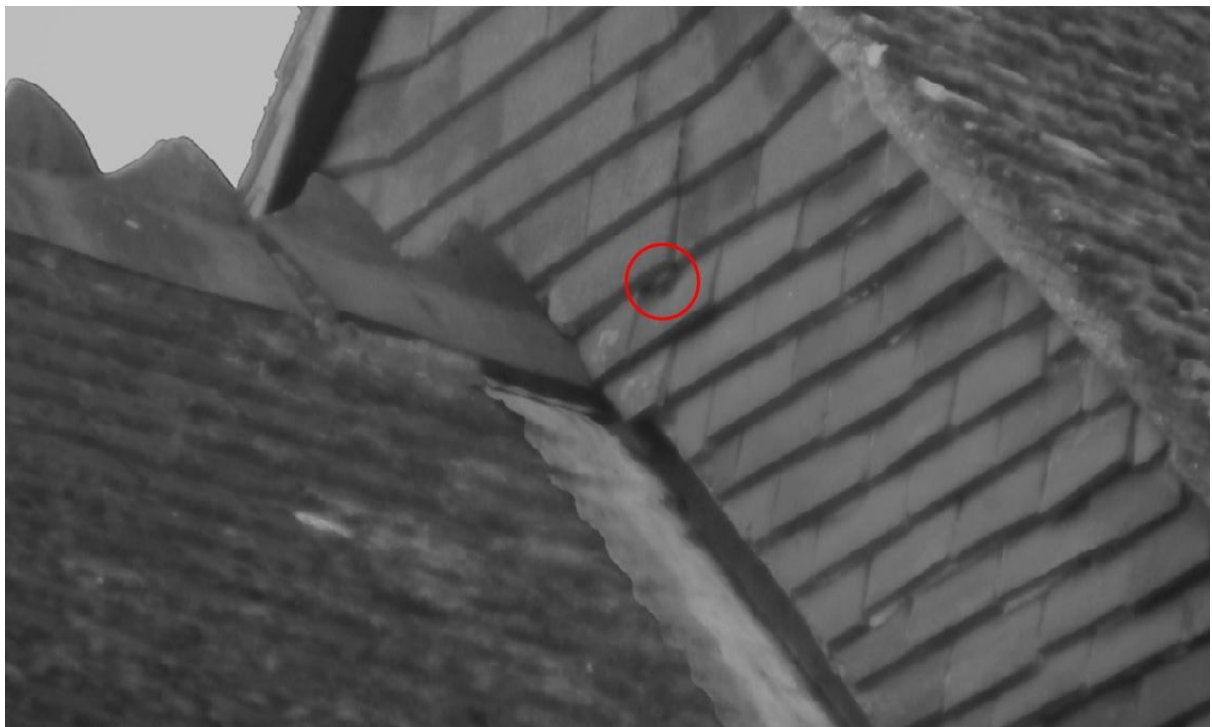
Common pipistrelle (circled) emerging from hanging tiles.

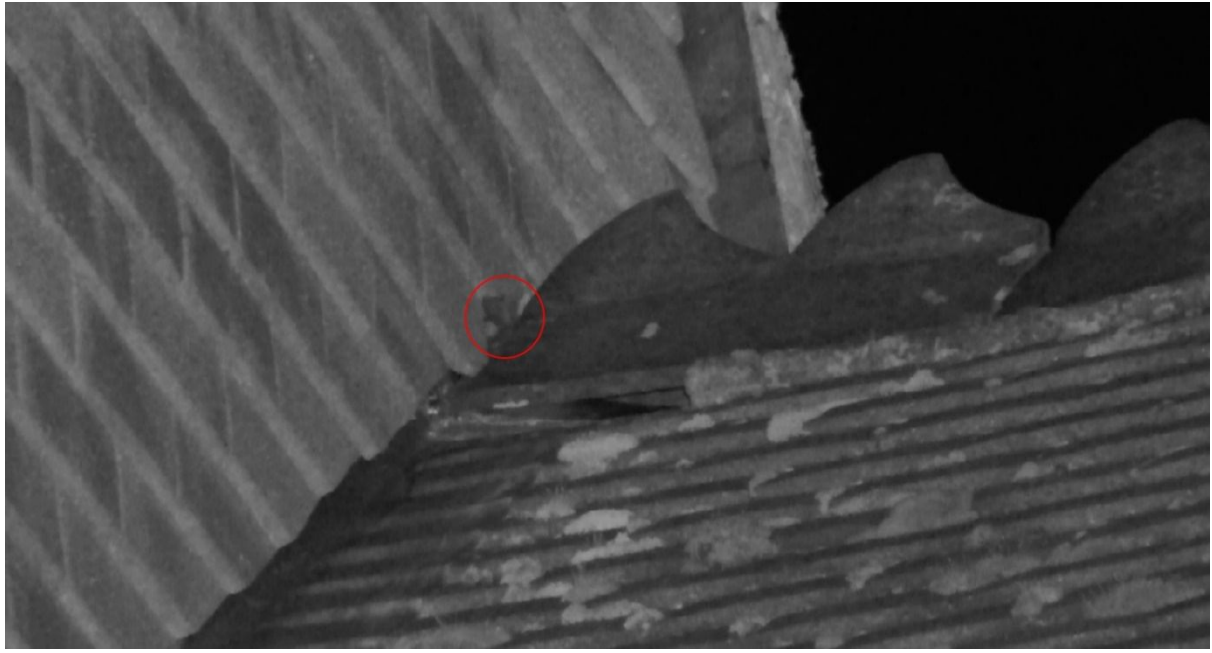
Soprano pipistrelle (circled) entering hanging tiles.

A few single common and soprano pipistrelles were also recorded using exterior features on the church. These were likely transitional roosts, although the fact that a soprano pipistrelle entered the hanging tiles during the autumn survey, which was during the peak mating season for UK bats, early in the evening may mean that this was a mating roost, with the male hoping to attract females to it using social calls.
