Bats in Churches Project: St Peter's Church, Guestwick

Bat Survey & Management Plan Report

February 2020 (revised v1.1 June 2020)

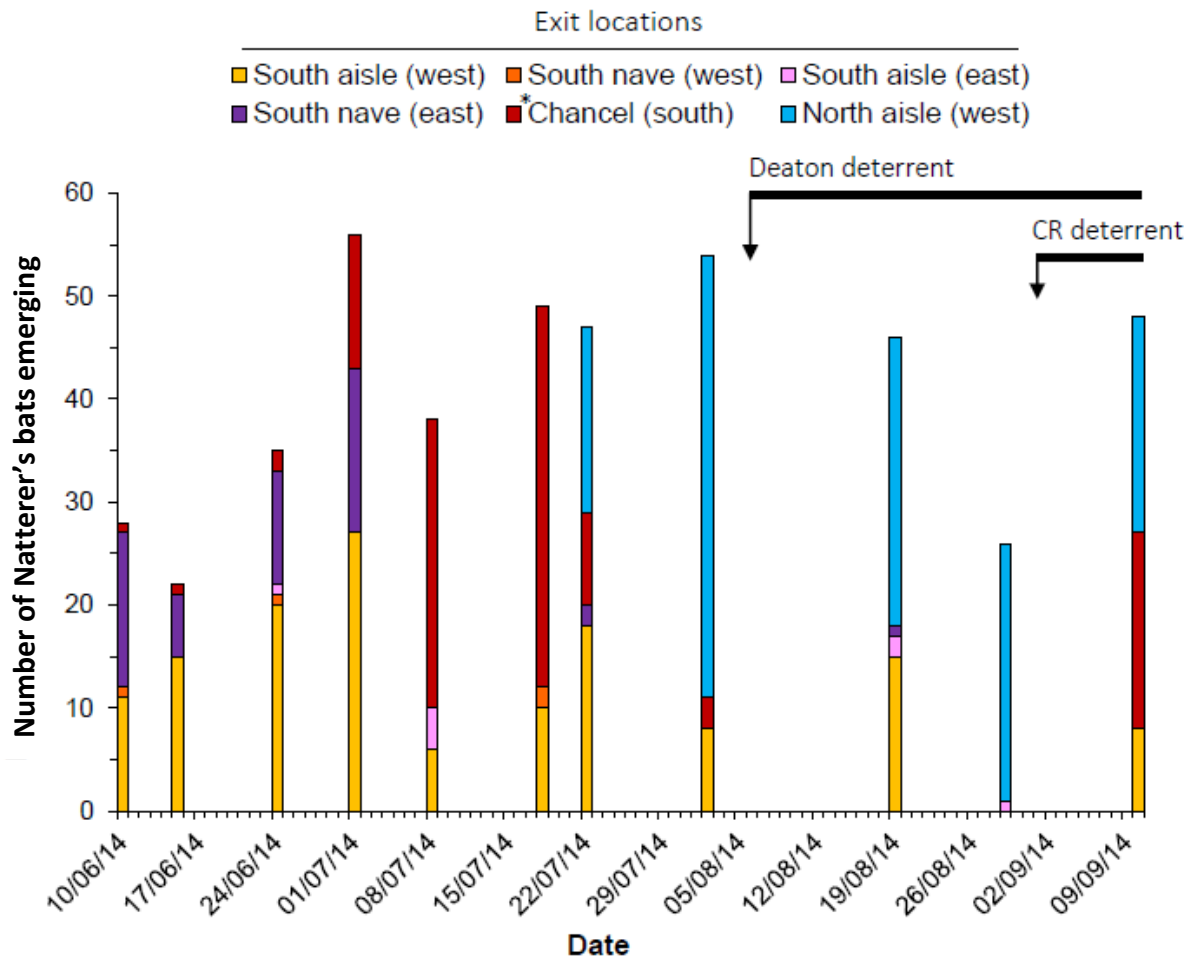
Figure 2. 2014 counts showing numbers of Natterer's bats emerging from different exit points at Guestwick Church, along with application of acoustic deterrents: pairs of Deaton speakers and a set of three Concept Research (CR) speakers. Note bats emerging from 'Chancel (south)', marked with an asterisk, were considered to be utilising a roost separate from the church interior. Taken from Packman *et al.* 2015.

- Eleven counts of bats emerging from the church were made between 10th June and 9th September 2014, with numbers ranging from 22 to 57 (mean 41) Natterer's bats, see Figure 2.

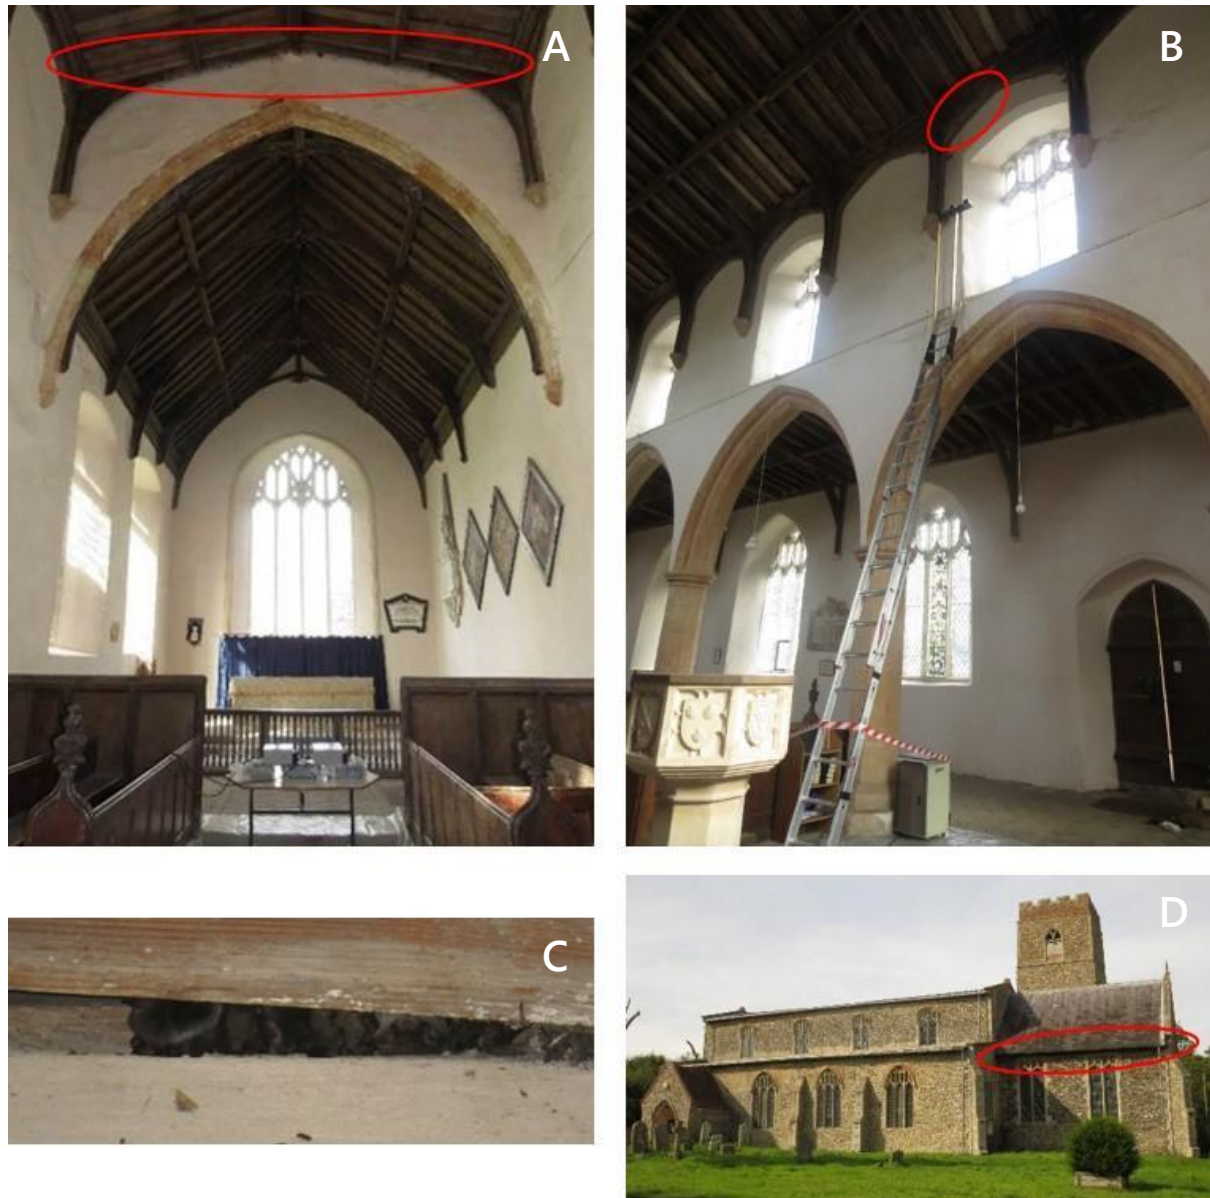
Figure 4. Acoustic deterrent use (37-day trial) at Guestwick Church in 2014. A pair of Deaton speakers under the original chancel arch roost (A), three CR speakers attached to a ladder to temporarily raise them to 1.5m below the next roost location, at the west end (south side) of the nave (B), Natterer's bats inside the roost at the west end of the nave (C) and the final roost location in the outer void of the south chancel eaves (D). Roost locations circled in red. Taken from Packman *et al.* 2015.

- A longer-term (37-day) trial of acoustic deterrent use at the church successfully moved the Natterer's bats from the chancel arch and south nave (west end) interior roosts to an exterior roost in the south chancel eaves void, see Figures 3 & 4 (without impacting overall numbers roosting at the church) – bringing about an effective reduction of impact (minimal dropping/urine deposition inside the church during the period of the trial).

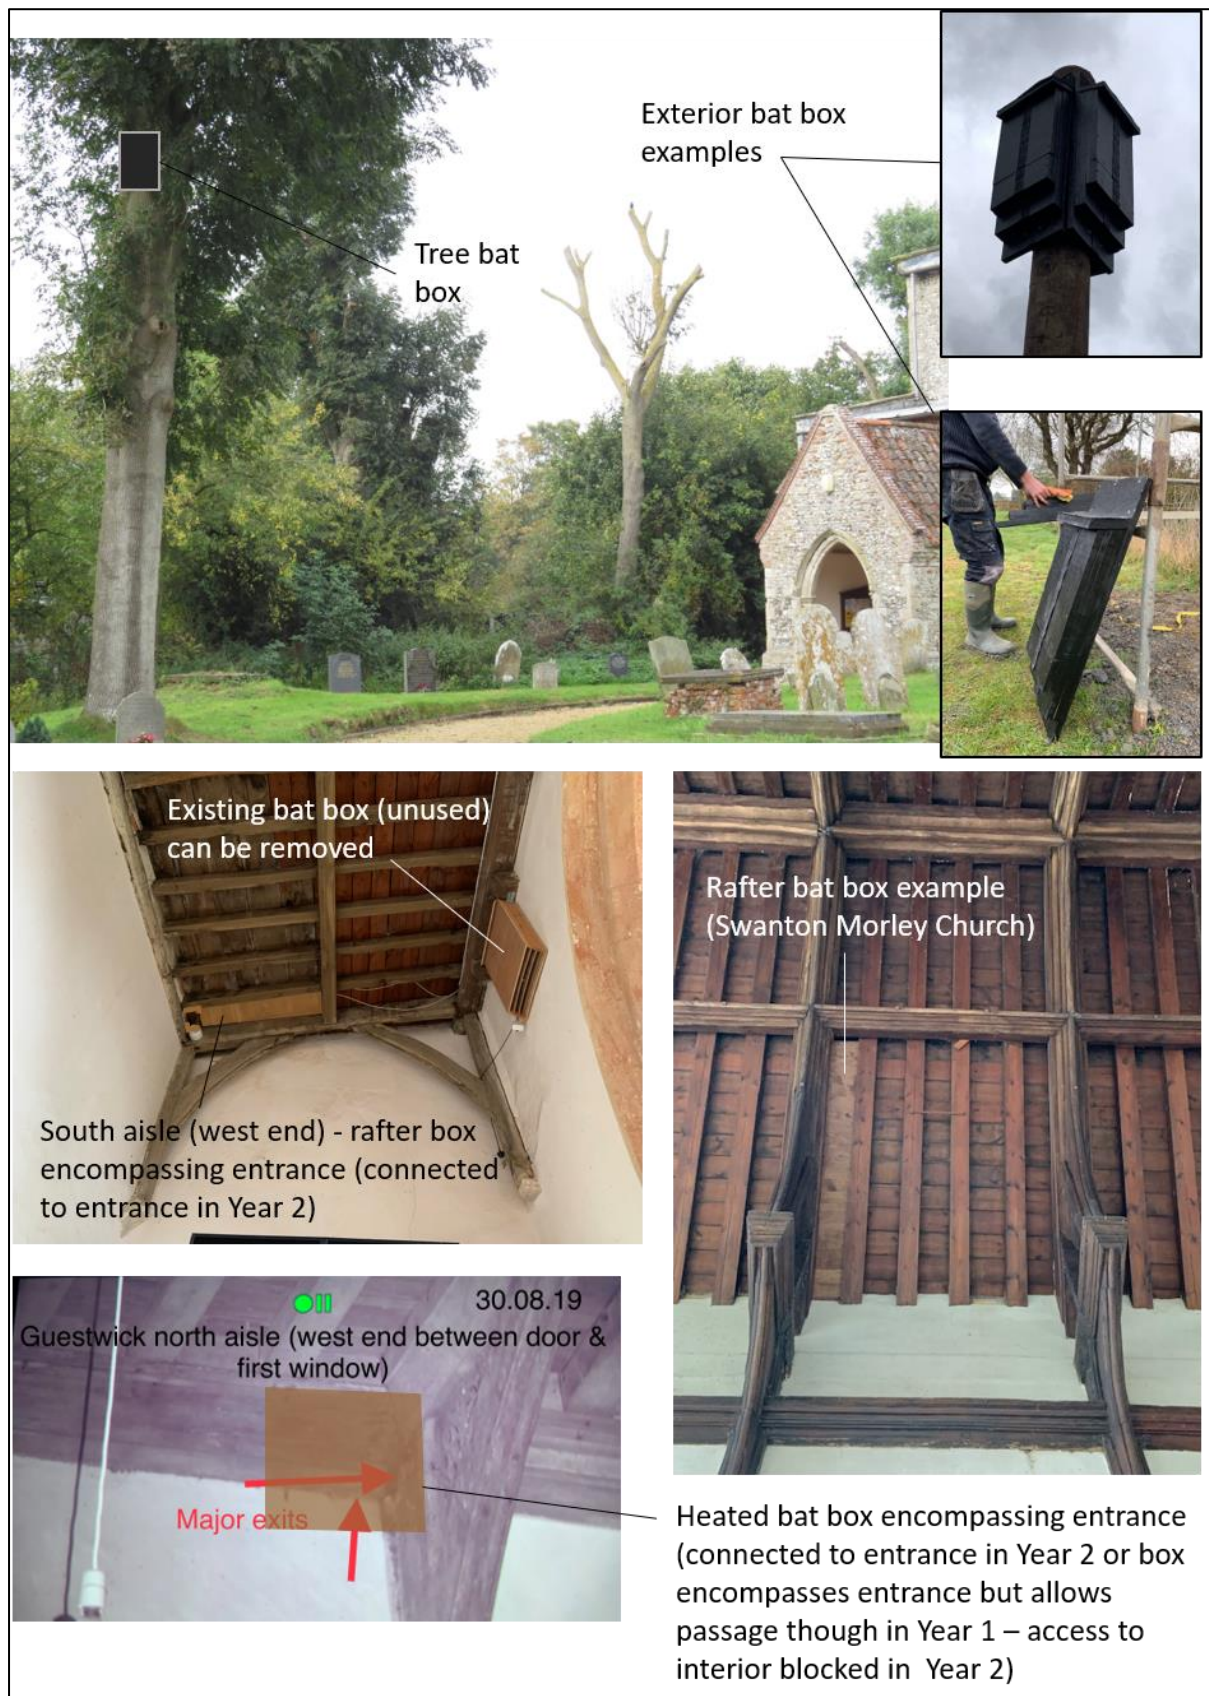
Figure 10. Illustrations of proposed artificial roosts.

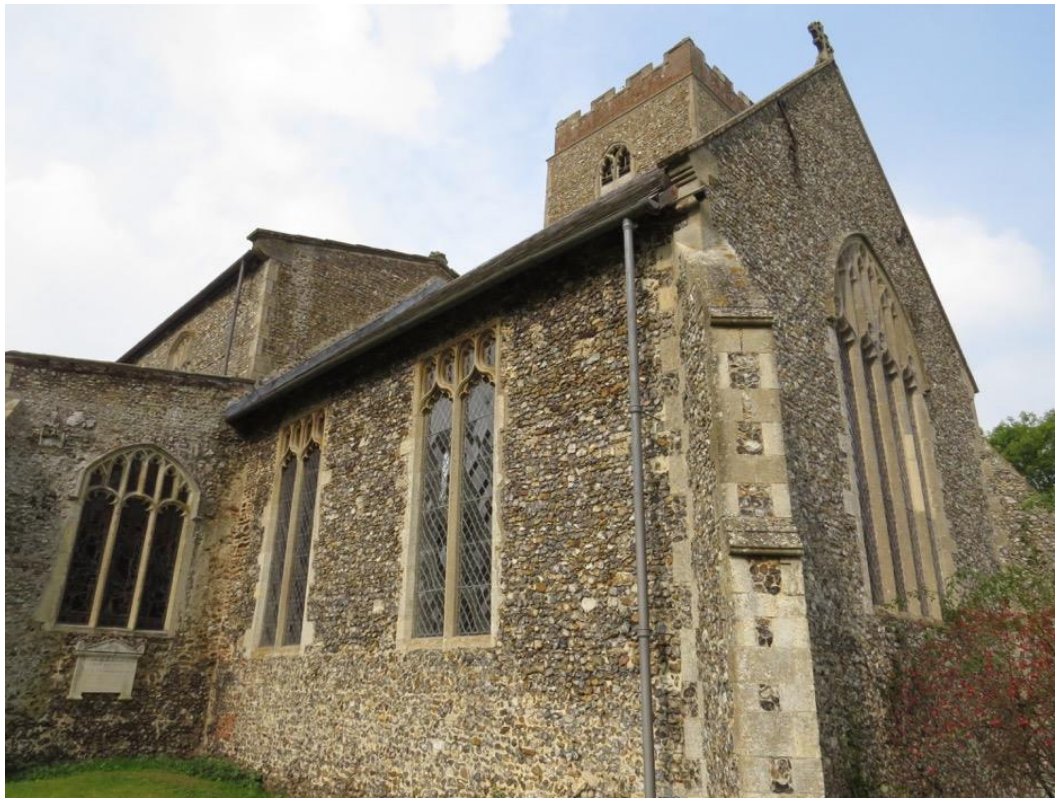
Two potential 'exterior' roosts (i.e. in the outer structure of the building without bats passing into the church interior) have been identified. There is a Natterer's bat roost in the south chancel eaves void: only one bat was observed using this during the four surveys in 2019, however this roost was regularly used during the 2014 surveys and the colony was successfully moved here during a 37-day acoustic deterrent trial in 2014 (Packman *et al.* 2015, see 2.2.3). The second probable exterior roost is at the south nave eaves (west end), used by common pipistrelles.

Photo 3. Chancel southern elevation ('exterior' roost located in eaves void).

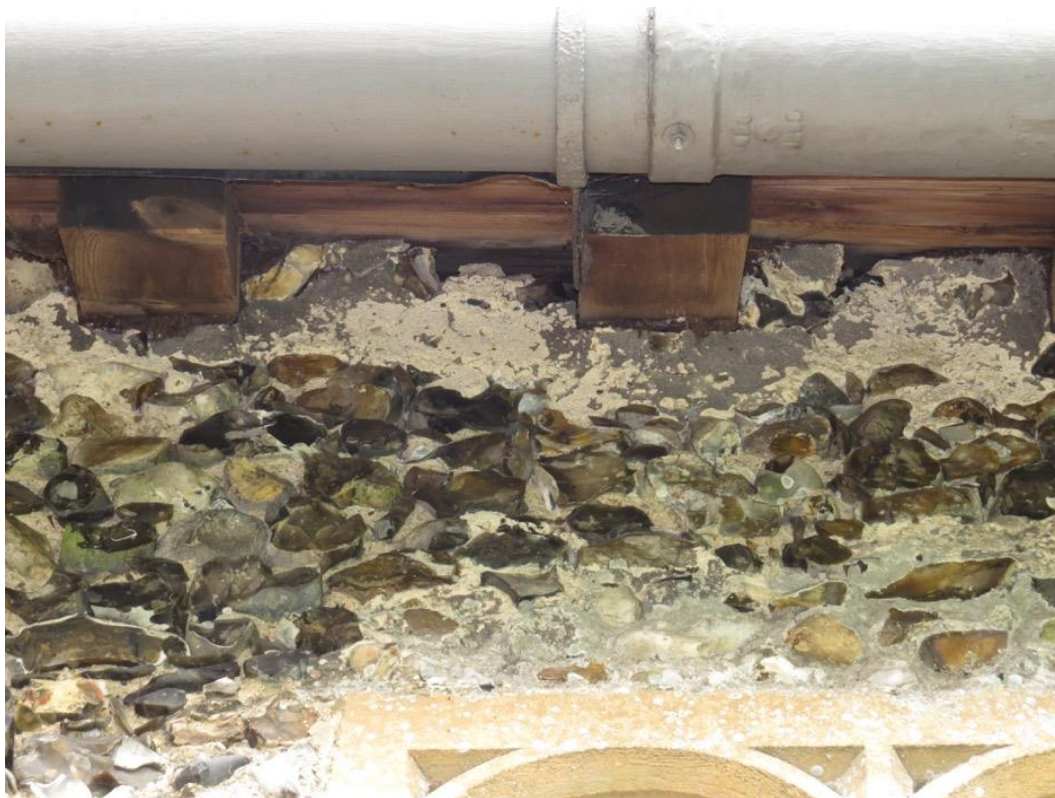
There is evidence of bat access at eaves level in the area above the north aisle door (western end), in the south-west corner of the south aisle and (to the exterior roost only) at the south chancel eaves. The building appears to be highly 'bat-porous' with potential access along the lengths of the eaves of both aisles and both sides of the nave and chancel.

Photo 4. Typical eaves-level bat access point via missing flints/mortar around protruding rafters.

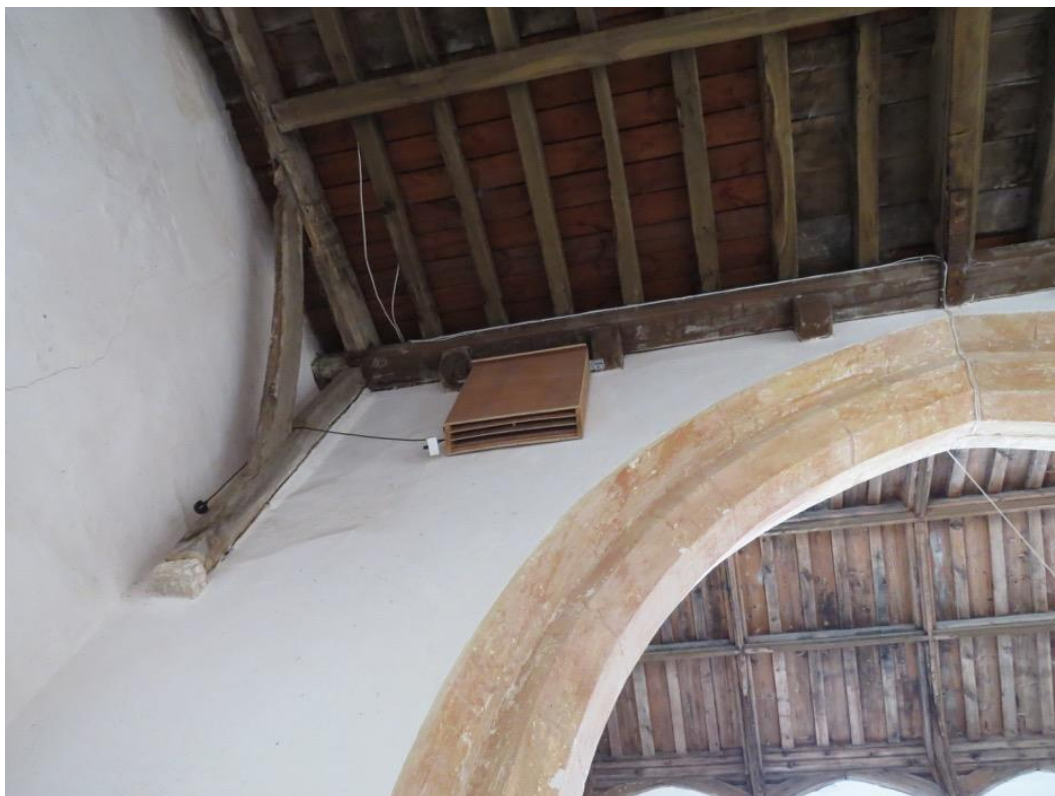
Photo 8. Existing bat box in south aisle (west end) – church have requested removal.

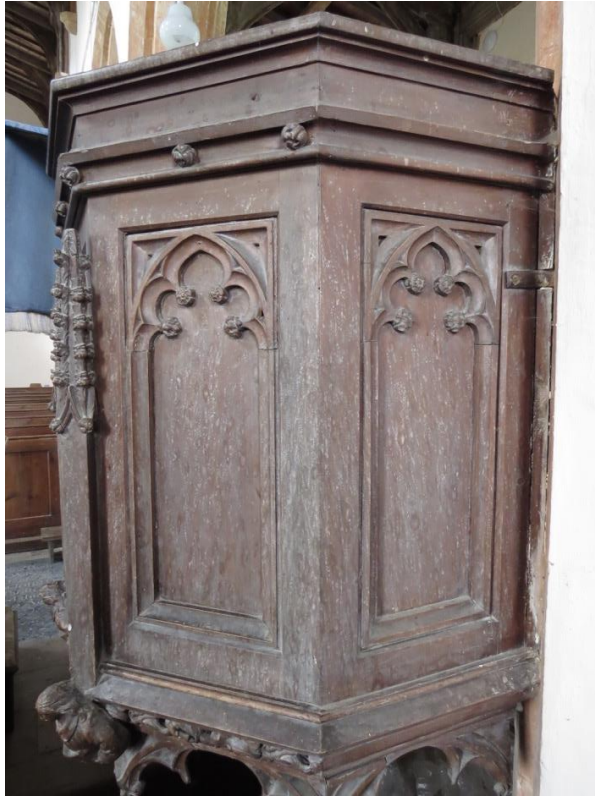
Photo 9. Bat urine staining to pulpit.

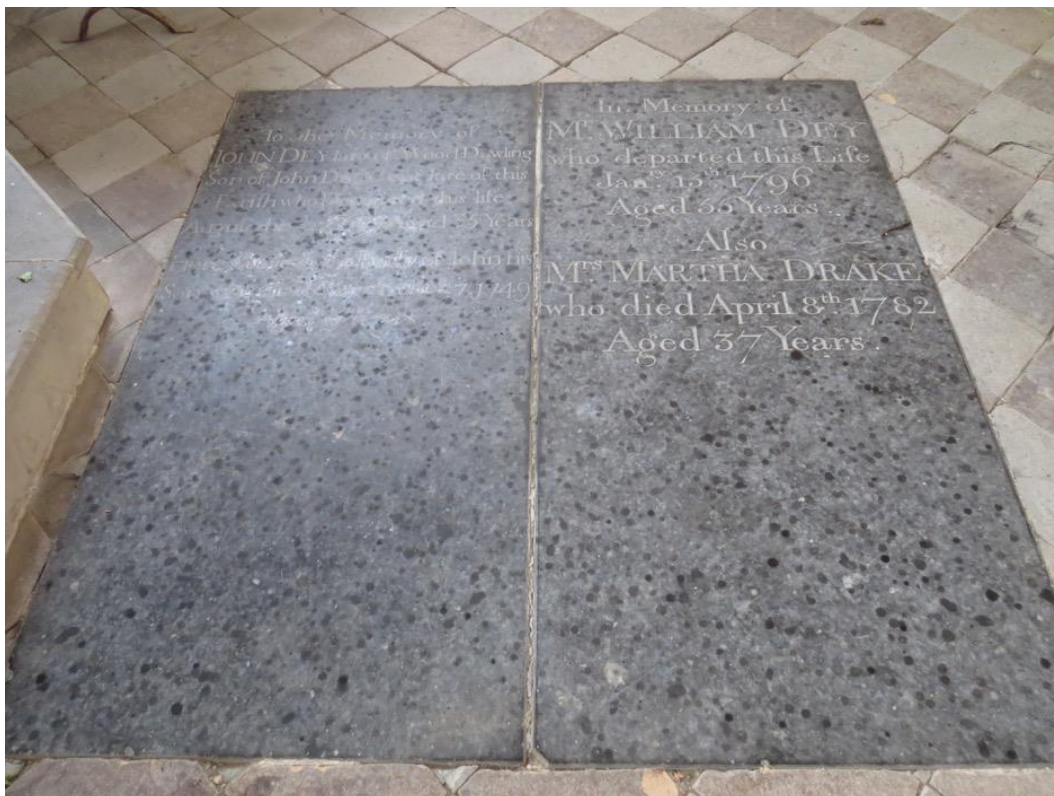
Photo 10. Bat urine staining to memorials.

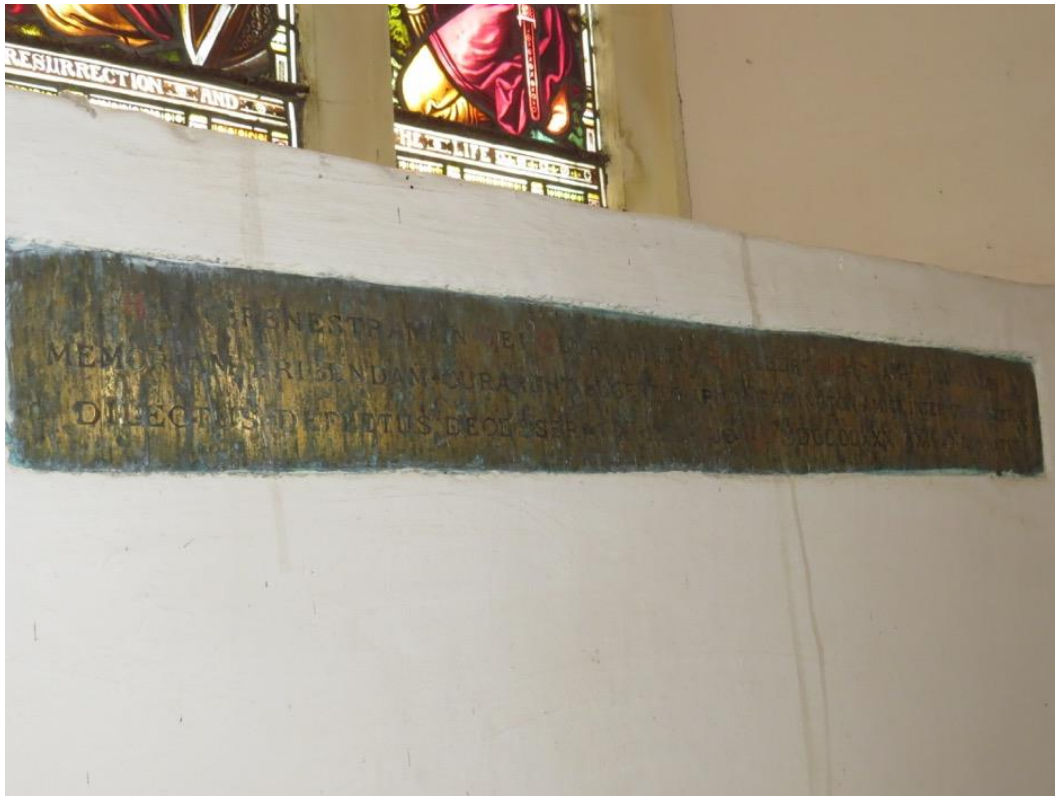
Photo 11. Bat urine staining to brass wall plaque.

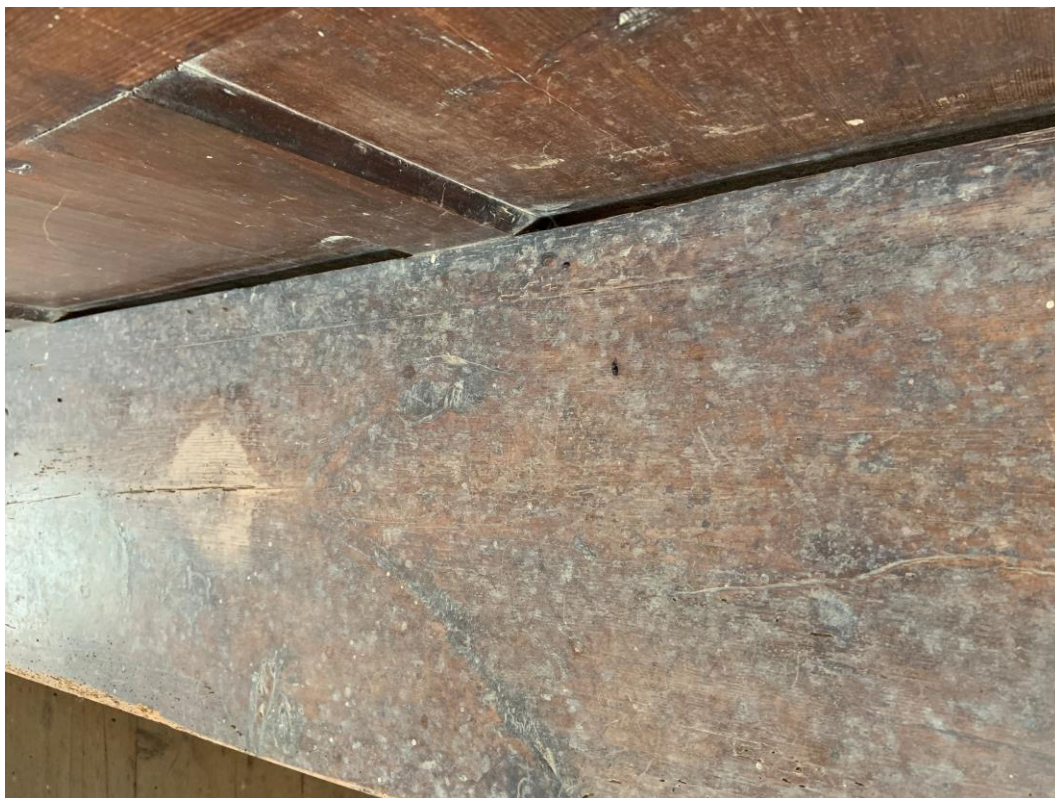
Photo 12. Bat urine staining to wooden pews.

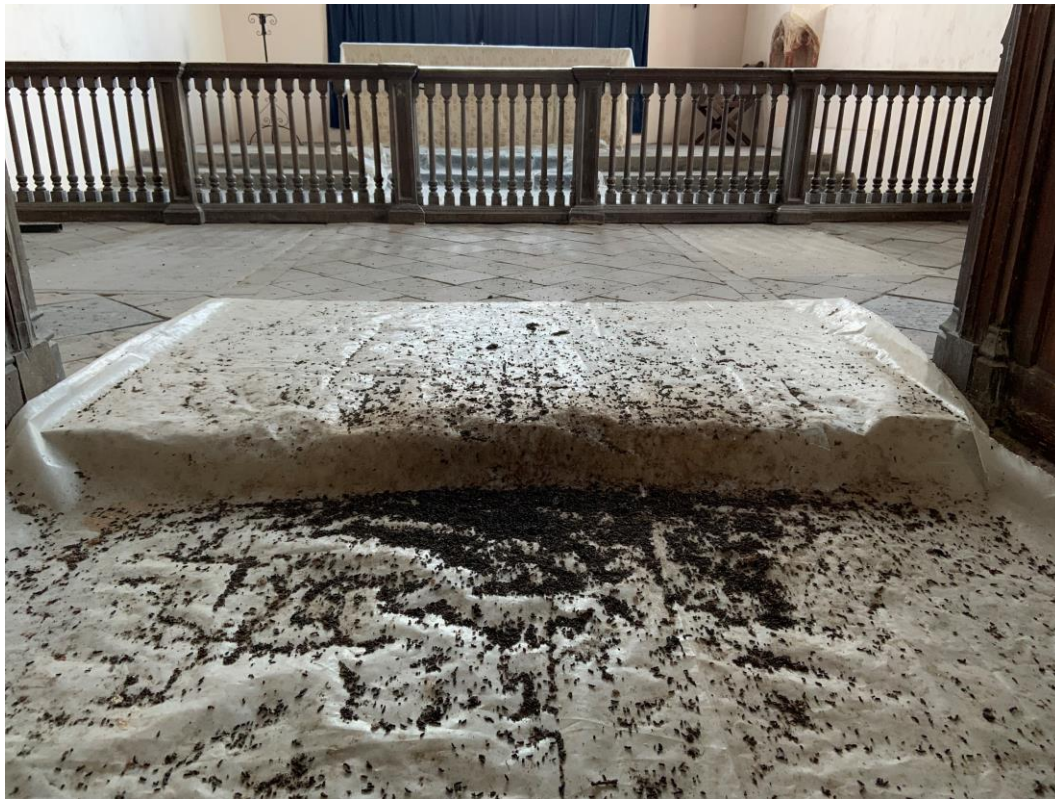
Long-term impacts from bats can be seen throughout the church: staining/bleaching from bat droppings/urine on floors, walls, pews, burials and wall plaques. Droppings are scattered throughout the church, but concentrated beneath the main roosts in the chancel arch (R1) and south side of the nave (western end, approximately in line with the porch, R2), see Figure 6. There are also signs of more minor roosts at the north side of the nave (eastern end, R3) and east end of the chancel (R5). Previous research (Packman *et al.* 2015) also established the presence of a roost in the eaves void on the south side of the chancel (R4), seemingly with no access to the church interior from this roost location. Droppings on the walls suggest there may be other minor/lesser-used roosts in the north and south aisle. There are also a small number of old bat droppings in the tower. Bat droppings present in the church include both 'Natterer's-type' and 'pipistrelle-type' droppings. There is a large wooden bat box inside the church positioned on the northern wall of the south aisle (western end), but with no signs of use (believed to have been put up by the Zeale *et al.* 2014 research project).

Photo 13. Bat droppings under chancel arch roost.

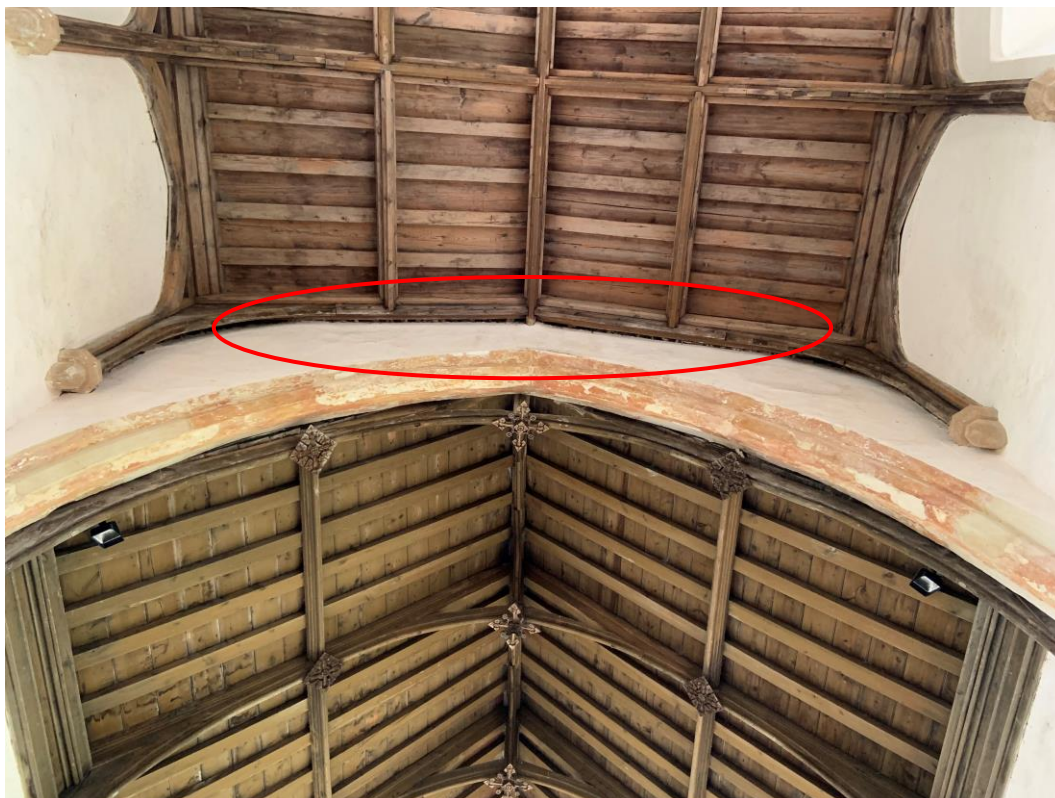
Photo 14. Chancel arch maternity roost (circled in red).

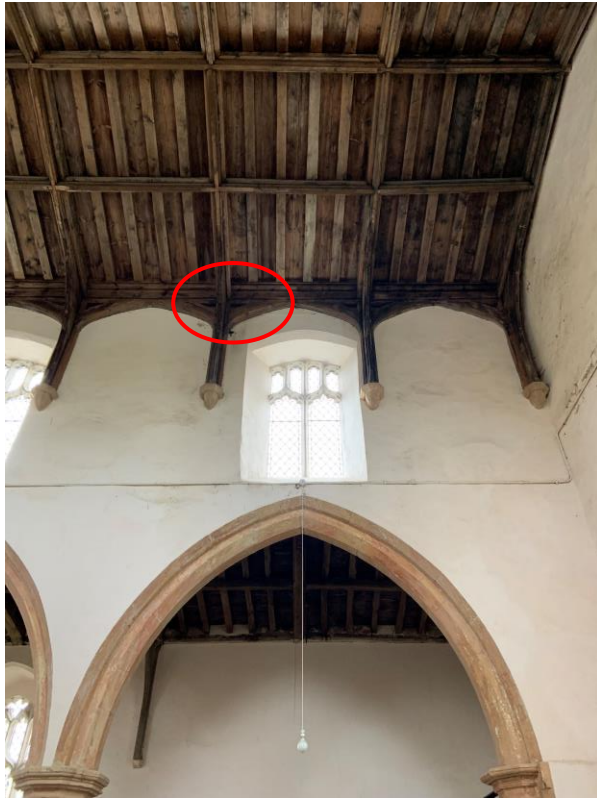
Photo 15. South nave (west end) roost (circled in red).
