BAT MANAGEMENT PLAN (INCLUDING BAT SURVEY RESULTS)

All Saints Church, Hoby

18th October 2021

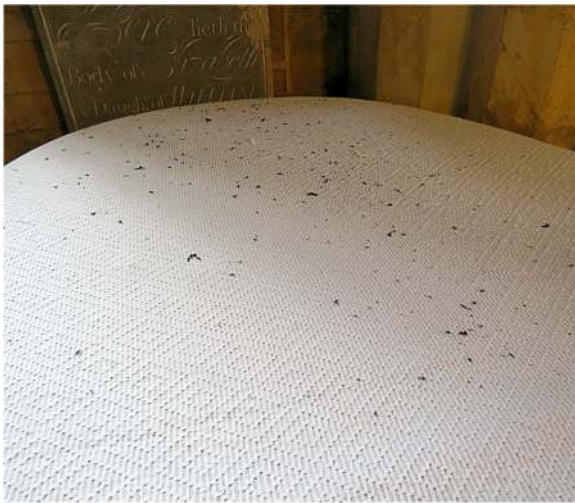
Photograph 2. Daubenton's bat droppings on the piano at the south-east corner of the north aisle (see Figure 2 (a))

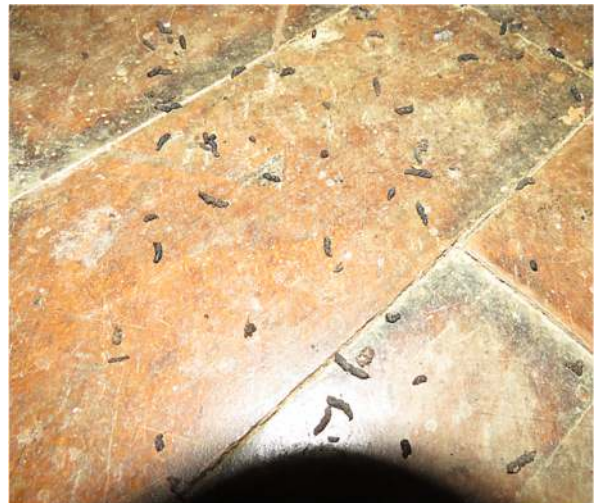
Photograph 3. Daubenton's bat droppings on the floor at the south-east corner of the north aisle (see Figure 2 (a))

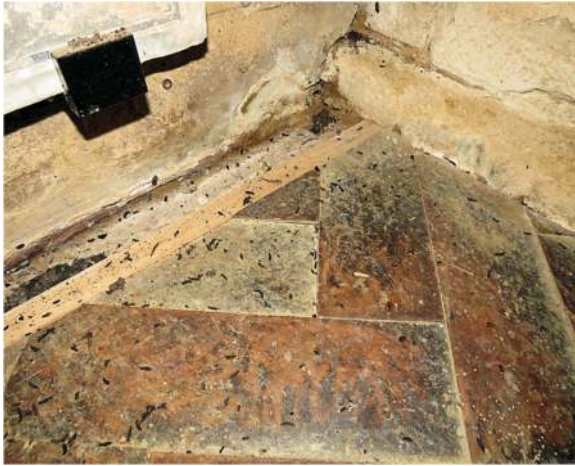
Photograph 4. Daubenton's bat droppings at the north-east corner of the north aisle (see Figure 2 (b))

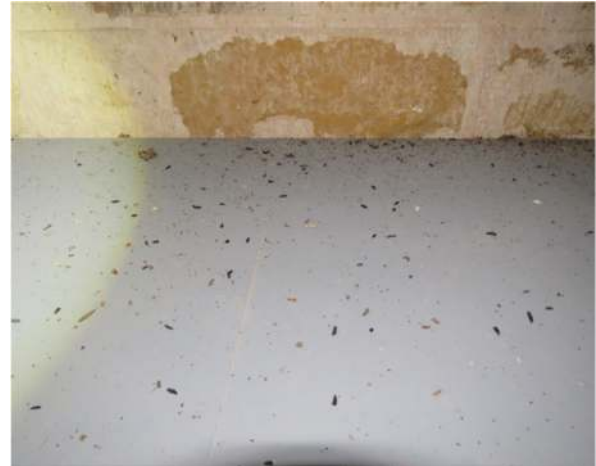
Photograph 5. Daubenton's bat droppings on top of the toilet at the north-west corner of the north aisle (see Figure 2 (c))

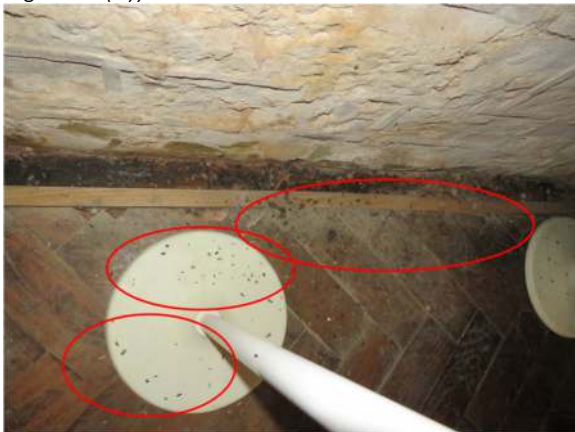
Photograph 6. Daubenton's bat droppings under the north wall in the north aisle (see Figure 2 (d))

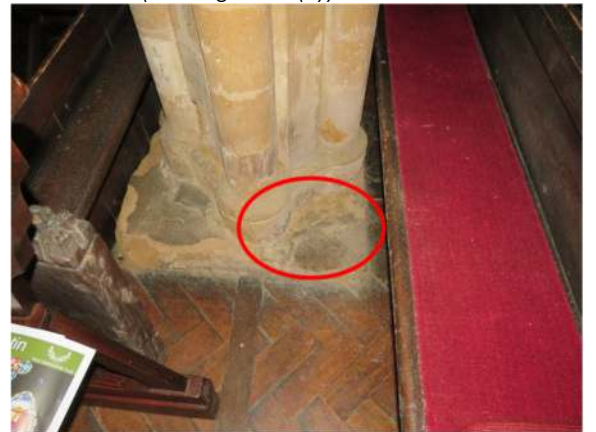
Photograph 7. Daubenton's bat droppings at the base of the first pillar from the eastern end of the north aisle (see Figure 2 (e))

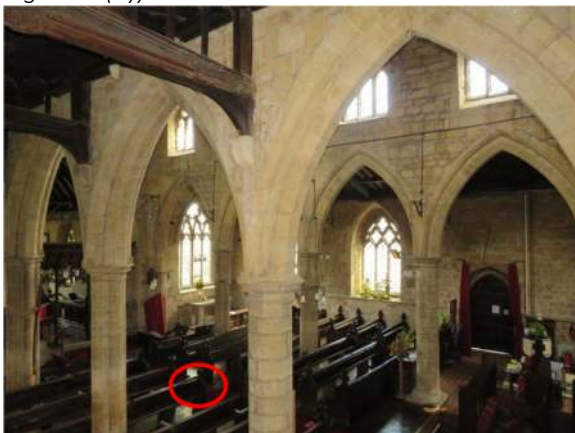
Photograph 8. Location of Daubenton's bat droppings in the nave (see Figure 2 (f))

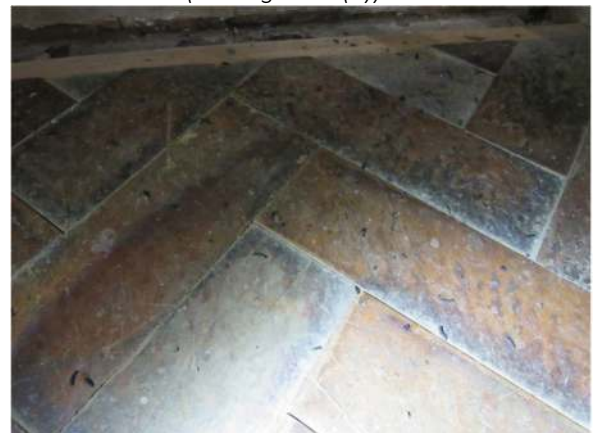
- Approximately 50 small-sized bat droppings on the floor and table at the south-east corner of the south aisle (Figure 2 (f); Photograph 9).

Photograph 9. Pipistrelle bat droppings at the south-east corner of the south aisle (see Figure 2 (g))

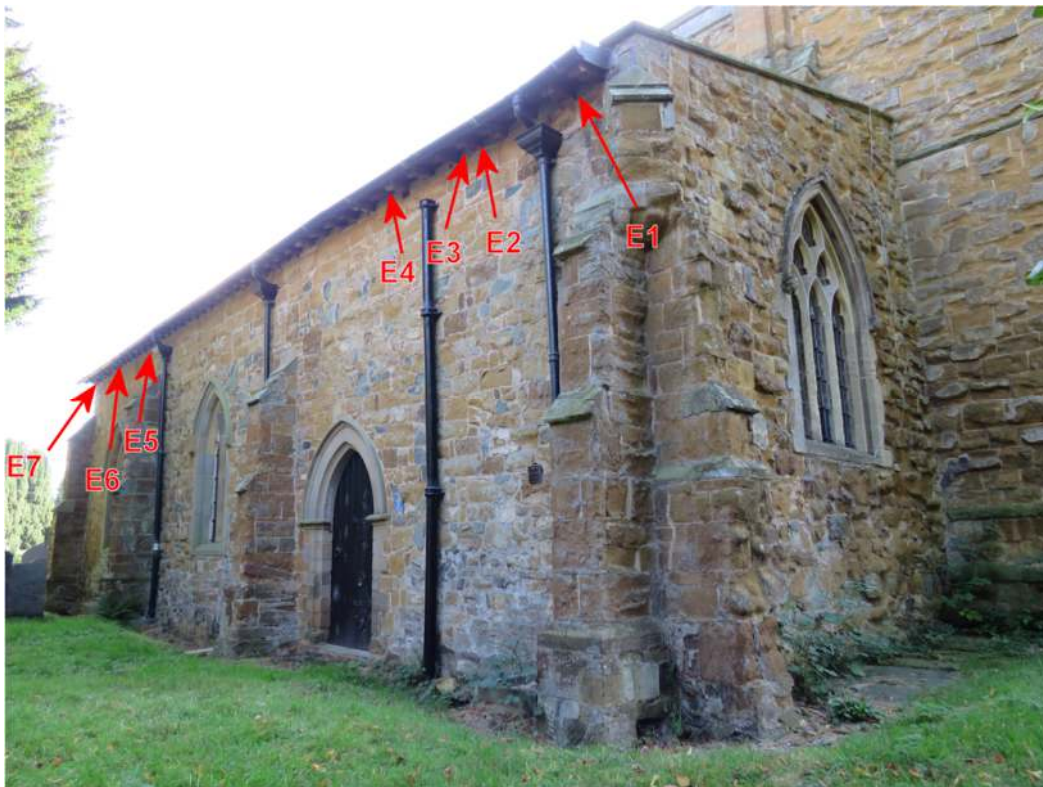
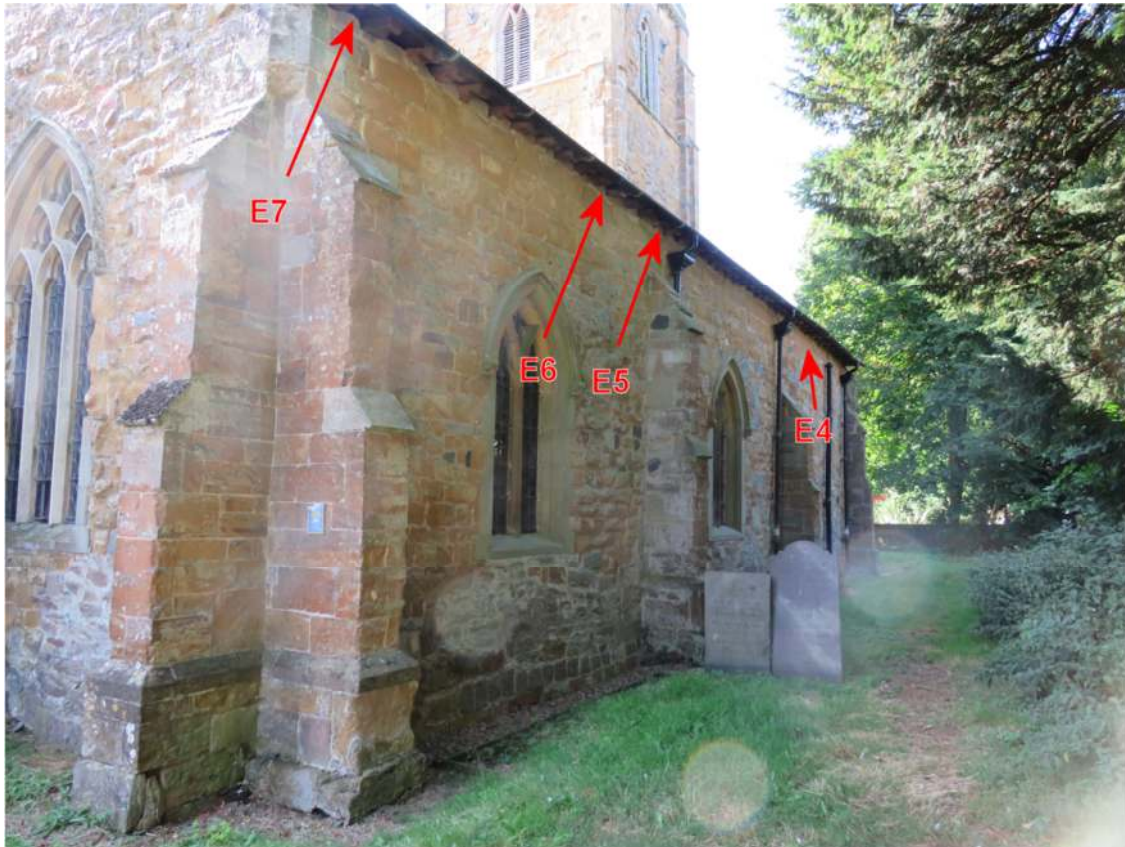
Common pipistrelles bats began flying within the church interior at 21:16 with two bats being observed at a single time. Four common pipistrelles subsequently emerged from the church at 21:23, 21:30, 21:37 and 21:40 via three openings at the top of the north wall (see Photographs 10 and 11: E2, E3 and E4).

Photograph 10. Location of bat access points along the north wall of the aisle (view from north-west corner)

Photograph 11. Location of bat access points along the north wall of the aisle (view from north-east corner)

Activity was very high with bats swarming from 03:35 between the north wall and the treeline and then inside the church interior. In total, 58 bats were observed entering the church at the north-west corner of the north aisle (Photographs 10 and 11: E1) between 03:38 and 04:18. During this period 3 bats entered the church above the north wall in the centre of the north aisle (Photographs 10 and 11: E5) and 24 bats at the north-east corner (Photographs 10 and 11: E7).

In total, 37 Daubenton's bats were observed emerging from the church, 30 from the north-west corner of the aisle (Photograph 10 and 11: E1), 3 from the centre (Photograph 10 and 11: E5 and E6) and 5 from the north-east corner (Photograph 10 and 11: E7).

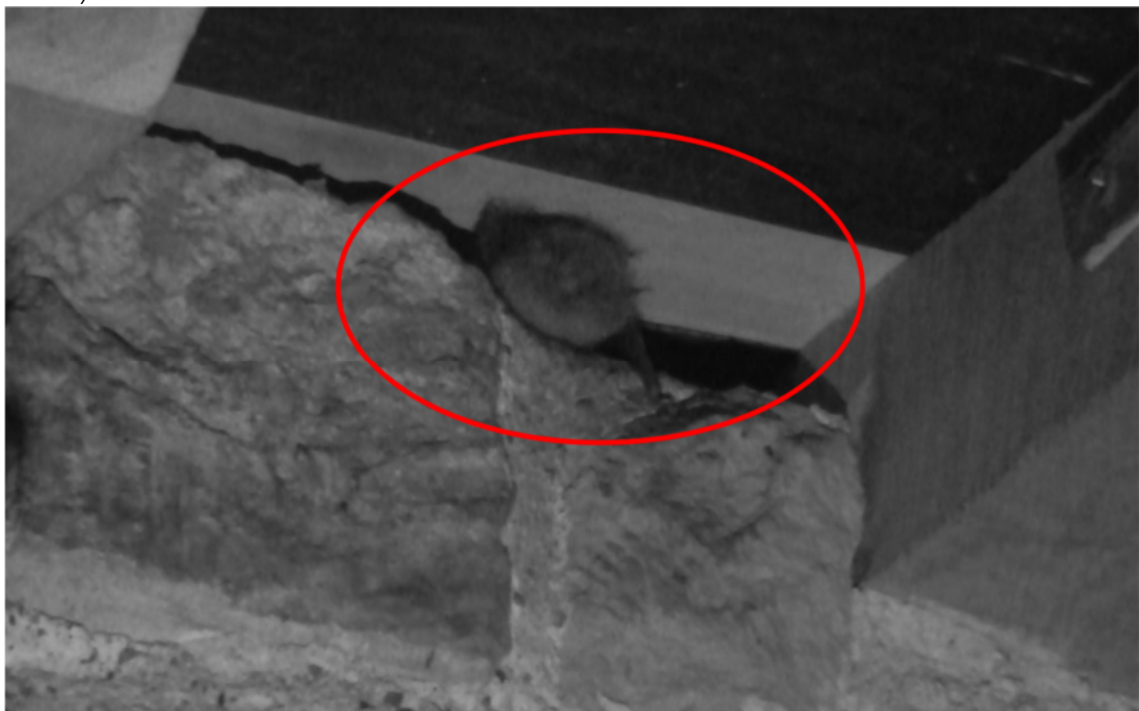
Photograph 12. Daubenton's bat emerging from a gap above the wall at the north-west corner of the north aisle

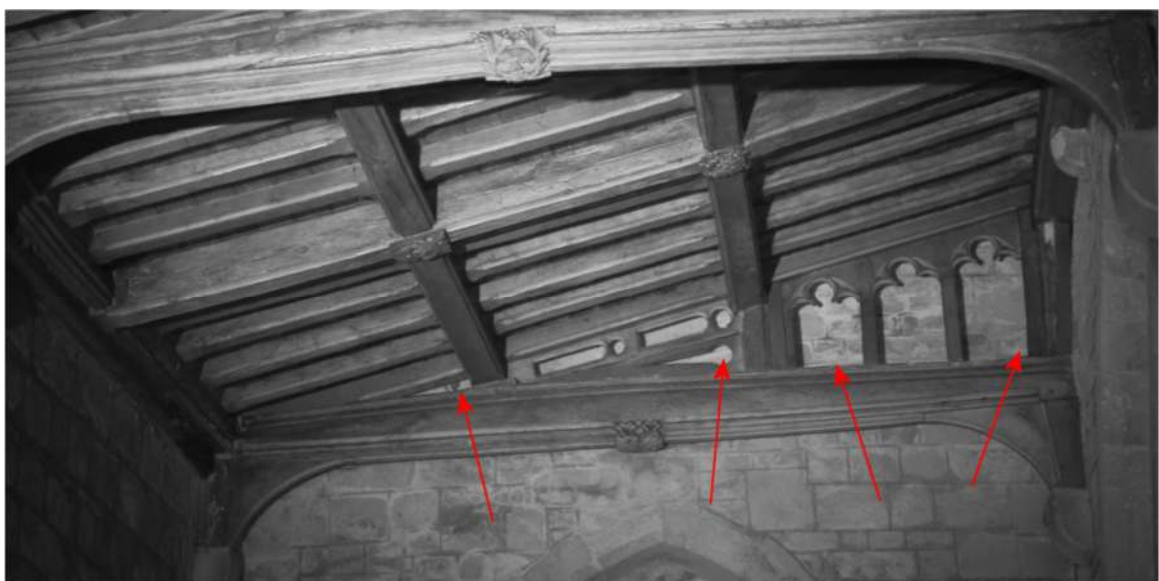
Photograph 13. Location of Daubenton's bat landing/exiting points along the truss at the eastern end of the nave

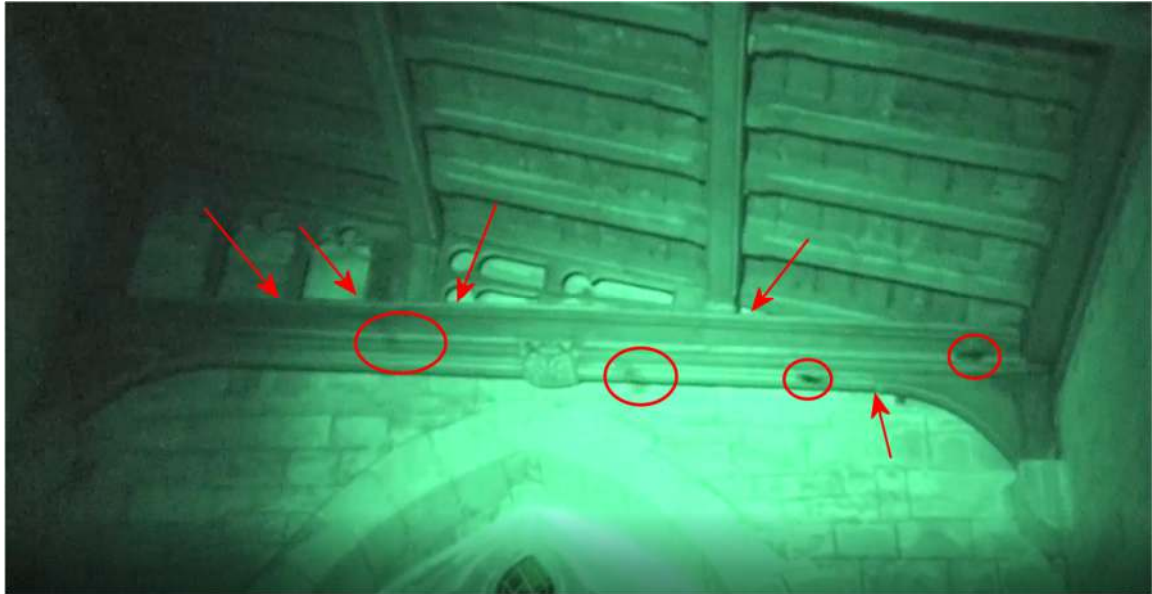
Photograph 14. Location of Daubenton's bat landing/exiting points along the truss at the eastern end of the nave. Bats in flight are circled.

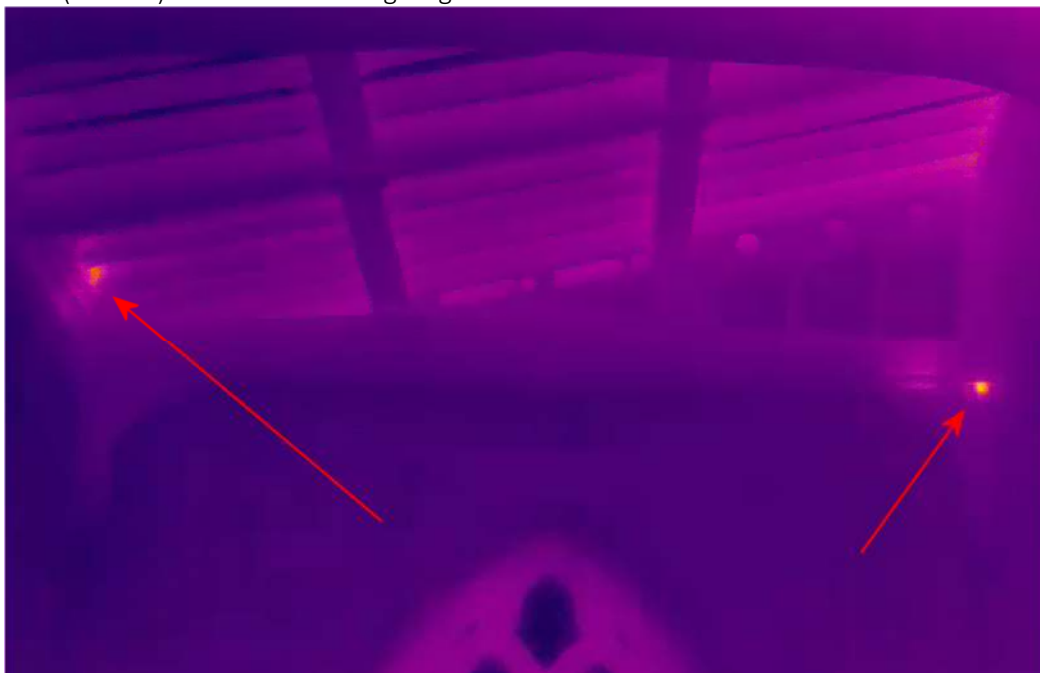
The location of roosts at the south-east and north-east corner of the north-aisle were immediately identified using a thermal scope (Photograph 15).

Photograph 15. Thermal image showing the two Daubenton's bat roosts at the eastern end of the north aisle.

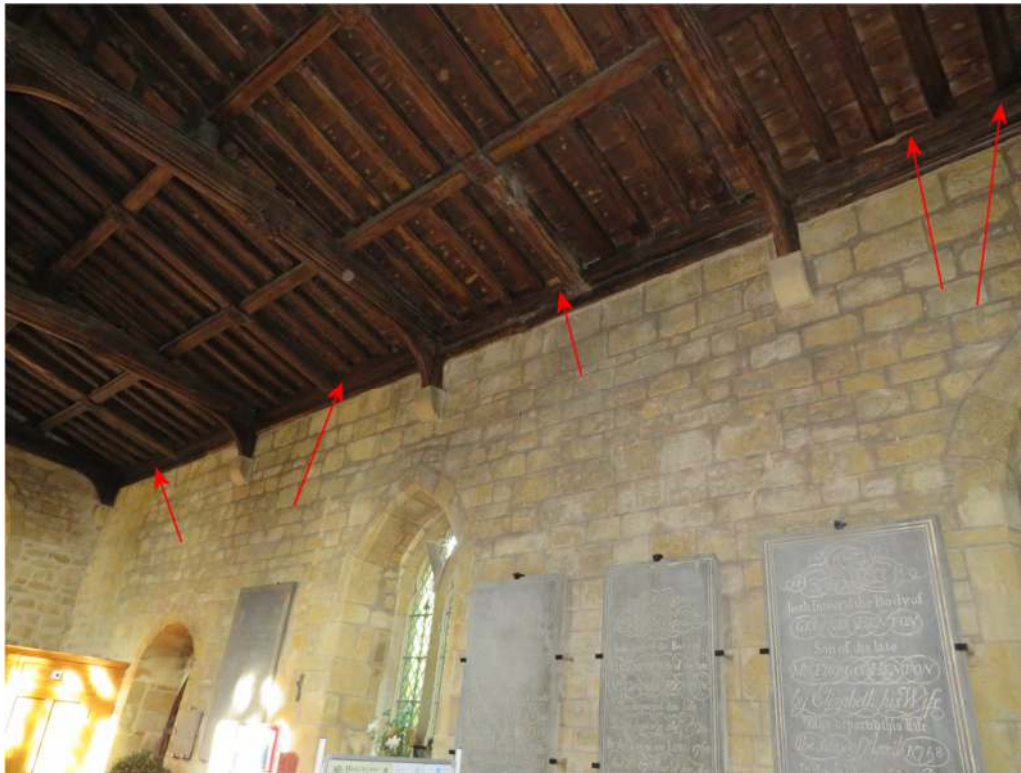
Daubenton's bats flew for some time in the open roof void of the north aisle and occasionally in the nave with the major exit points being the north-east and north-west corners of the north aisle. However, bats landed and exited the building via several other points along the north wall (Photograph 17).

Photograph 17. Location of bat egress points at the top of the north wall of the north aisle (excluding access points at the corners)

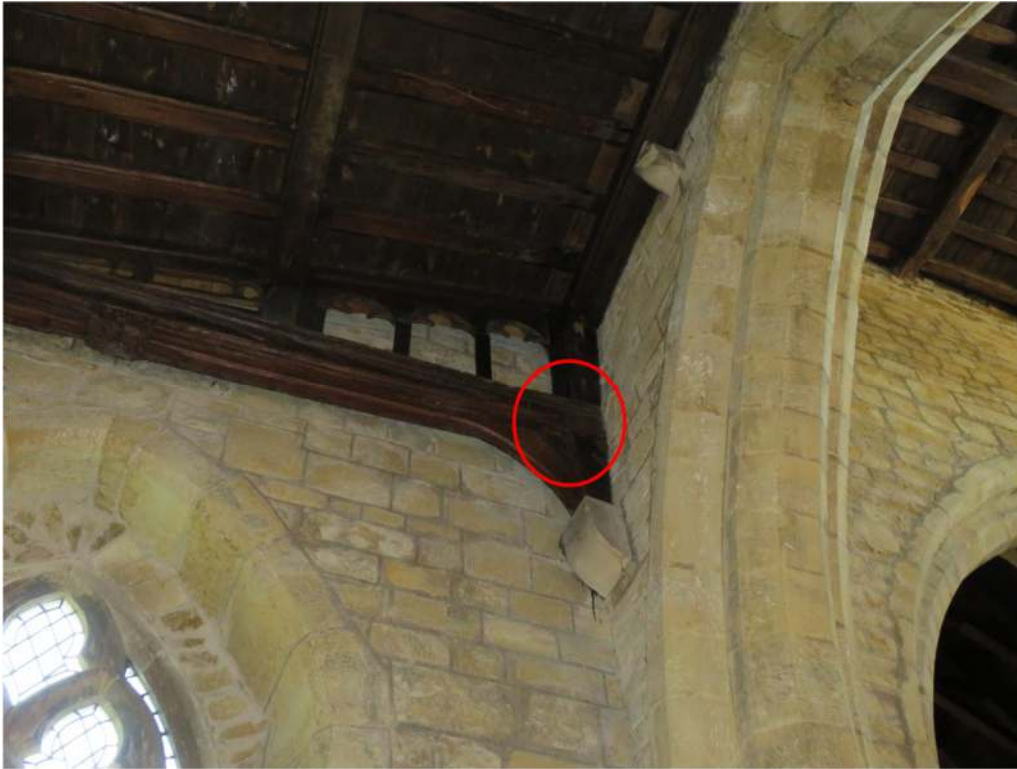
Photograph 18. Main Daubenton's bat roost behind the truss at the south-east corner of the north aisle

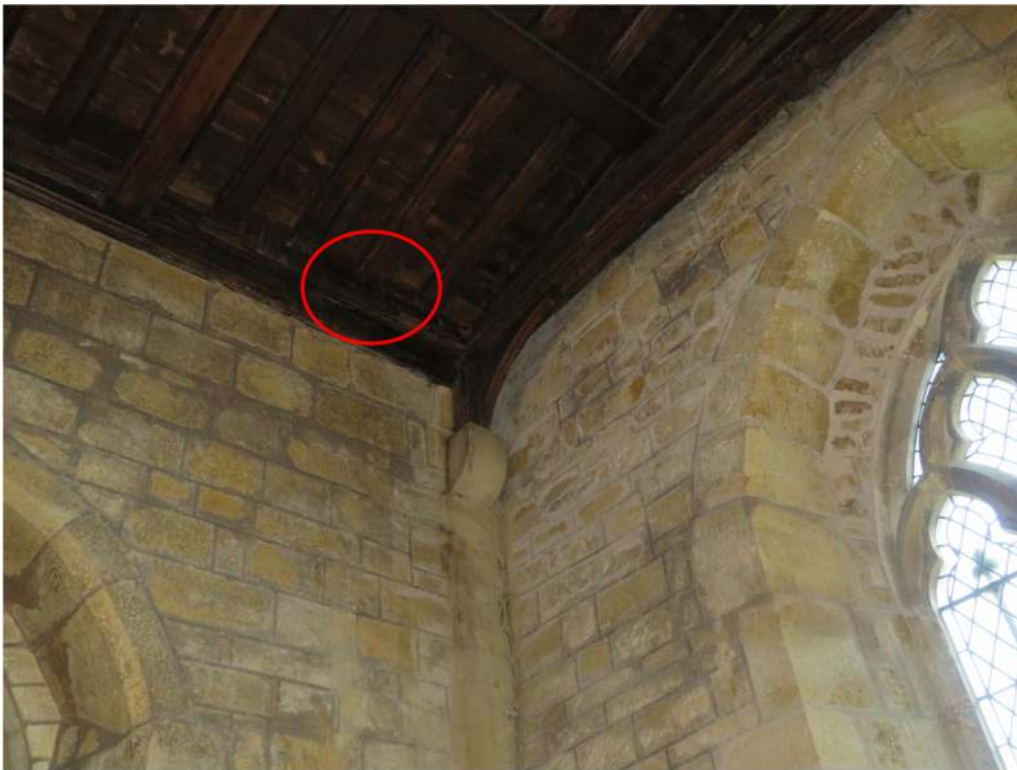
Photograph 19. Daubenton's bat roost above the timber sarking at the north-east corner of the north aisle

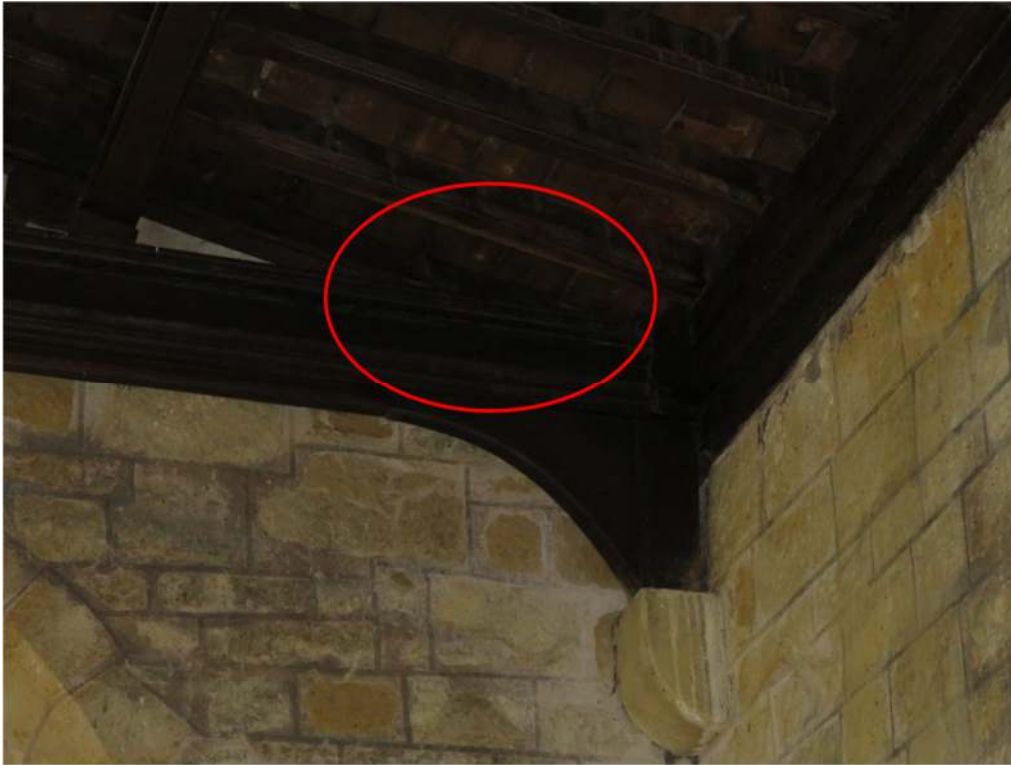
Photograph 20. Daubenton's bat roost behind the truss at the north-west corner of the north aisle

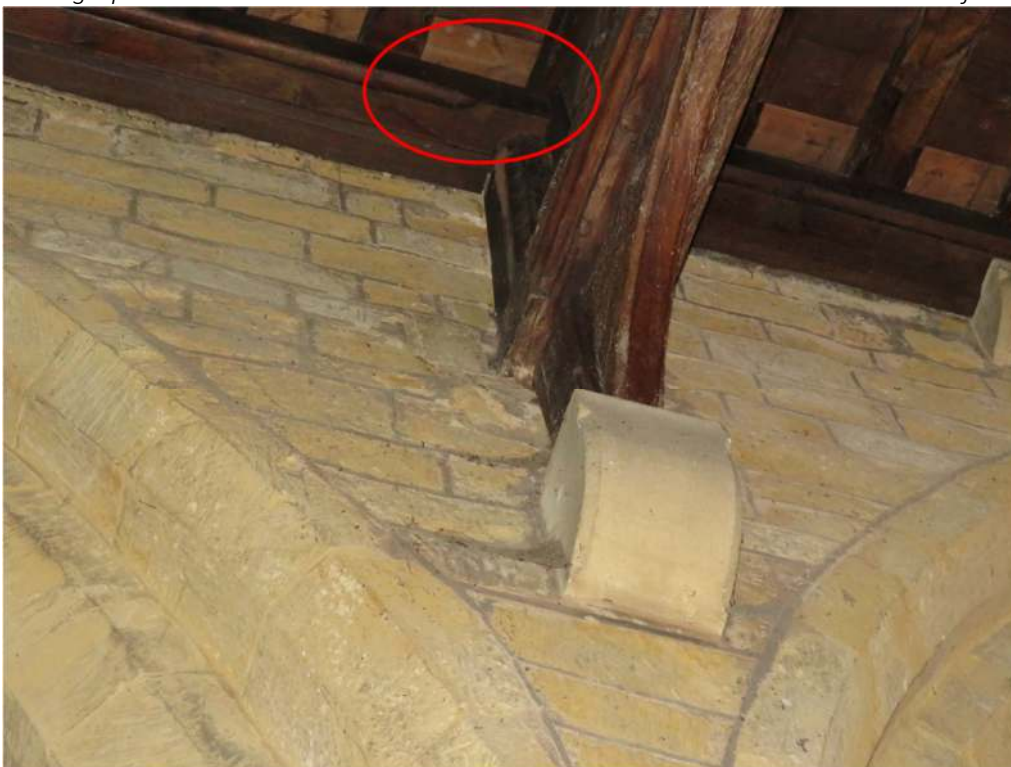
Photograph 21. Daubenton's bat roost behind the truss at the top of the first pillar from the eastern end of the north aisle

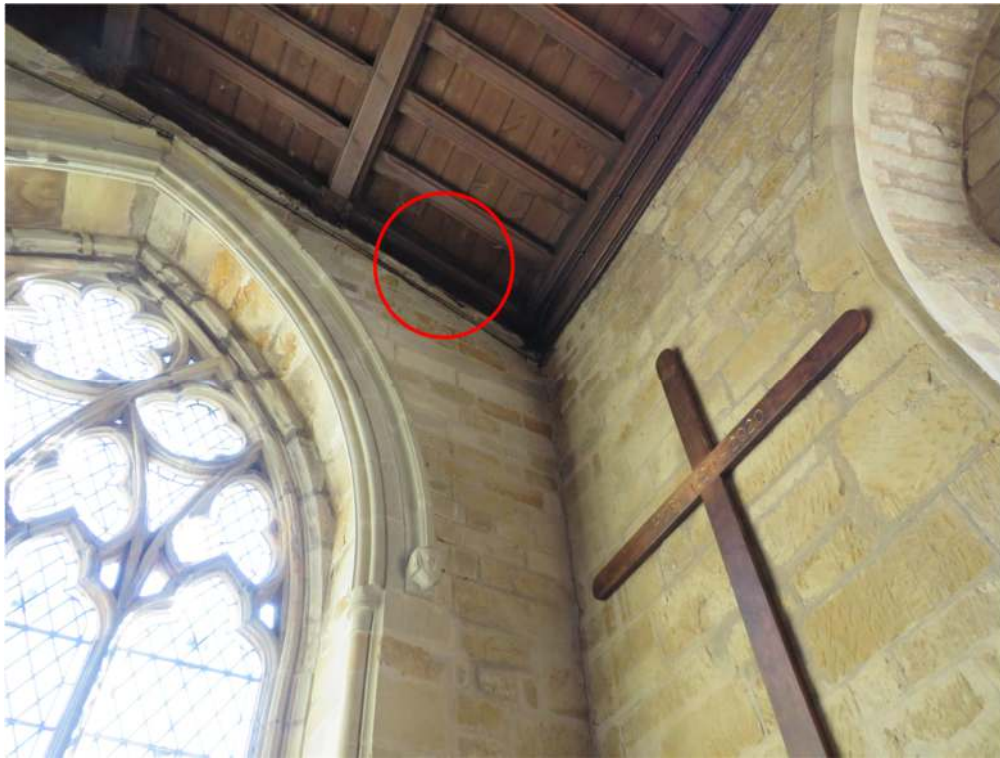
Photograph 24. Common pipistrelle day roost behind the end rafter at the south-east corner of the south aisle

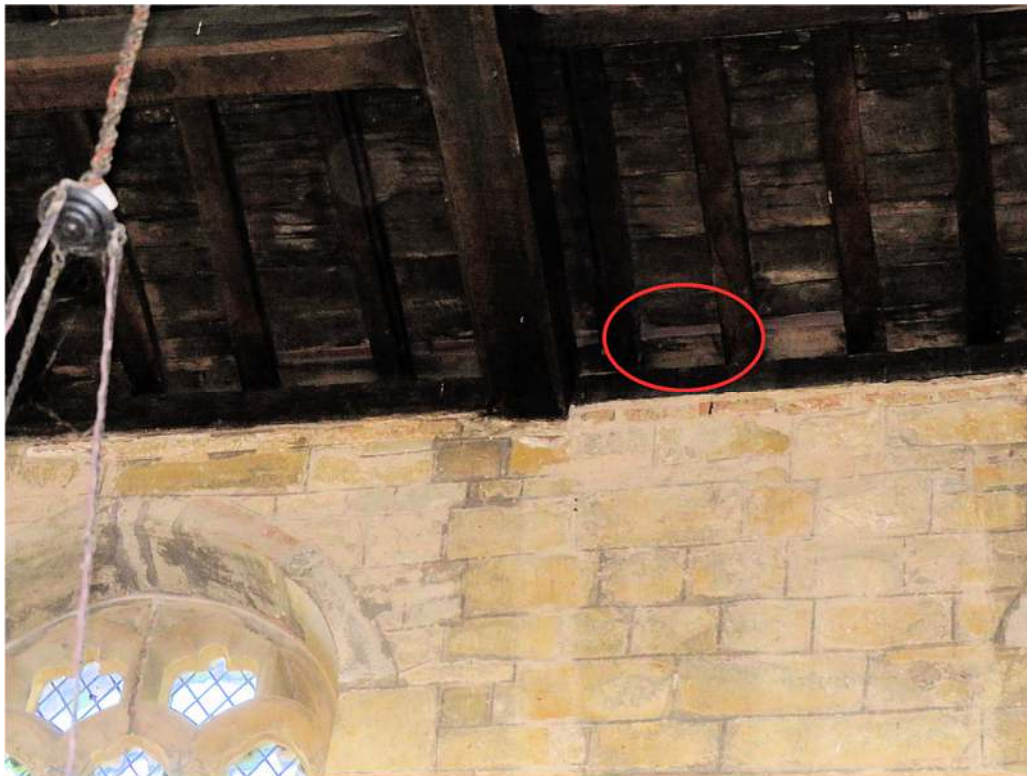
Photograph 25. Common pipistrelle day roost above the wall plate near the eastern end of the nave

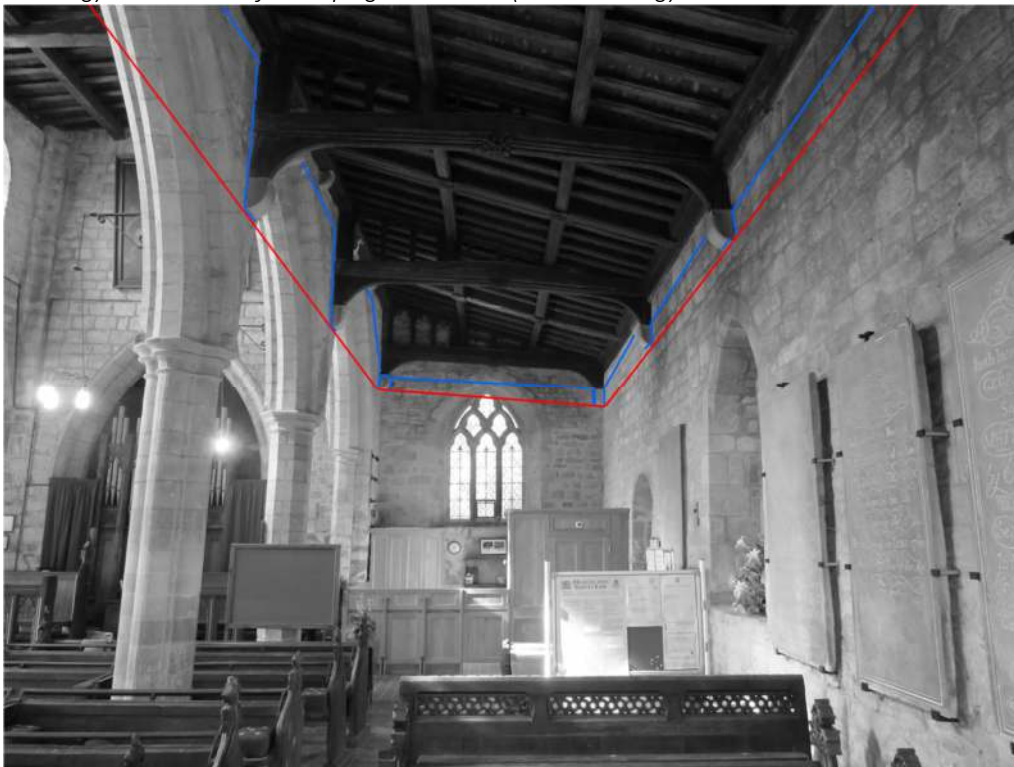
Photograph 26. The north aisle (view to west showing the edges of the temporary ceiling (red) and the extent of the raised edges (blue)

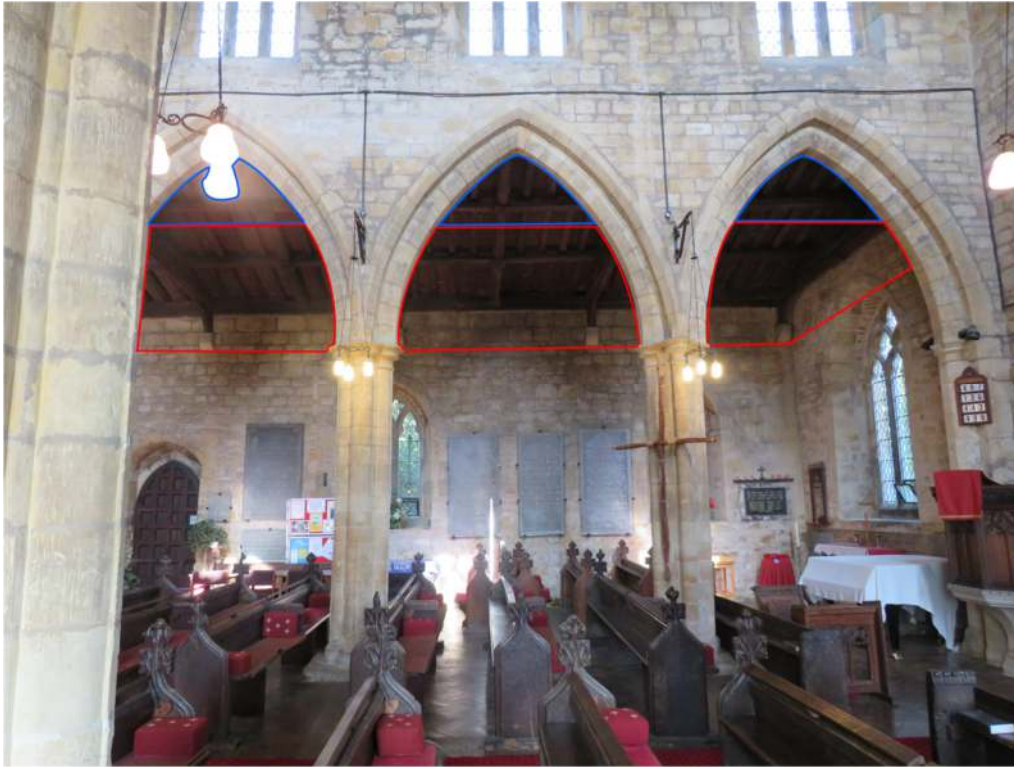
Photograph 27. The north aisle (view to north) showing the edges of the temporary ceiling (red) and the extent of the raised edges (blue)
