2020 BAT SURVEY RESULTS

HOLY TRINITY CHURCH, TATTERSHALL, LINCOLNSHIRE

January 2020

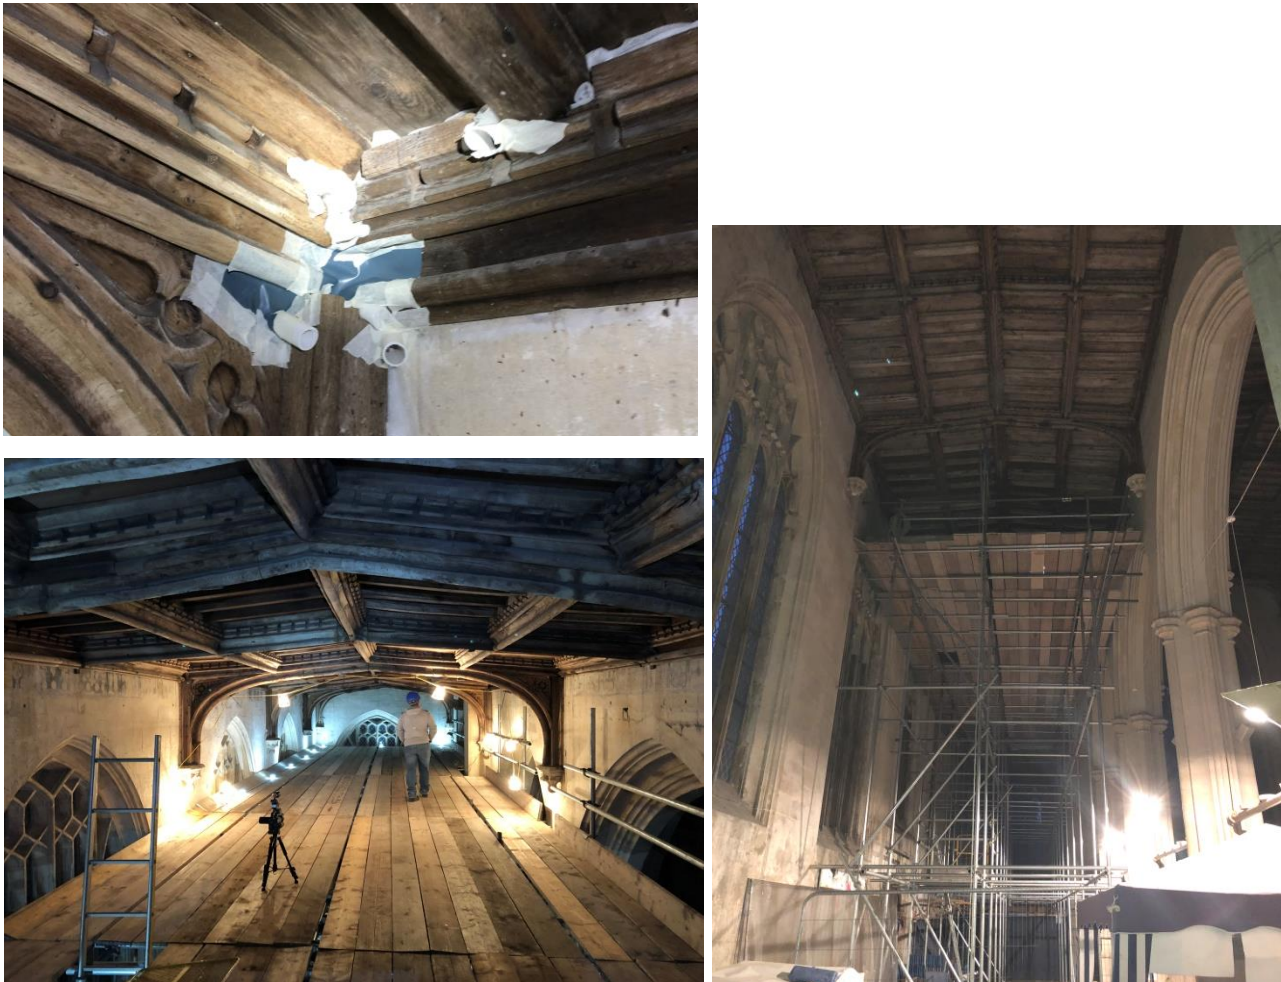
Photographs 1- showing the birdcage scaffold installed to allow access to carry out the exclusion of roost features above the Heritage Centre and Served area, and the exclusion work undertaken.

Over 2019 the actions to address Objective 1 were undertaken in September 2019, rather than the initial April/May proposal in the management plan. Photographs of these actions are visible in photograph 1 below.

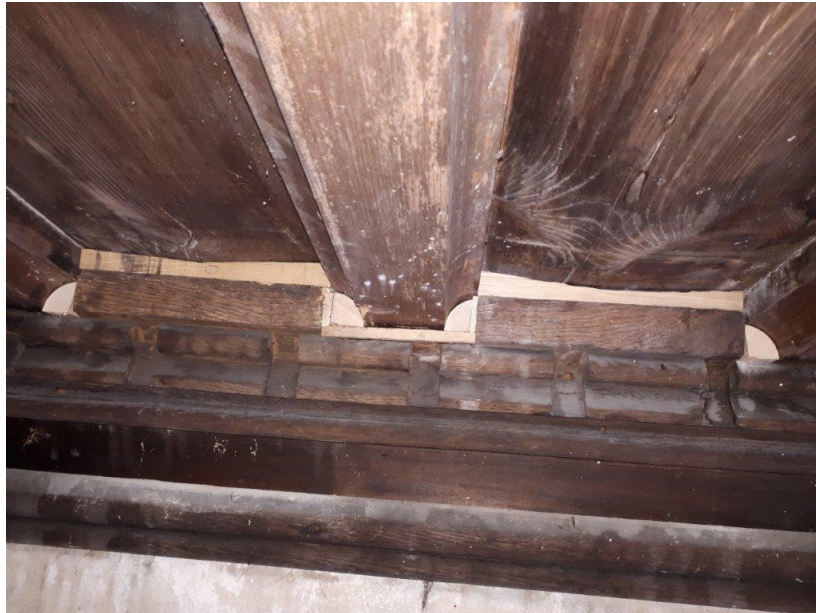
Photograph 2 - showing the gaps following infilling by the contractors' joiners

The contractors attended site and commenced the permanent closure of all of the gaps using sections of timber cut and spliced into the various gaps.

The work was completed by the end of October 2019 and the scaffolding was removed.

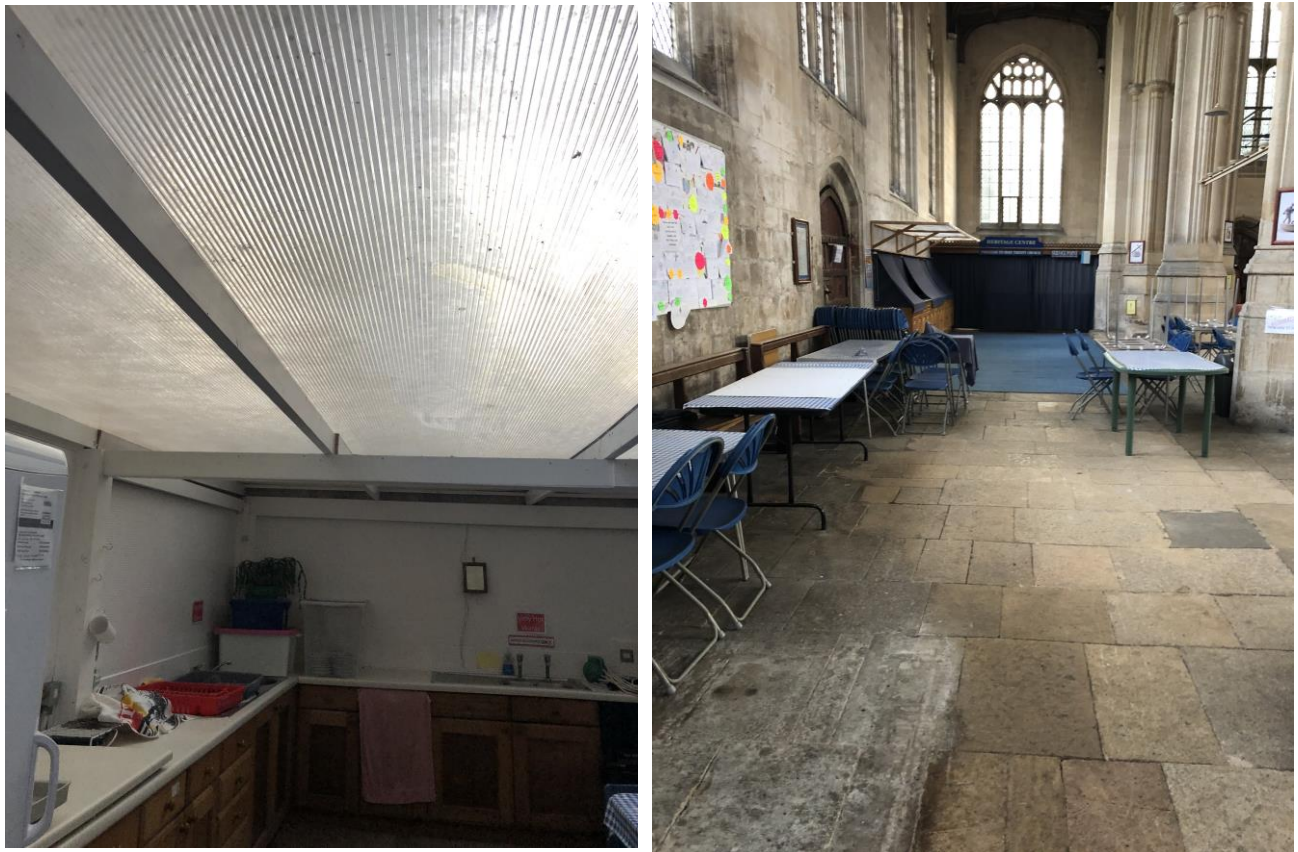
Photograph 3 - showing the lack of droppings on the roof of the Heritage Centre and on the floor of the South aisle

The site of the Objective 1 work, notably the south aisle and the servery/Heritage Centre, was then visited and inspected in June 2020 at a time when there was a peak count of bats present within the church.

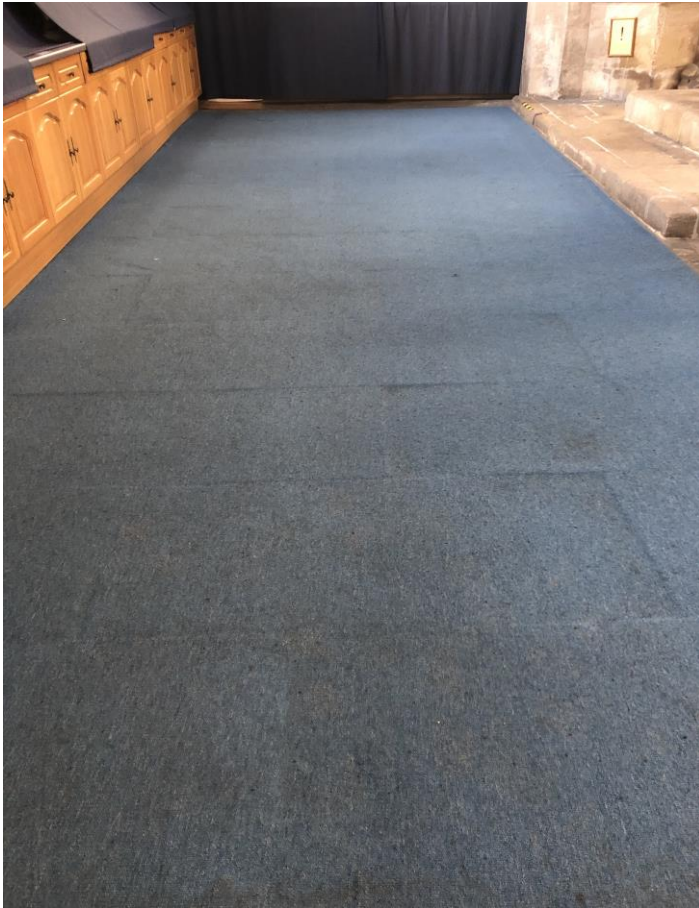
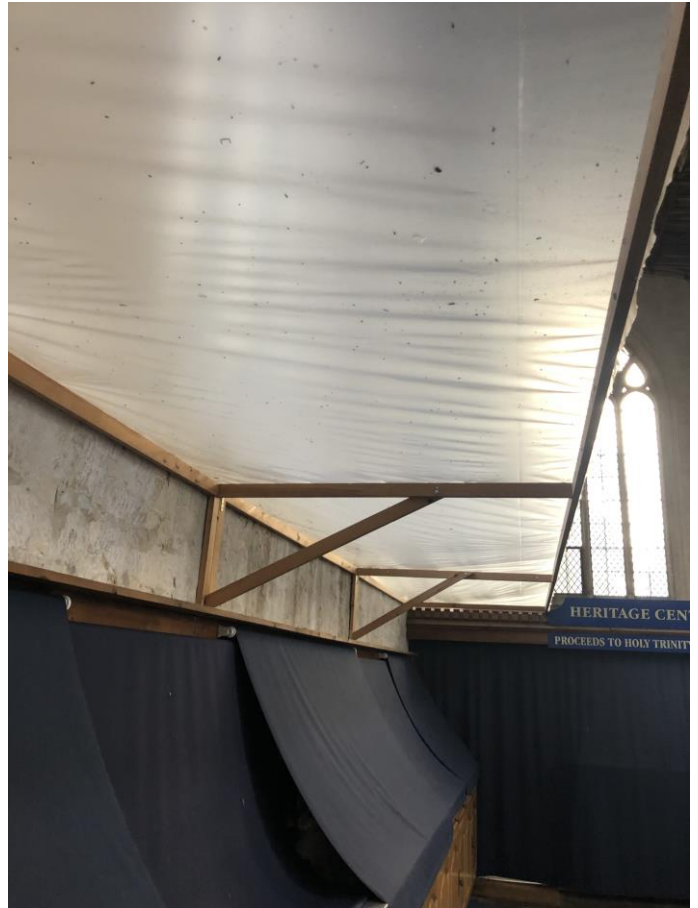
Photographs 4 - showing the lack of droppings on the carpet of the Served area of the south aisle in June 2020, alongside the plastic screen protecting the display cases alongside the south wall of the south aisle

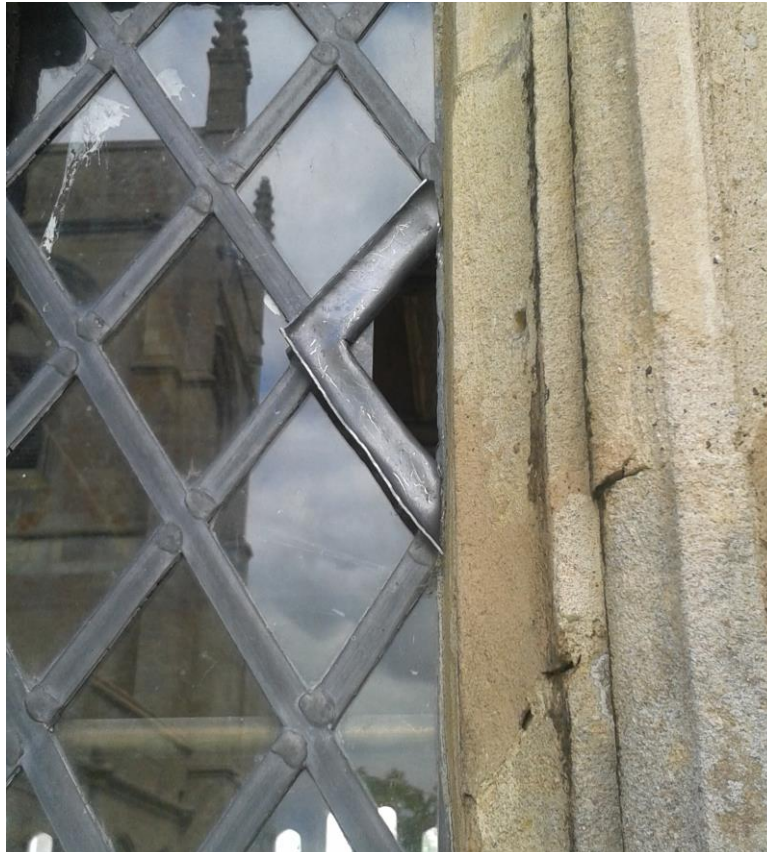
Photograph 5 - showing the new bat access point which was installed in the high-level windows on the Western south of the south transept

Over 2020 there was no evidence as to the use of this bat roost feature observed during the emergence and activity surveys and there is no evidence that bats are accessing and using the new feature.

To achieve this a new bat access point was installed high on the Western side of the south transept. Due to difficulties the Church have been experiencing with birds entering via these open window features the access had to be closed to a smaller diameter than was anticipated and hoped.

A large opening was originally anticipated as this would be more easily identified by the bats, allowing them to habituate to it. Instead in order to keep birds from out of the building a much smaller access point was installed, but one that is typical of window access features identified in use by bats in other churches studied by this consultancy.

An outcome of this meeting was that the window access proposal would be trialled on the north and west sides of the church, with sections of windowpane removed from the window directly above the North door and the West door of the church. It may be necessary to remove more than one triangular section alongside the frame to provide a large enough focus for the bats to locate.
