BATS IN CHURCHES

St Moran, Lamorran, Cornwall

The remote church of St Moran stands by Lamorran Creek on the Fal.

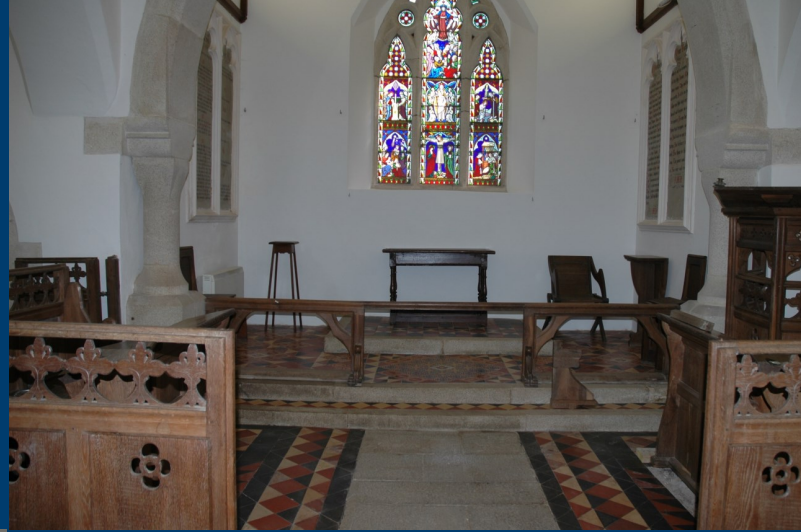
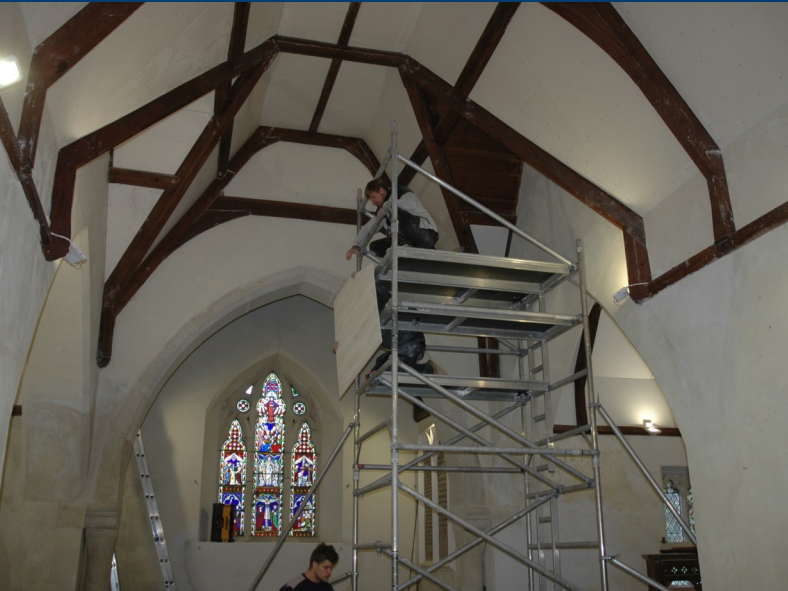
The church shelters several bat roosts: Greater Horseshoe bats in the detached bell tower; Lesser horseshoe Bats in the base of the tower and south porch; Common and Soprano pipistrelles and a maternity roost of Brown Long-eared bats in the church.

The Brown Long-eared bats were able to enter the nave from their roost in the roof

void and flew around the church.

The impact of their urine and faeces was so severe that the church unofficially closed in 2014. The cleaning overwhelmed the small community and the fixtures and fittings were deteriorating.

The church re-opened for worship in January 2023, the Parochial Church Council (PCC) working with the Bats in Churches project. Firstly, the project commissioned a detailed bat survey from Burton Reid Associates, which identified exactly how bats were using the church

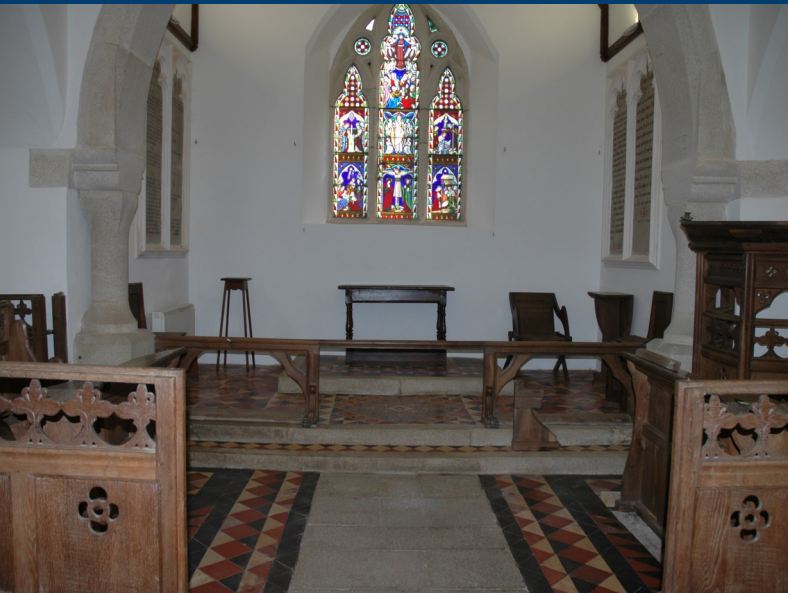
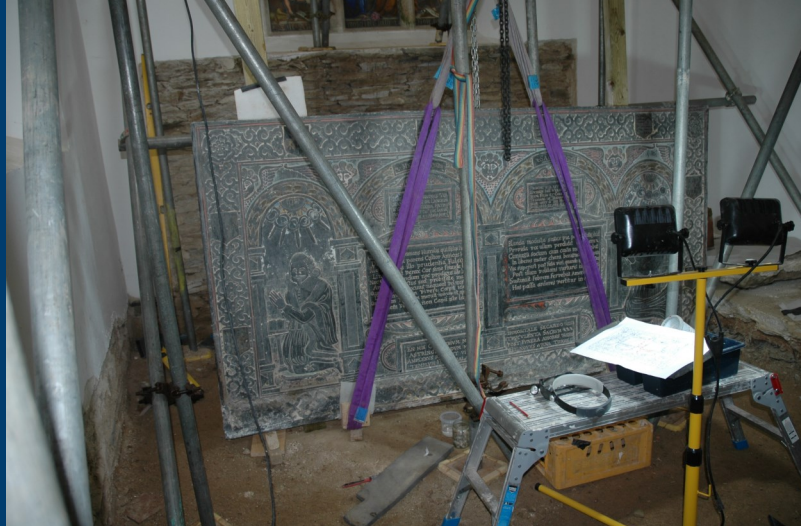
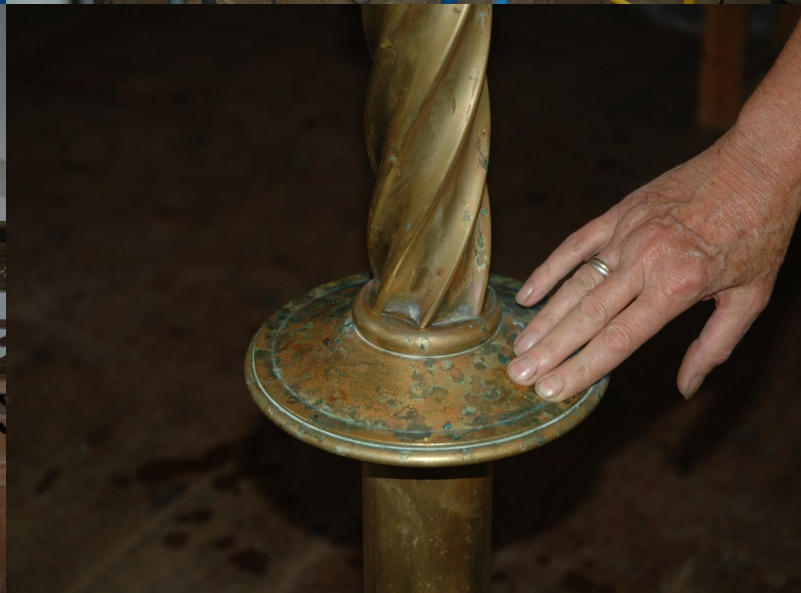
The PCC, Burton Reid Ecology, the church architect Robert Shaw and the project worked together to devise a way of separating the bat impacts from the church interior. The solution was an ingenious modification of a historic building. False ceilings were built into the transepts to provide two large dedicated bat lofts. These allow the Brown Long-eared bats to access to their existing roosts from the outside and provide them with an enclosed space to fly around that does not allow access into the nave.

Monitoring has shown that although the brown long-eared bats initially moved into the porch, they are now exploring and using their new roosts.

The church furniture has been conserved and cleaned, lintels replaced, leadwork repaired, tiles conserved, and new lighting fitted.
