## St Peter's Church, Little Rissington

### Bat Surveys and Bat Management Plan Report

On behalf of Natural England

Project Code: EP2021009Av2

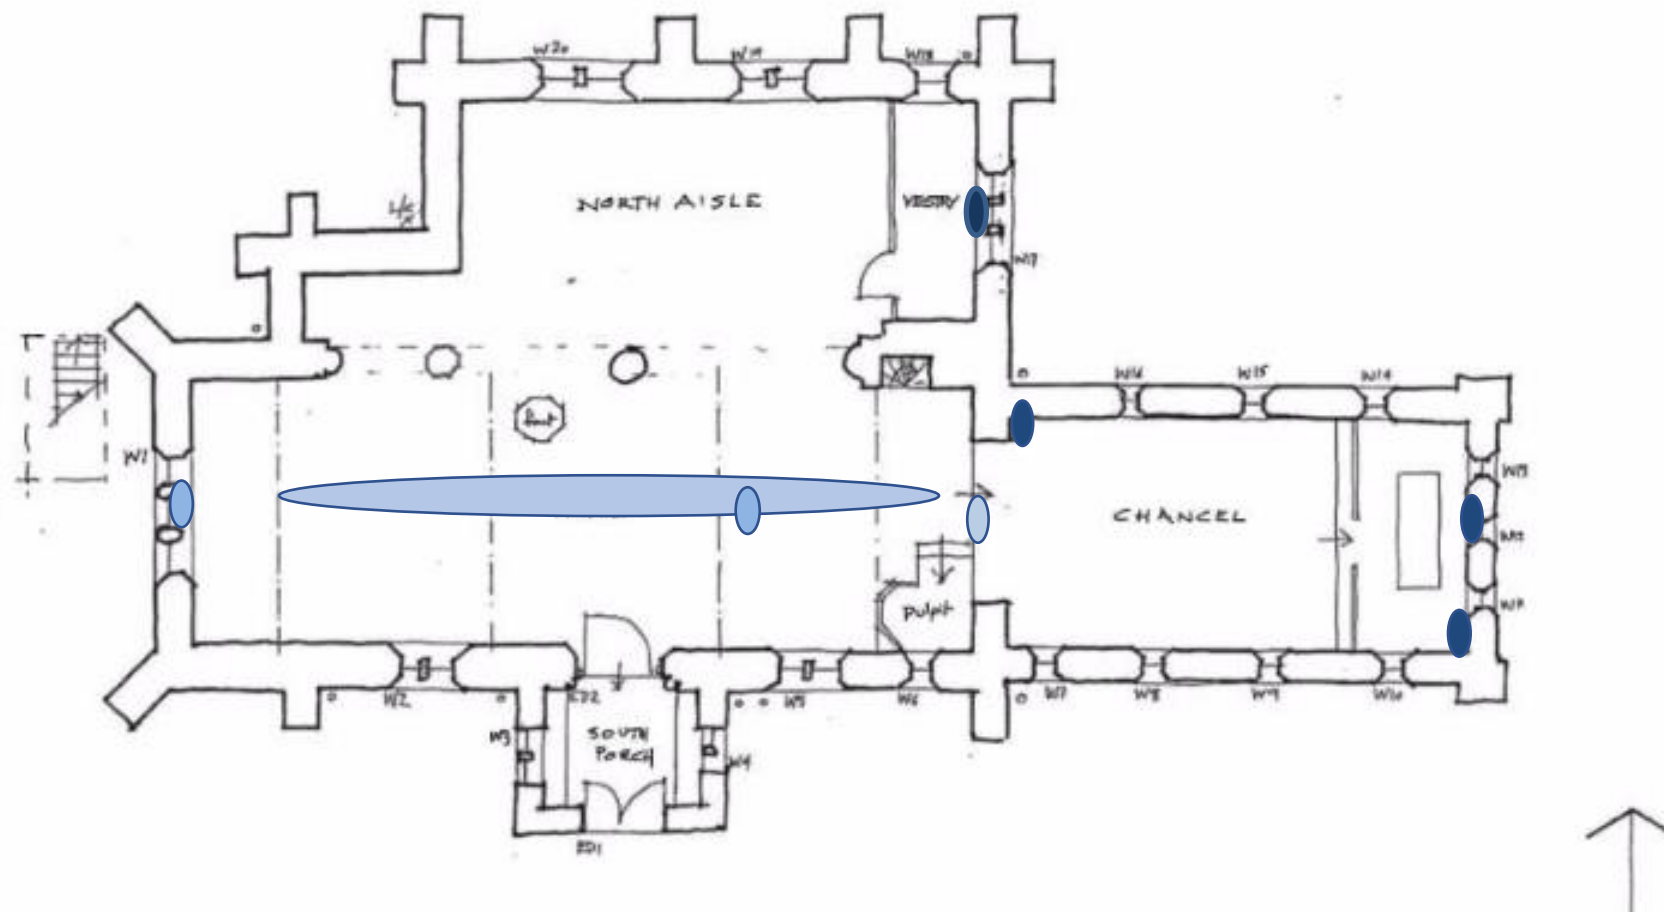
Figure 1b. Plan of St. Peter's Church, Little Rissington (provided by client) showing bat roosts

Dark blue circle = historic bat roosts plus droppings, pale blue = current bat roosts 2021

- 4.1.4 Roost locations noted from previous surveys and locations of bat droppings are shown in Figure 1b and comprise spaces between wooden rafters and ceiling in
-

various locations: east end of north aisle, east end of chancel (above alter) and west ends of chancel (northern side and central part at roof apex), plus the central part of nave at apex of roof and the west end of nave. (It should be noted that these areas were not all found to still support roosting bats during these surveys.)

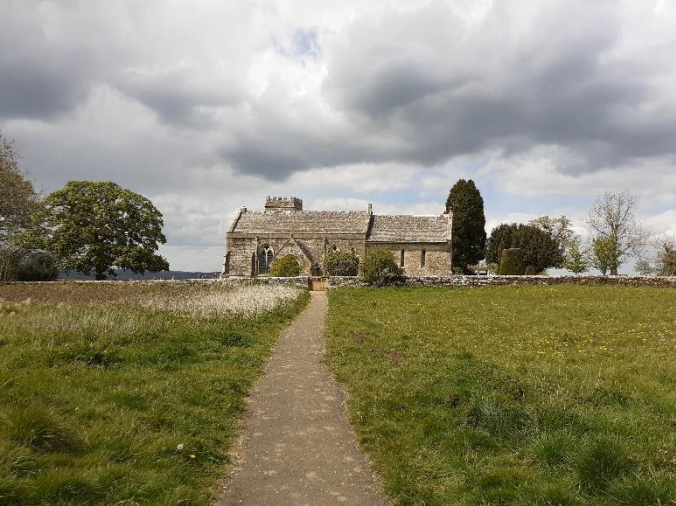
No	Photo	Description
1

<p>A photograph showing the exterior of St Peter's church, a stone building with a gabled roof and a small tower, situated in a rural landscape. A dirt path leads through a grassy field towards the church. The sky is overcast with grey clouds.</p>	<p>St Peter's church and surrounding habitat</p>
2

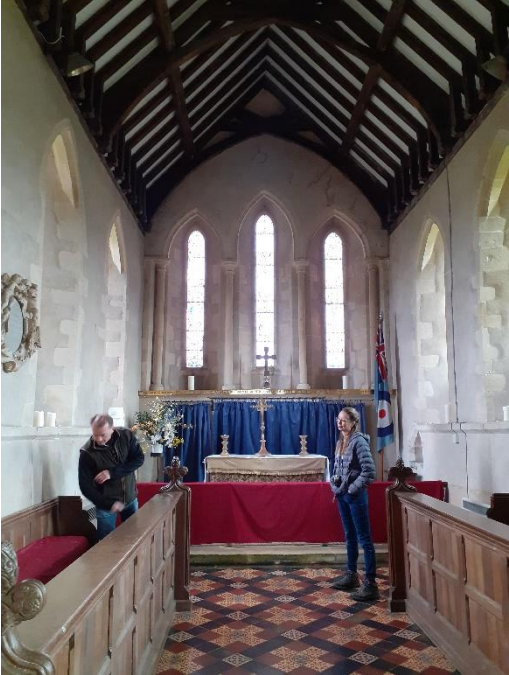
<p>A photograph showing the interior of St Peter's church, focusing on the chancel. The view is from the nave looking towards the altar. The ceiling is high with dark wooden beams. The altar is covered with a red cloth and has a blue curtain behind it. There are three tall, narrow windows above the altar. Two people are standing in the nave, one on the left and one on the right, providing a sense of scale.</p>	<p>Interior of church - showing chancel</p>

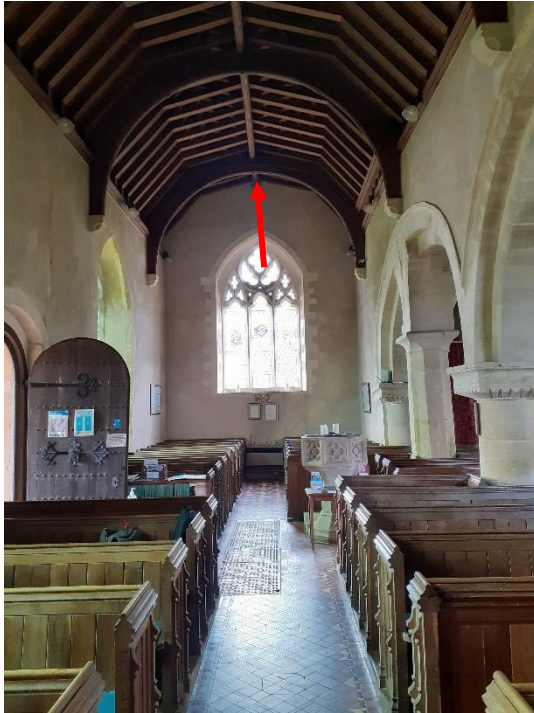
3

Interior of church showing nave and BLE bat roost located at gable end as shown by arrow.

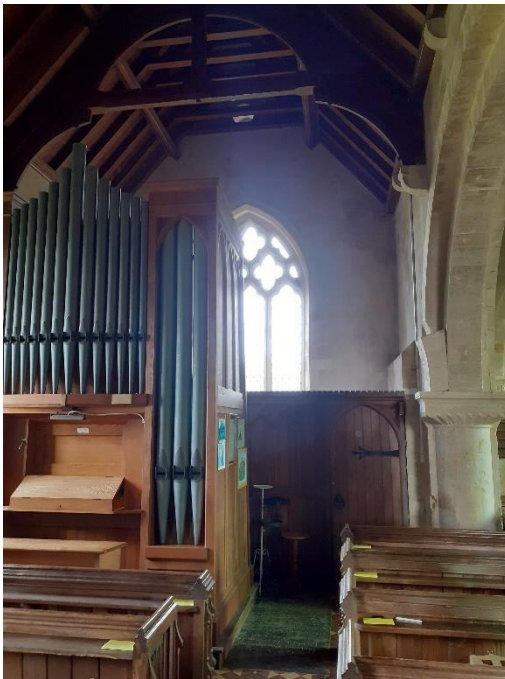
4

Interior of church showing area where bat loft proposed above vestry

- 5.2.11 The bat loft will need to be installed with insulation boarding to ensure an even temperature and it is recommended that a temperature logger is fitted to monitor the temperature of the bat loft. As the church provides habitat for a maternity roost

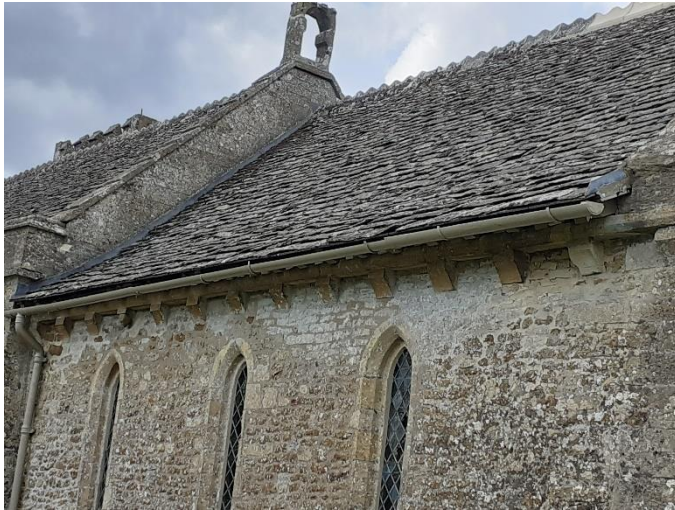
5

Exterior of church (south side) showing stone tiles of roof which provide external roosting features for bats especially pipistrelles.

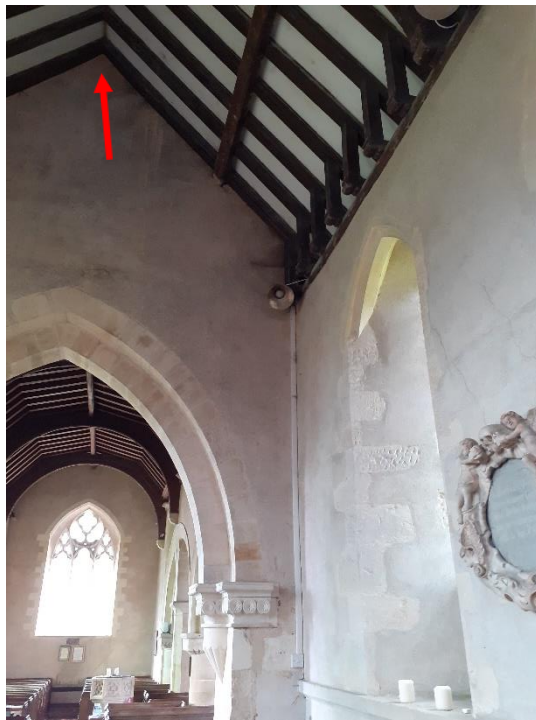
6

Interior of church showing location of BLE bat roost above chancel entrance shown by arrow

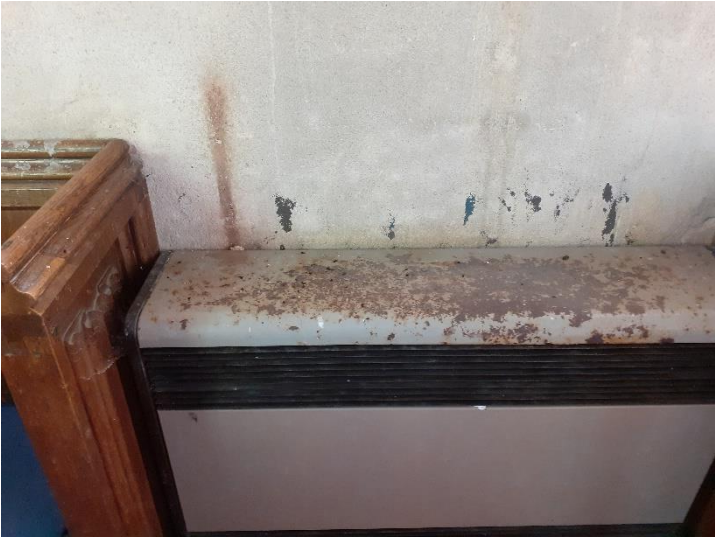
A photograph showing the interior of a church, specifically the nave gable end. The image captures a radiator and the wall above it. The radiator is heavily stained with brown and black marks, indicating damage from bat urine and burnt droppings. The wall above the radiator is also stained and discolored, with a prominent vertical stain on the left side. A wooden bench or pew is visible on the left side of the frame.	<p>Interior of church, nave gable end where radiator damaged by bat urine and bat droppings burnt on.</p>

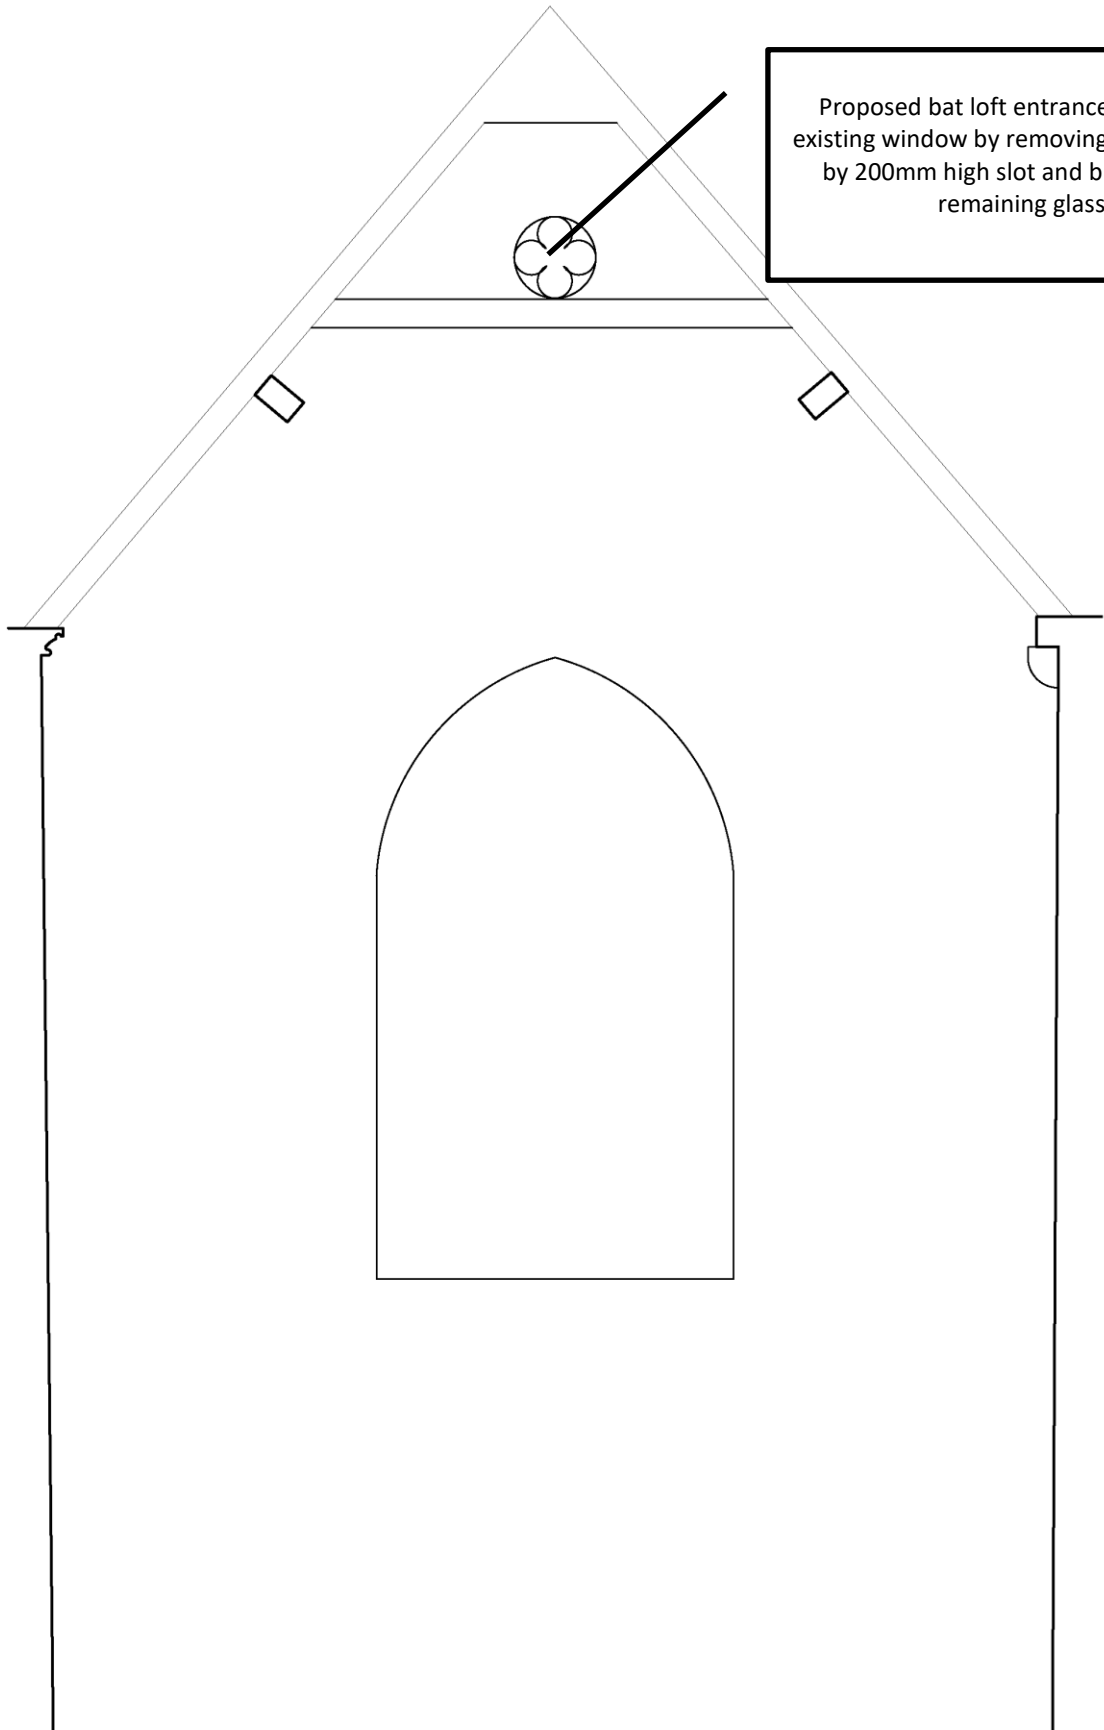
Proposed bat loft entrance created in existing window by removing 300mm long by 200mm high slot and blacking out remaining glass

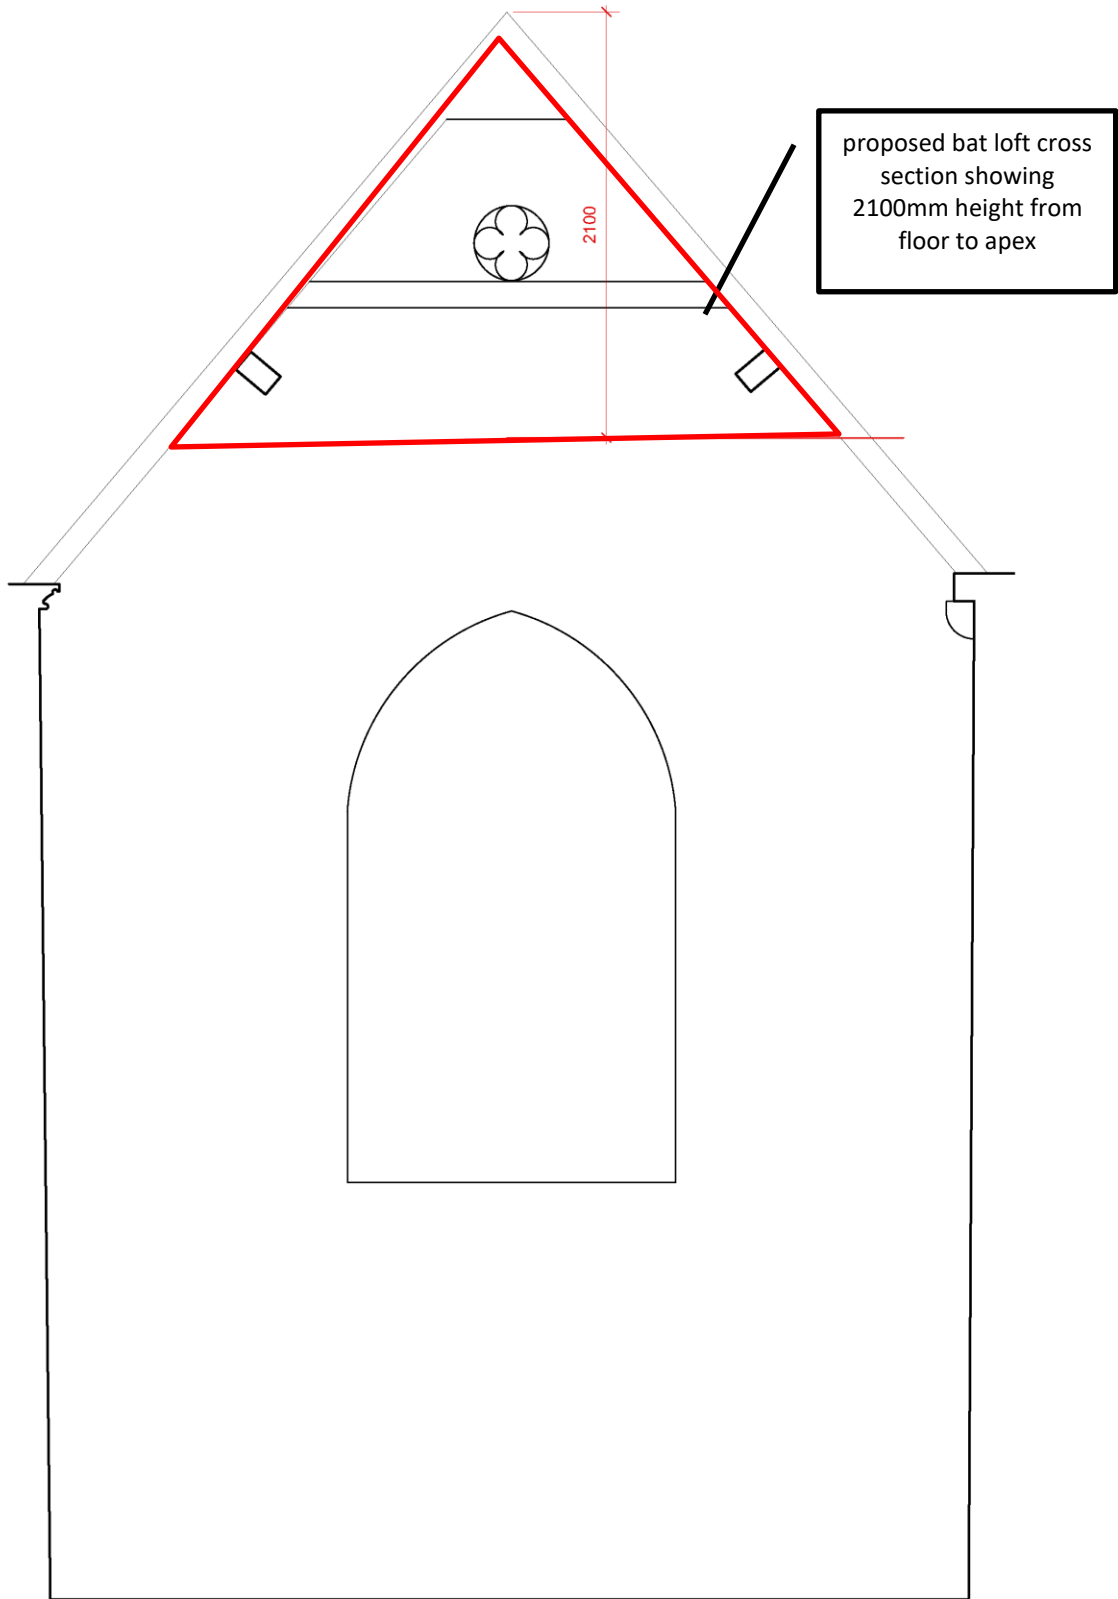
St Peter's Church - Little Rissington - Gloucestershire East Gable End North Aisle 1:20  
Nick Joyce Architects Ltd - 5 Barbourne Road - Worcester - WR1 1RS Tel. 01905 726307 e- enquiries@nickjoycearchitects.co.uk

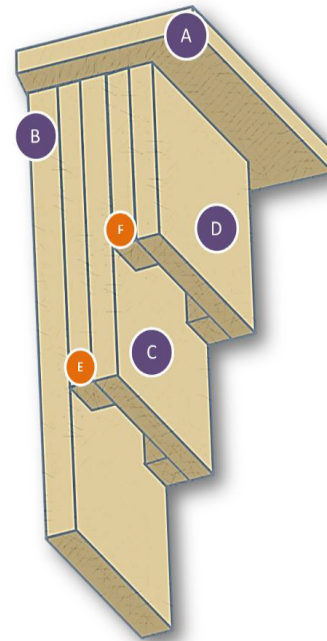
Measurements for one Kent bat box kit would be as follows:

Part	Quantity	Size (mm)
Roof (A)	1	250 x 160 x 20
Back (B)	1	450 x 200 x 20
Centre (C)	1	330 x 200 x 20
Front (D)	1	210 x 200 x 20
Centre Rails (E)	2	330 x 20 x 20
Front Rails (F)	2	210 x 15 x 15
Stand-offs (optional)	2	200 x 20 x 20
