Wild Wings Ecology

Bats in Churches Project: All Saints' Church, Toftrees Bat Survey & Management Plan Report February 2020 (revised v1.1 June 2020) v1.1

Document type	Bats in Churches Project – Bat Survey & Management Plan Report
Version	1.1
Author	Dr Charlotte Packman PhD CEcol MCIEEM
Client	Natural England
Site address	All Saints’ Church, Shereford Road, Toftrees, Fakenham, Norfolk, NR21 7EA.
Site grid reference	TF 89790 27569
Survey period	May – August 2019
Report date	11 th February 2020, updated 10 th June 2020 (v1.1) with revised Schedule of Works needed due to Covid-19 restrictions

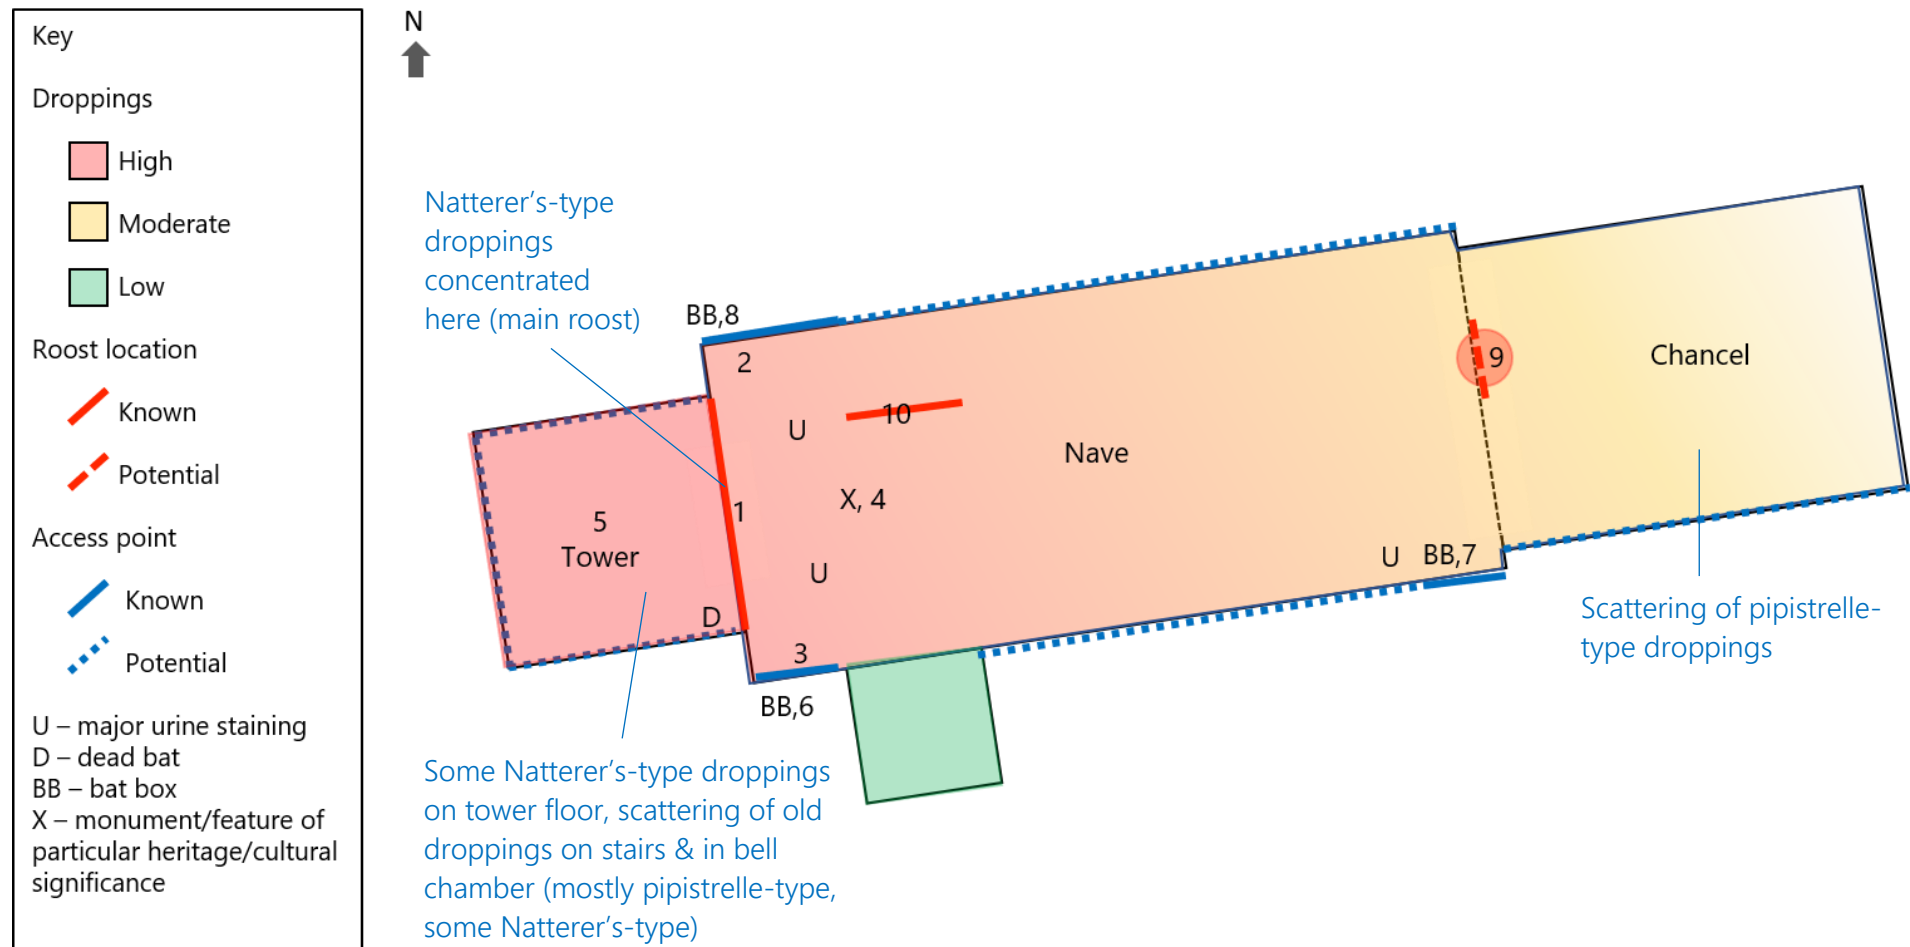
Figure 4. Visual inspection results from Light Touch Survey 12/09/17, updated 09/05/19 (annotated on plan in blue). Plan not to scale. (1) Main roosting location for Natterer's bats, against the tower wall in roof timbers above the tower arch, sheeting covers the ground in this area to collect/protect against droppings and urine. (2) Known Natterer's bat exit location, colony hand-netted here during Zeale *et al.* (2014) research. (3) Known Natterer's bat exit location, colony hand-netted here during Zeale *et al.* (2014) research. (4) Location of Norman font, covered to prevent damage from droppings and urine. (5) Gaps from ground floor into the tower, very few droppings in tower room. (6) External bat box has fallen off the wall, no signs of use by bats. (7) Internal bat box - no signs of use. (8) External box, no signs of use. (9) Potential roost location, concentration of pipistrelle-type droppings on the chancel side of the arch. (10) Radio-tagged Natterer's bats roosted here during Zeale *et al.* (2014) research.

Long-term impacts from bats can be seen throughout the church: staining/bleaching from bat droppings/urine on floors, walls, pews, ledgers and wall plaques. At the time of the visual inspection, Natterer's-type droppings were scattered throughout the church, but concentrated beneath the main Natterer's bat roost above the arch at the west end of the nave (where it meets the tower), see Figure 4. There were also some Natterer's-type droppings on the tower floor. The tower stairs and bell chamber had a scattering of old droppings (mostly pipistrelle-type, some Natterer's-type) and there was also a scattering of pipistrelle-type droppings in the chancel. The building appears to be highly 'bat-porous', with potential bat access along the length of the nave and chancel eaves (both north and south sides) and at the eaves of the tower roof.

Previous research (Zeale *et al.* 2014) established the presence of another Natterer's roost location, towards the western end of the nave in the northern side of the roof (interior, see 10. on Figure 4). There is a large wooden bat box inside the church positioned on the southern wall of the nave (east end), but with no signs of use (believed to have been put up by the Zeale *et al.* 2014 research project). Major bat access points at the time of the research project were located at eaves level at the west and east ends of the south side of the nave and at the west end of the north side of the nave.

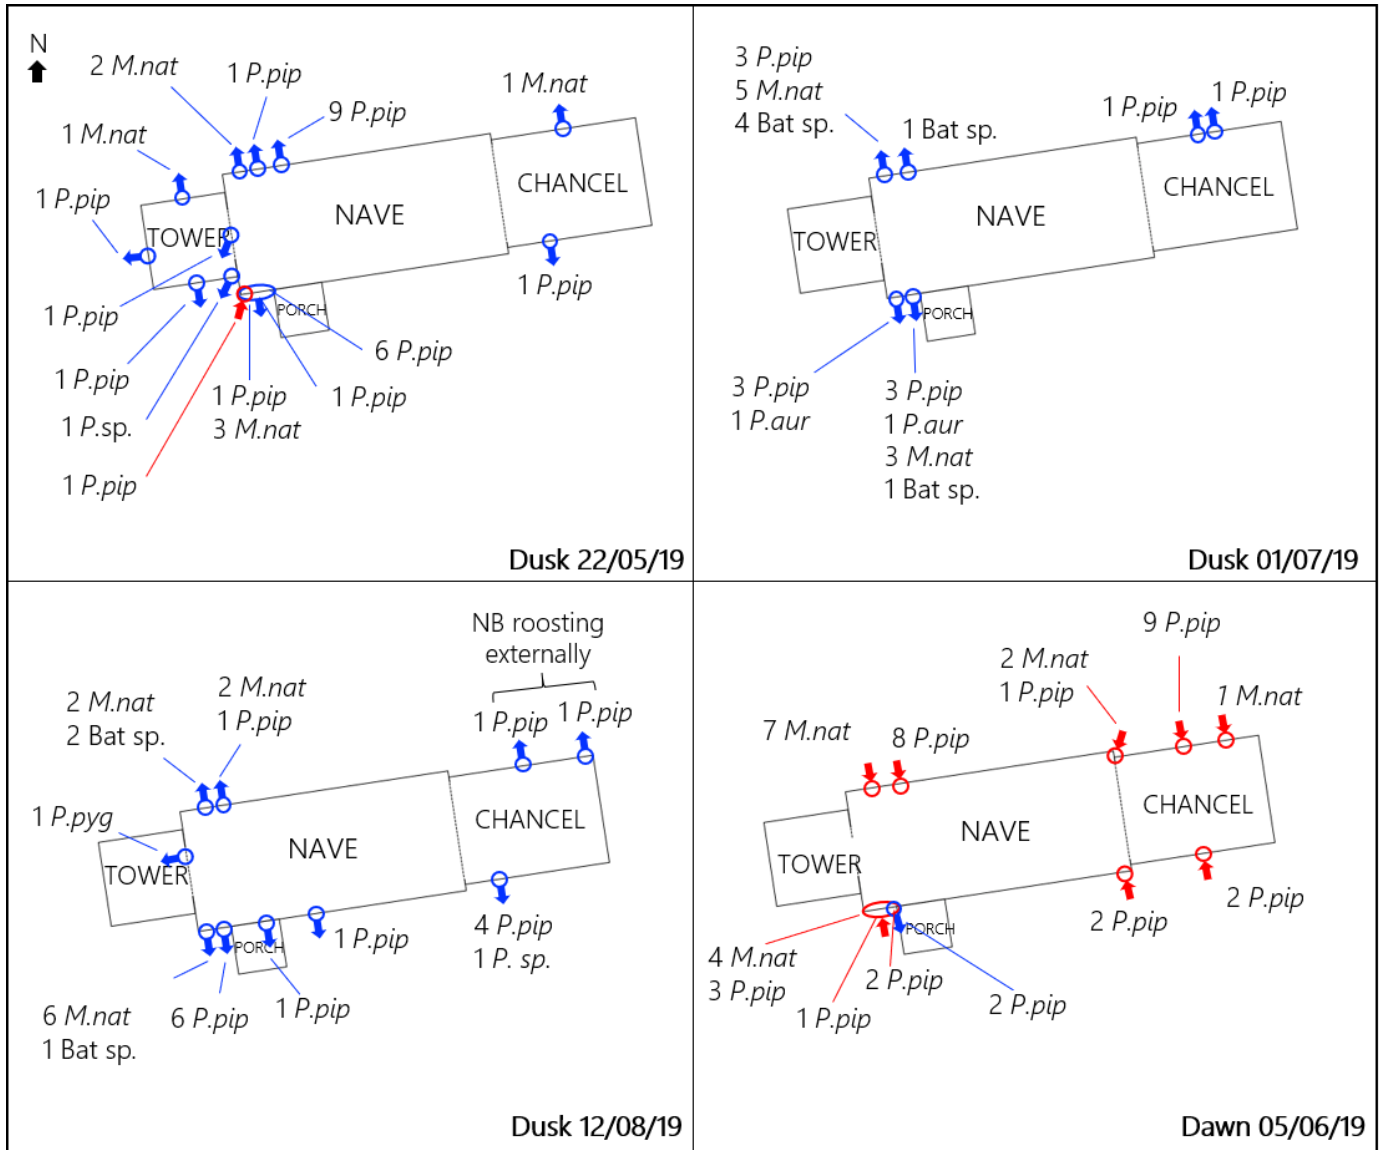
Figure 5. Results from the bat activity surveys (dusk 22nd May, 1st July and 12th August 2019 and dawn 5th August 2019) shown on a simplified plan of the church: emergence (blue circle & arrow)/re-entry (red circle and arrow) locations, species and numbers. Note the cluster of emergence/re-entry activity located at the western end of the nave, south side (to the west of the porch), consisted of three separate access points (observed during the May dusk and June dawn survey).

Most emergence and re-entry (for both Natterer's bats and common pipistrelles) was at eaves level at the west end of the nave, on both the north and south sides (Figures 5 & 6). Smaller numbers also emerged/re-entered at the chancel (most of which were thought to be common pipistrelles exiting/re-entering the exterior eaves' roost) and the tower. The church is very 'bat-porous', with a considerable number of different access points.

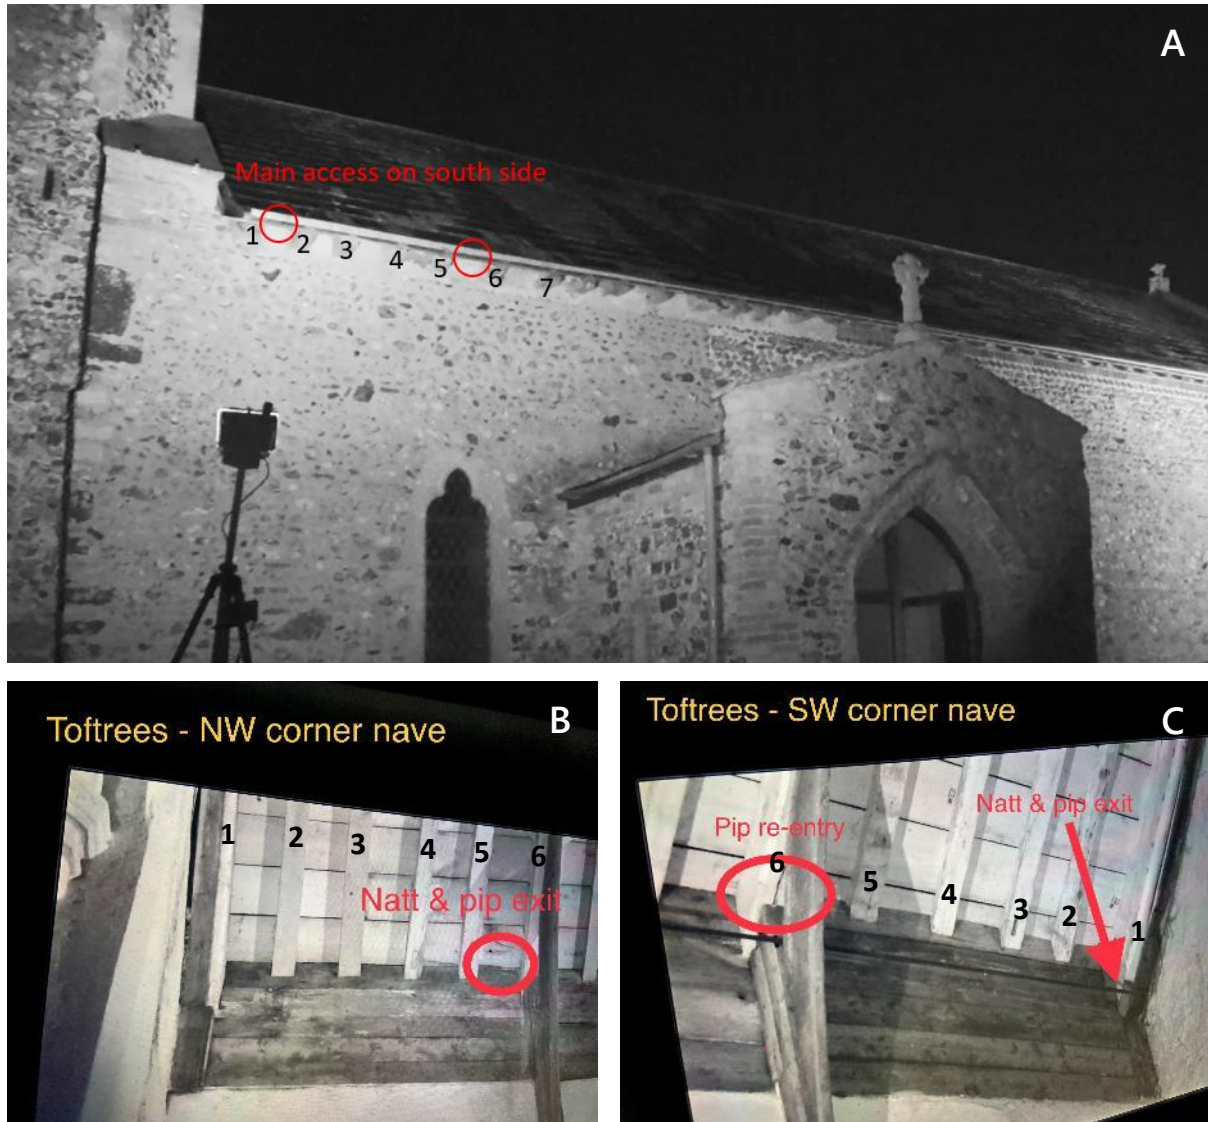
Figure 6. A. Infrared image of the southern elevation of the church, with protruding rafters numbered 1-7 (west to east) and main access points circled in red. B. & C. Interior activity surveys – photos of infrared camcorder field monitor annotated during surveys (with rafters numbered from west to east, i.e. those in A on the southern exterior, west end, corresponding with those in C on the interior): B. shows the main access point on the north side of the nave (west end) and C. shows the two main access points on the south side of the nave (west end).

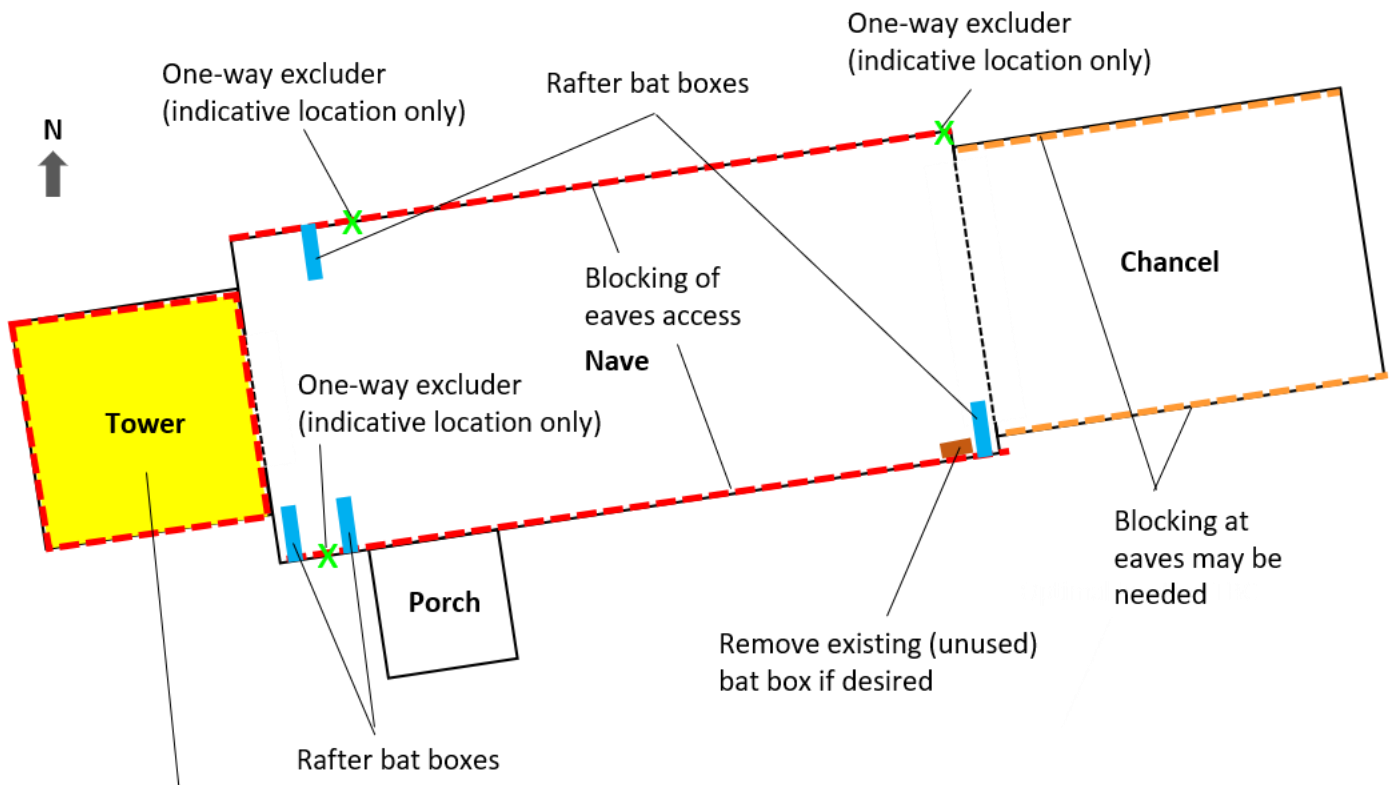
Enhance roost suitability with provision of roost niches/boxes in upper section of tower, access retained at tower eaves, blocking of gaps around first floor to church interior

Figure 8. Annotated church plan showing locations of the proposed management interventions. Note exact locations (and numbers) of one-way excluders would be determined during the blocking work.

The proposed management approach is as follows (refer to Figure 8 for church plan annotated to show locations of proposed interventions and Figure 9 for images illustrating some of the proposed measures):

- Rafter bat boxes to be built-in at four access points (including the major access locations and to provide a range of conditions): two at the west end of the south side of the nave (between rafters 1-2 and 5-6, counting from the west end of the nave), one at the west end of the north side of the nave (between rafters 5-6, counting from the west end of the nave, see Figure 6) and one at the east end of the south side of the nave (exact location to be confirmed, but probably in easternmost bay).

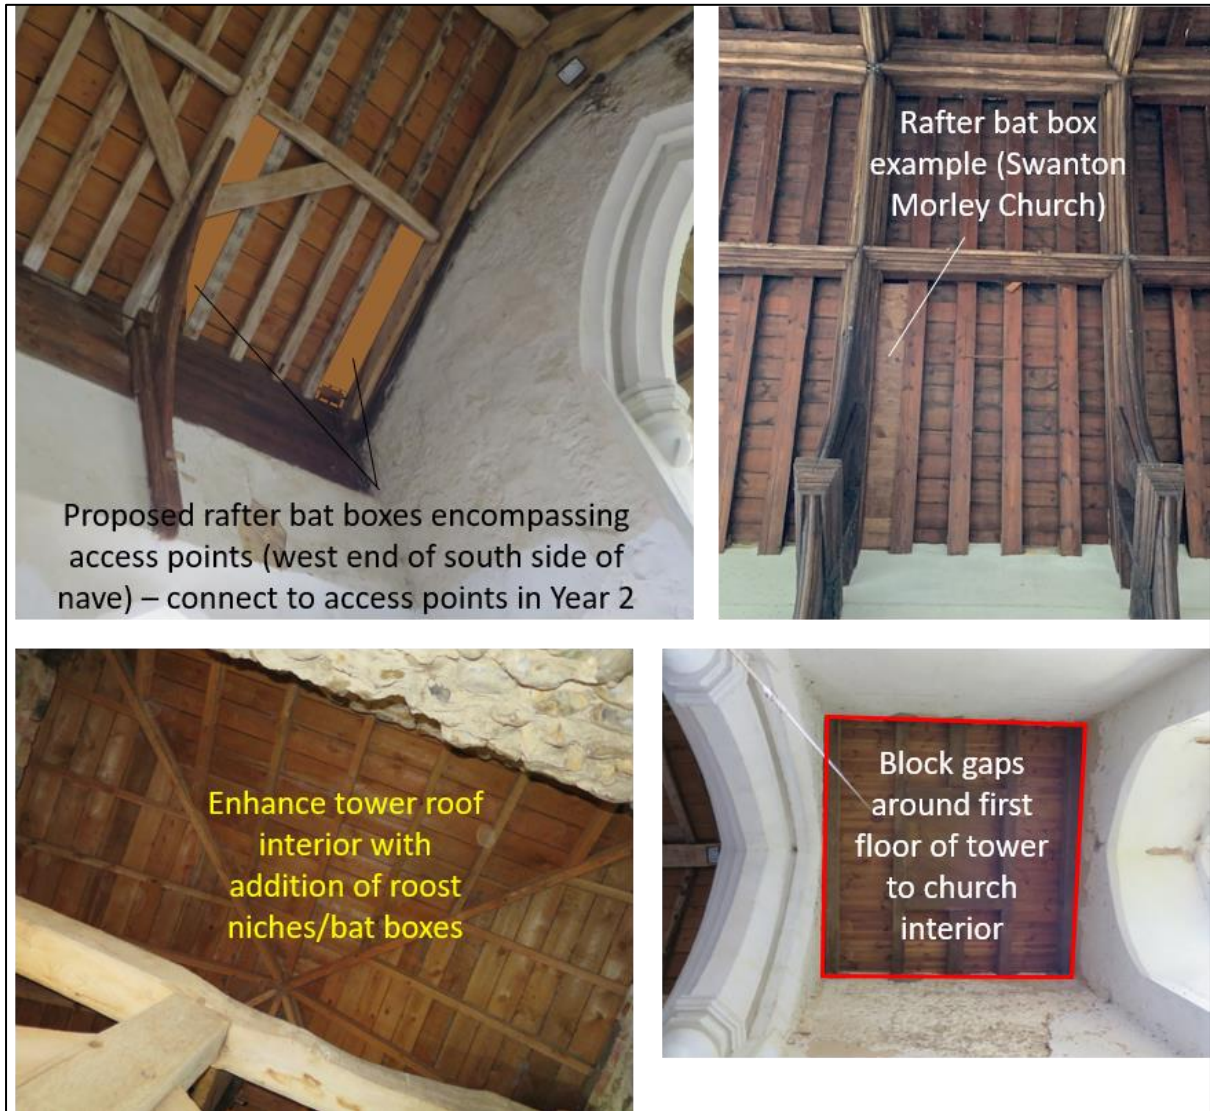
Figure 9. Illustrations of proposed measures.

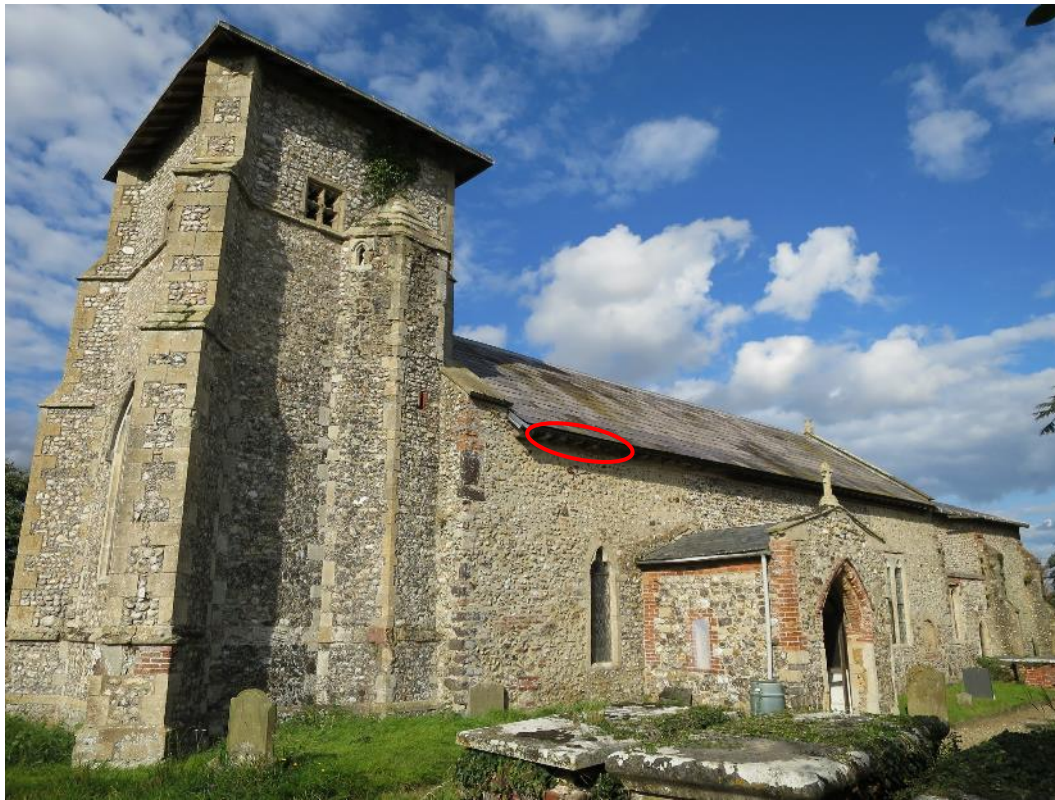
Photo 1. Southern elevation (main access circled in red).

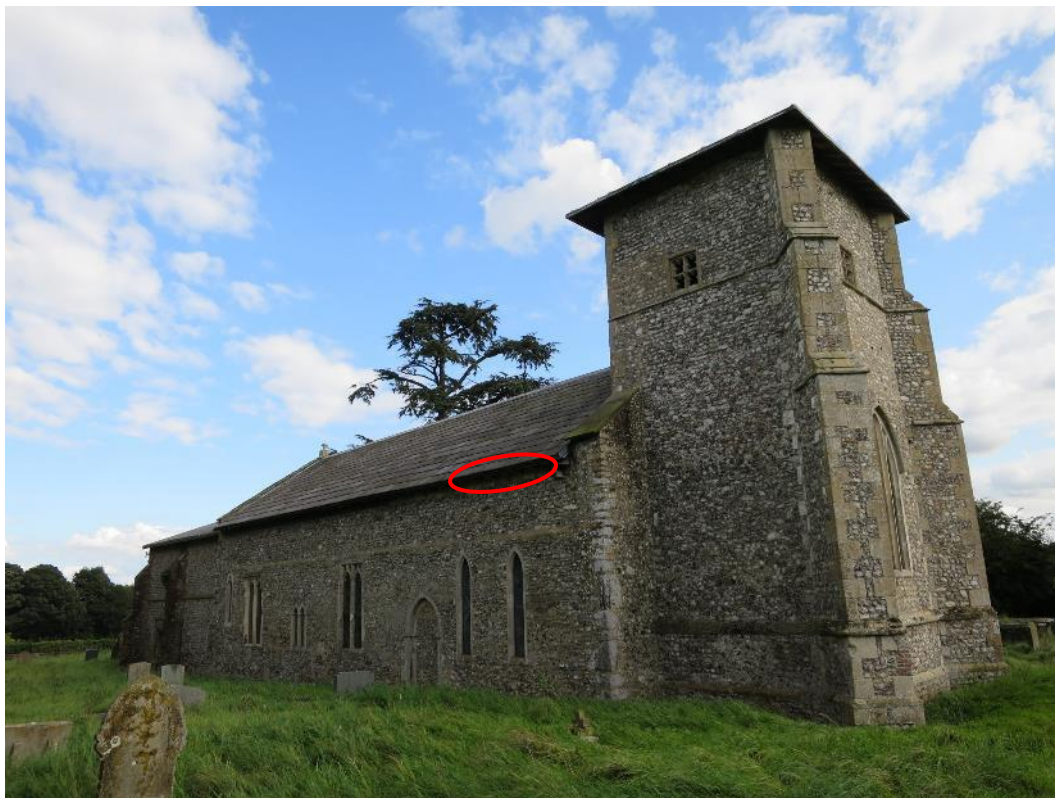
Photo 2. Northern elevation (main access circled in red).

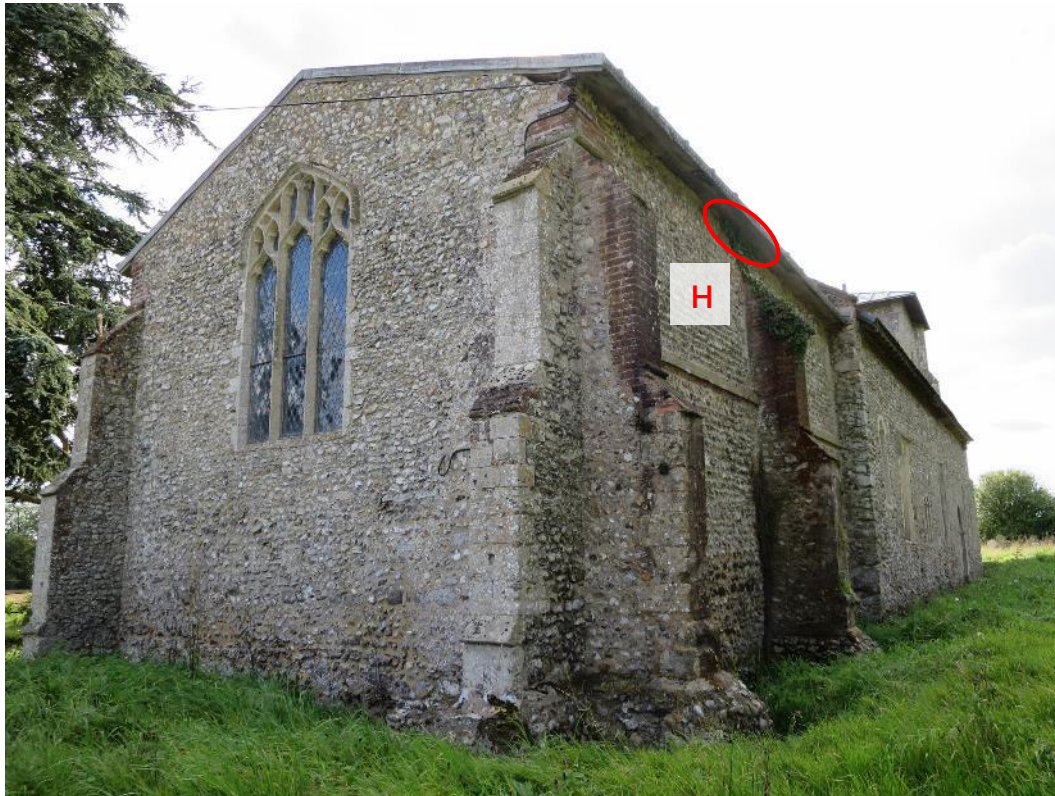
Photo 3. North-eastern end of chancel, with 'exterior' common pipistrelle roost area circled in red (access at eaves, around ivy patch, roost H in Figure 7).

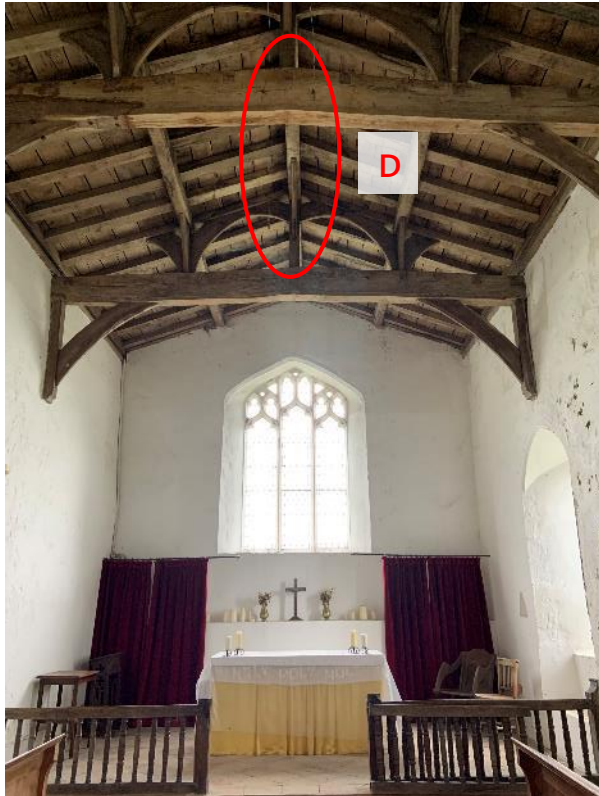
Photo 5. Chancel interior (facing east). Probable common pipistrelle roost above central ridge beam/sarking boards circled in red (roost D in Figure 7).

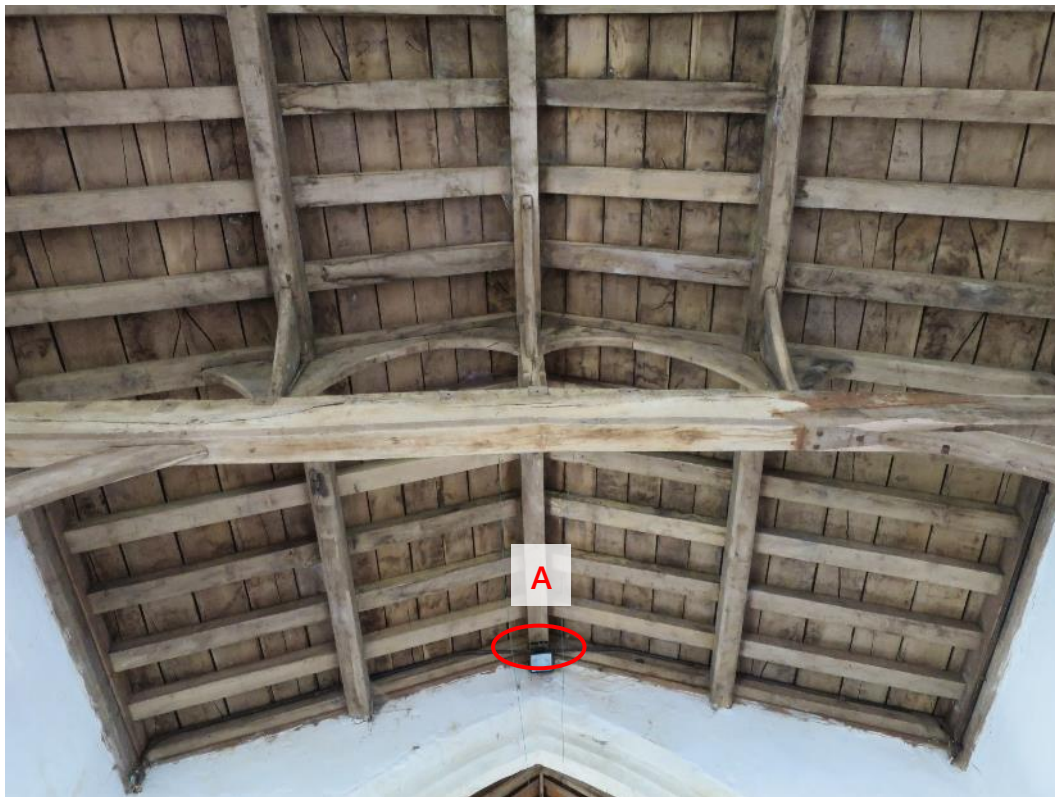
Photo 6. West end of chancel roof interior. Natterer's bat roost access circled in red (roost A in Figure 7).

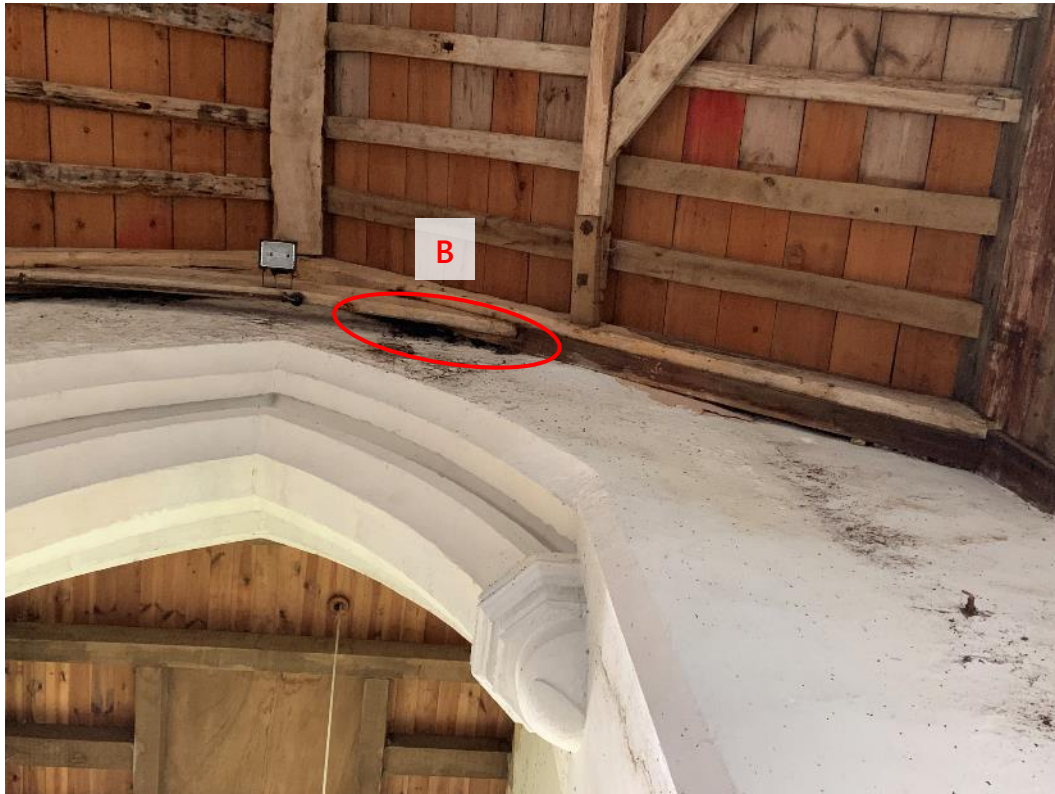
Photo 7. West end of nave roof interior, nave/tower arch and tower. Natterer's bat roost circled in red (B in Figure 7). Note droppings' staining on walls.

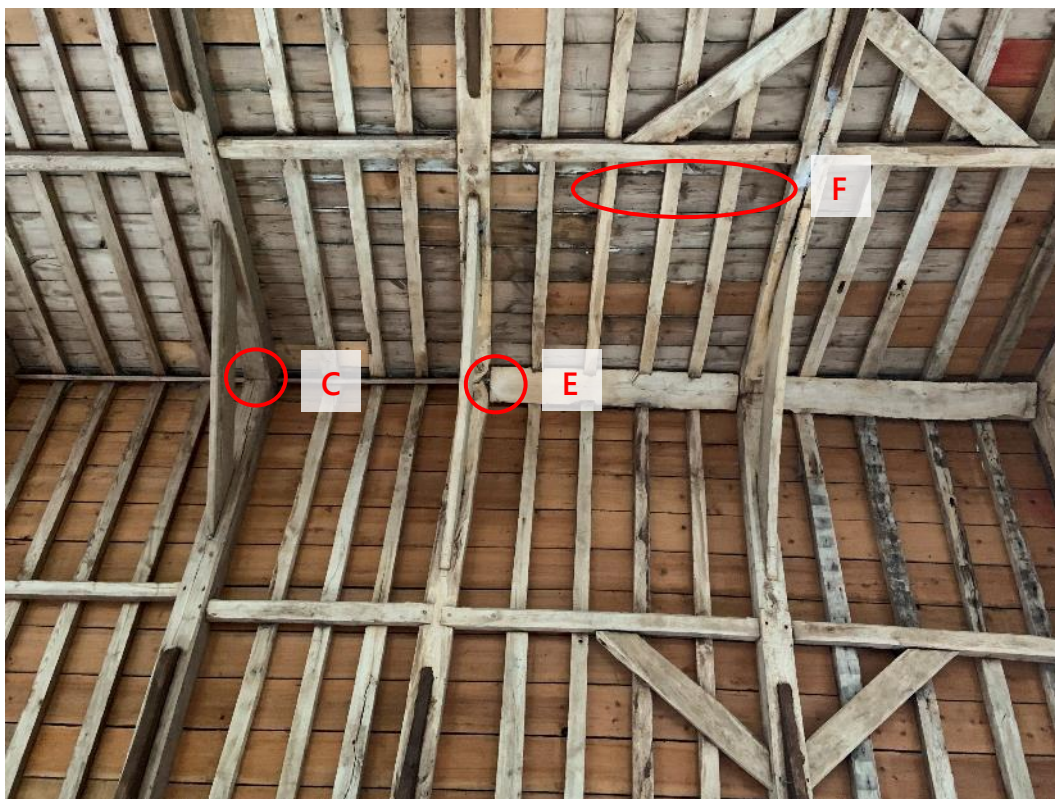
Photo 8. Nave roof interior (west end), roosts circled in red and labelled (see Figure 7). C is a common pipistrelle roost, E & F are Natterer's bat roosts.

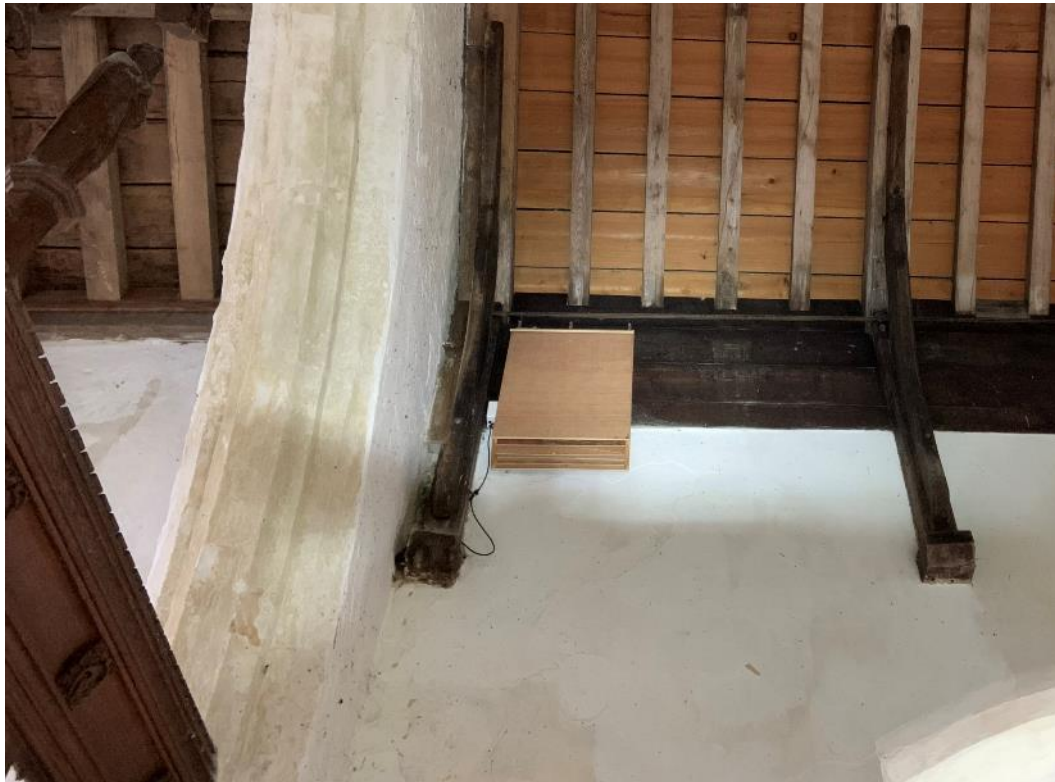
Photo 9. Bat box on south side of nave interior (east end).

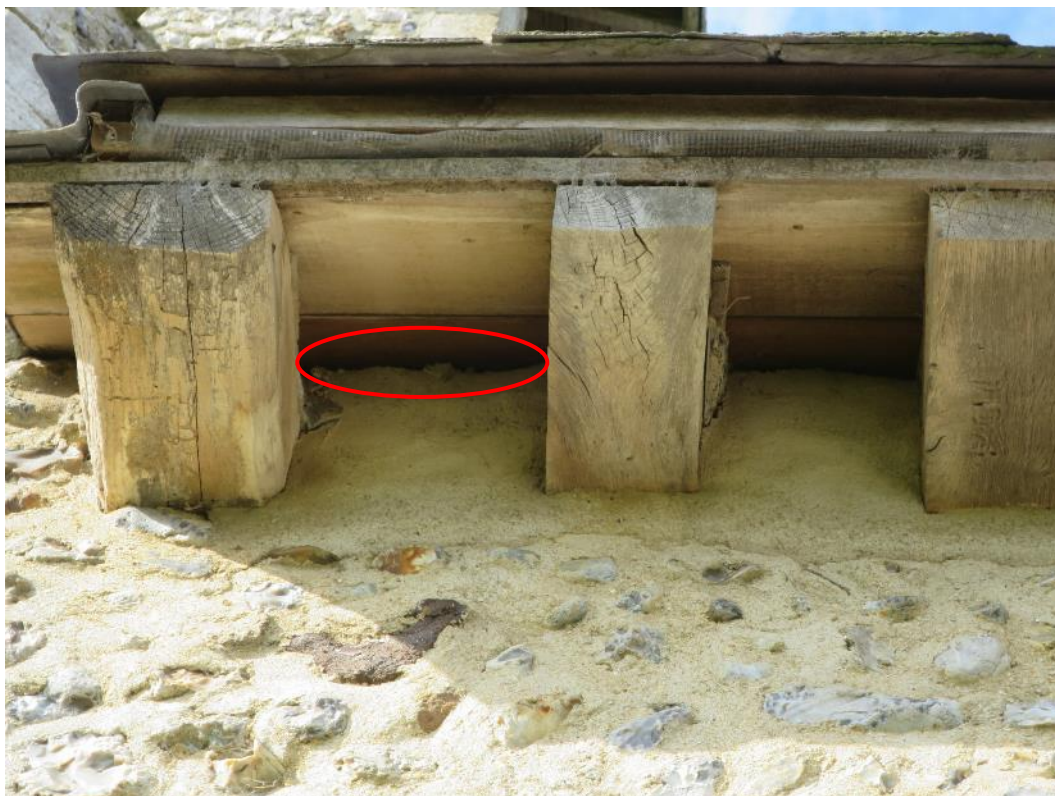
Photo 10. Typical access to/from the outside at eaves (circled in red).

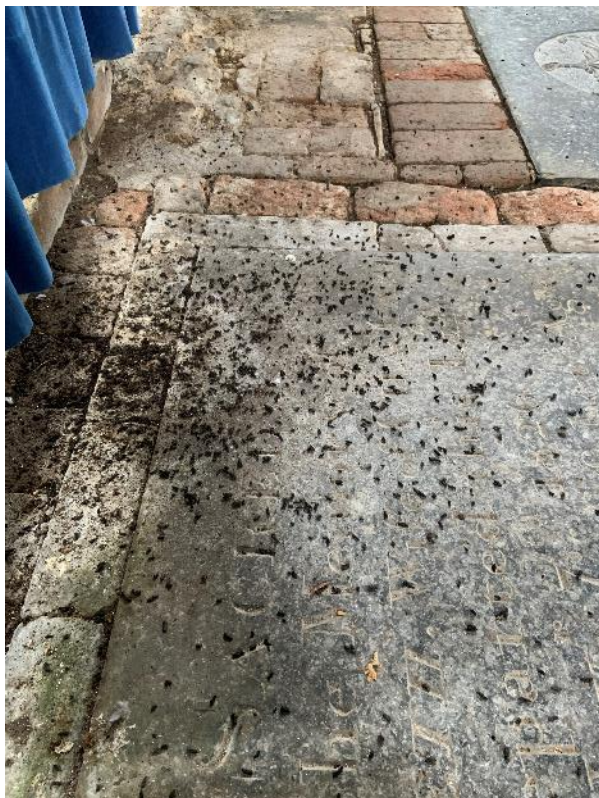
Photo 12. Bat droppings at west end of nave (beneath roost B, Figure 7) with staining/bleaching to ledger.

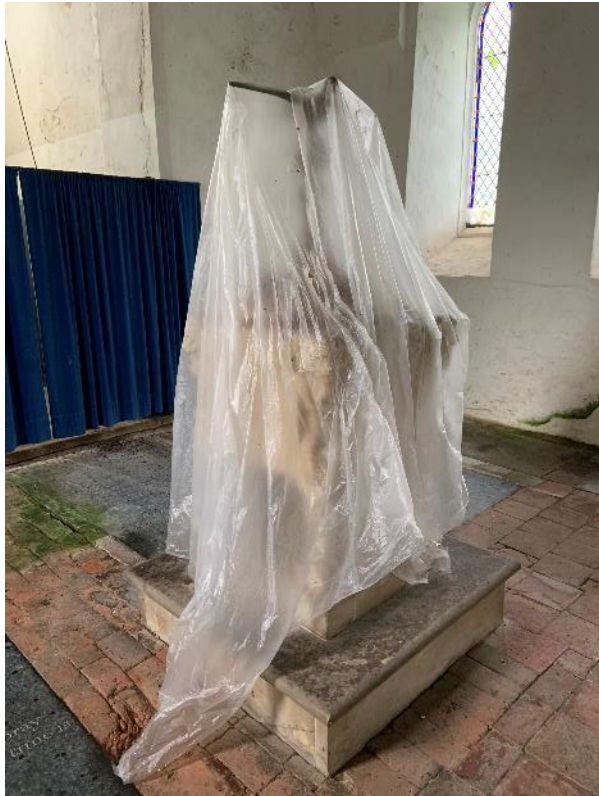
Photo 13. Font covered with plastic sheeting for protection from bat droppings/urine.

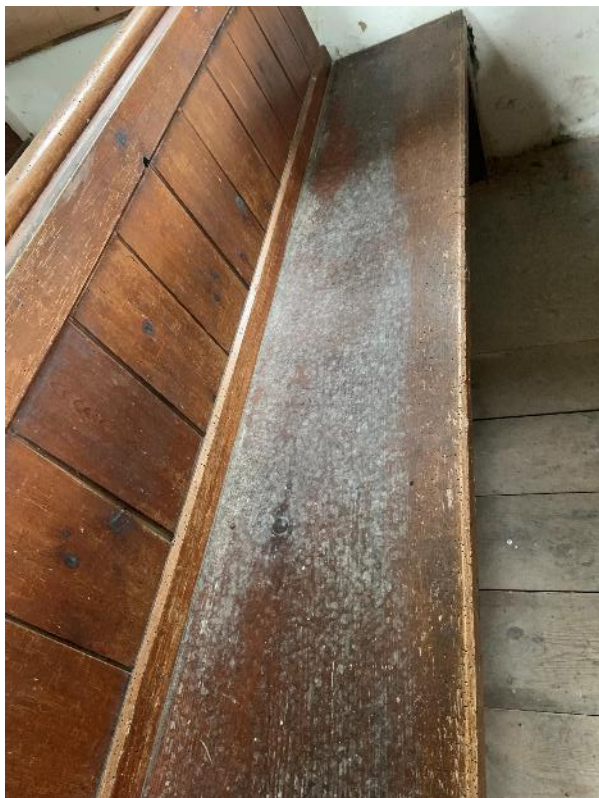
Photo 14. Bat urine bleaching on pews.
