THE CHURCH OF ST MARY THE VIRGIN, WIGGENHALL ST MARY, NORFOLK

BAT SURVEY AND MITIGATION PROPOSALS IN RESPECT OF THE HLF BATS IN CHURCHES PROJECT

Report ref: P2019-35 R1

Date: 11th December 2019

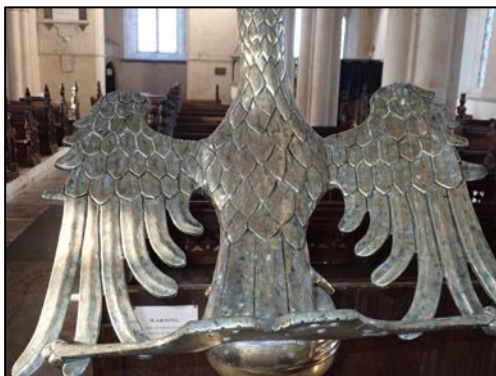
Figure 3 – Severe urine damage on the Brass eagle lectern

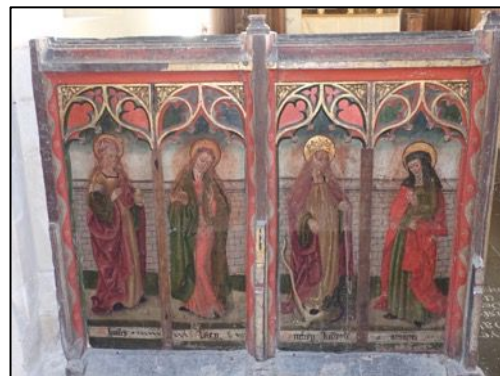
Figure 4 – C15 Chancel screen with droppings and urine

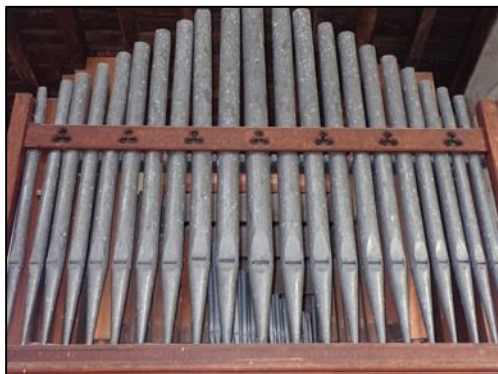
Figure 5 – Urine staining on the C19 organ pipes

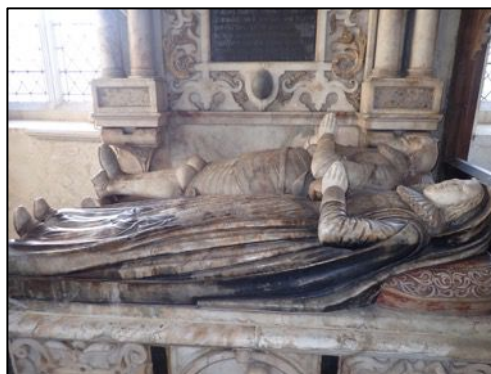
Figure 6 – Droppings and urine on the Sir Henry Kervile tomb

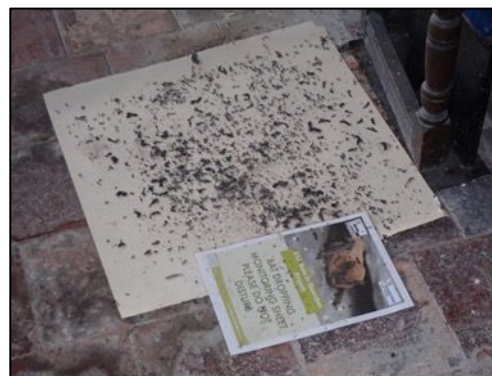
Figure 8 – Recording sheet under roost location A (Dec 2019). This sheet was cleaned during the August survey and therefore the droppings represent the deposition since that time

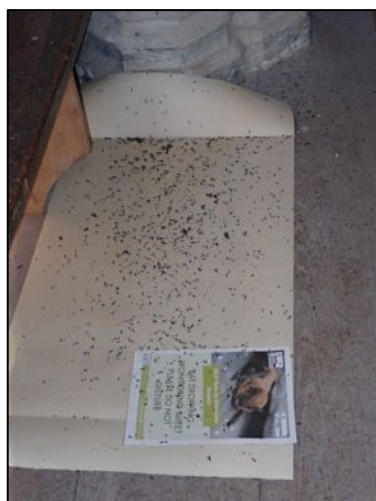
Figure 9 – Recording sheet under roost location B (Dec 2019) – This has been in place since August 2019

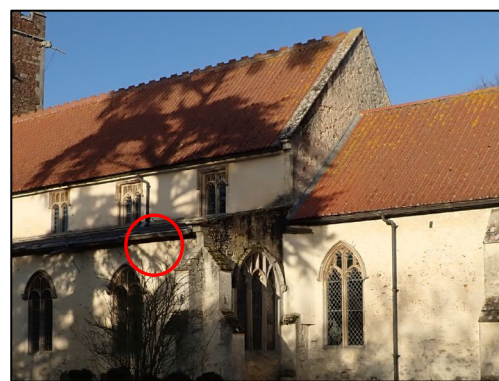
Figure 10 – Location of occasional pipistrelle access/roost E on the south side of the nave

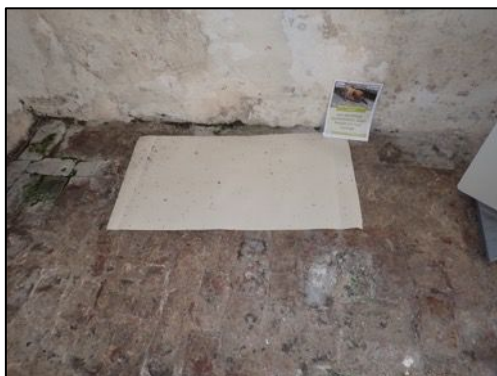
Figure 11 – Recording sheet in the south-west corner of the south aisle where the soprano pipistrelles were noted to be roosting in September 2017 and occasional roost in 2019

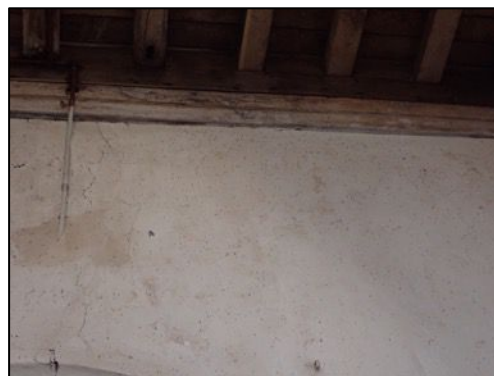
Figure 12 – Large numbers of droppings in the south-west corner of the south aisle (close to roost C). The only bat seen to potentially emerge during the surveys from this location was a natterer's during the August surveys

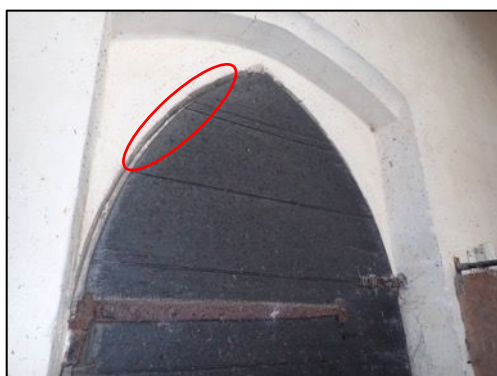
Figure 13 – Large numbers of droppings on the north door indicating the principal access point into the church. The main area for access is highlighted red.

The majority of the bats currently emerge over the north door. From experience, bats are more likely to accept changes to the roost site rather than the access point. Therefore, another option proposed is the construction of a bat box over the inside of the north door. Given that this would be on the north side of the church, the box would need to be heated. The use of a reptile heat mat could be considered for this. It would also be provided with a camera to allow the use to be monitored (refer to Appendix A for details).

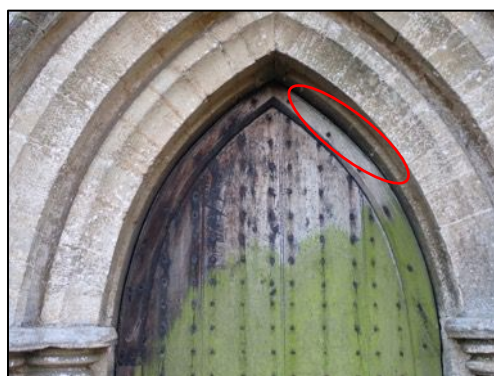
Figure 14 – Outside of the north door showing where the lichen has been worn away, presumably by the bats landing on the door.

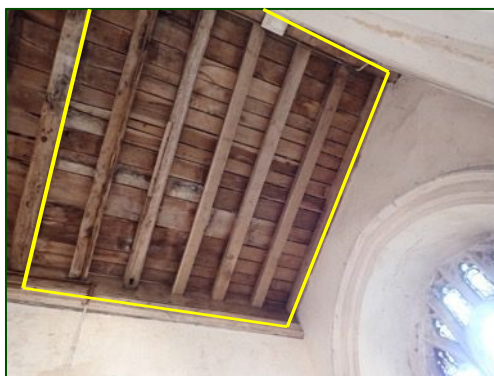
Figure 15 – Proposed location for the south-west south aisle box

As discussed in Section 1.1, the Light Touch Survey suggested a possible mitigation of creating a bat box in the south-west corner of the south aisle (where the bats were noted to be roosting in September 2017) and providing an alternative access out at eaves level. The bottom layer of wooden boards (visible inside the church) run lengthways along the aisle. The upper layer of boards runs perpendicular, separated by diagonal battens. Gaps between the boards allow access into the main body of the church from the roosting area. Although a limited number of bats were noted to be roosting here during the 2019 surveys, droppings on the sheet below this area, post the survey on the 10th September 2019 suggest that they did move towards the

end of the survey season (perhaps mirrors the 2017 use). It is proposed that a new access is created into this area at eaves level near the porch and then monitored through the use of a camera (access) or paper sheets (roost), this location is shown in Drawing D4. Following a minimum of 1 years monitoring, the gaps in the boards would be blocked with wooden infills to create a single bat box. Consideration should be given to providing some provision for cleaning out the box (perhaps by temporarily removing some of the infills or lower boards).

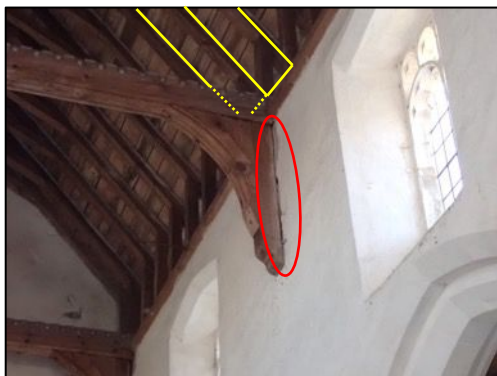
Figure 16 – Location of main bat roosting area behind the wall post with the location for the boxes shown

The main soprano pipistrelle roost appears to be behind wall posts in the nave (Roost A), and a similar feature on the north side of the church (Roost B). It is proposed therefore that 2 boxes are built under the south slope of the roof adjacent to the principal rafter (Roost A). There is no purlin on the roof so the box will either need to extend up to the ridge or be blocked at the top end, half-way up. The proposed location is shown on Figure 16 and 17. Initially, the box would not be connected to the eaves, just made available for the bats to use. At the time the box is installed, the potential for access at eaves level would be investigated and enhanced (created) as necessary. Again, the box would be provided with cameras to allow the use to be monitored. Finally, after 2 years of monitoring, the box would be connected to the created/enhanced access point to allow bats direct access.

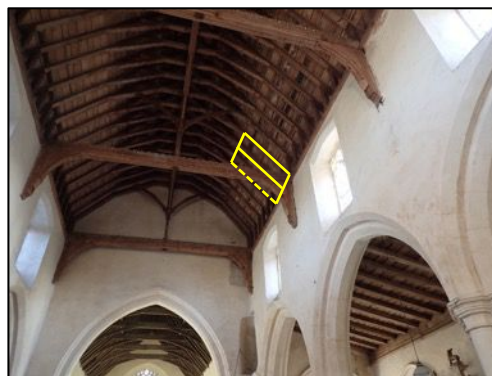
Figure 17 – Proposed location of bat boxes under the slope of the south nave roof next to current mid-summer roosting location

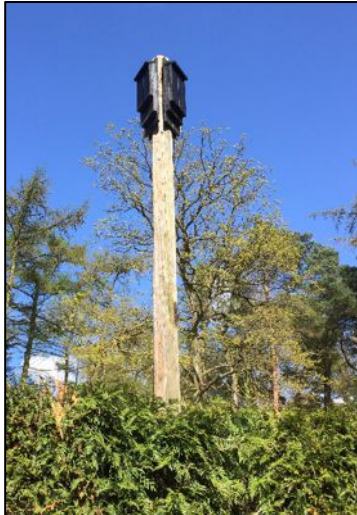
Figure 19 – Example of bat boxes erected on pole

Consider erecting a pole mounted maternity bat box in the churchyard. This would need to be positioned in a location that is in full sun, so it benefits from natural thermal radiation, thus avoiding any heating. An example is shown in Figure 19 below. Such a feature is likely to require planning permission and may require a faculty. The precise location would also depend on the positioning of graves etc.
