St Lawrence's Church, Willington Bedfordshire

DEFRA and Bats in Churches Project

29th December 2022

Site: St Lawrence's Church, Willington,
Bedfordshire, MK44 3PX
Grid reference: TL1066449868
BiC Class Licence: WML-CL32
Your Site Reference: B32RC006-8a
Licence Period: 1st August 2020 to 31st December 2023
Licence Monitoring: 2020 - 2023

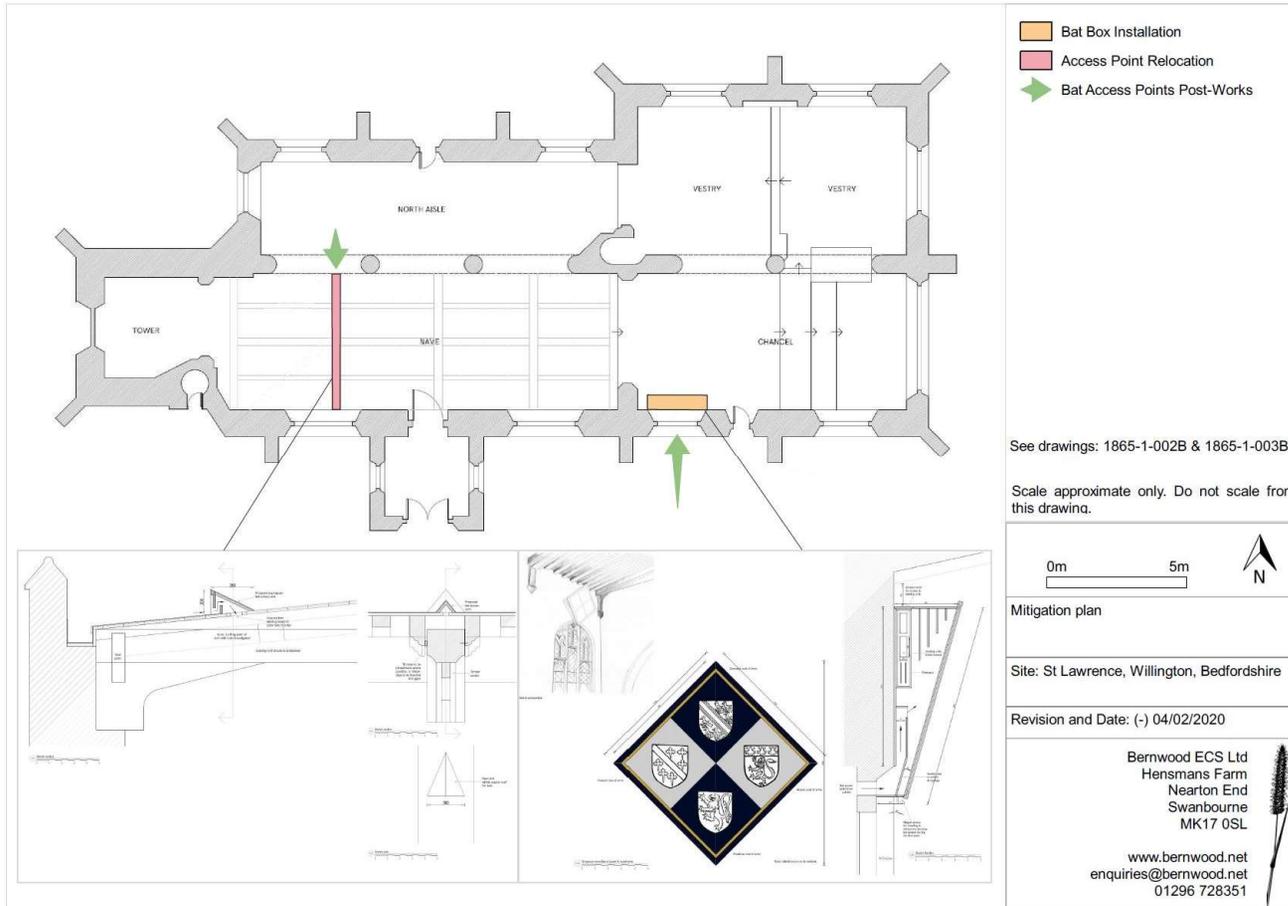
Appendix 3. Mitigation proposals

In 2020 under the Bats in Churches Class licence B32RC006-8a a bespoke heated bat box was erected in the chancel (completion: 30th October) with an additional copper gabled bat access point created in the roof above the primary roost beam in the nave, Appendix 1.

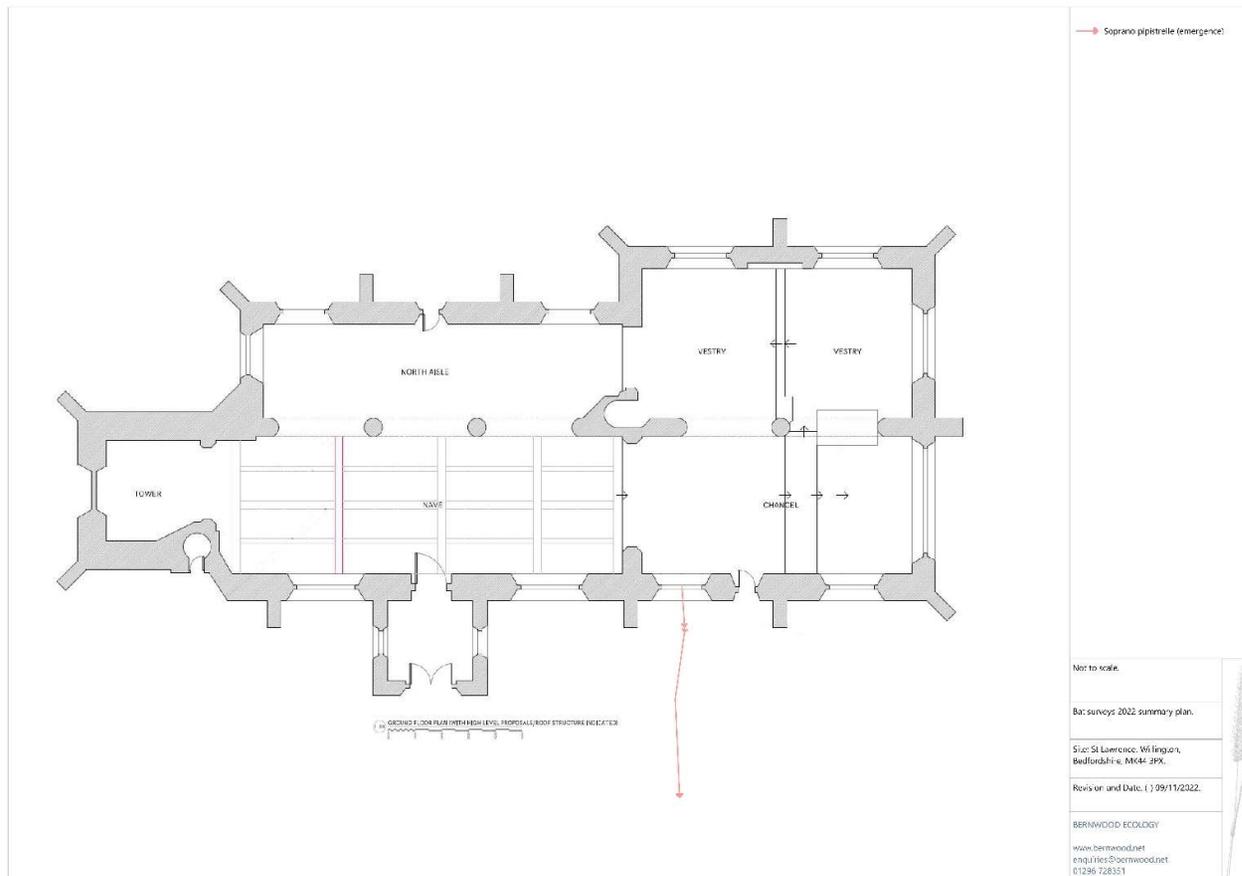
Appendix 4. 2022 Survey results summary showing bat entry/ exit point.

During the dusk emergence survey one soprano pipistrelle was observed exiting the heated batbox. No bats were observed within the church.

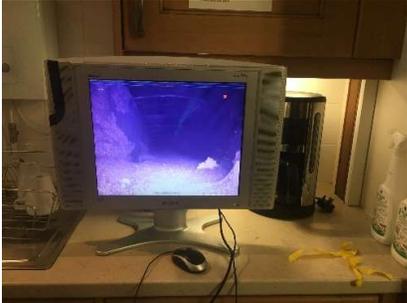
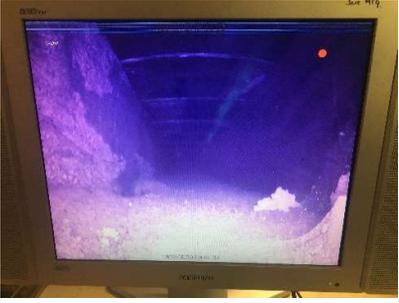
<p>28th October 2022 – Camera installation</p>

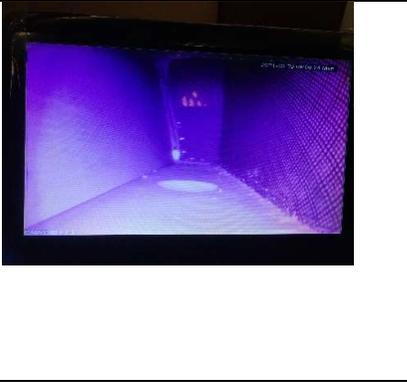
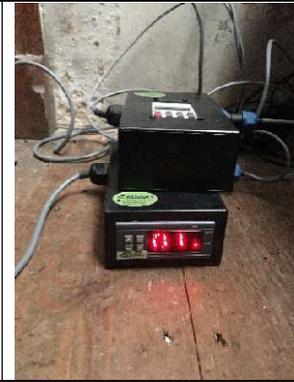
29th March 2021. No evidence of bat droppings visible on the internal camera of the heated bat box. No bat droppings were found in the boxed-in bat space of nave.

<p>29th March 2021. No evidence of bat droppings</p>

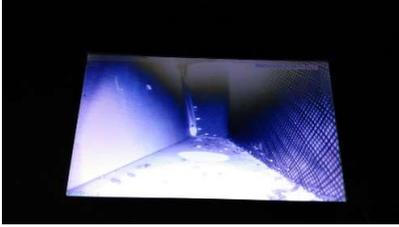
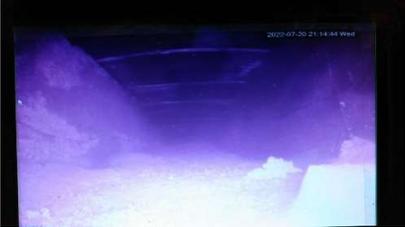
At least 20 bat droppings were visible on the internal camera of the heated bat box. The thermostat was found switched off and was reset (temperature reading was ~27°C); the timer was on and running. Hazard tape and other measures were used to prevent suspected interference with the church wi-fi modem. No evidence of bat use was visible in the boxed-in bat space of nave.

<p>20th July 2022. 20+ Bat droppings present in heated bat box. Signage added to help prevent accidental switching off of heating system & tripping out.</p>

To investigate, with specialist electrician advice, how the heated bat box system power supply can be maintained and prevented from tripping out due to accidental switching off or electrical storms, etc..

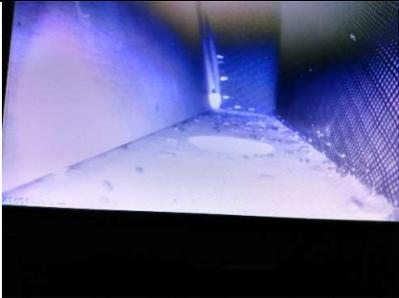
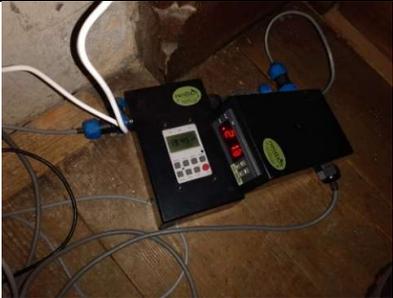
The camera inspection of the heated bat box showed ≥ 40 droppings. Both thermostat and timer were on and running (temperature reading was ~22°C). No evidence of bat use was visible in the boxed-in bat space of nave.

<p>7th September 2022. 40+ Bat droppings present in heated bat box</p>

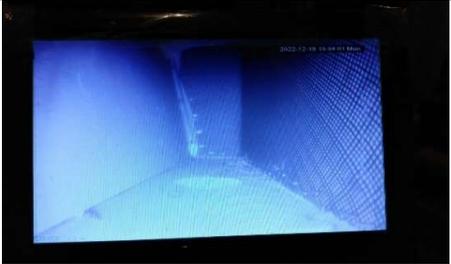
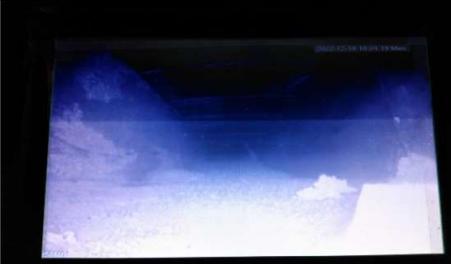
Small number of droppings present in heated bat box but previous evidence decayed. No evidence of bat use was visible in the boxed-in bat space of nave.

<p>19th December 2022. Small number of droppings present in heated bat box but previous evidence decayed</p>
