**St Pega's Church, Peakirk**

**Final Report for Bats in Churches Project**

**October 2023**

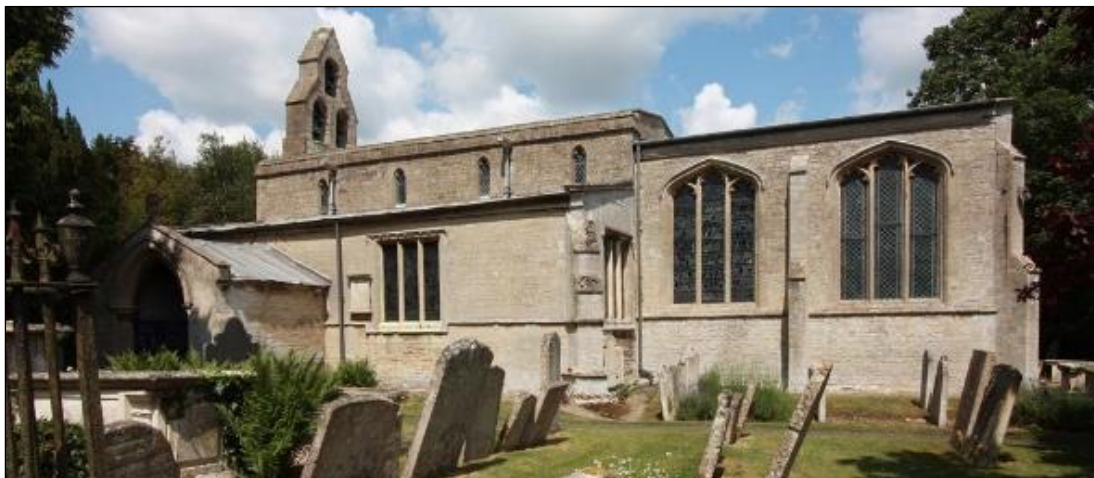
- 1.3.1 The church can be seen in Photograph 1.2.1. It is a Grade I listed building that dates to C11. It consists of a nave (with clerestory), a chancel incorporating the altar, north and south aisles, and a south porch. The church has no spire but instead has a bell tower on the west end of the nave.

Photograph 1.2.1: View of the church (in 2015) from the south facing north. Photo taken by John Salmon, CC BY-SA 2.0: <https://commons.wikimedia.org/w/index.php?curid=40710741>.

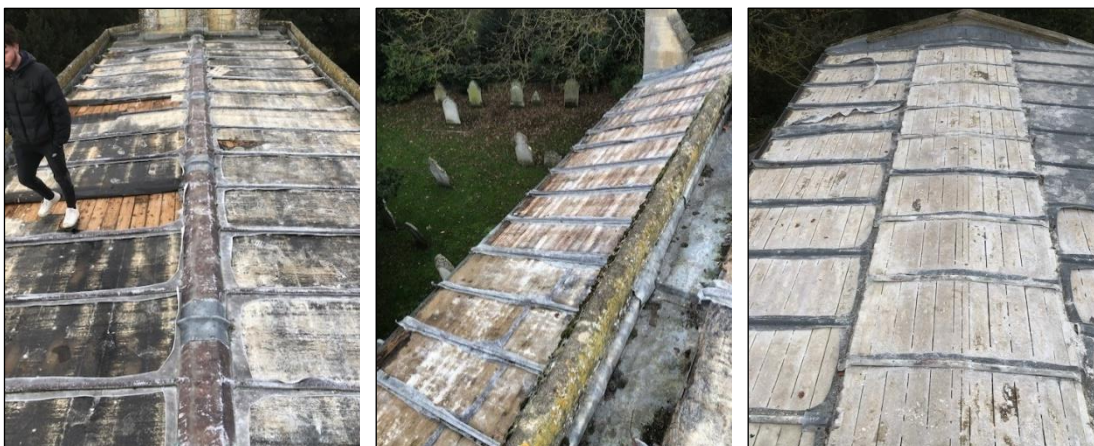
- 1.5.1 The extent of the lead theft in November 2018 can be seen in Photographs 1.5.1 to 1.5.3. Lead was stolen from the roofs of the nave, north aisle, and most of the chancel.

Photographs 1.5.1 to 1.5.3: The extent of the lead stolen from the church roofs can be seen in the photographs below, which left to right show the nave roof (facing west), the north aisle roof, and the roof of the chancel (facing east) including the area of lead that was not stolen where most bats roost.

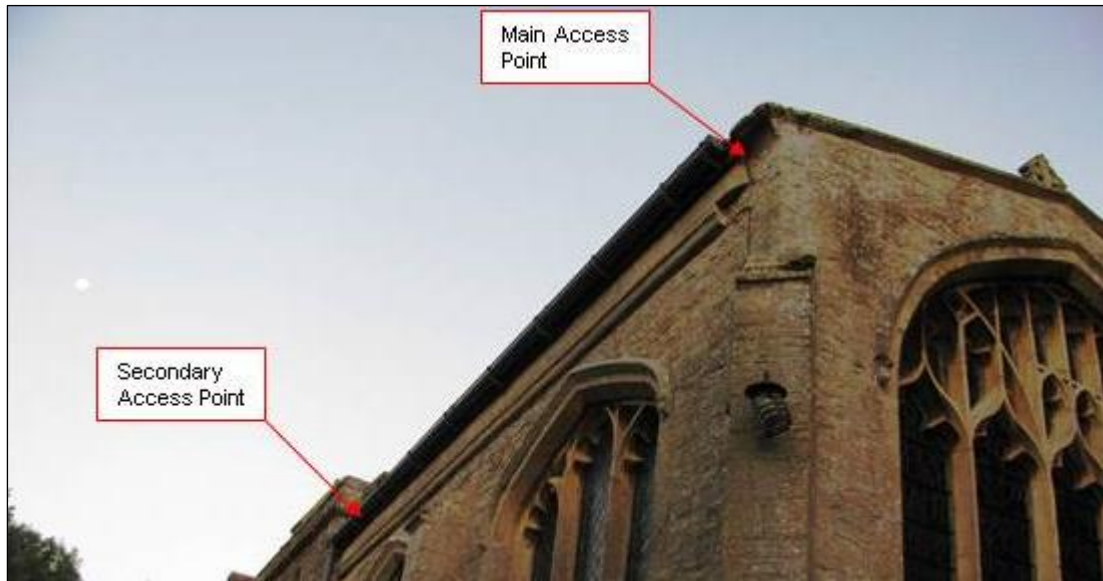
Photograph 2.1.1: The main features (on the south elevation of the chancel) used by the soprano pipistrelles to access and egress their roost in 2013 are shown by the arrows and text boxes.

- 2.1.5 The documents also report that the main bat access / egress feature for the soprano pipistrelle roost comprises an aperture in the stonework at the south-east corner of the building, although there are other features that low numbers of bats of both species have used to access and egress the church interior, such as above the south porch door, and along the gutter fascias at the eaves of the chancel and north aisle.

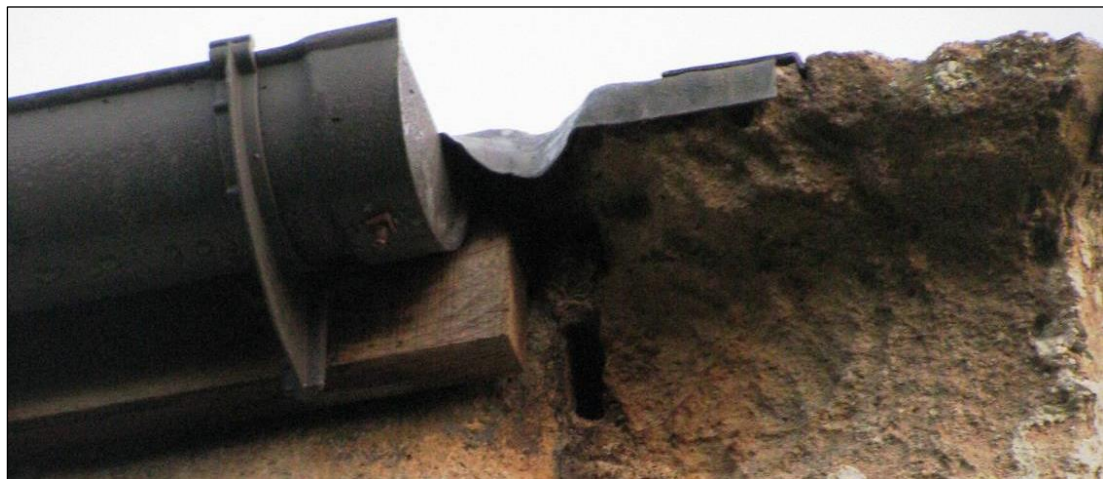
Photograph 2.1.2: Close-up view of the main access / egress feature used by the soprano pipistrelles at the south-east corner of the chancel in 2013.

- 2.3.5 On the June 2019 survey 144 soprano pipistrelles were recorded emerging from the known roost access / egress feature at the south-east corner of the church – see Photographs 2.1.1 and 2.1.2 – with 23 soprano pipistrelles recorded emerging from northern elevations: four from behind the gutter fascia along the eaves of the north aisle and 19 from the eaves of the chancel.

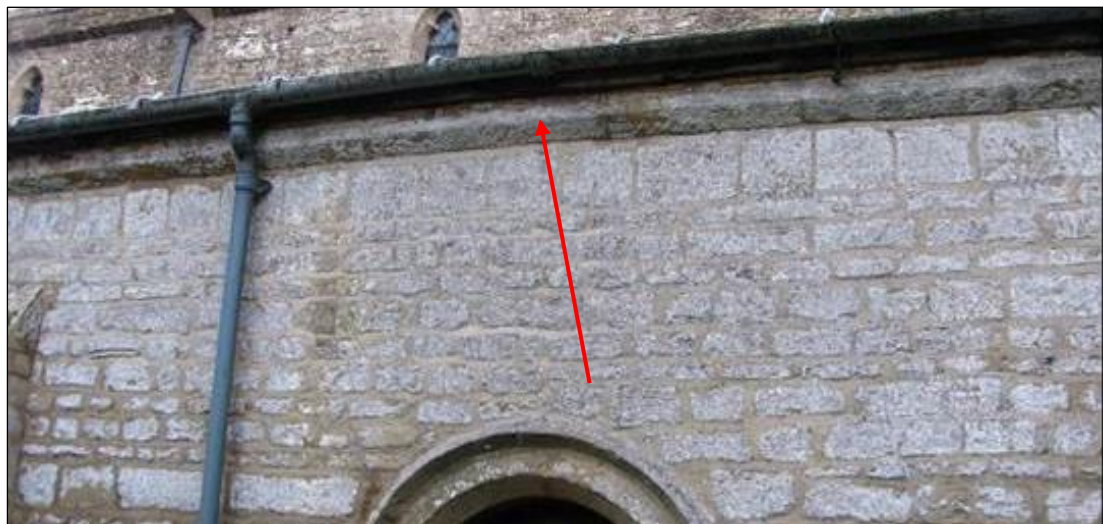
Photograph 2.1.3: There was an additional access / egress feature recorded in 2013 behind the gutter fascia above the door of the north aisle.

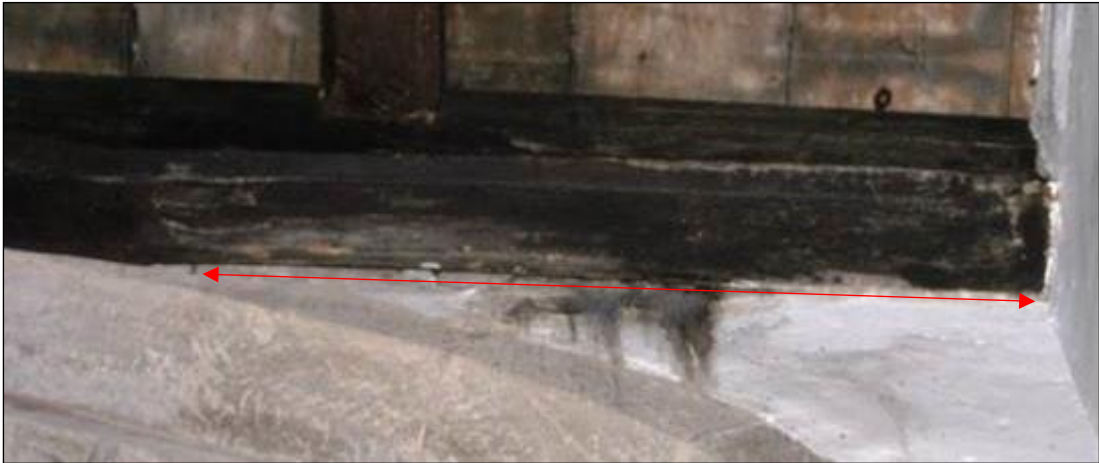
Photograph 2.1.4: It was reported in 2013 that most of the droppings inside the church fall from a gap between the end beam and wall above the window at the east end of the chancel, as shown here.

4.3.4 The remedial work in April 2021 was undertaken by CEL again. It intended to fill the space between the easternmost roof timber and the chancel east wall – see Photograph 2.1.4 - where the droppings and debris fell from and where bats could find their way into the church.

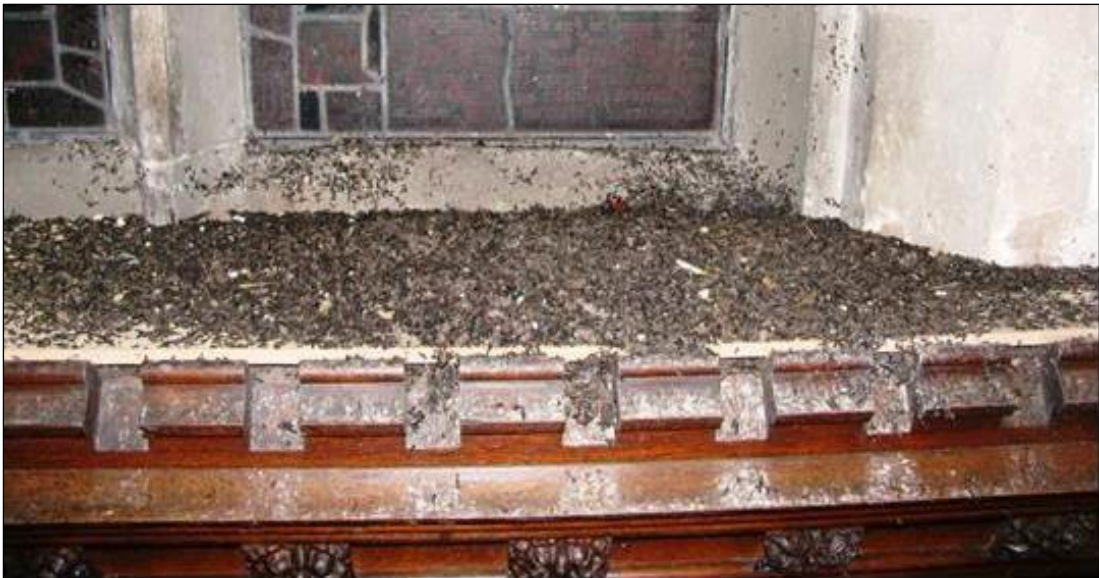
Photograph 2.1.5: A photograph of the droppings on the windowsill behind the reredos in 2013.

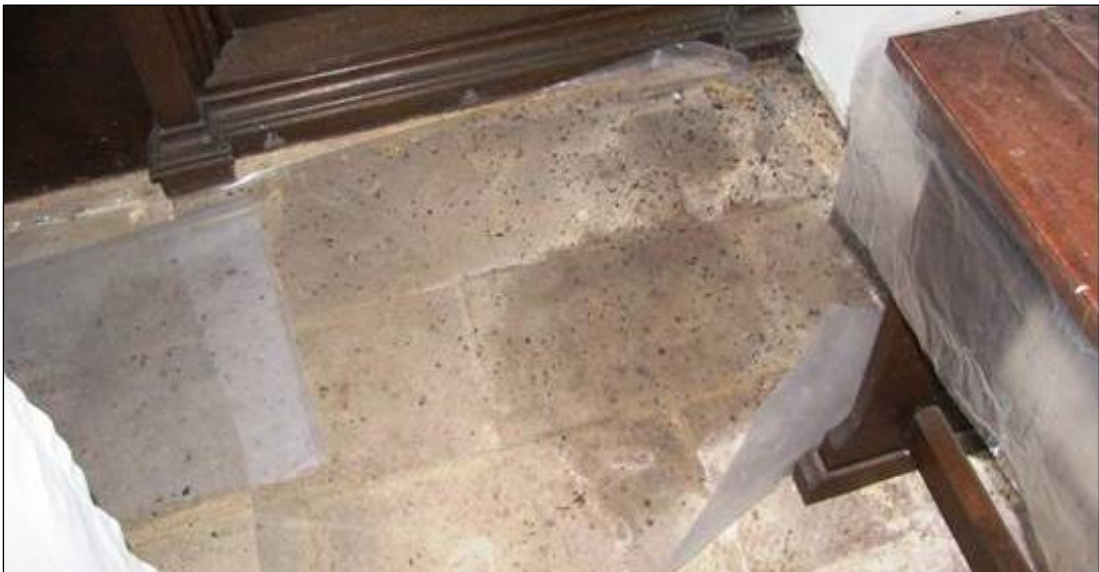
Photograph 2.1.6: A photograph of some of the droppings on the altar floor (near the reredos) in 2013.

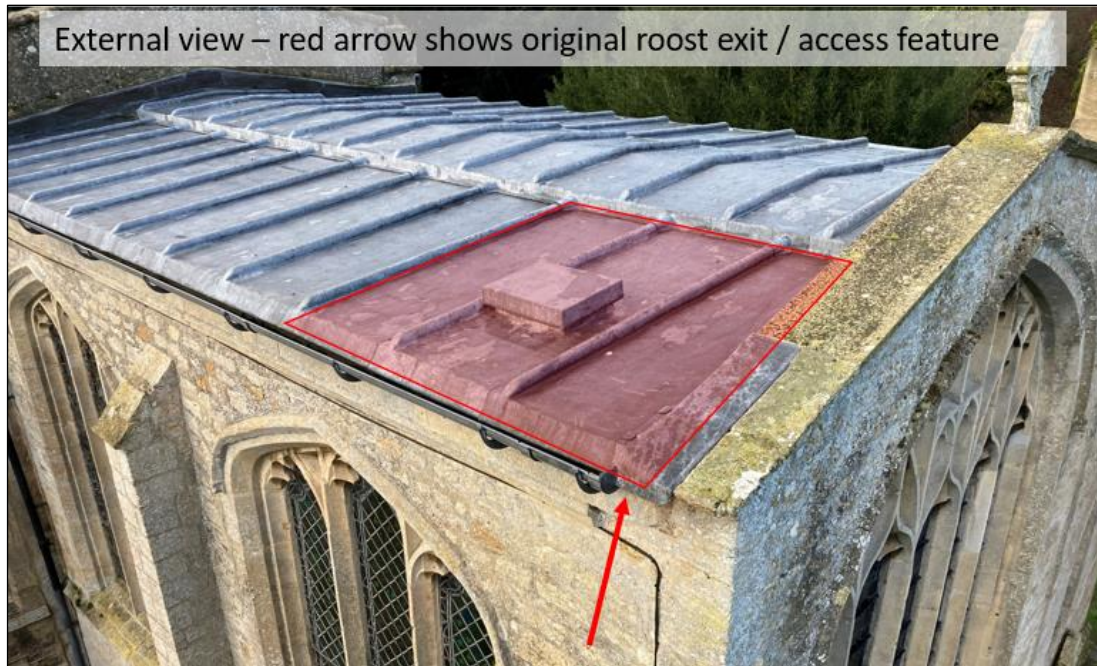
Photograph 4.2.1: View of the area where the bat compartment is located within the chancel roof, as well as the access hatch. The red arrow shows the main roost access / egress feature.

- 4.2.4 The work to install the bat compartment and re-roof the church was undertaken by [CEL Group](#). The lead that remained on the chancel roof was removed week commencing 30 September 2019 with the RC in attendance. Six soprano pipistrelles were uncovered during this initial phase of the work. These bats were re-homed by the RC to the bat boxes.
- 4.2.5 Installation of the bat compartment commenced following the removal of the lead. Progress was monitored by the RC and Architect. The bat compartment was completed by CEL week commencing 21 October 2019.
- 4.2.6 Photographs of the bat compartment are shown in Photographs 4.2.1 and 4.2.2.

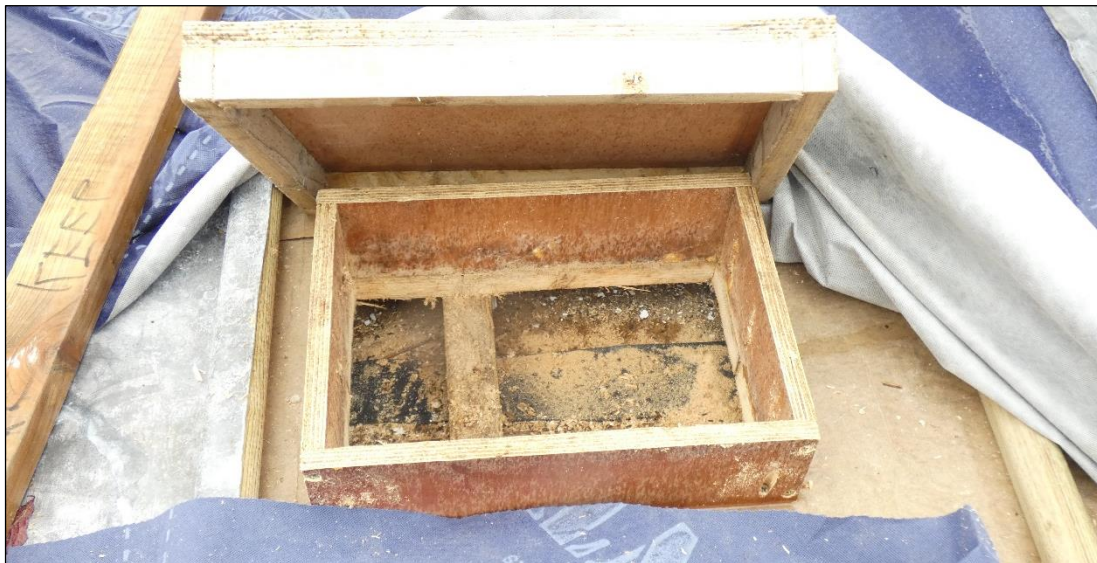
Photograph 4.2.2: View inside the access hatch, showing the internal space around it available to the soprano pipistrelle maternity colony.

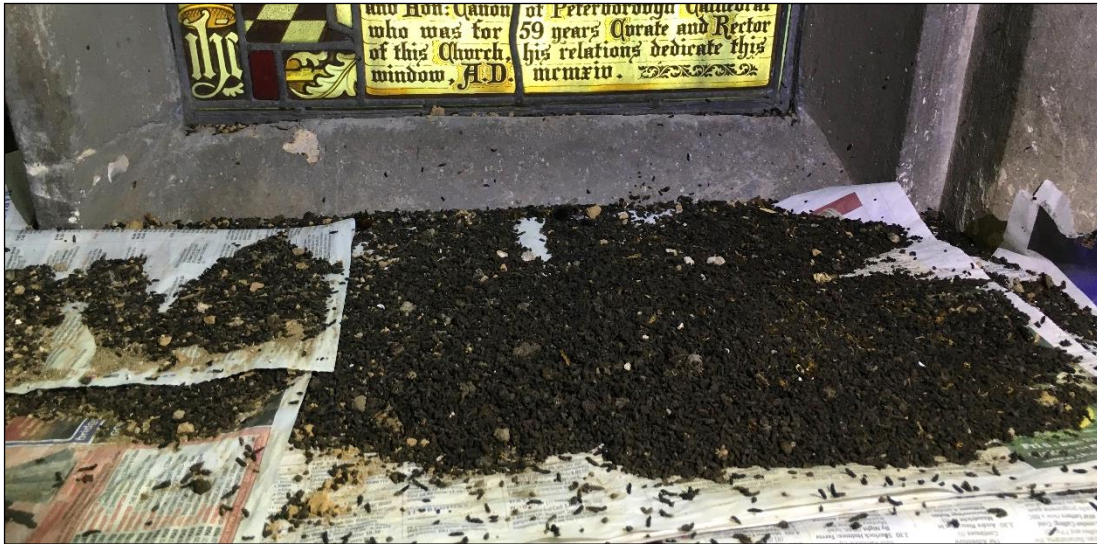
4.3.3 Overall, therefore, although the bats had returned to the church (see Section 6) the main issues caused by them had not been resolved by 2020.

Photograph 4.3.1: View of the debris on the windowsill behind the reredos in August 2020. This includes some bat droppings.

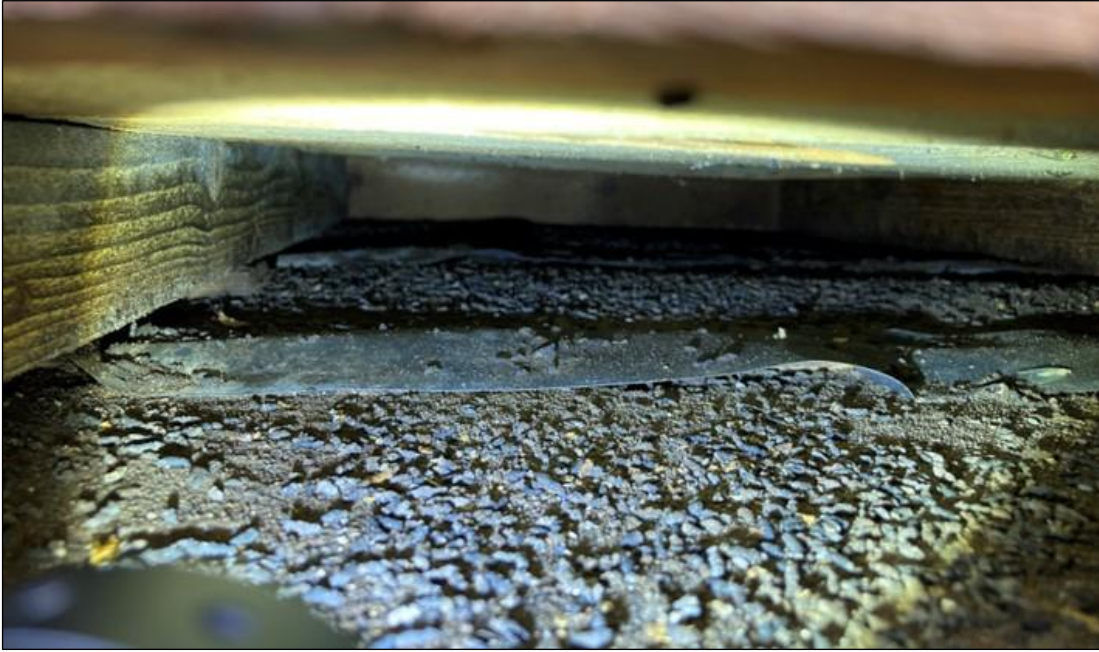
- 6.1.9. The monitoring in 2021 included an assessment of the amount of bat droppings that had accumulated inside the bat compartment since late 2019 via a MEWP. This revealed that ample space remained inside the roost compartment for bats and droppings, as evidenced by Photograph 6.1.1.

Photograph 6.1.1: Indicative view of the amount of bat droppings inside the bat compartment in December 2021, after two summers of usage by the maternity colony.

- 7.1.14. Safe access for volunteers to monitor and clean the bat compartment was a problem repeatedly highlighted by the BiCCL RC during the Site Registration period and an agreeable way forward was not found. It is strongly recommended that as part of the legacy of the BiC Project a solution is pursued, to ensure that the bat compartment at the church remains fit for purpose.

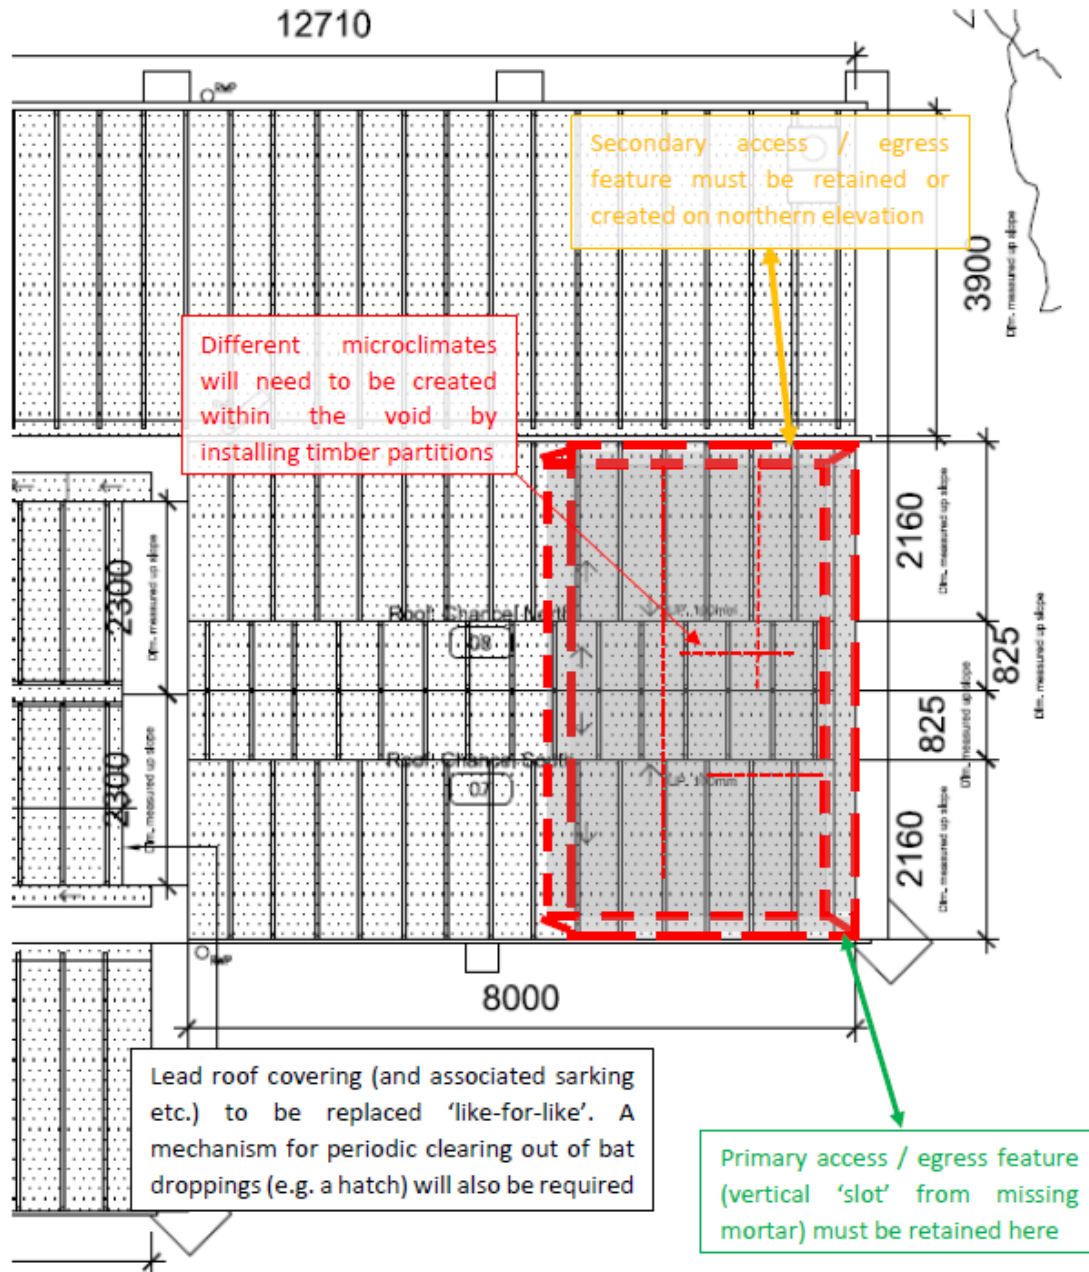
9.4 2019 Bat Mitigation Drawing #1

St Pega Church, Peakirk – Sketch of Proposed Bat Roost Provision in Chancel Roof – 4 July 2019
