THE CHURCH OF ST ANDREW, WOOD DALLING, NORFOLK

BAT MANAGEMENT PLAN

Report ref: P2021-20 R2 **FINAL**

Date: 30th October 2021

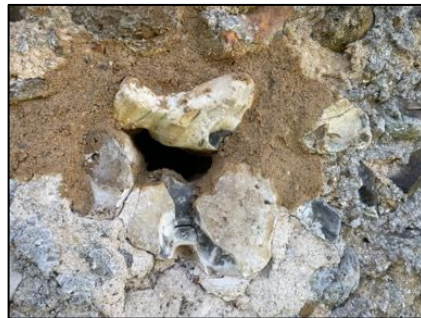
Figure 6 – One of the newly installed putlog holes

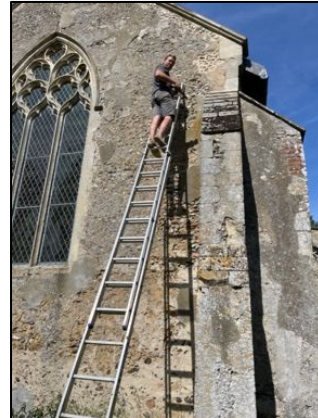
Figure 7 – Installation of the additional putlog holes on the east face of the chancel

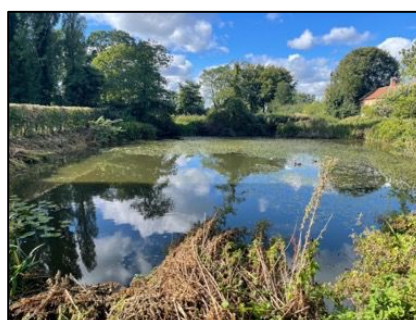
Figure 19 - Pond to the north of the church attracts foraging bats

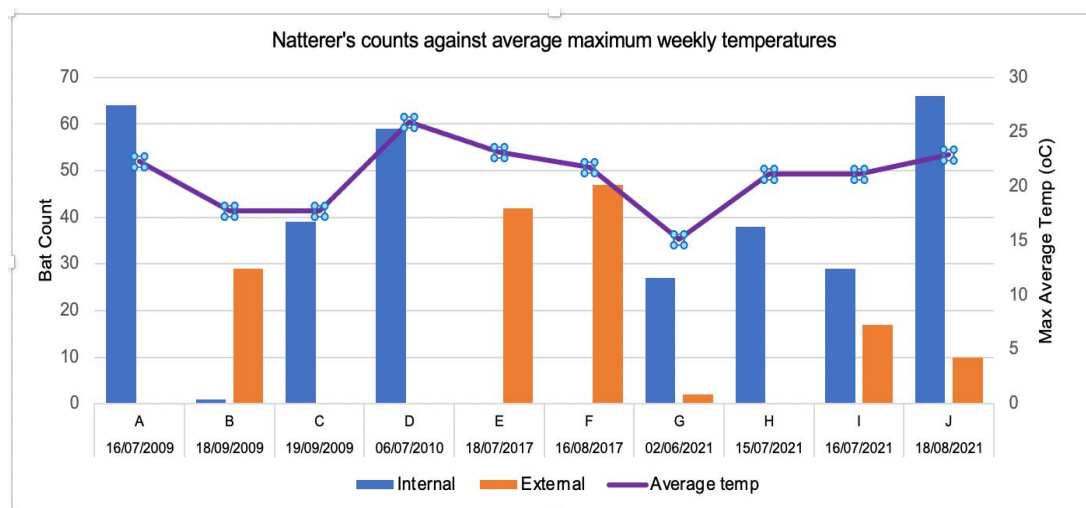
Graph 1 – Natterer's internal and external count against a weekly average temperature

5.6 The natterer's roost is confirmed as a maternity (dead juvenile found in 2021) with the roost moving between various locations internally and identified location externally (eastern elevation) although other external locations have previously been used. Comparison has been made to the prevailing weather temperatures (see graph above) to how the locations of the roosting bats change. It is concluded that there appears to be no direct correlation in the number of bats roosting externally or internally during periods of colder or warmer weather conditions.

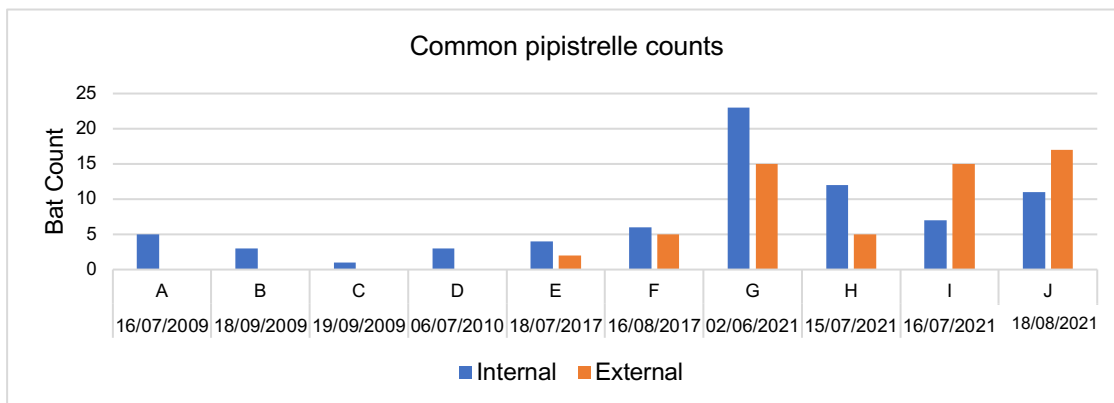
5.8 The graph above shows that the number of common pipistrelles present at St Andrews church in 2021 has more than doubled since it was last surveyed in 2017 with the utilisation of external roosts significantly greater than previously recorded.

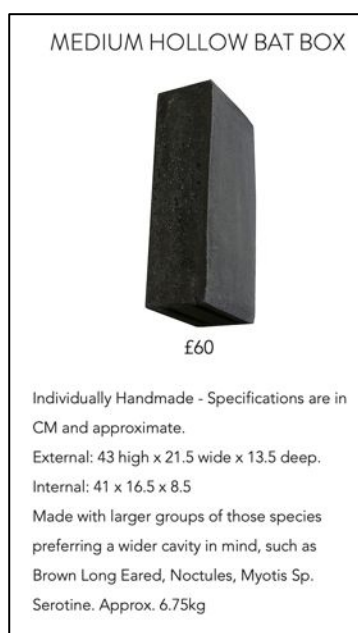
Figure 24 – Example of a Greenwood Ecohabitat bat box

- 7.8 It is recommended that further roosting opportunities could be provided through the opening up more putlog holes and by erecting suitable bat boxes on the elevations which are considered to be less conspicuous. This would provide an ideal opportunity for further research into potentially low cost solutions for a species that is otherwise difficult to manage for. Some boxes that are currently being trialled for natterer's at Saxlingham which resemble putlog holes are constructed by Greenwood Eco Habitats and comprise of 2-3 access slots leading to an internal void (Figure 24 below). These can be coloured to match the general wall colour. It would not be possible to attach them to the walls in the same orientation as the putlog holes so they would either have to be erected horizontally or vertically against the walls.

- 7.9 Consideration could be given to attaching two of the above boxes to the south aisle wall, possibly between the top of the buttress and the eaves where they would be least visible, as shown on the following photograph extract.

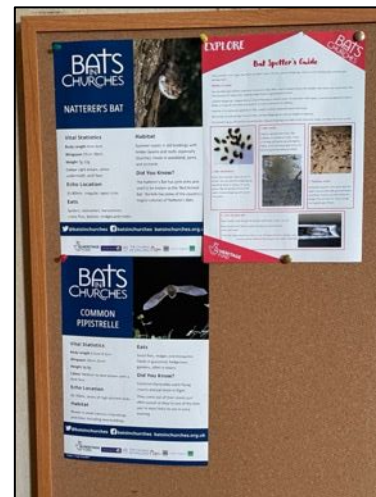
Figure 29 – Bat posters at the church – a more bespoke poster setting out the mitigation and management proposals would be preferable

- 7.23 Further events could be considered in future years although how these are organised will depend on what is decided about whether the bats are managed internally or excluded.
- 7.24 In order to better inform about the proposed works, it is recommended that a detailed display board is installed into the church explaining to visitors about the bats present and the works that are being undertaken.
