## St Mary the Virgin Church, Bromfield

Bat Surveys and Bat Management Plan

Project Code: EP2021019Av3

Bats in Churches HF Project HG-16-02183: BiC-2021-022

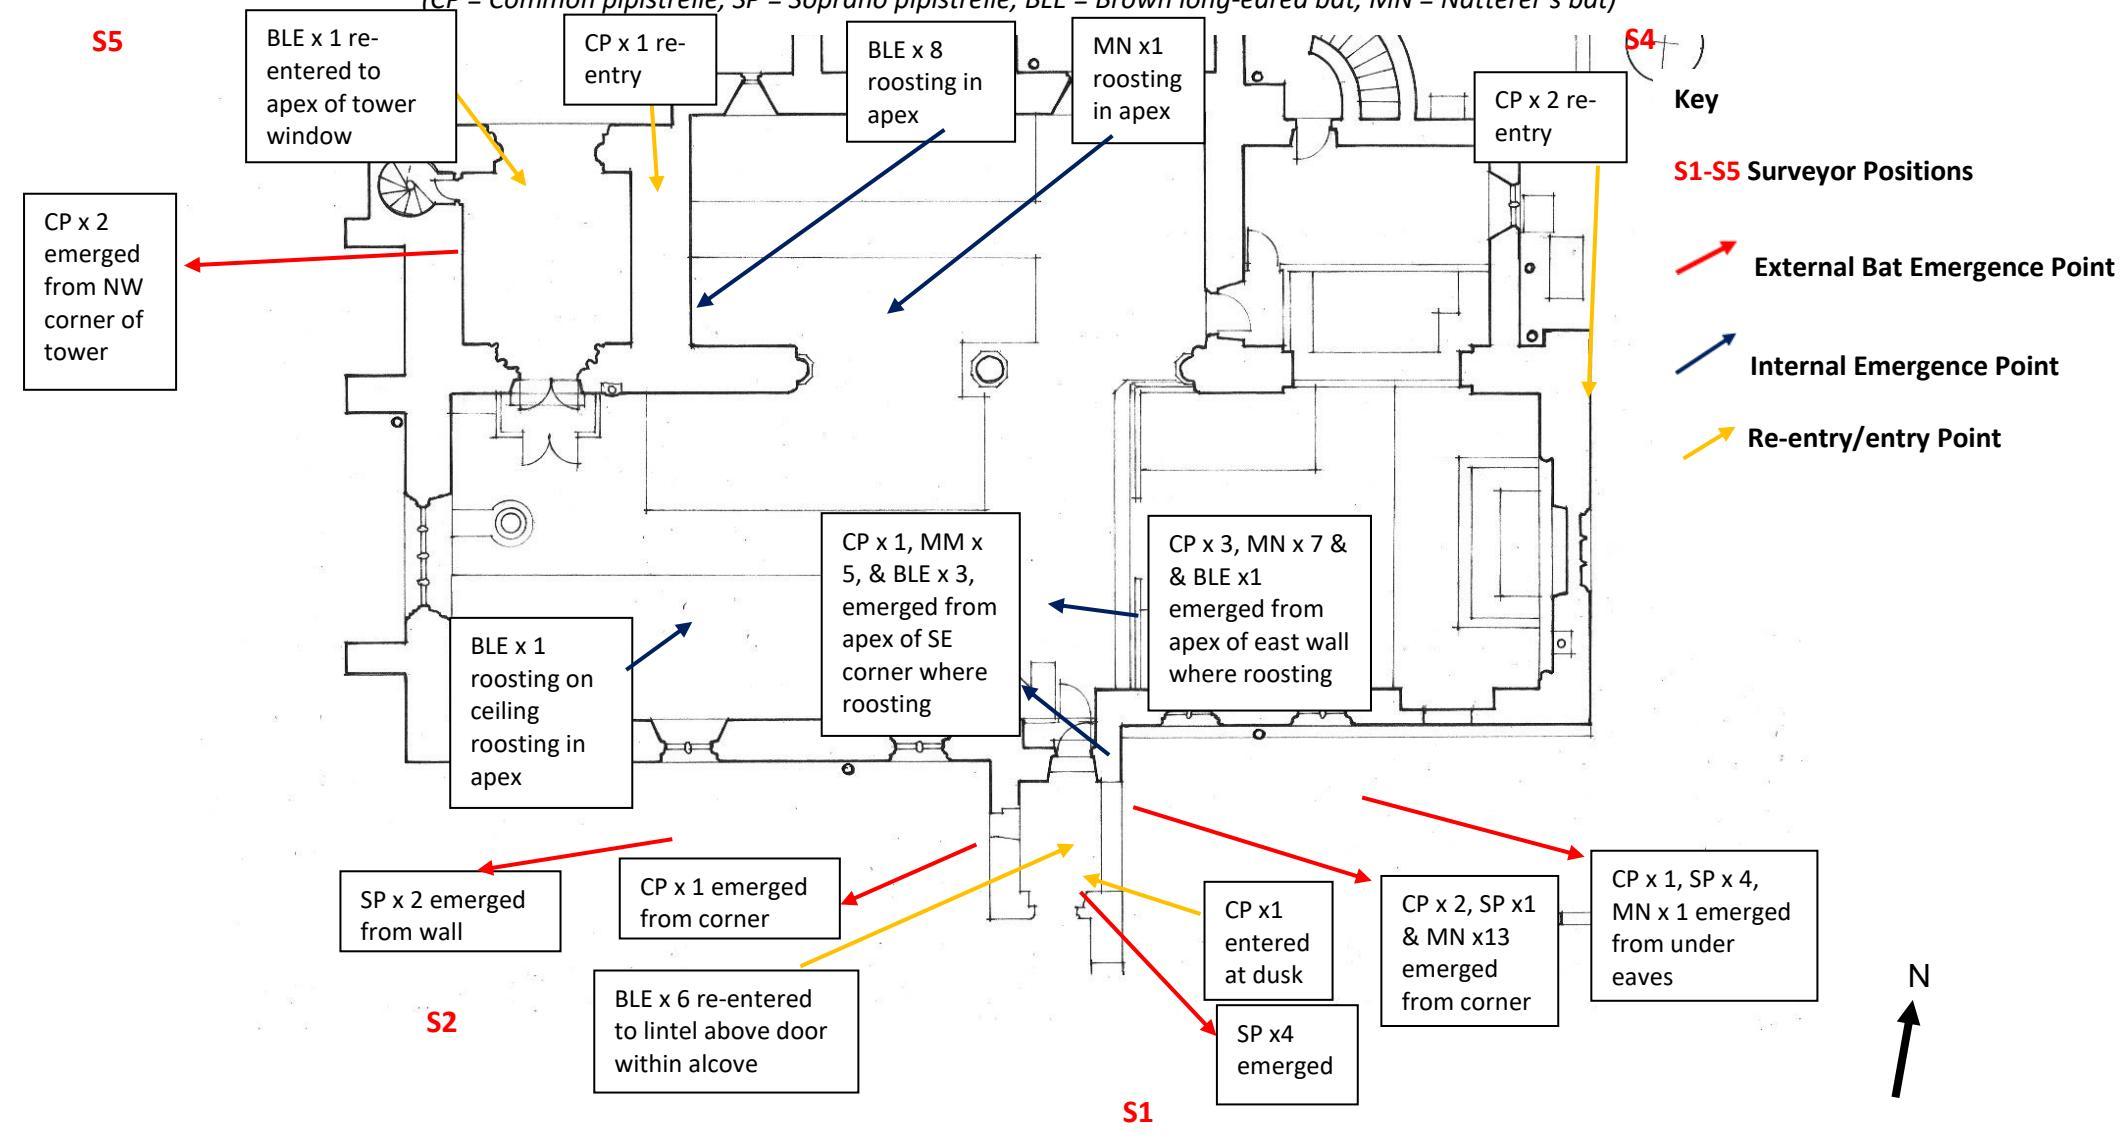
4.3.2 Figure 1a. Plan of St. Mary the Virgin, Bromfield (provided by client) including Bat Emergence/Re-entry Points (i.e. bat access points) (CP = Common pipistrelle, SP = Soprano pipistrelle, BLE = Brown long-eared bat, MN = Natterer's bat)

- 4.1.3 Survey weather data is recorded in Table 1. The results of the dusk emergence survey are summarised below, and full survey results are provided in Tables 2.1., 2.2., 2.3. and 2.4., and surveyor positions are labelled on Figure 1. Reference should be made to the photographs provided in Appendix 2. Bat emergence and re-entry points (i.e. access points) are shown in Figure 1a (pg 11) and bat roosting locations are shown in Figure 1b (pg 12).

- 4.1.8 Figures 1a and 1b should be referenced for bat emergence points and roost locations.

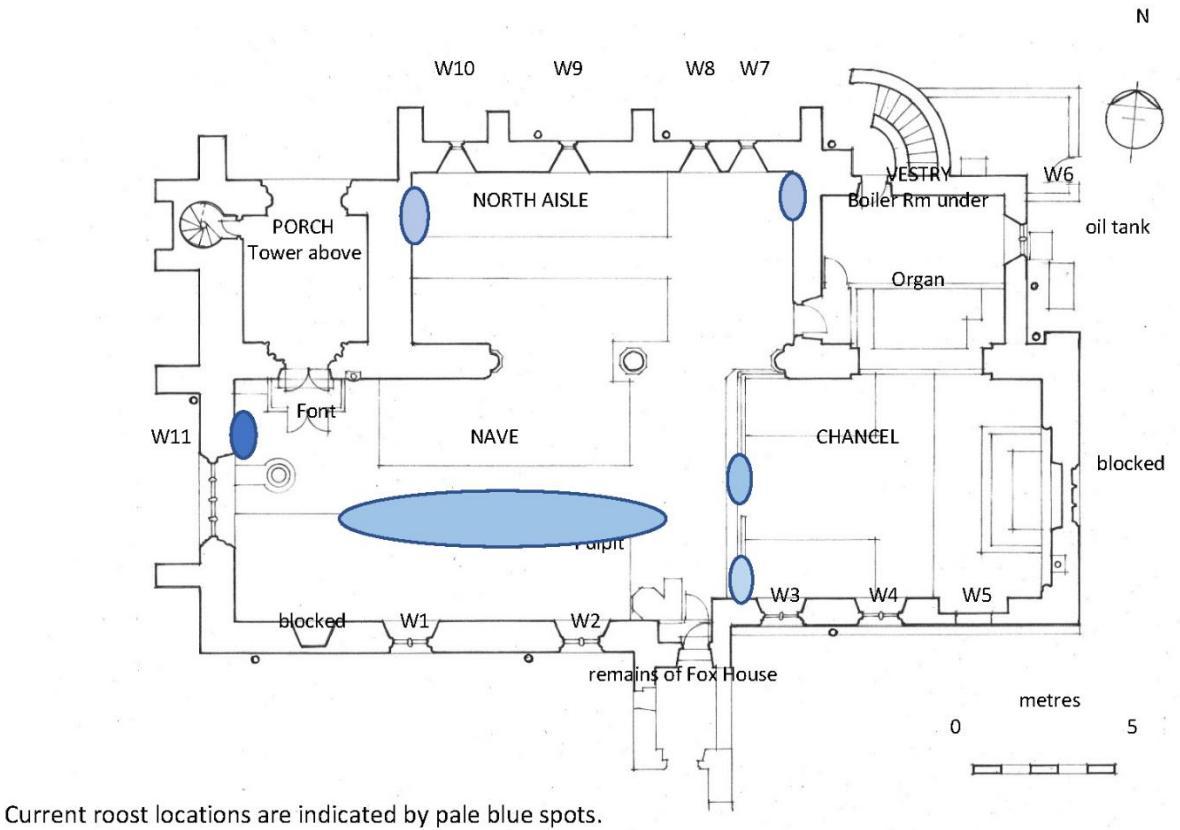
## Figure 1b. Plan of St. Mary the Virgin, Bromfield (provided by client) showing current roosts in pale blue and historic roost in dark blue

Historic roost locations are indicated by pale blue spots.

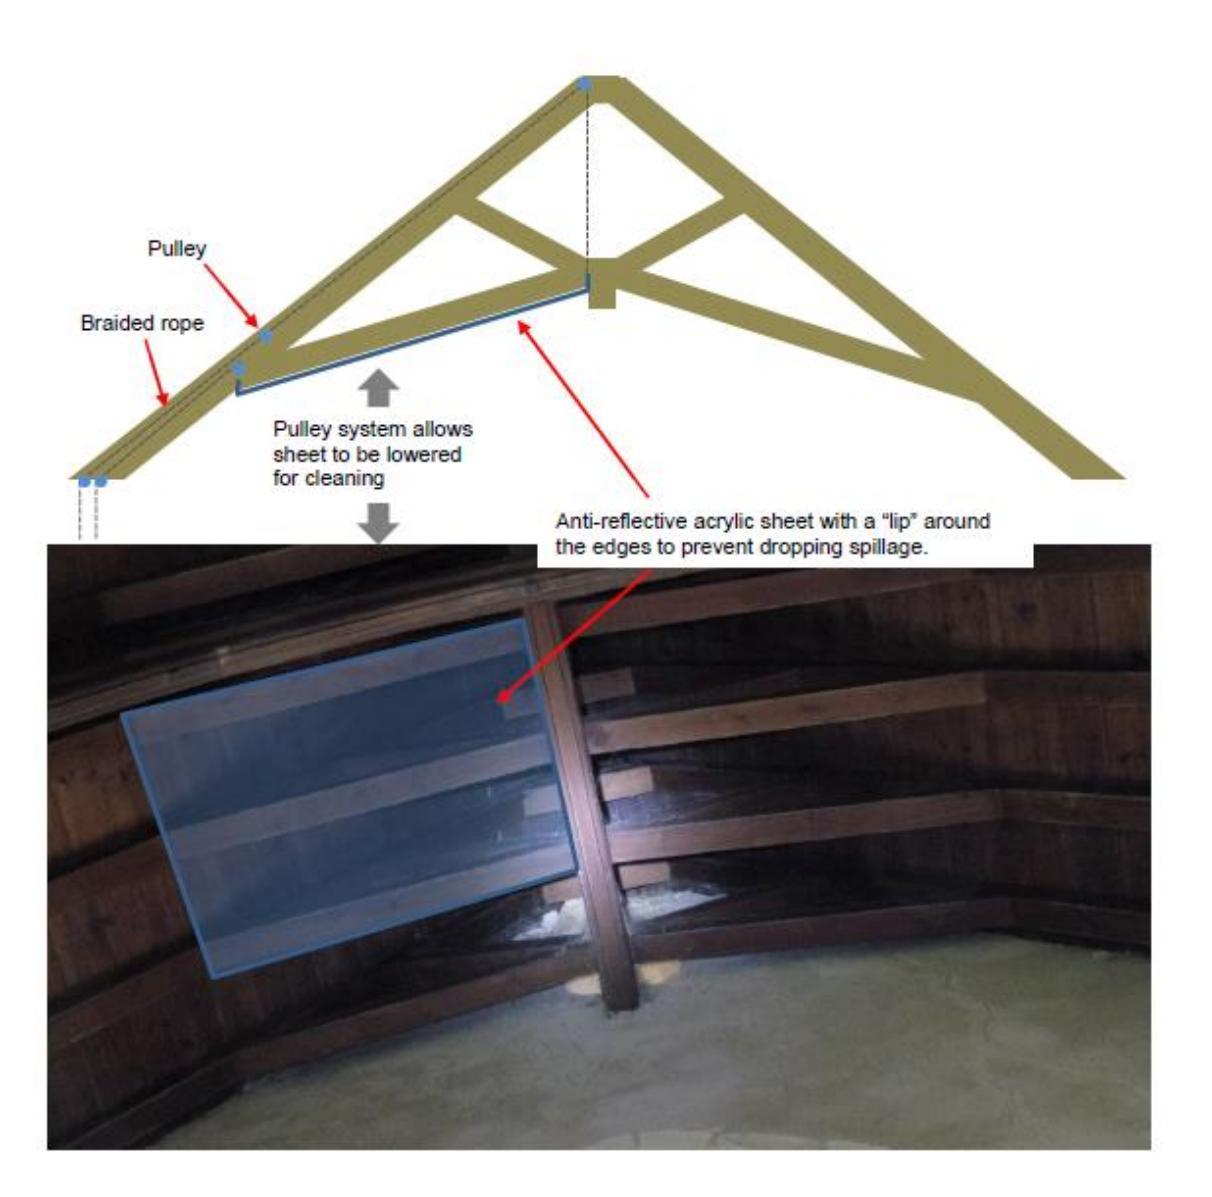
Figure 2. Proposed design for droppings catcher to be fitted under roosts (Palmer/Link Ecology 2020)

- 5.2.9 A suitable droppings catcher design has been proposed by E. Palmer for St Peters Church in 2020 and is included below. A transparent acrylic sheet would be used to minimise the visual impact. Installation of droppings catcher under roosting locations (see Figure 1b) would not require an EPS BiC mitigation licence providing that it did not obstruct bat access to a roost entrance. To ensure this, the contracted bat ecologist for the scheme should be involved in the precise locating of the droppings catcher within the church. It should be noted that the droppings catcher would need to be emptied on a regular basis and it would be advisable for the church warden/other suitable person to monitor the effectiveness of the droppings catcher.

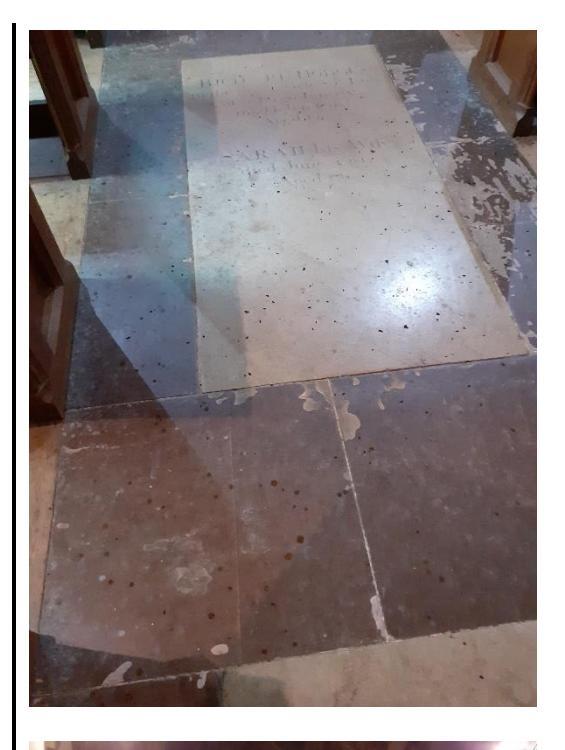
#### Droppings on floor of nave

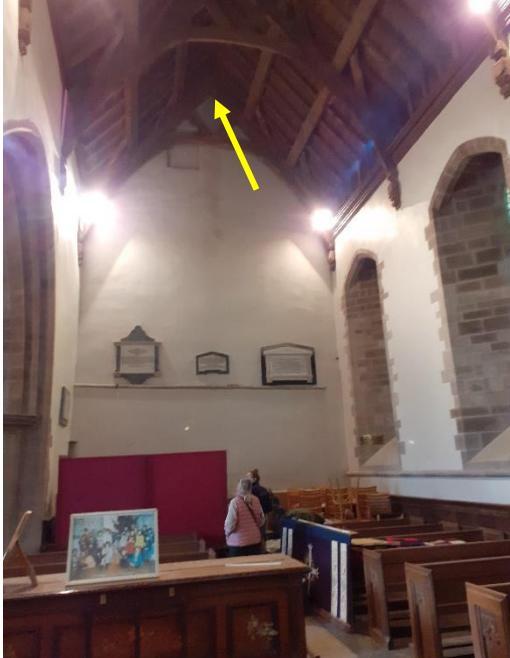
North Aisle, yellow arrow shows roost location

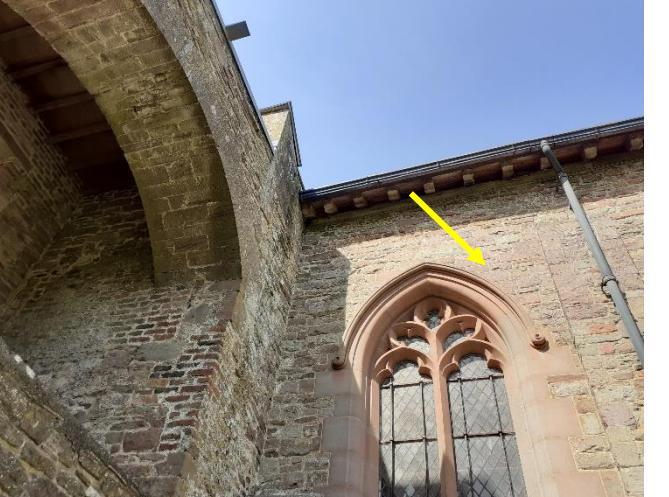
Bats emergence from southeastern side of church as shown by yellow arrow 10

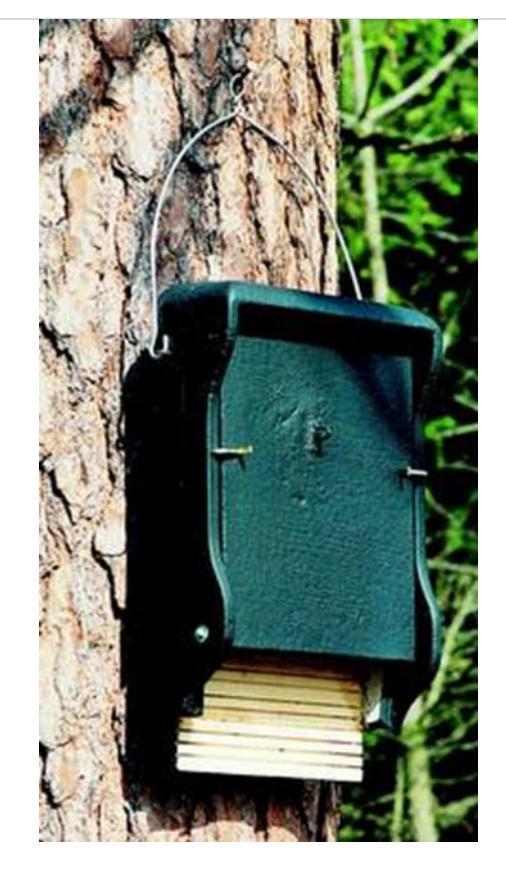
## Schwegler 1FF bat box

- 5.2.11 External roosting opportunities could be provided for bats in the form of wall-mounted bat boxes, which should be placed a minimum heights of 4m and ideally by installed to face away from a north-westerly direction. These bat roosting features should not be illuminated. Further details are provided in Appendix 3. By installing bat boxes on the exterior of the church (for example, the Remains of Fox House), these may encourage certain species such as common pipistrelle bats to use these features rather than roosting in the church. However, brown long-eared bats in particular tend

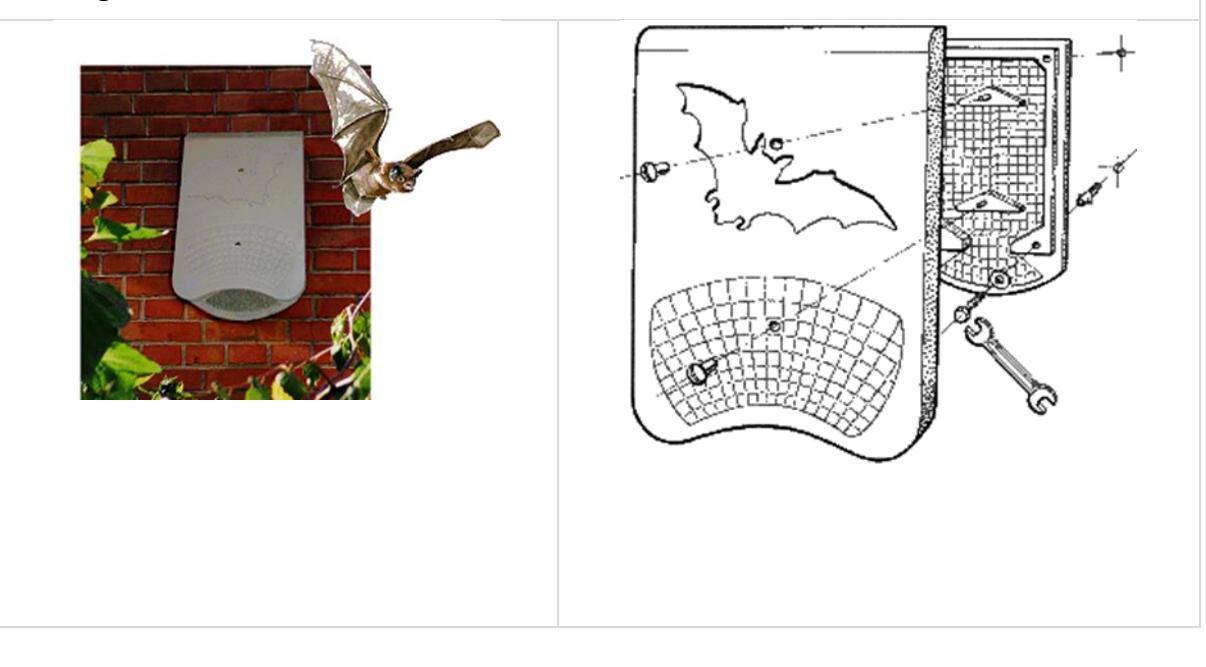
#### Schwegler 1WQ Summer & Winter bat
