Bats in Churches Project: Holy Trinity Church Great Hockham Bat Survey & Management Plan Report January 2020 (revised v1.1 June 2020)

Document type	Bats in Churches Project – Bat Survey & Management Plan Report
Version	1.1
Author	Dr Charlotte Packman PhD CEcol MCIEEM
Client	Natural England
Site address	Holy Trinity Church, Great Hockham, Thetford, Norfolk, IP24 1NZ.
Site grid reference	TL 95069 92097
Survey period	May – August 2019
Report date	4 th February 2020, updated 3 rd June 2020 (v1.1) with revised Schedule
	of Works needed due to Covid-19 restrictions

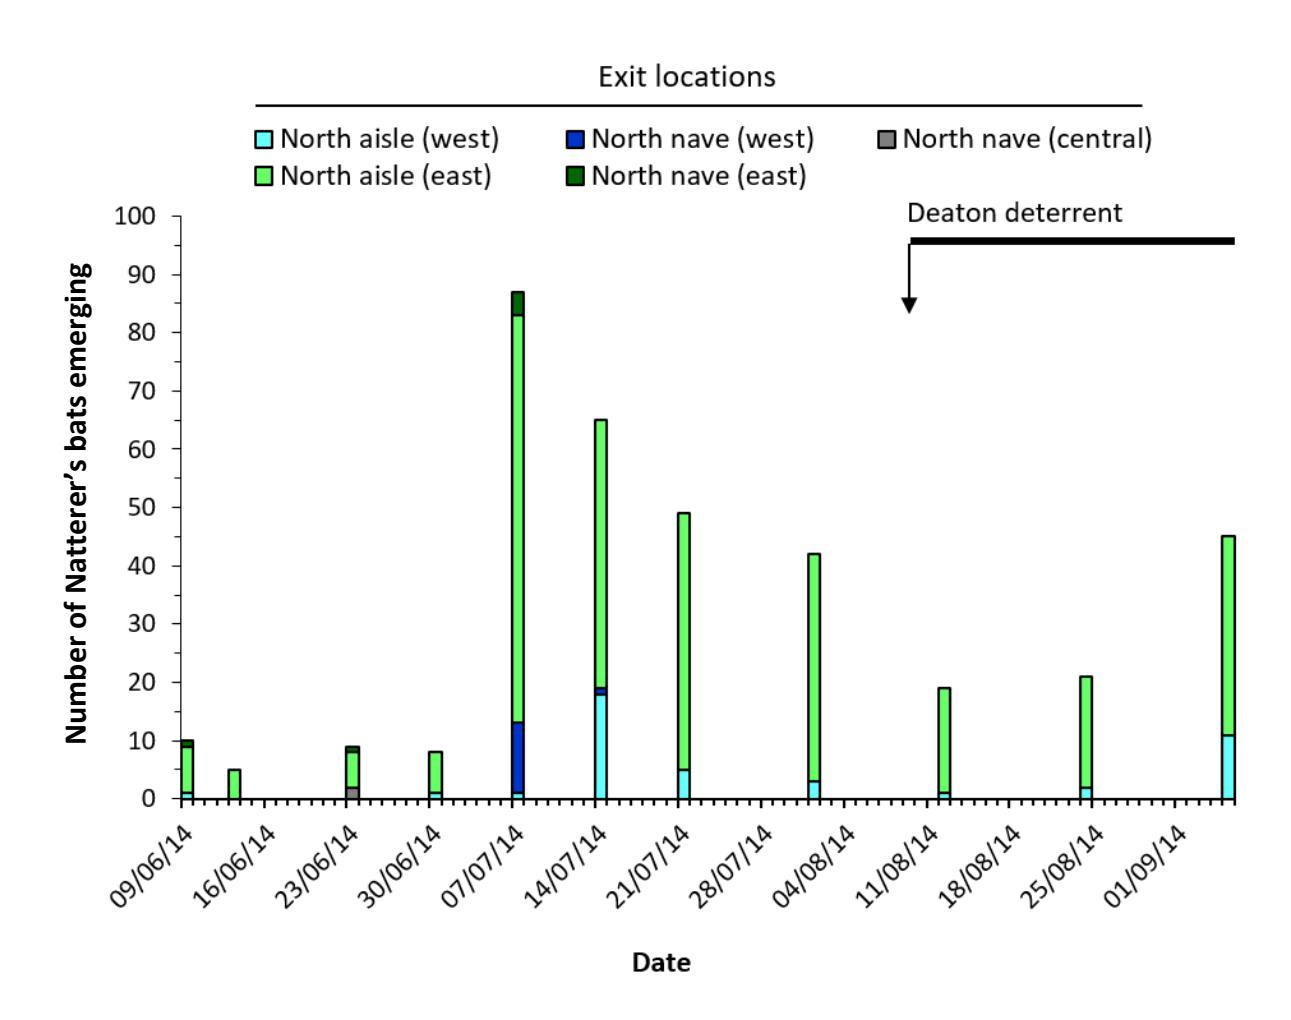
Figure 3. Dusk emergence counts showing numbers of Natterer's bats emerging from different exit points at Great Hockham Church, along with application of the Deaton acoustic deterrent. Taken from Packman *et al.* 2015.

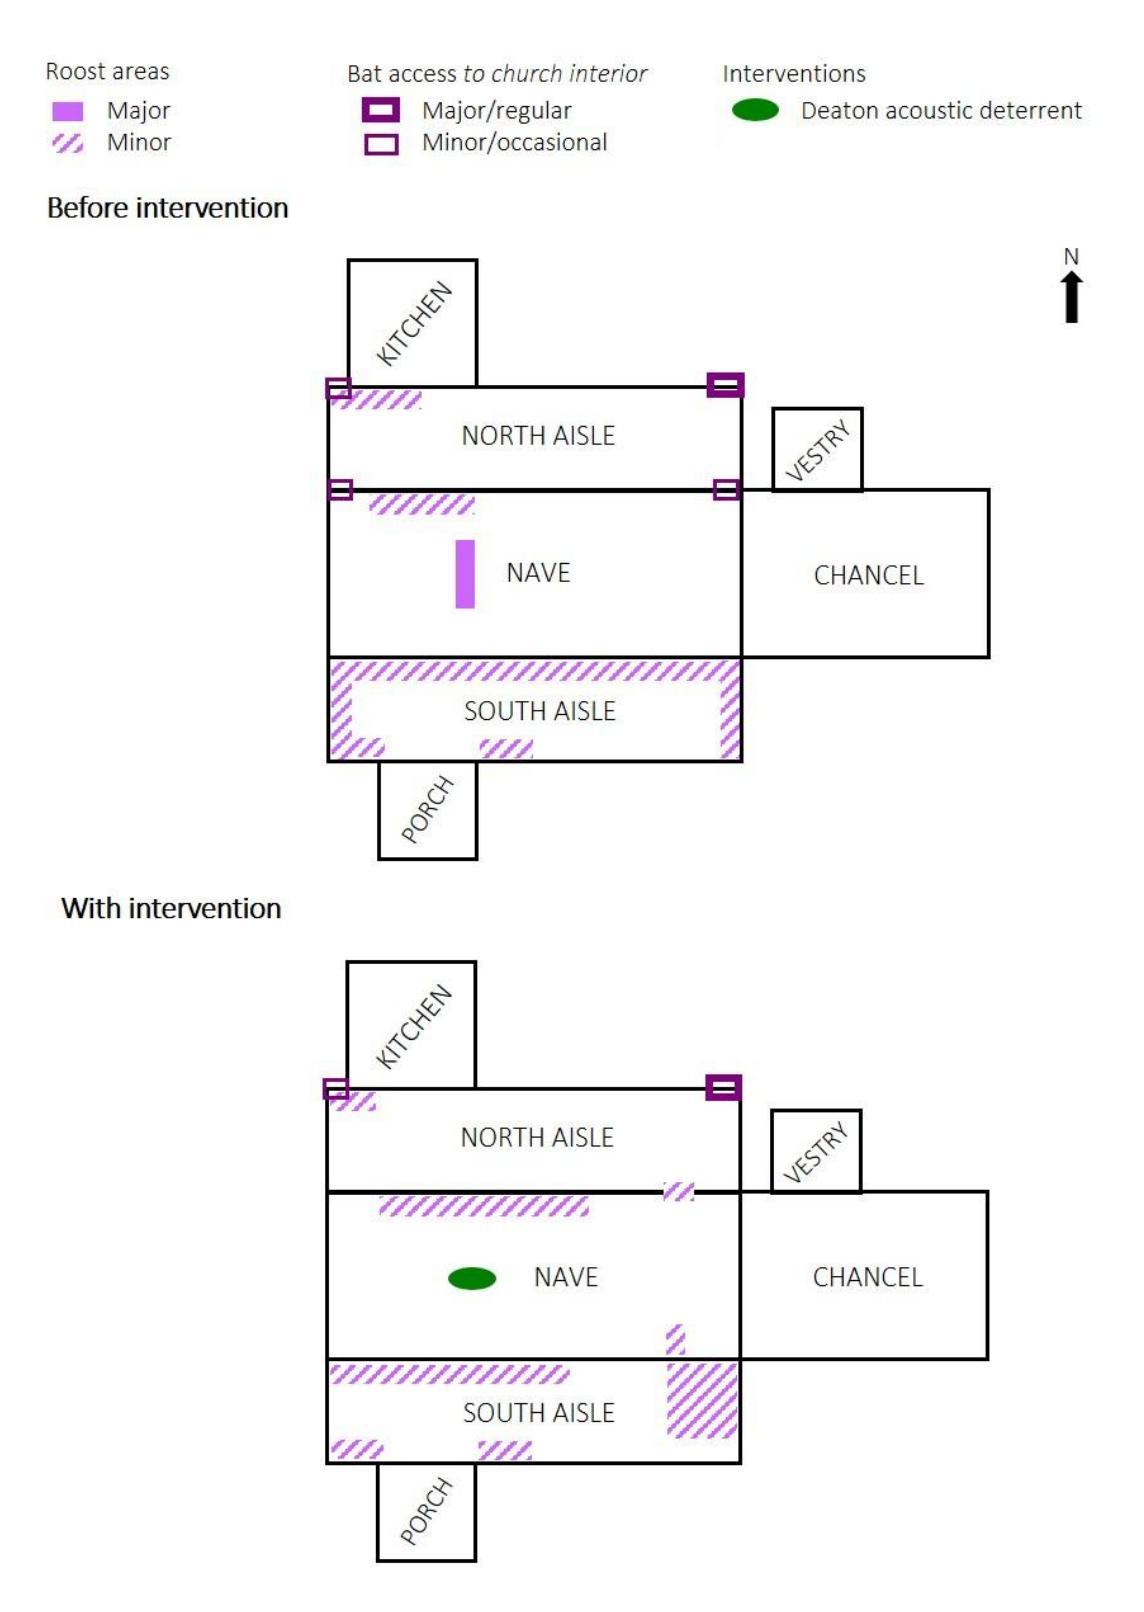
Figure 4. Simplified plan of Great Hockham Church (not to scale) showing main roost areas and bat access points to the church interior before and during deterrent use (Phase 2, August-September trials). Taken from Packman *et al.* 2015.

- Natterer's bats were found to roost at a number of different locations in the nave, south aisle and north aisle (see Figure 4). The major access point was located at the east end of the north aisle, with more minor access points at the west end of the north aisle and east and west ends of the nave (see Figure 4).

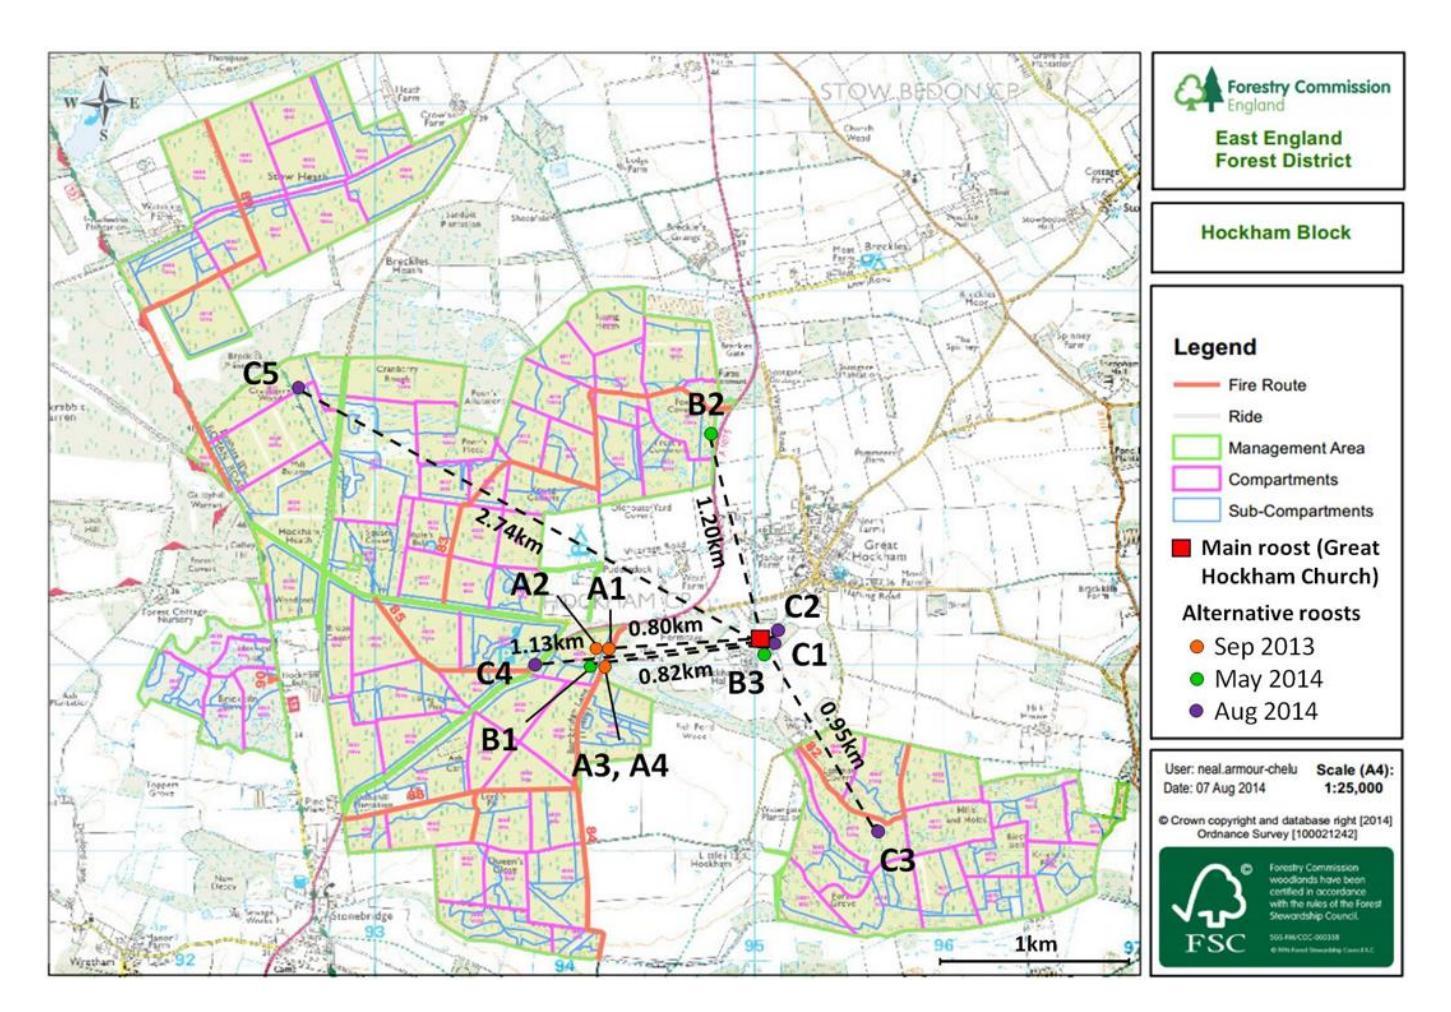
Figure 5. Alternative day roosts used by adult female Natterer's bats radio-tagged at Great Hockham Church, September 2013 (from Zeale *et al.* (2014), n = 10 bats tagged, four roosts located (A)) and May (n = 15 bats tagged, three roosts located (B)) and August 2014 (n = 4 bats tagged, five roosts located (C)) marked on a forestry base map provided by Forestry Commission. Dashed lines are labelled with the distance from the main roost (Great Hockham Church) to the alternative roost location. Taken from Packman *et al.* 2015.

- Fifteen adult female Natterer's bats were radio-tagged at the church in mid-May and a further four in early August 2014. The roosting behaviour of bats at this church differed somewhat from the other study churches. There was a higher proportion of occurrences of bats roosting outside of the church during the nine-day spring radio-tracking deterrent trials (all were tree roosts). Furthermore, this was the only church for which a significant alternative colony roost (beyond the church) was located (in a tree used by 19 Natterer's bats simultaneously). However, this alternative colony roost was not used by the bats at the time of giving birth and raising their young pups in June. The majority of the alternative roosts used by the Natterer's bats were in trees in the Hockham Block of Thetford Forest, but there was also a cluster of tree roosts around the churchyard (see Figure 5).

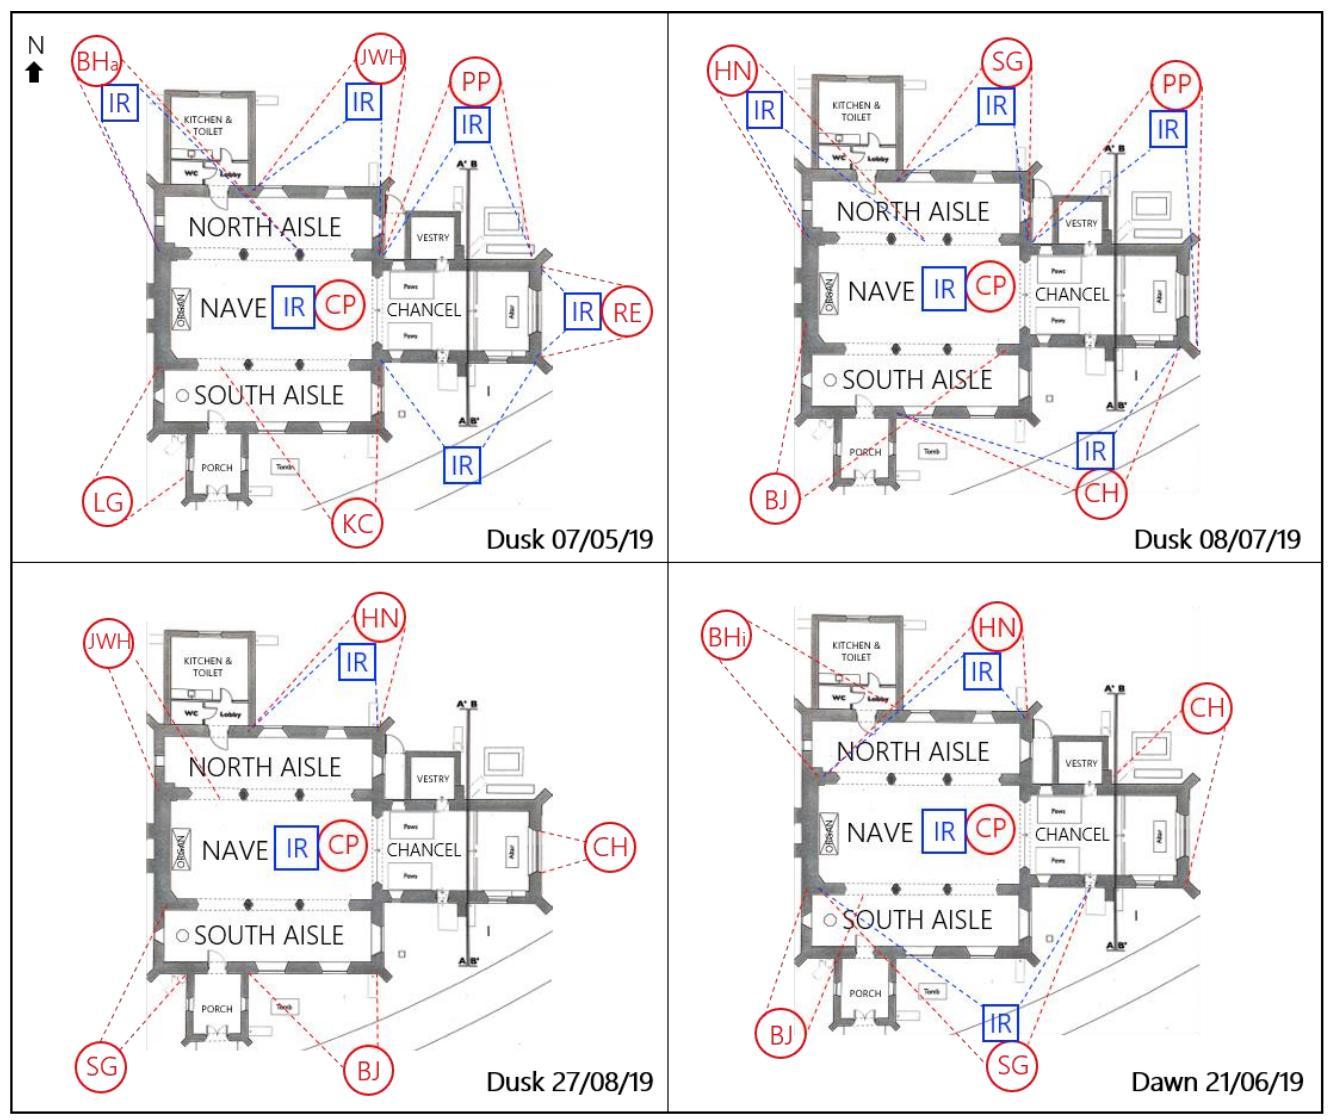
Figure 6. Bat activity survey locations of: surveyors (red circles with surveyor initials (see Table 1), fields of view indicated by red dashed lines) and infrared cameras (blue squares labelled 'IR', fields of view indicated by blue dashed lines) overlaid on church plan (by Nicholas Warns Architects). Surveyors and cameras positioned outside the church remained in fixed locations for the duration of the survey. The surveyor located inside the church moved around to observe behaviour and assess access points into/out of the church interior, equipped with a mobile infrared camera set-up.

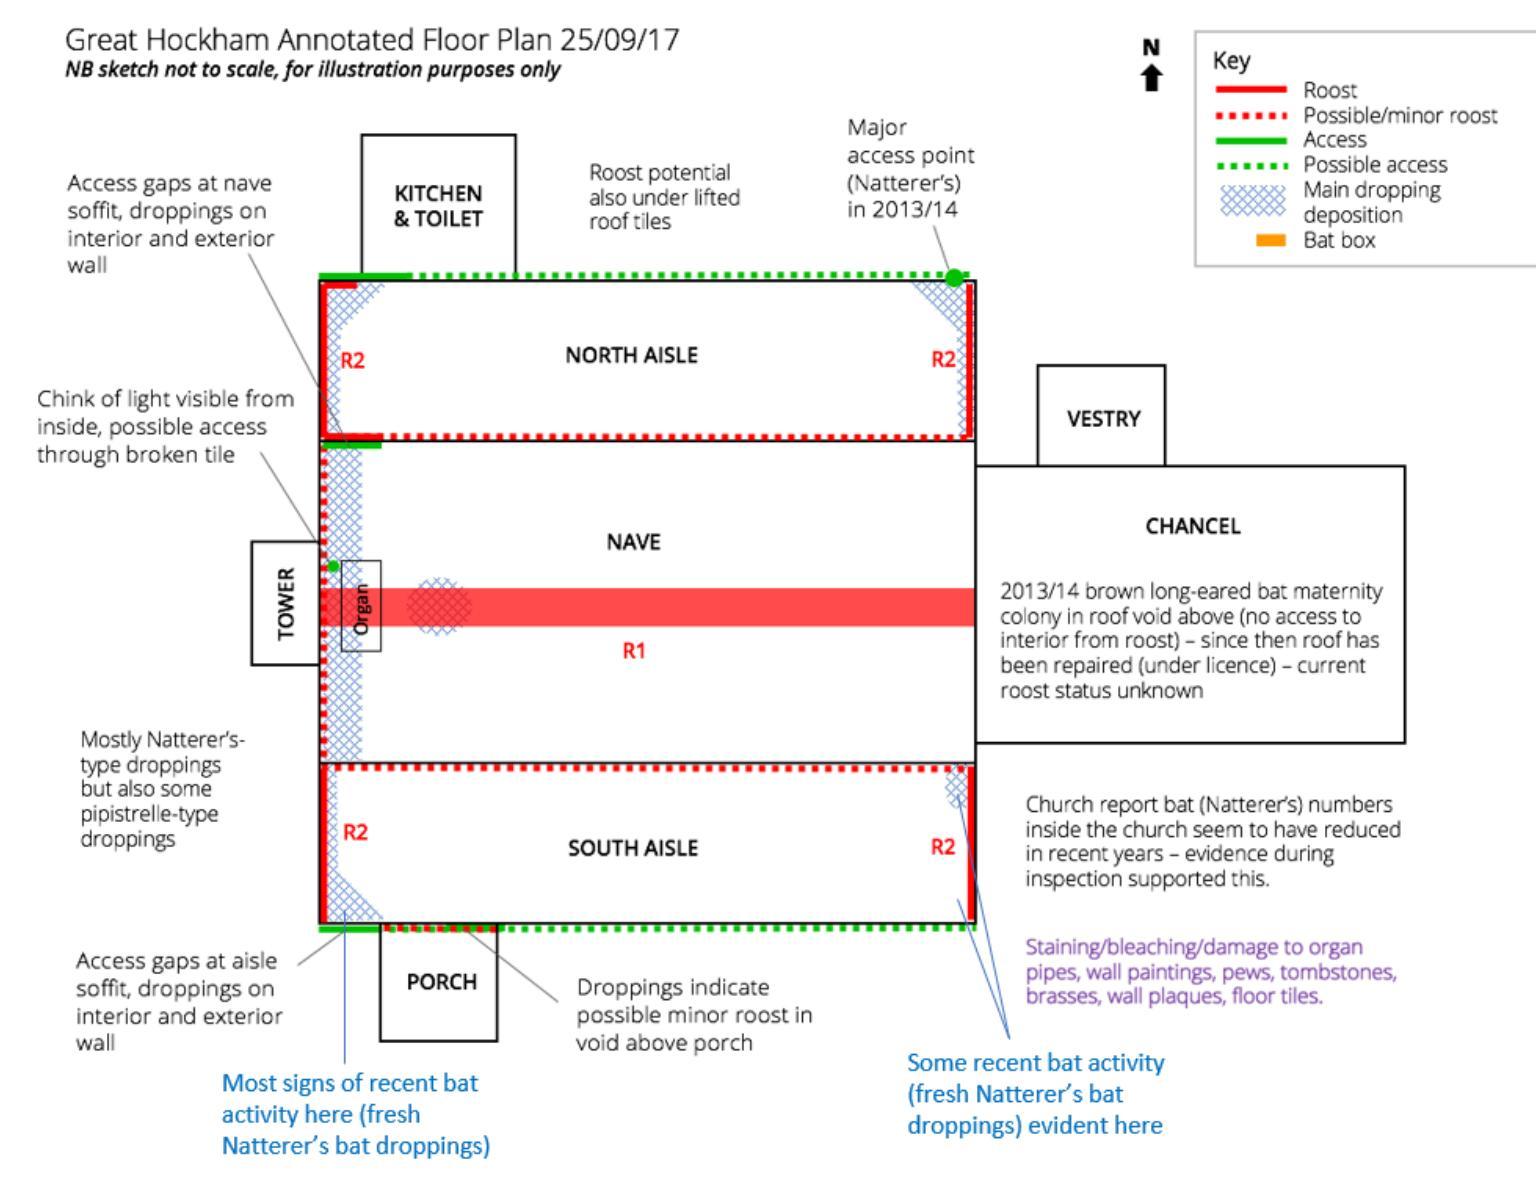
Long-term impacts from bats can be seen throughout the church: staining/bleaching from bat droppings/urine on floor tiles, walls (including wall paintings), pews, ledger stones, brasses, wall memorials and the organ pipes. At the time of the visual inspection, fresh Natterer's-type droppings were concentrated at the west end of the south aisle with some also at the corners of the east end of the south aisle (R2, Figure 7). During the 2017 Light Touch Survey visual inspection, droppings were evident at these locations as well as concentrations at the west end of the nave and east and west ends of the north aisle (R2, Figure 7). The distribution of droppings indicated roost presence along the nave ridge (R1, Figure 7) and at the ends of both aisles, with some more minor roosts likely to be present along the northern side of the south aisle, southern side of the north aisle, west end of the nave and porch roof void. There are confirmed (Zeale *et al.* 2014 and Packman *et al.* 2015) access points at the east end of the north aisle, northern side of the nave (particularly at the west end) and west end of the south aisle. There is potential further access along the lengths of the aisles and nave; the building appears to be quite 'bat-porous'.

Figure 7. Visual inspection results from Light Touch Survey 25/09/17, updated 07/05/19 (annotated on plan in blue). Plan not to scale. Rx indicates roost locations (see main text and 2017 Bat Roost Visit Report Form, Appendix 1).

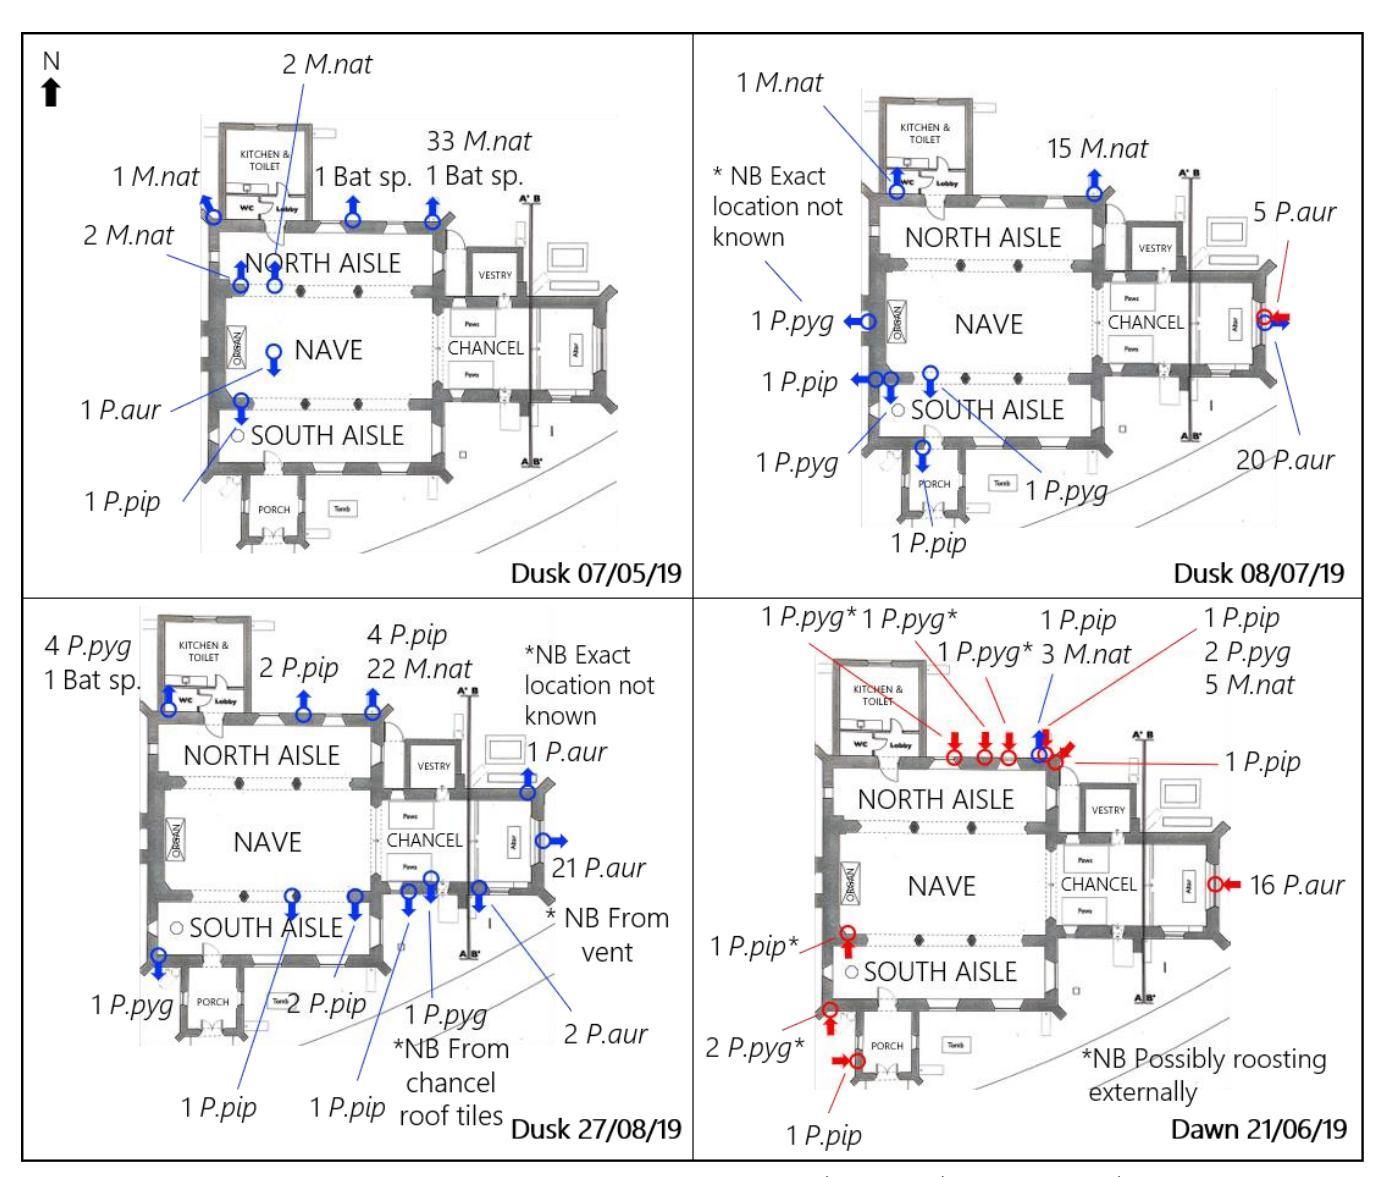
Most emergence (and re-entry) for Natterer's bats (and for pipistrelle species accessing the church interior) was at eaves level at the east end of the north aisle (Figures 8 & 10). Small numbers of Natterer's bats also exited from the west end of the nave (and one from the west end of the north aisle). Individual pipistrelles also exited/entered the building at other points along the north aisle, west end of the south aisle and west end of the nave (south side), but at least some of these appeared to be external roosts only (i.e. without the bats passing from/to the interior of the church). Almost all of the brown long-eared bats emerged from a vent high up on the east gable end of the chancel (see Figures 8 & 10), with small numbers occasionally also emerging from the south and north sides of the chancel roof.

Figure 8. Results from the bat activity surveys (dusk 7th May, 8th July and 27th August 2019 and dawn 21st June 2019) shown on a plan of the church (Nicholas Warns Architects): emergence (blue circle & arrow)/re-entry (red circle and arrow) locations, species and numbers.

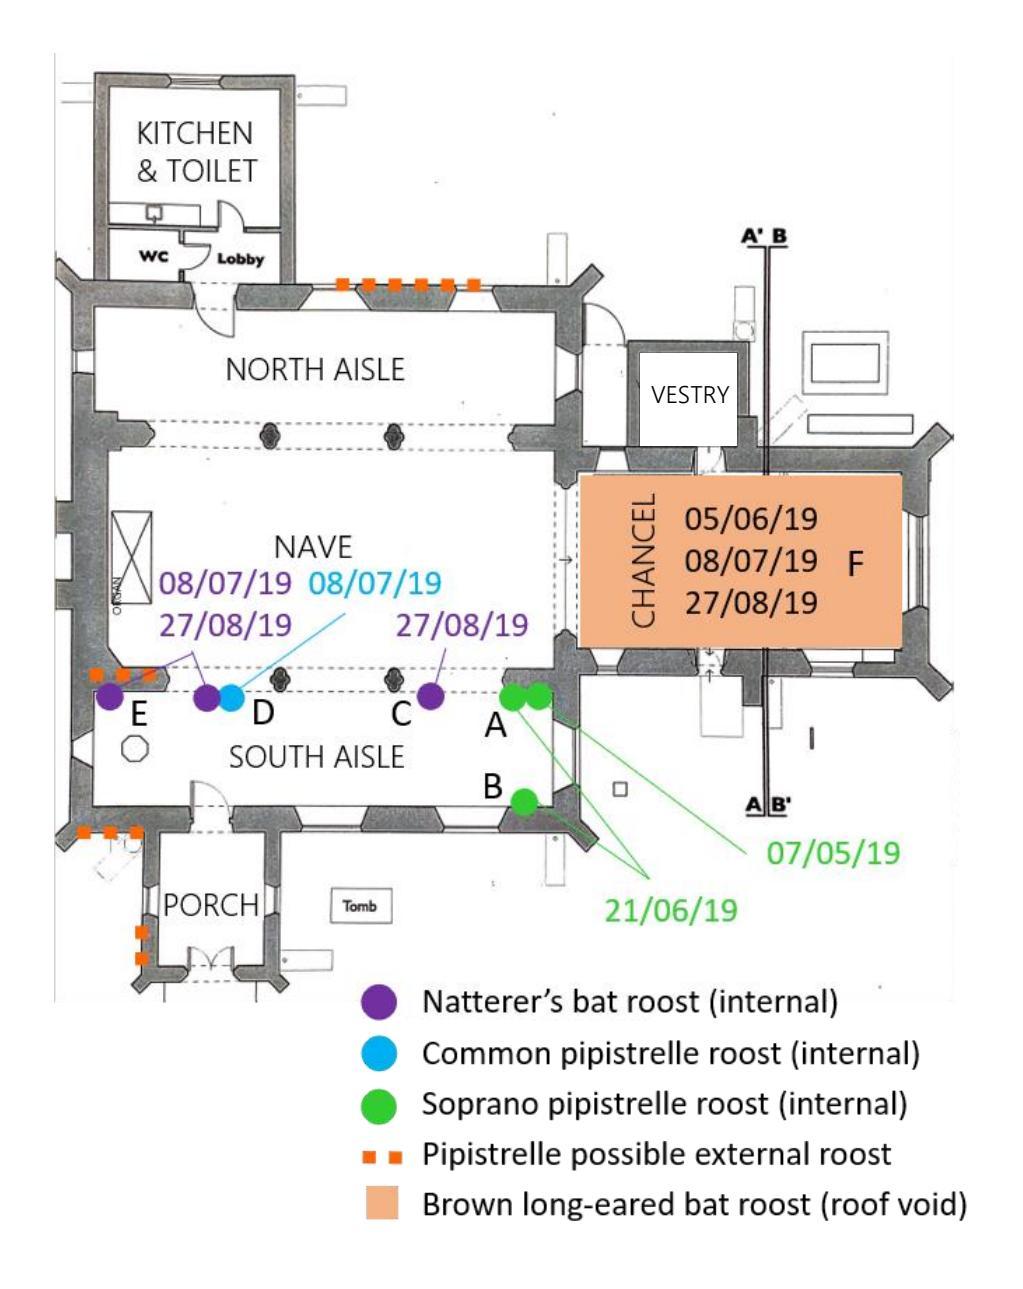
There are many different roost areas that have been identified in the church over the multiple years of study (see Figures 7 & 9). During the 2019 activity surveys, Natterer's bats (and the occasional common pipistrelle) were mostly roosting at the western end of the south aisle (north wall, roosts D & E in Figures 9 & 11), although droppings also indicated roosting activity further east of this location (roost C in Figure 9). Small numbers of soprano pipistrelles were observed using roosts at the east end of the south aisle (north and south walls, roosts A & B in Figures 9 & 11). It is also thought that some of the pipistrelles at the church are roosting externally, as noted above. The brown long-eared bat roost is located in the chancel roof void (without access to the church interior, roost F in Figure 9, see also Figure 10).

Figure 9. Roost locations (labelled A-F) identified during activity surveys (survey dates given) through either internal observations of bats emerging/re-entering the roosts at these locations, through concentrations of droppings on the floor beneath these locations (C) or through internal and external simultaneous observations confirming bats were likely to be roosting externally i.e. re-entering from the outside but not passing through to the building's interior. Note this is not a comprehensive record of all roosts – only those that were evident during the 2019 activity surveys. Information overlaid on church plan by Nicholas Warns Architects.

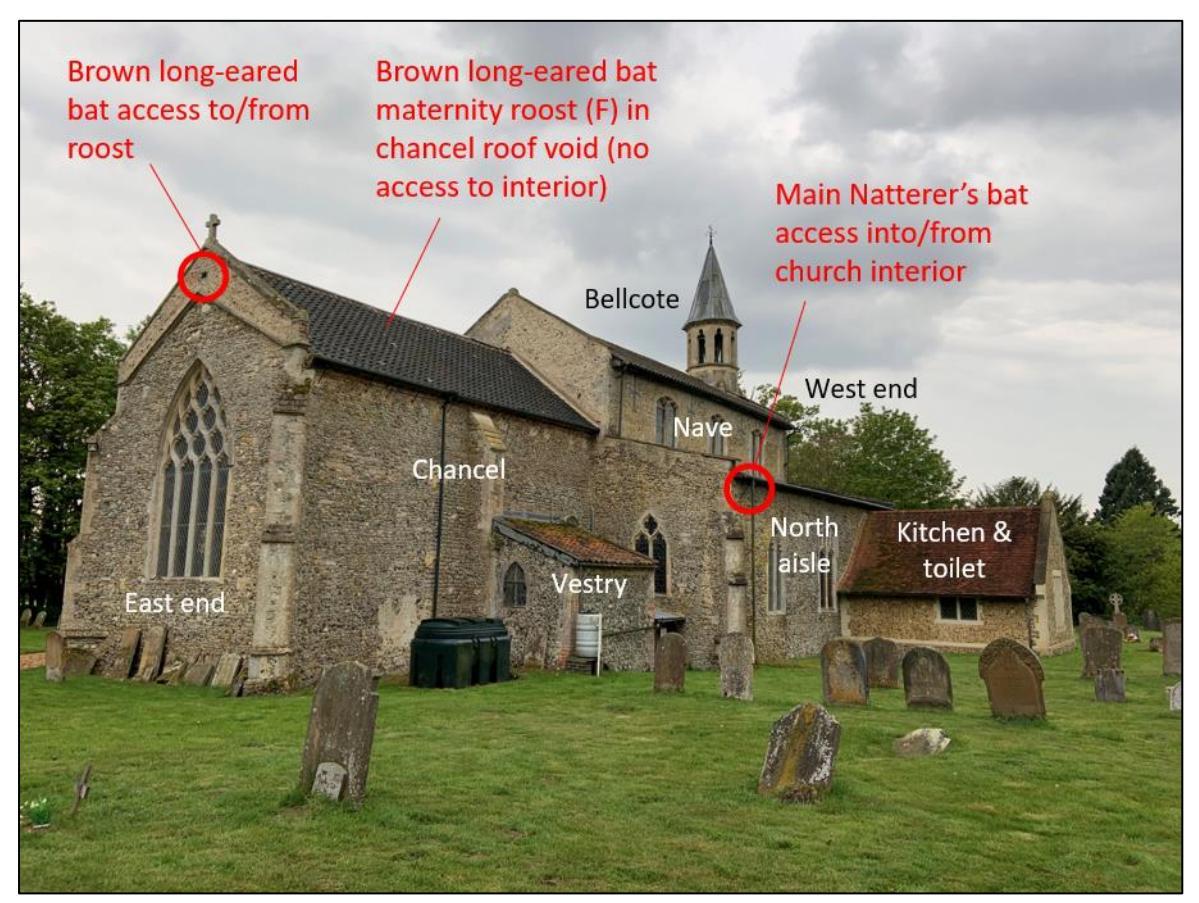
Figure 10. Annotated photo of the northern elevation of the church (with parts labelled) showing main access point and roost location for brown long-eared bats (roost F in text & Figure 9) and main access point into/from the church interior for Natterer's bats.

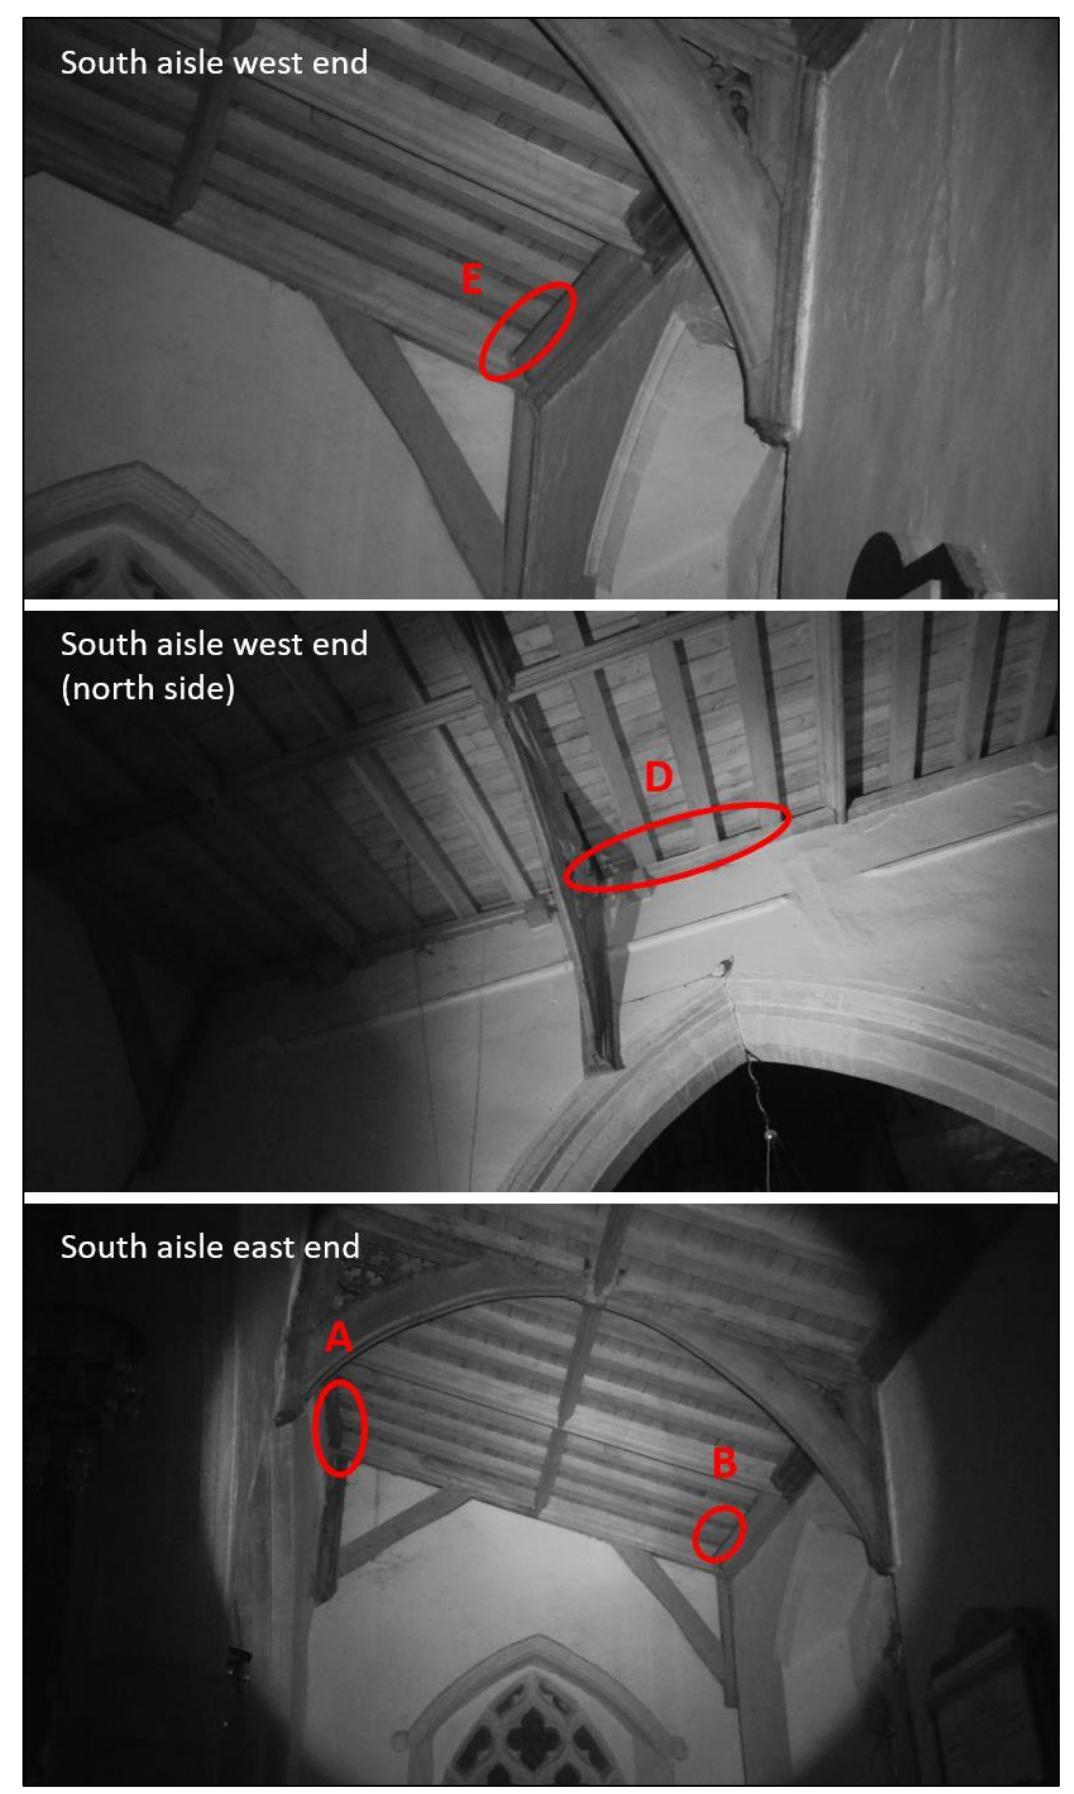
Figure 11. Annotated infrared photos showing interior roost locations during 2019 bat activity surveys (all in south aisle). Roost labels (A, B, D & E) as in text and Figure 9.

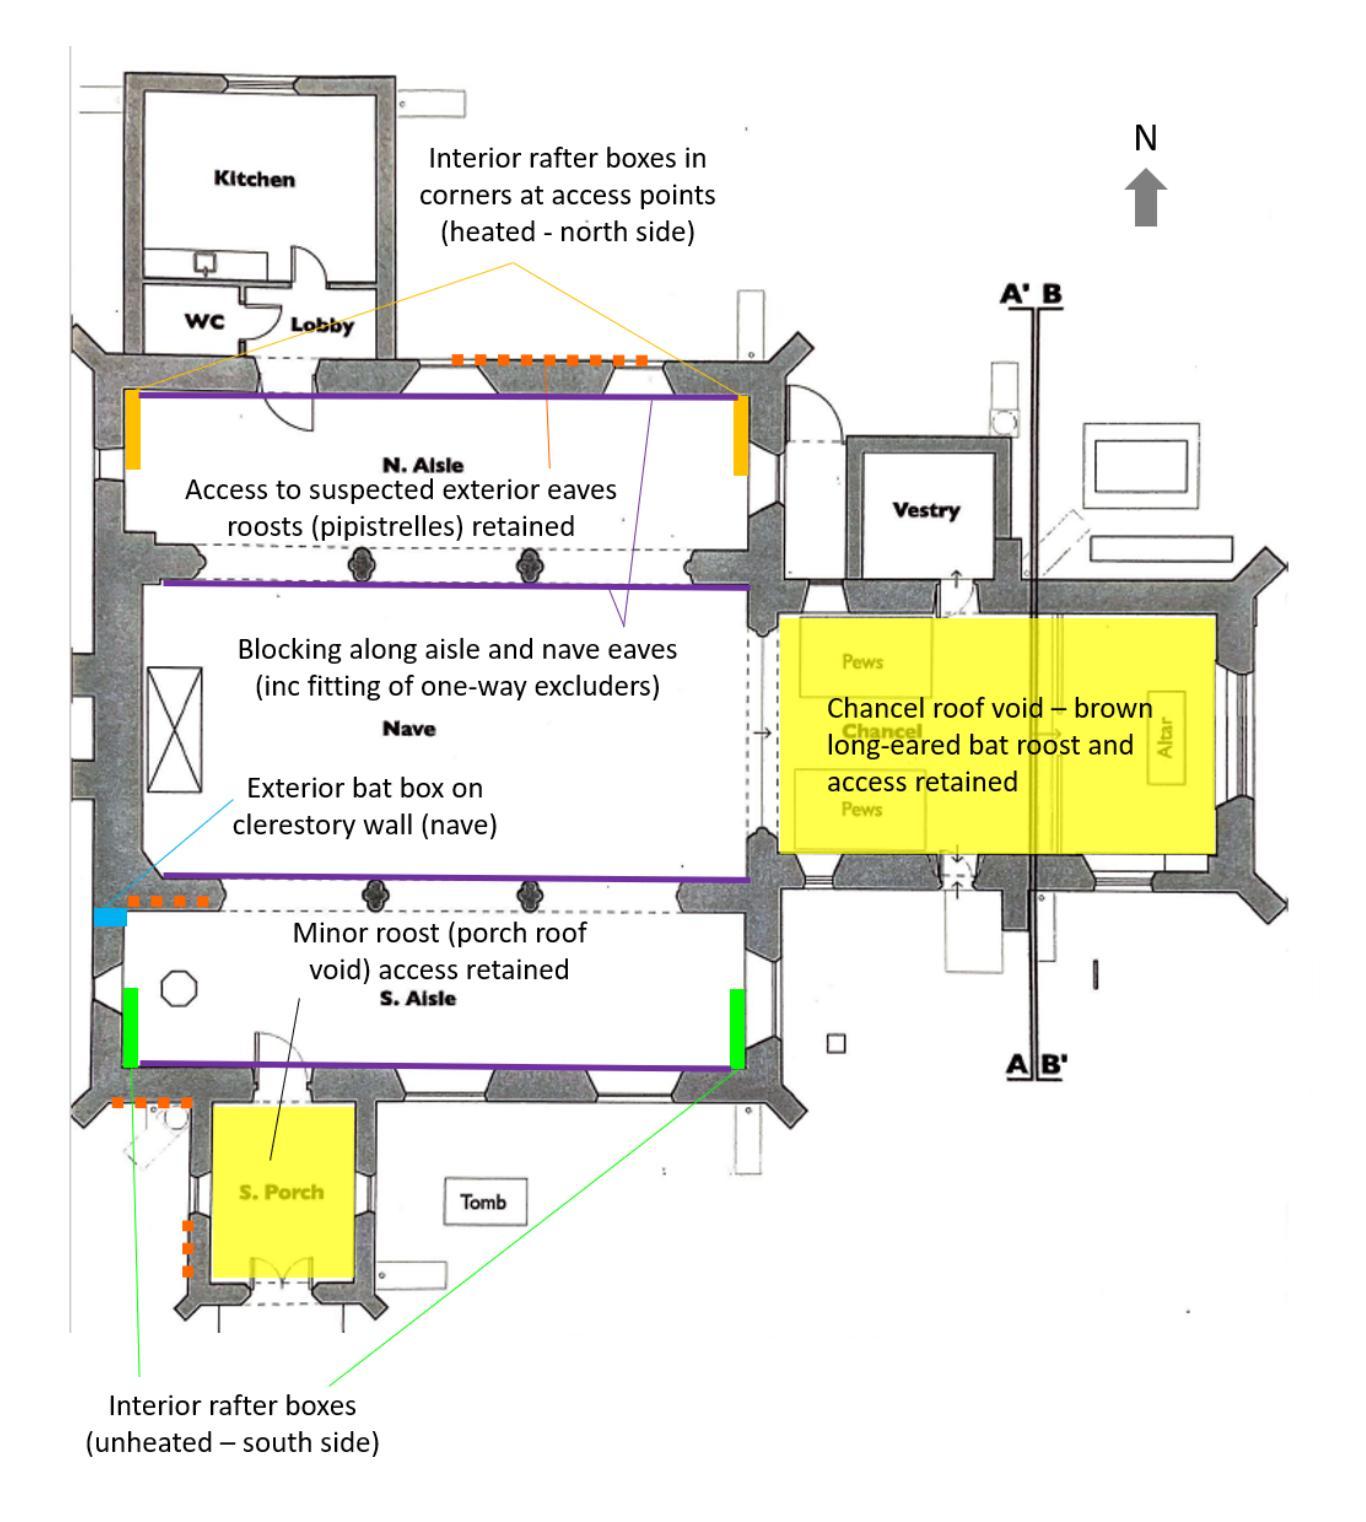
Figure 12. Annotated church plan (Nicholas Warns Architects) showing locations of the proposed management interventions (and roosts to be retained/not affected).

The proposed management plan would involve construction of four artificial roosts (rafter bat boxes) around existing access points/roost areas in the church interior (at each end of the north and south aisles) and an exterior bat box on the south nave clerestory wall. The two north aisle rafter bat boxes would be fitted with heat pads to compensate for the northerly aspect and all four rafter boxes would have roost cameras installed to facilitate monitoring. In Year 1 (2020) these would be installed with an interior access slot, allowing the bats to familiarise themselves with the new roost provision whilst still having access to the church interior (thus reducing the risk of desertion and negative impacts on the bat colonies). Access to the existing (suspected) exterior pipistrelle roosts (in the church structure but without access to the interior) would be retained, along with the self-contained brown long-eared bat maternity roost in the chancel roof void (without direct access to the church interior).

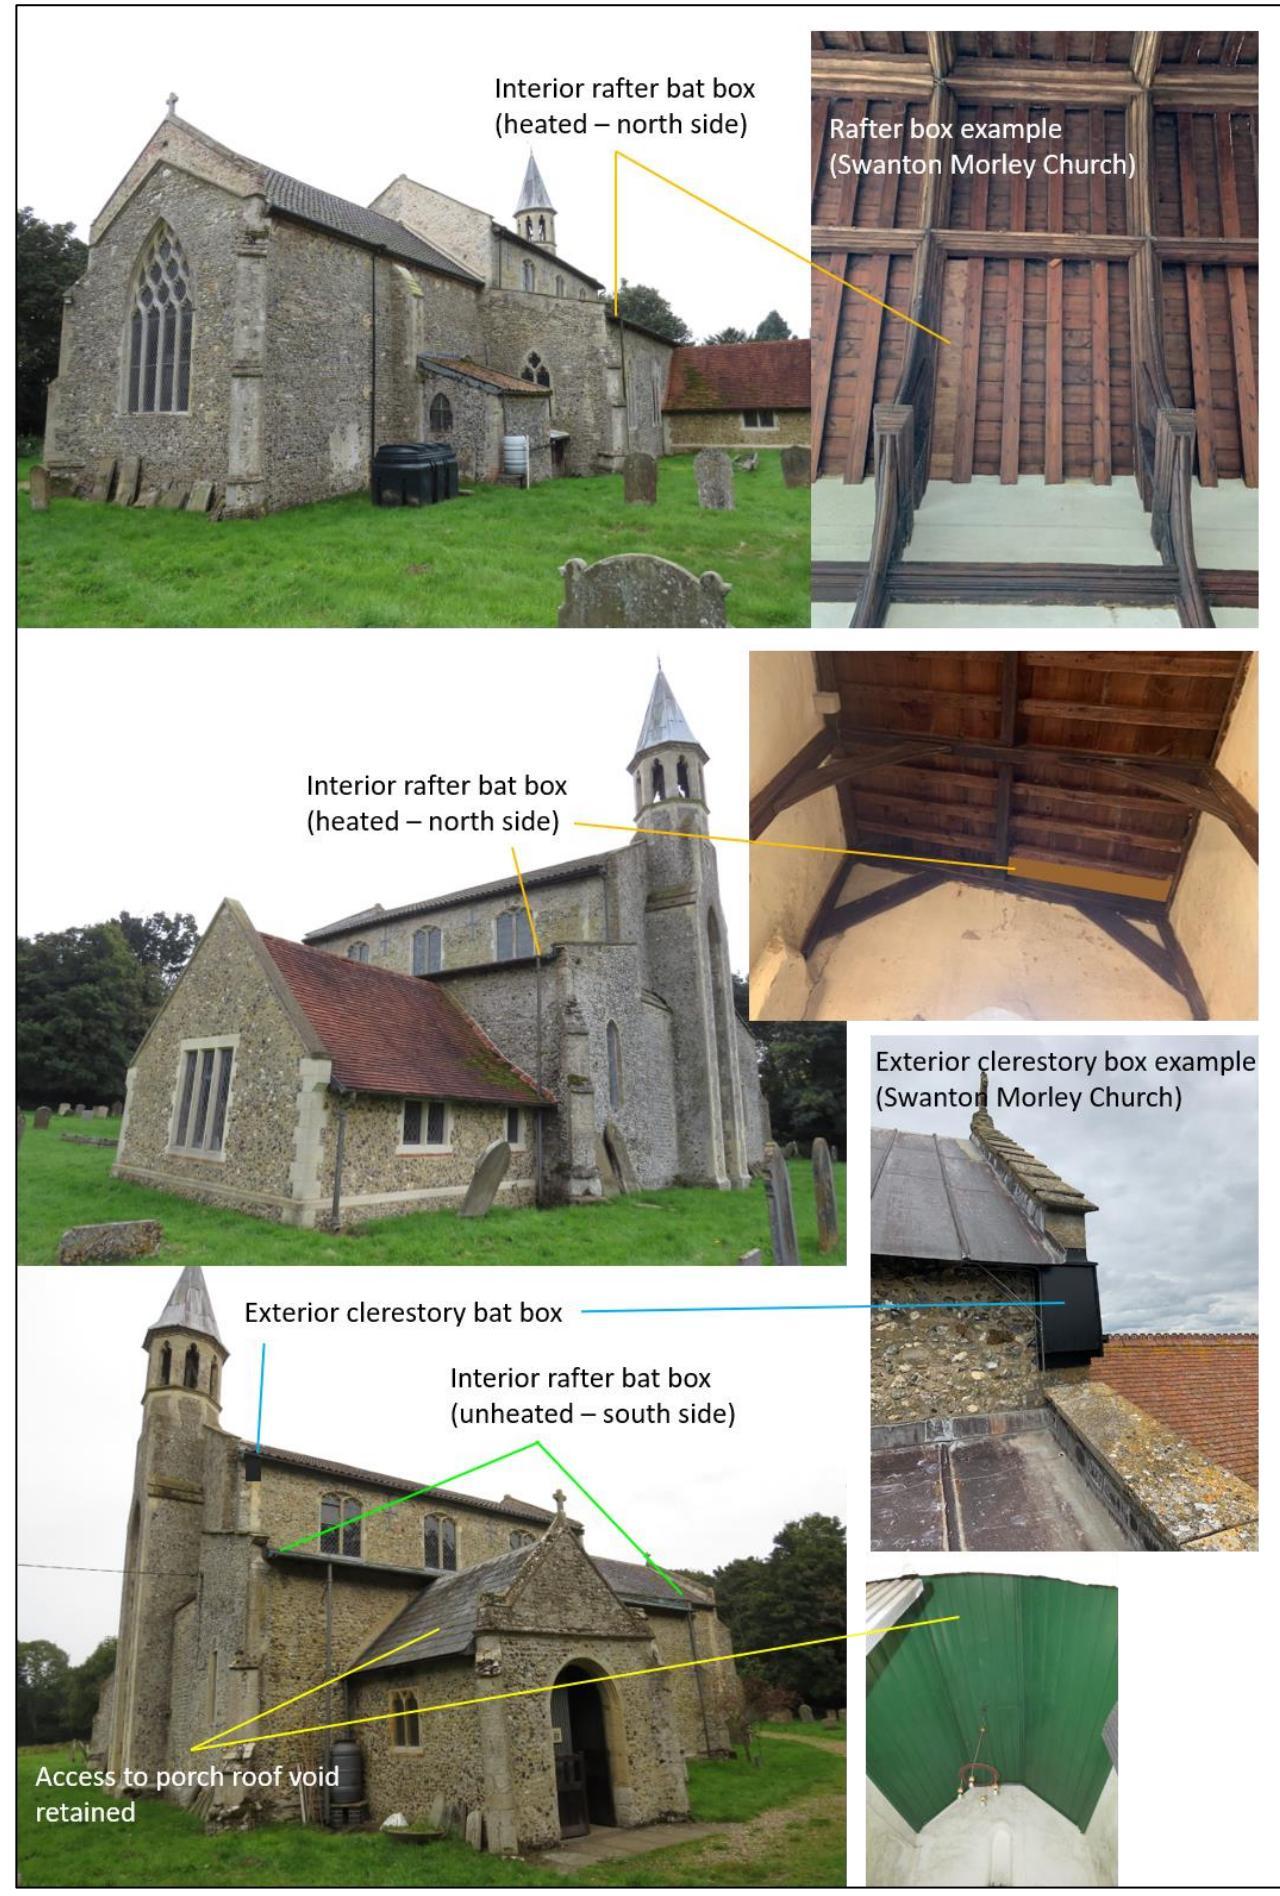
Figure 13. Photos/illustrations of proposed measures.
