Bats in Churches Project: Holy Trinity Church Great Hockham Bat Survey & Management Plan Report January 2020 (revised v1.1 June 2020)

Document type	Bats in Churches Project – Bat Survey & Management Plan Report
Version	1.1
Author	Dr Charlotte Packman PhD CEcol MCIEEM
Client	Natural England
Site address	Holy Trinity Church, Great Hockham, Thetford, Norfolk, IP24 1NZ.
Site grid reference	TL 95069 92097
Survey period	May – August 2019
Report date	4 th February 2020, updated 3 rd June 2020 (v1.1) with revised Schedule
	of Works needed due to Covid-19 restrictions

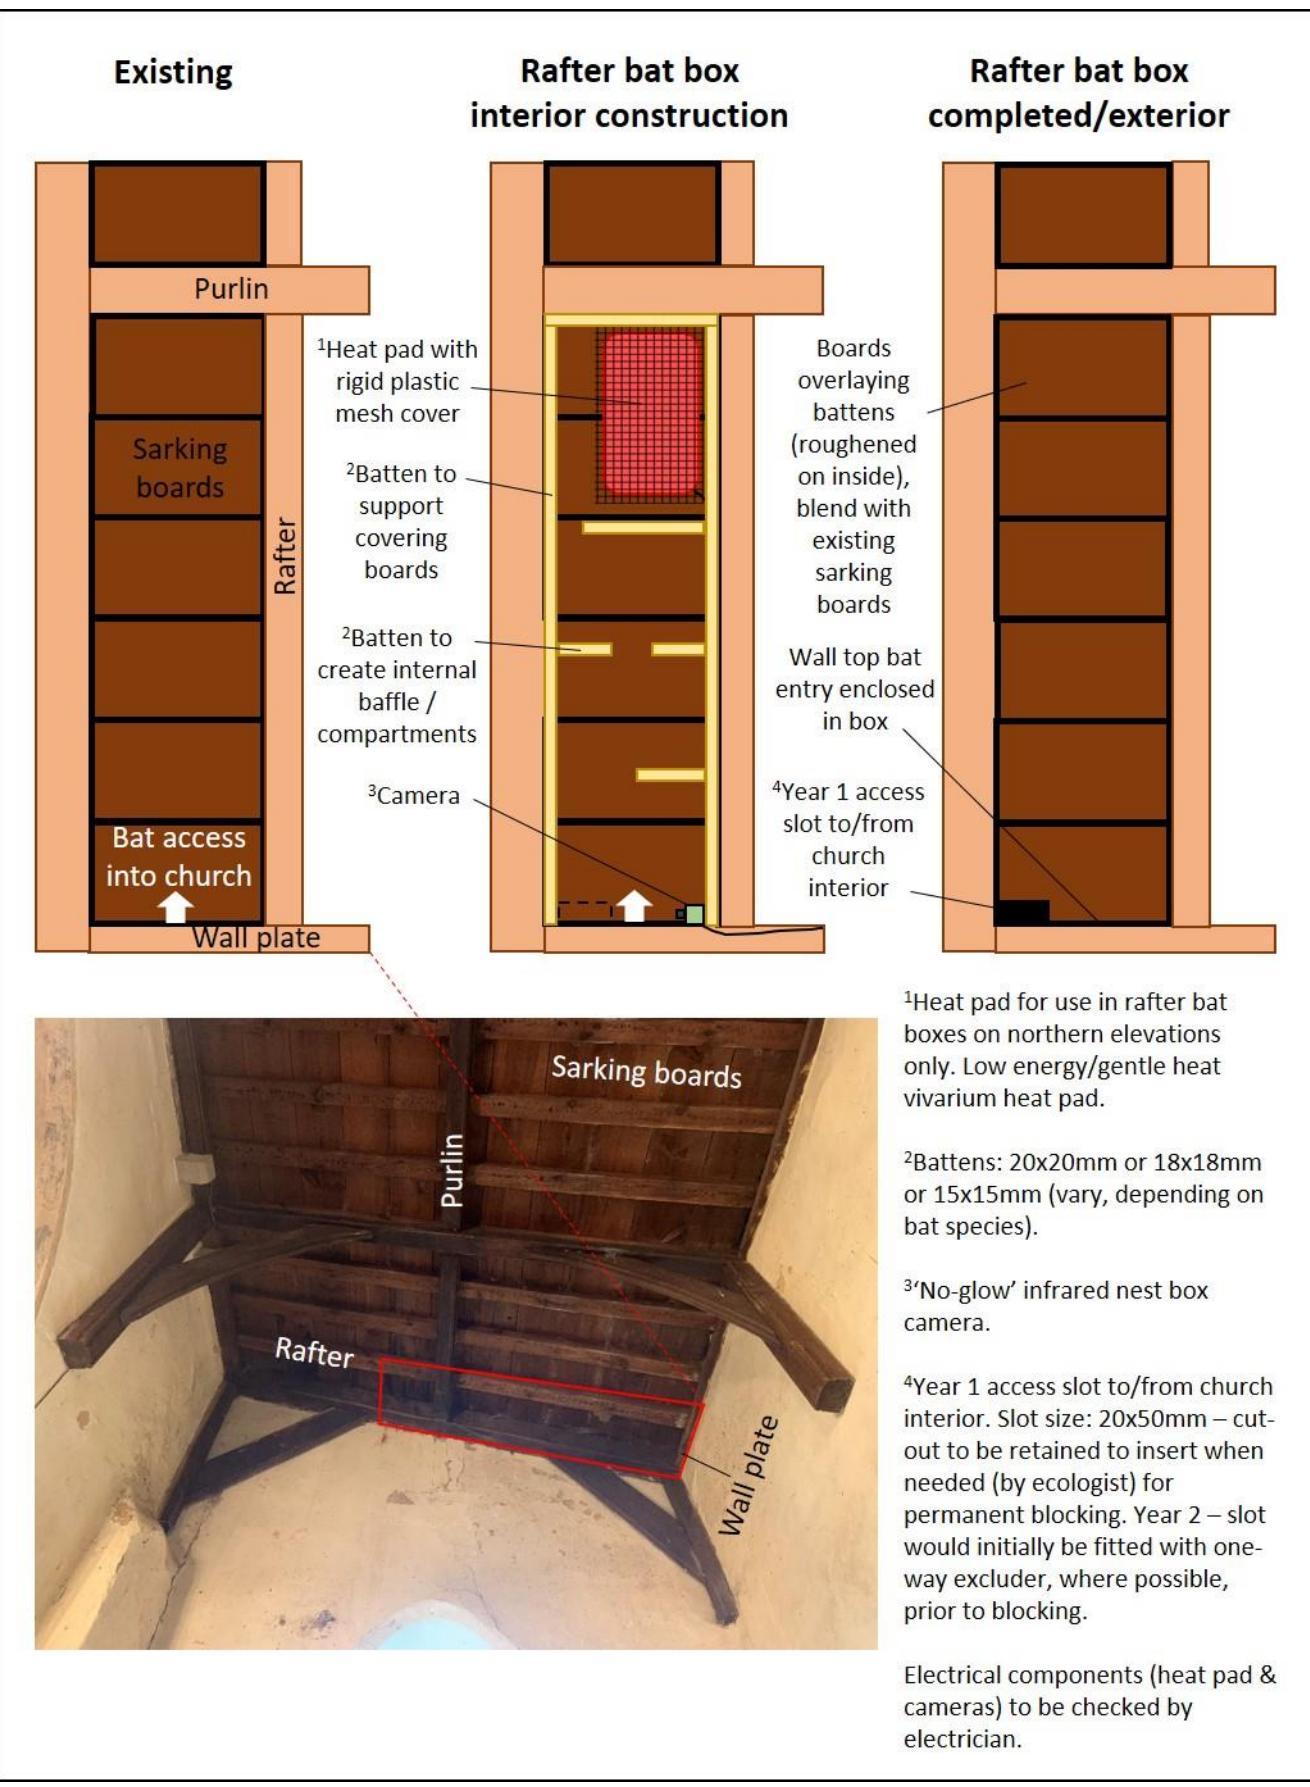
Figure 14. Rafter bat box design (generic), C. Packman.

The proposed management plan would involve construction of four artificial roosts (rafter bat boxes) around existing access points/roost areas in the church interior (at each end of the north and south aisles) and an exterior bat box on the south nave clerestory wall. The two north aisle rafter bat boxes would be fitted with heat pads to compensate for the northerly aspect and all four rafter boxes would have roost cameras installed to facilitate monitoring. In Year 1 (2020) these would be installed with an interior access slot, allowing the bats to familiarise themselves with the new roost provision whilst still having access to the church interior (thus reducing the risk of desertion and negative impacts on the bat colonies). Access to the existing (suspected) exterior pipistrelle roosts (in the church structure but without access to the interior) would be retained, along with the self-contained brown long-eared bat maternity roost in the chancel roof void (without direct access to the church interior).

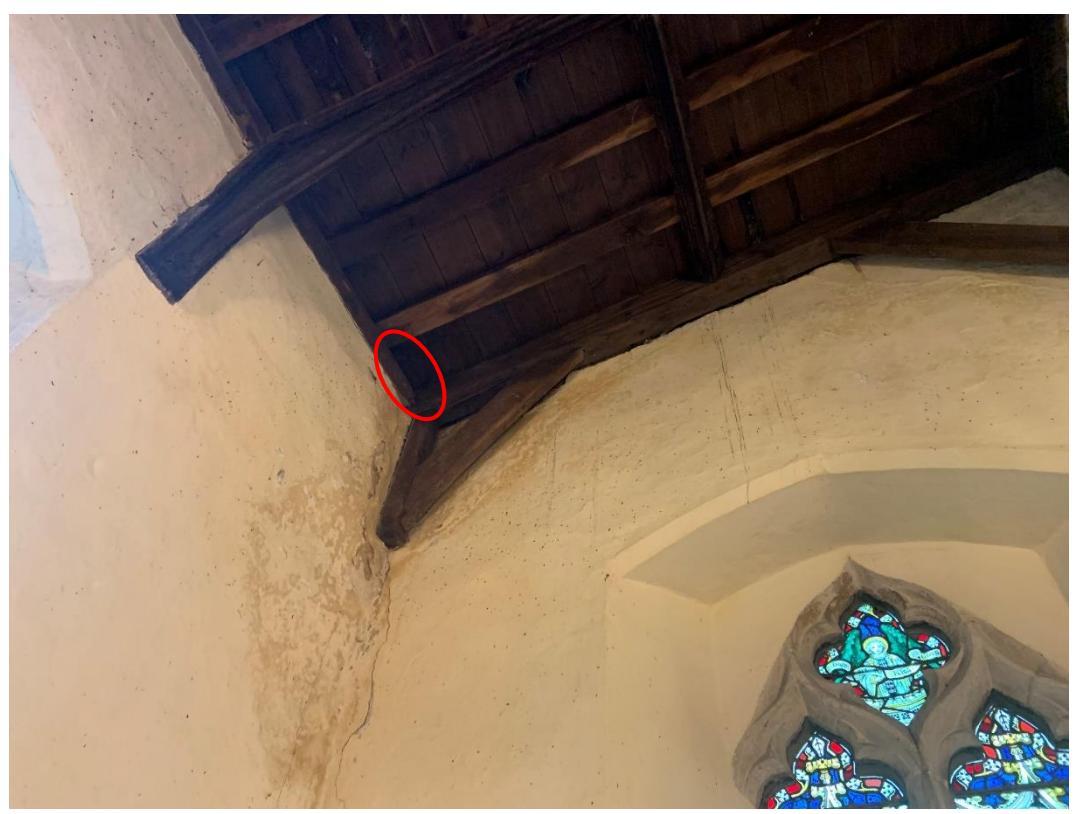
Photo 8. North aisle (east end) major Natterer's bat access point into/from church interior (circled in red, damage to wall from water ingress).

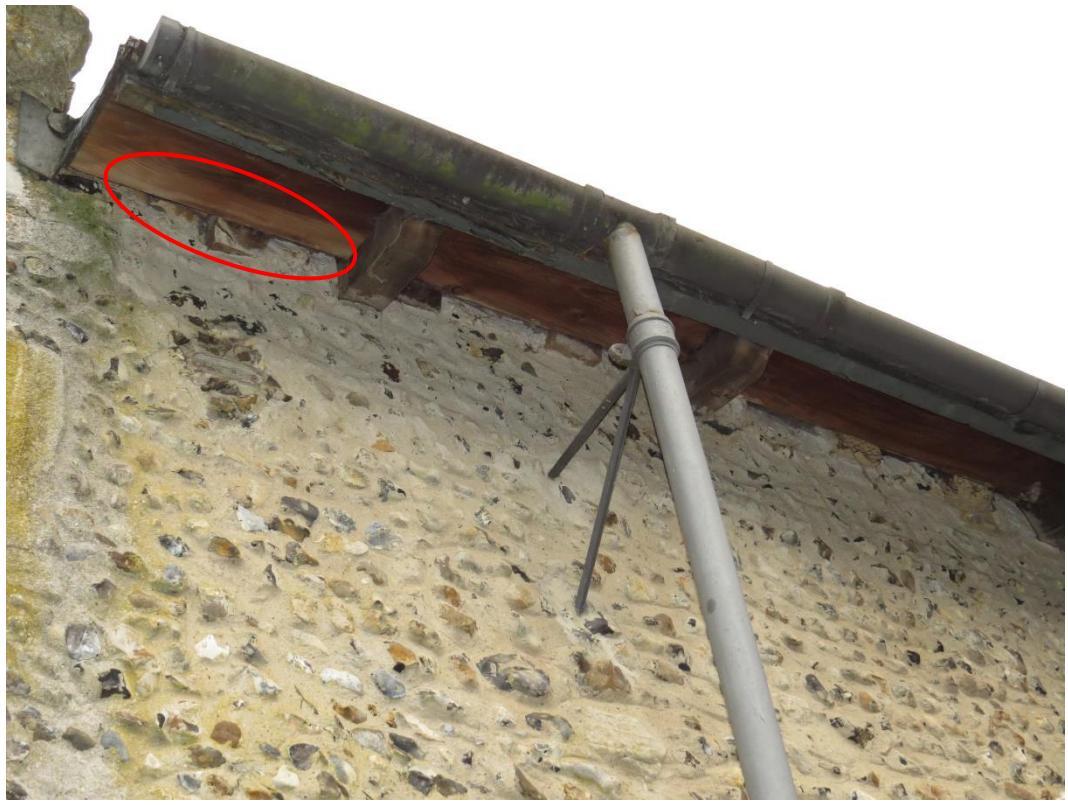
Photo 9. East end of north aisle – major Natterer's bat access circled in red.

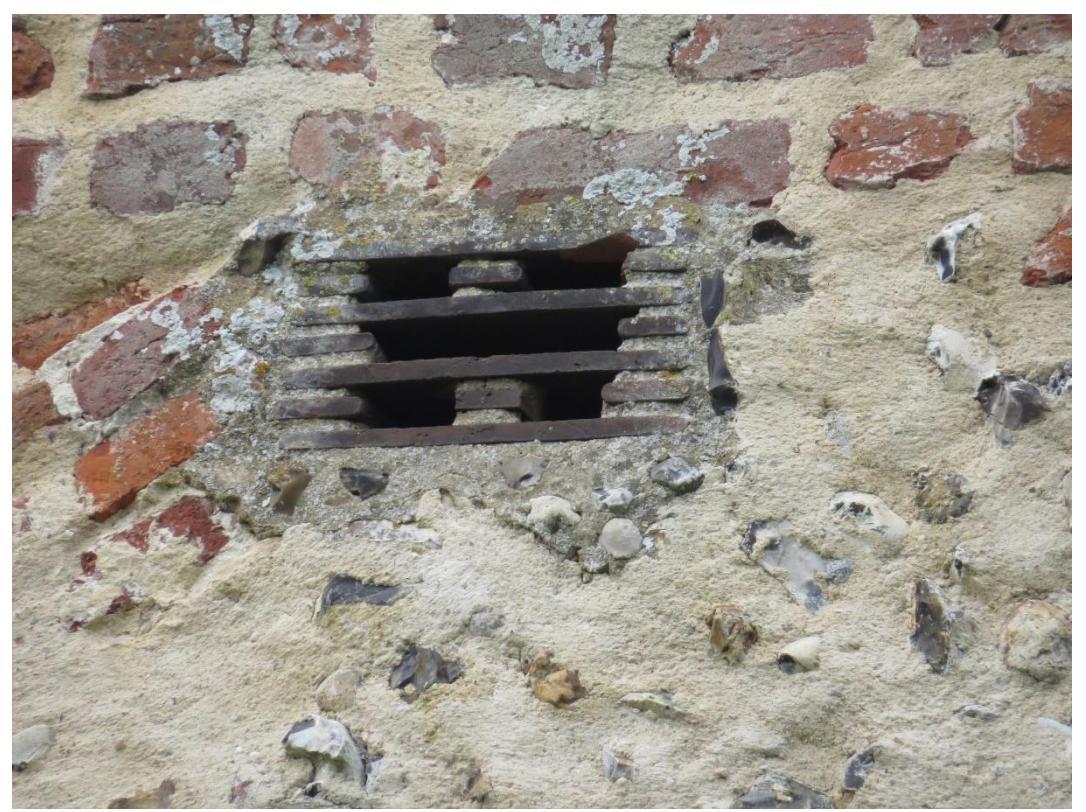
Photo 10. Brown long-eared bat access to/from chancel roof void (east end of chancel).

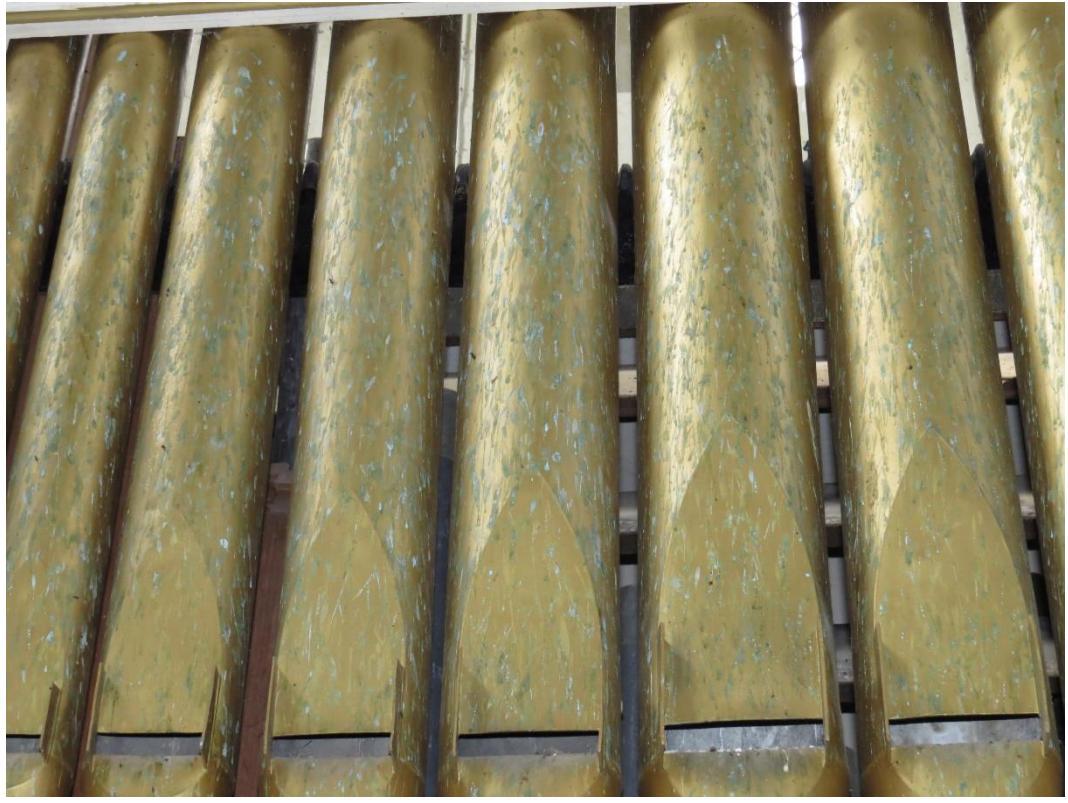
Photo 11. Bat urine staining on organ pipes.

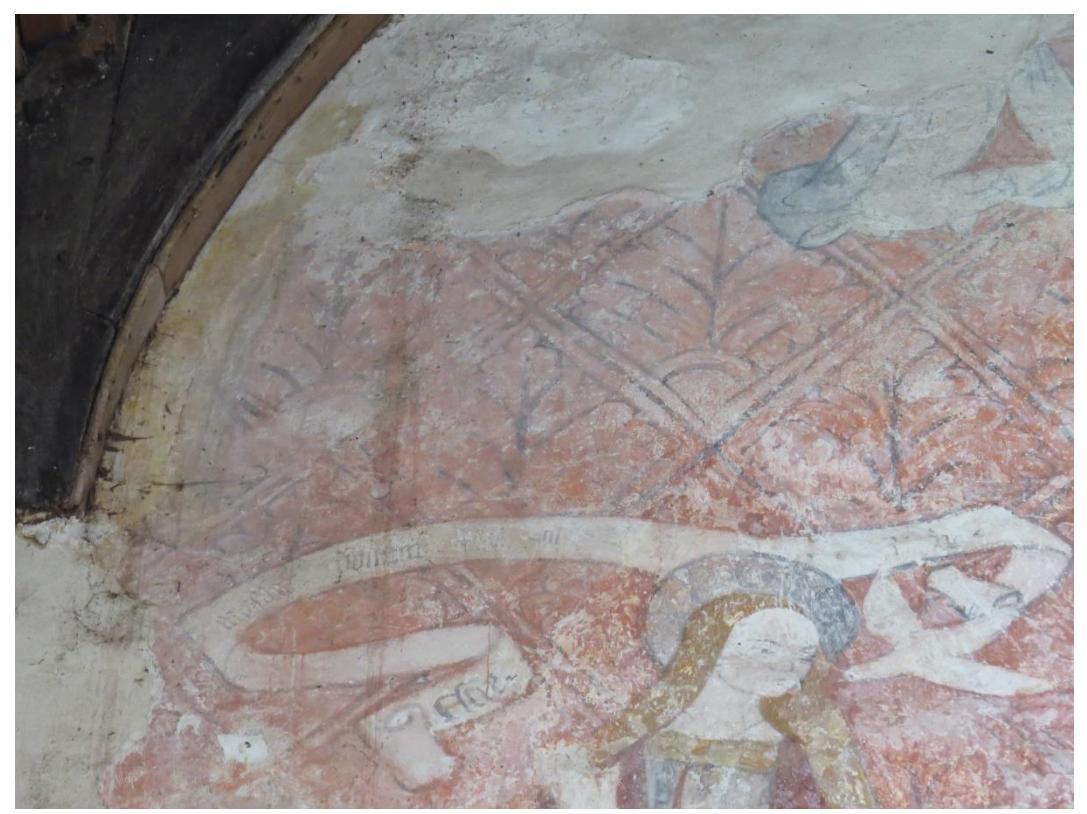
Photo 12. Staining on wall painting (nave east wall, above chancel arch).

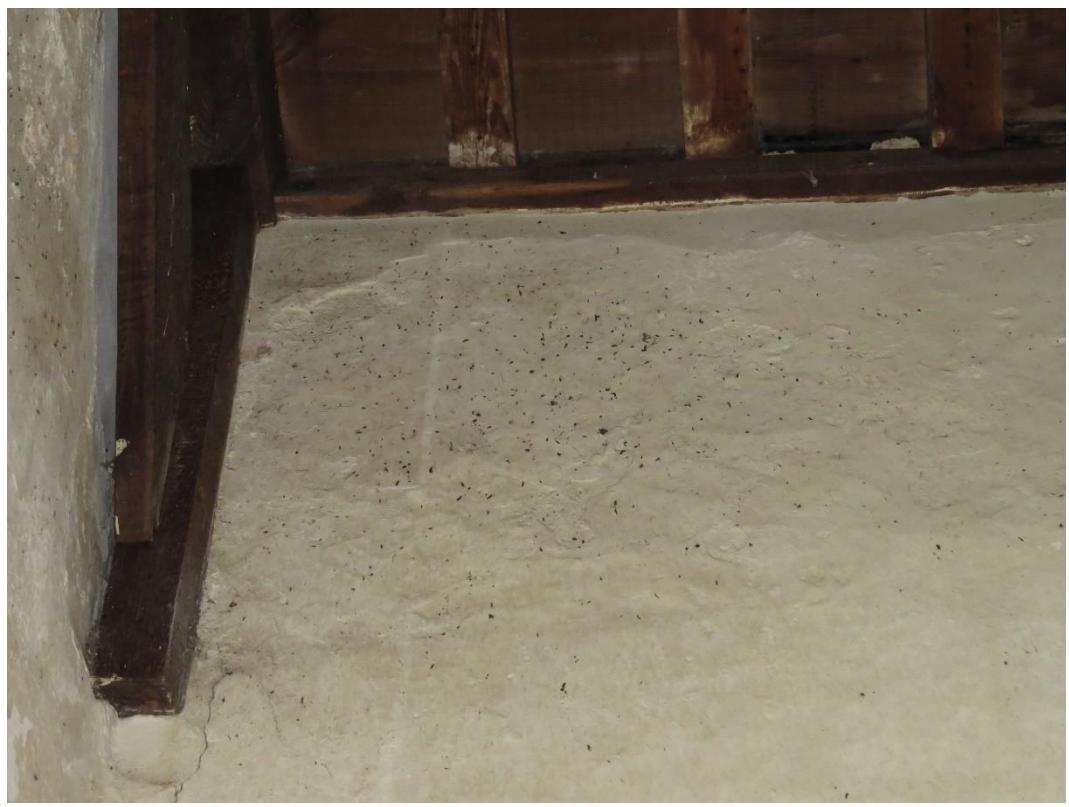
Photo 13. Bat droppings on wall.

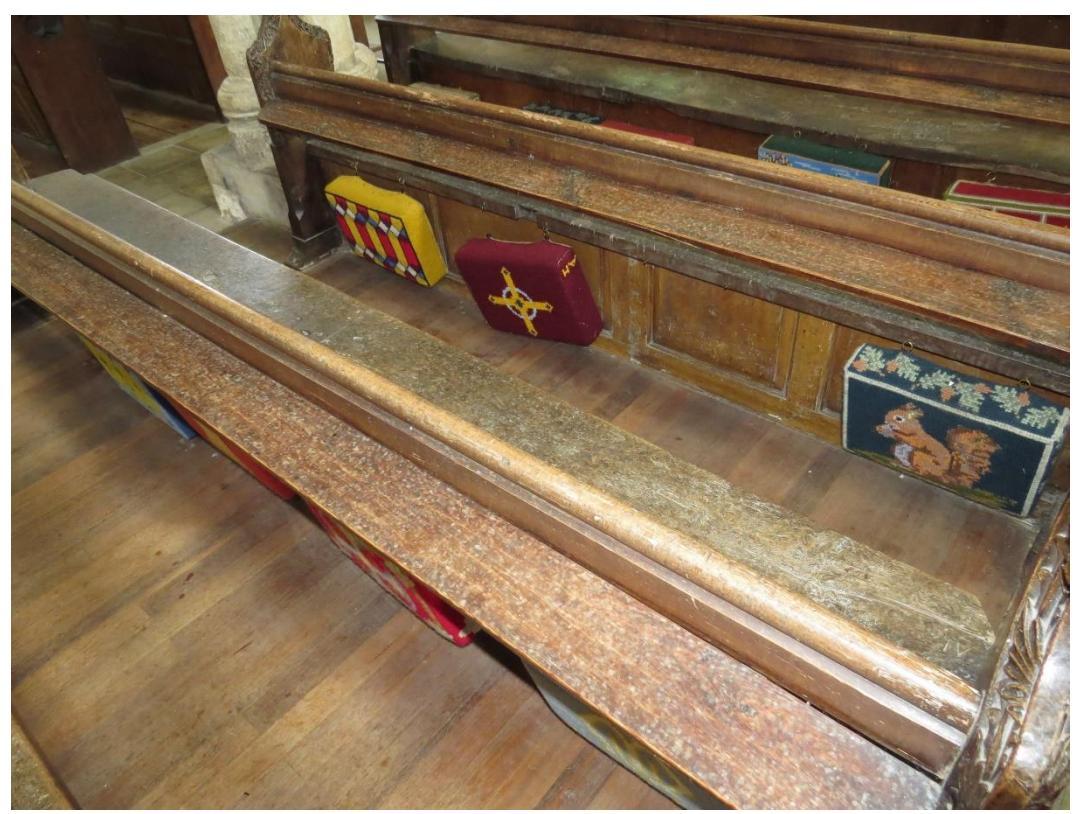
Photo 14. Bat urine bleaching on pews.

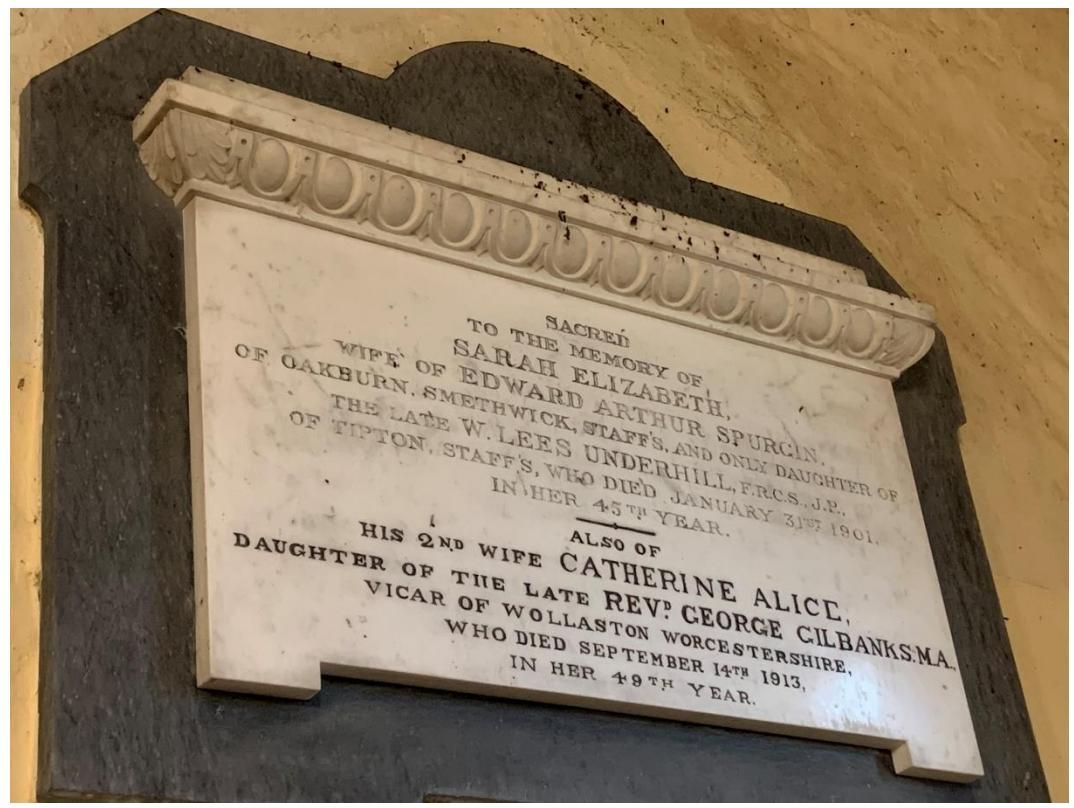
Photo 15. Bat droppings and urine staining on wall memorial.
